**Functional Site Servicing and
Stormwater Management Report
Rev.03 – 1987 Robertson Road
(Stillwater Station)**

Stantec Job #160401686

The Properties Group Management Ltd.

Stantec Consulting Ltd.

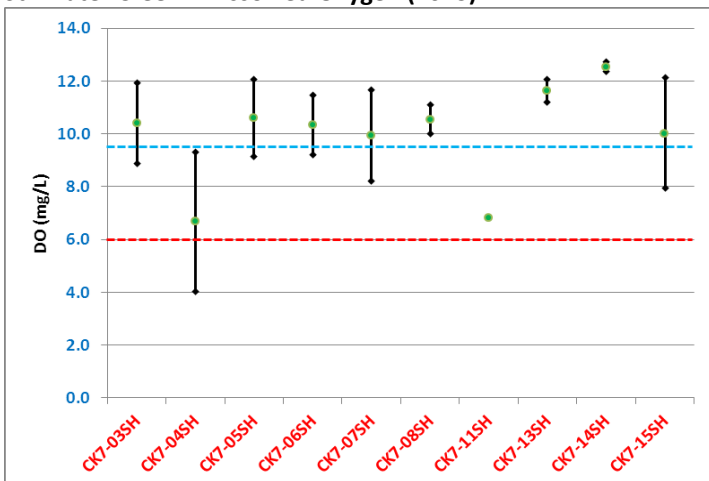
Figure 5. Dissolved oxygen ranges recorded at each sampling site along Stillwater Creek (CEQG: Red-Warmwater biota minimum tolerance – Blue: Coldwater biota minimum tolerance)

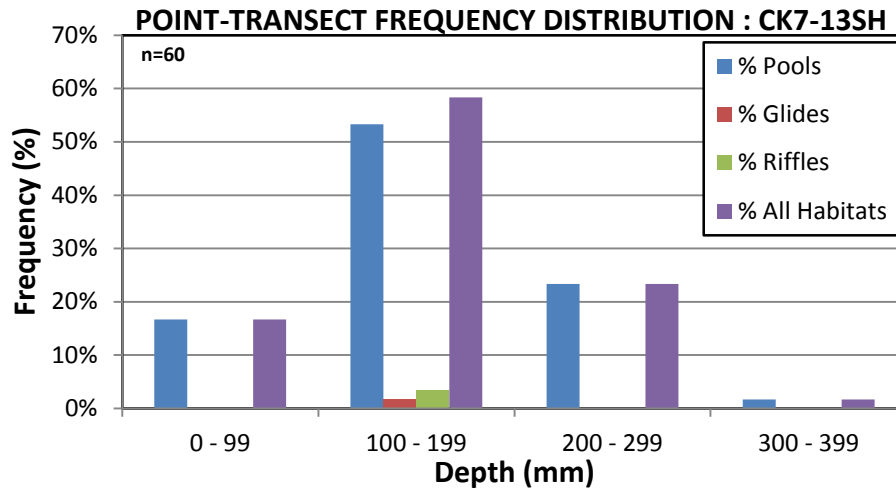
The results of the habitat assessment for site CK7-13SH are summarized in Figure 13. The analysis revealed a total habitat area of approximately 131.6m², consisting of 95% pool habitat, 2% glides and 3% riffles. Embedded cover was observed over approximately 12% of the site, and consisted solely of rock materials. Unembedded cover included flat and round rock, and was observed over approximately 57% of the site (Appendix IV).

Figure 13. Frequency distribution of habitat types/stream velocities at 100mm intervals for site CK7-13SH

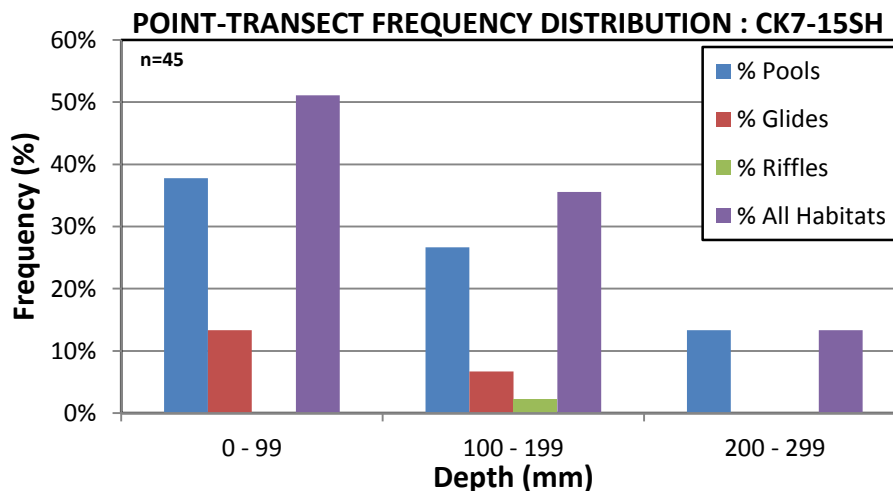
The results of the habitat assessment for site CK7-15SH are summarized in Figure 15. The analysis revealed a total habitat area of approximately 84.3m², consisting of 78% pool habitat, 20% glides and 2% riffles. Embedded cover was observed over approximately 9% of the site, and consisted solely of rock materials.

Figure 15. Frequency distribution of habitat types/stream velocities at 100mm intervals for site CK7-15SH

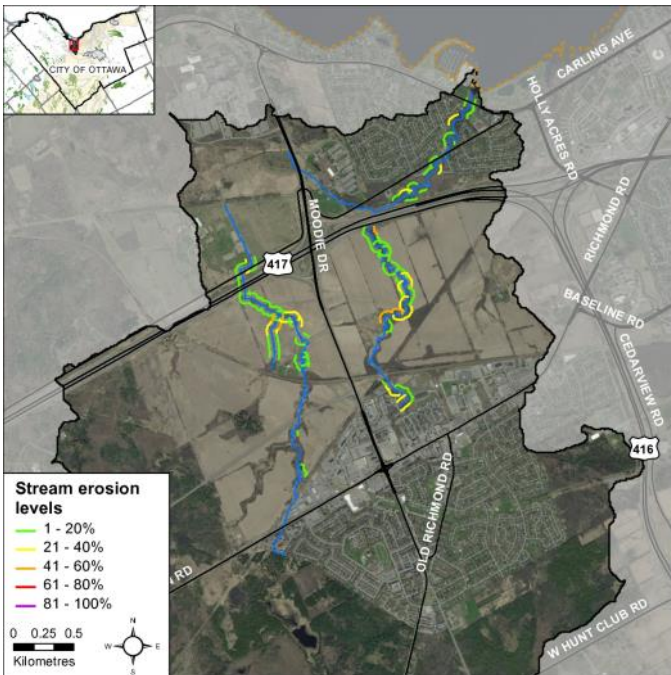
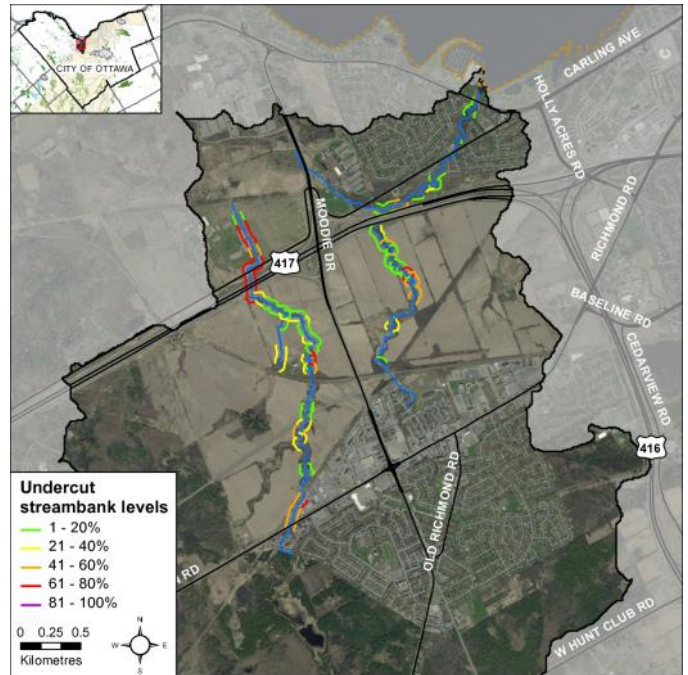
Undercut banks are a normal and natural part of stream function and can provide excellent refuge areas for fish. Figure 5 shows that the bank undercutting on Stillwater Creek varied considerably. Much of the creek had low levels of bank undercutting but these were interspersed with areas of moderate to high level undercutting. The highest levels of undercutting were observed where highway 417 crosses Stillwater Creek. The bank and substrate composition in this area is dominated by clay and the riparian vegetation is predominantly grasses so there is a possibility that the bank undercutting in section of the creek may lead to bank failure over time.

Figure 4 Erosion along Stillwater Creek

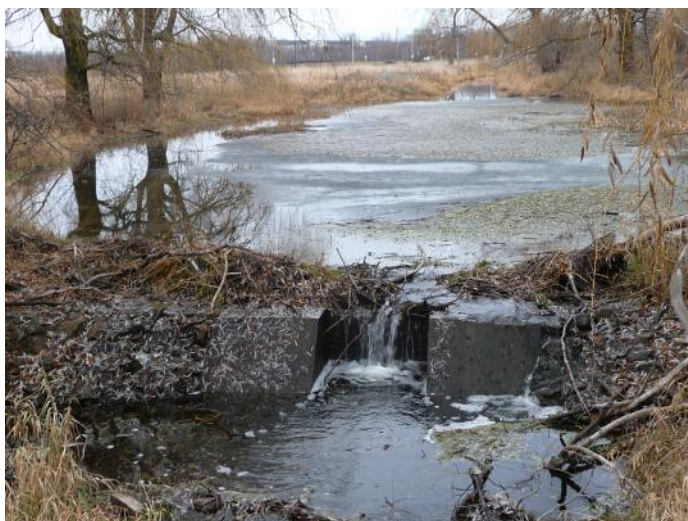
A weir constructed along Stillwater Creek downstream of Moodie Drive that was observed in 2009 and 2015

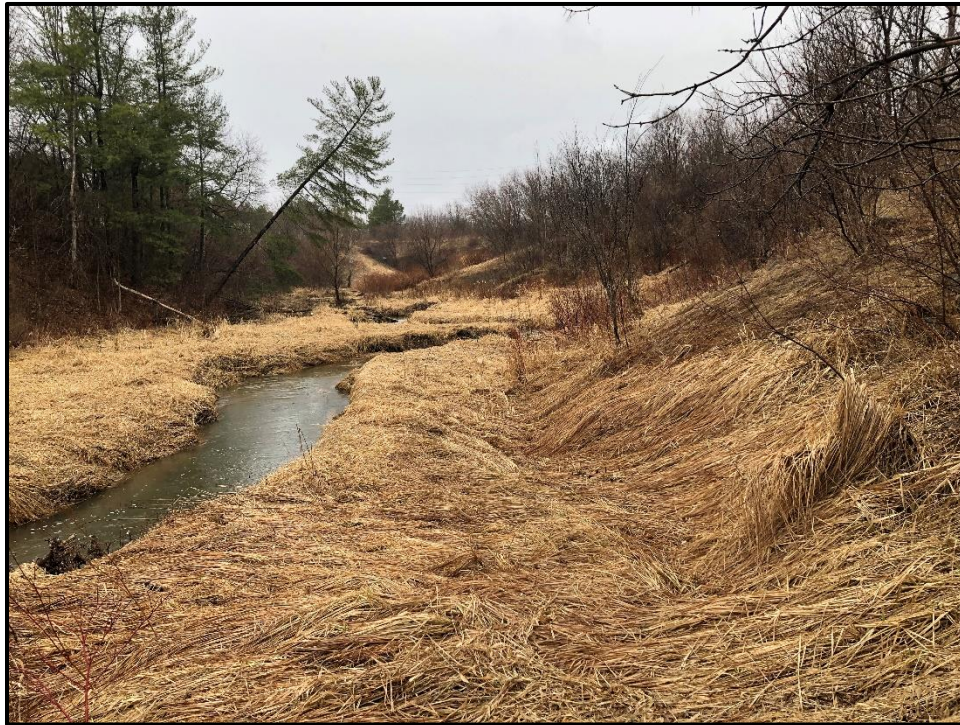
Photo 2: Photograph of Stillwater Creek and toe of slope taken at the west portion of the site towards the north illustrating grass covered side slopes, minor toe erosion was observed.
