Preliminary Geotechnical Investigation

Proposed Mixed Use Development 1987 Robertson Road Ottawa, Ontario

Report: PG5715-1 Revision 3

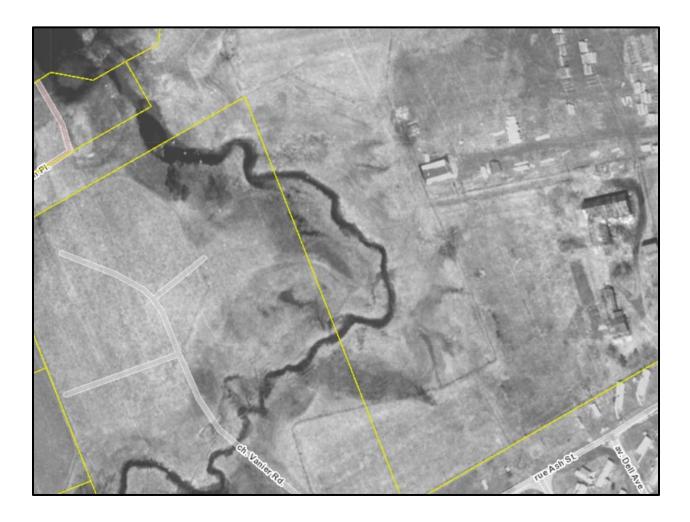
FIGURE 2

1958 AERIAL IMAGE

Based on historical aerial images of the slope face obtained from GeoOttawa, the natural course of the creek has been altered due to fill placement within the subject site. When aerial images of the creek from 1958 and 2011, shown in Figures 2 to 4 in Appendix 2, are compared the natural course of the creek was observed to have shifted to the west and the meander shapes were altered. In-filling at the site has forced the water course to re-establish further west. The original top of slope is set back further from the apparent existing top of slope as under existing conditions what appears to be the top of slope has been infilled and does not represent the natural top of slope.

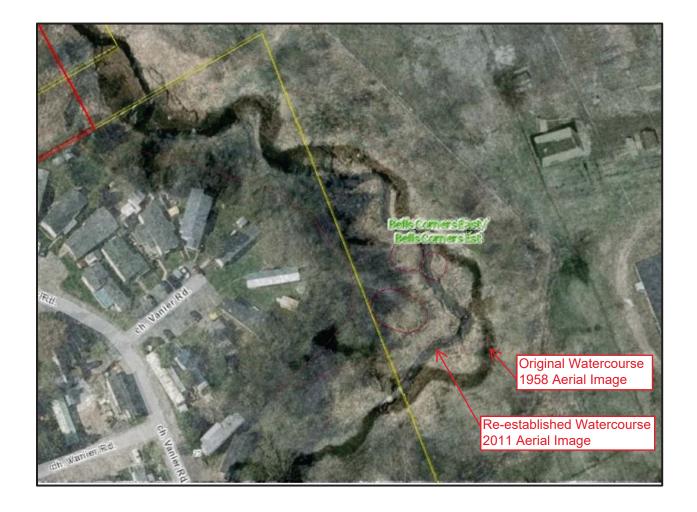
FIGURE 4

OVERLAY OF 1958 & 2011 AERIAL IMAGES

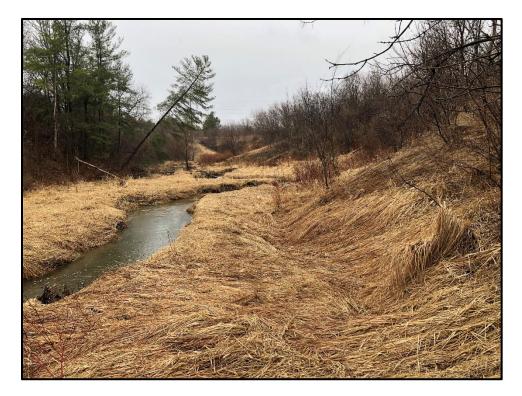
Photo 1: Photograph of Stillwater Creek and toe of slope taken at the west portion of the site towards the north illustrating grass covered side slopes, no toe erosion was observed.

Generally, the overall slope face was observed to be grass covered with some mature trees, minor toe erosion was observed along the edges of the meanders at some locations. Significant in-filling was observed at the top of the slope and down the slope face. Photographs taken during our site visit to assess the slope condition can be found in Appendix 2.

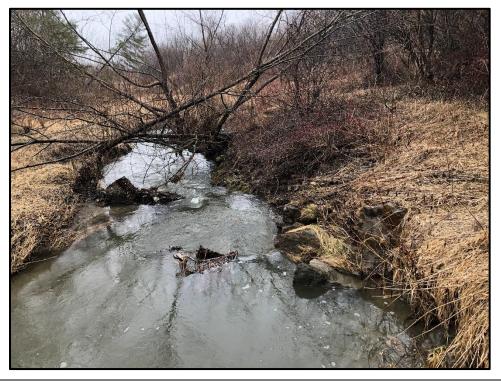
Photo 2: Photograph of Stillwater Creek and toe of slope taken at the west portion of the site towards the north illustrating grass covered side slopes, minor toe erosion was observed.

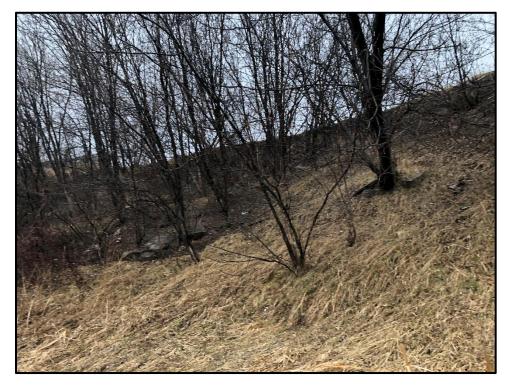
Photo 3: Photograph from the creek looking east towards the top of slope illustrating fill on the slope.

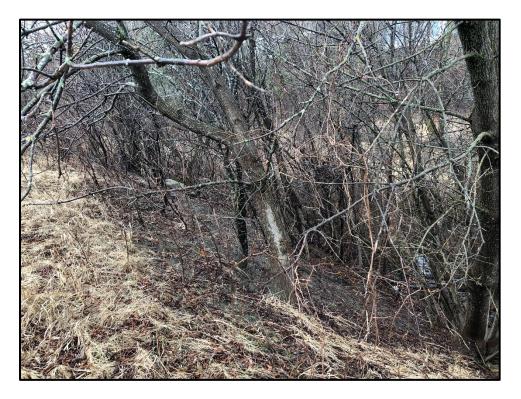
Photo 4: Photograph from the top of slope looking west towards the creek illustrating fill on the slope.
