August 7, 2018  
File: PE4378-LET.01

Subject: **Phase II - Environmental Site Assessment**  
**1987 Robertson Road**  
**Ottawa, Ontario**

## SOIL PROFILE AND TEST DATA

Phase II - Environmental Site Assessment  
1987 Robertson Road  
Ottawa, Ontario

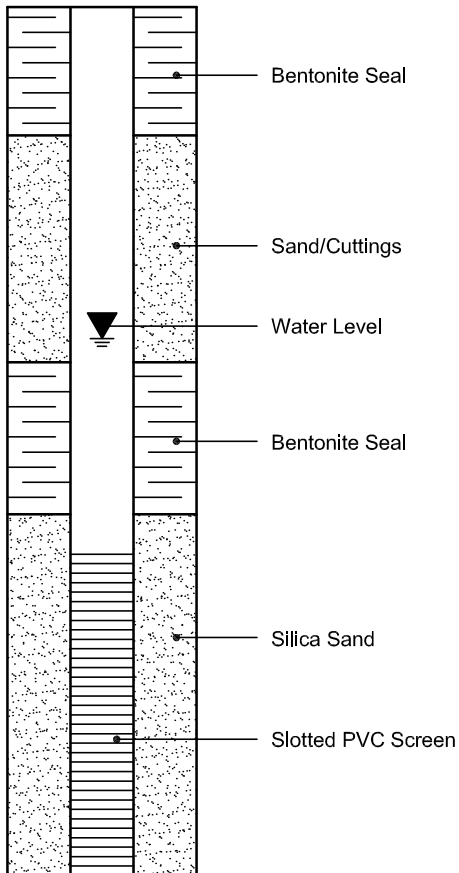
#### MONITORING WELL CONSTRUCTION

Groundwater monitoring wells were installed in BH5 and BH6, the location of which can be seen on the attached Test Hole Location Plan. Typical monitoring well construction details are described below:

- Slotted 32 mm diameter PVC screen at base of borehole.
- 32 mm diameter PVC riser pipe from the top of the screen to ground surface.
- No.3 silica sand backfilled within annular space around screen.

- Bentonite above sand pack to just below ground surface.
- Clean backfill from top of bentonite plug to the ground surface.

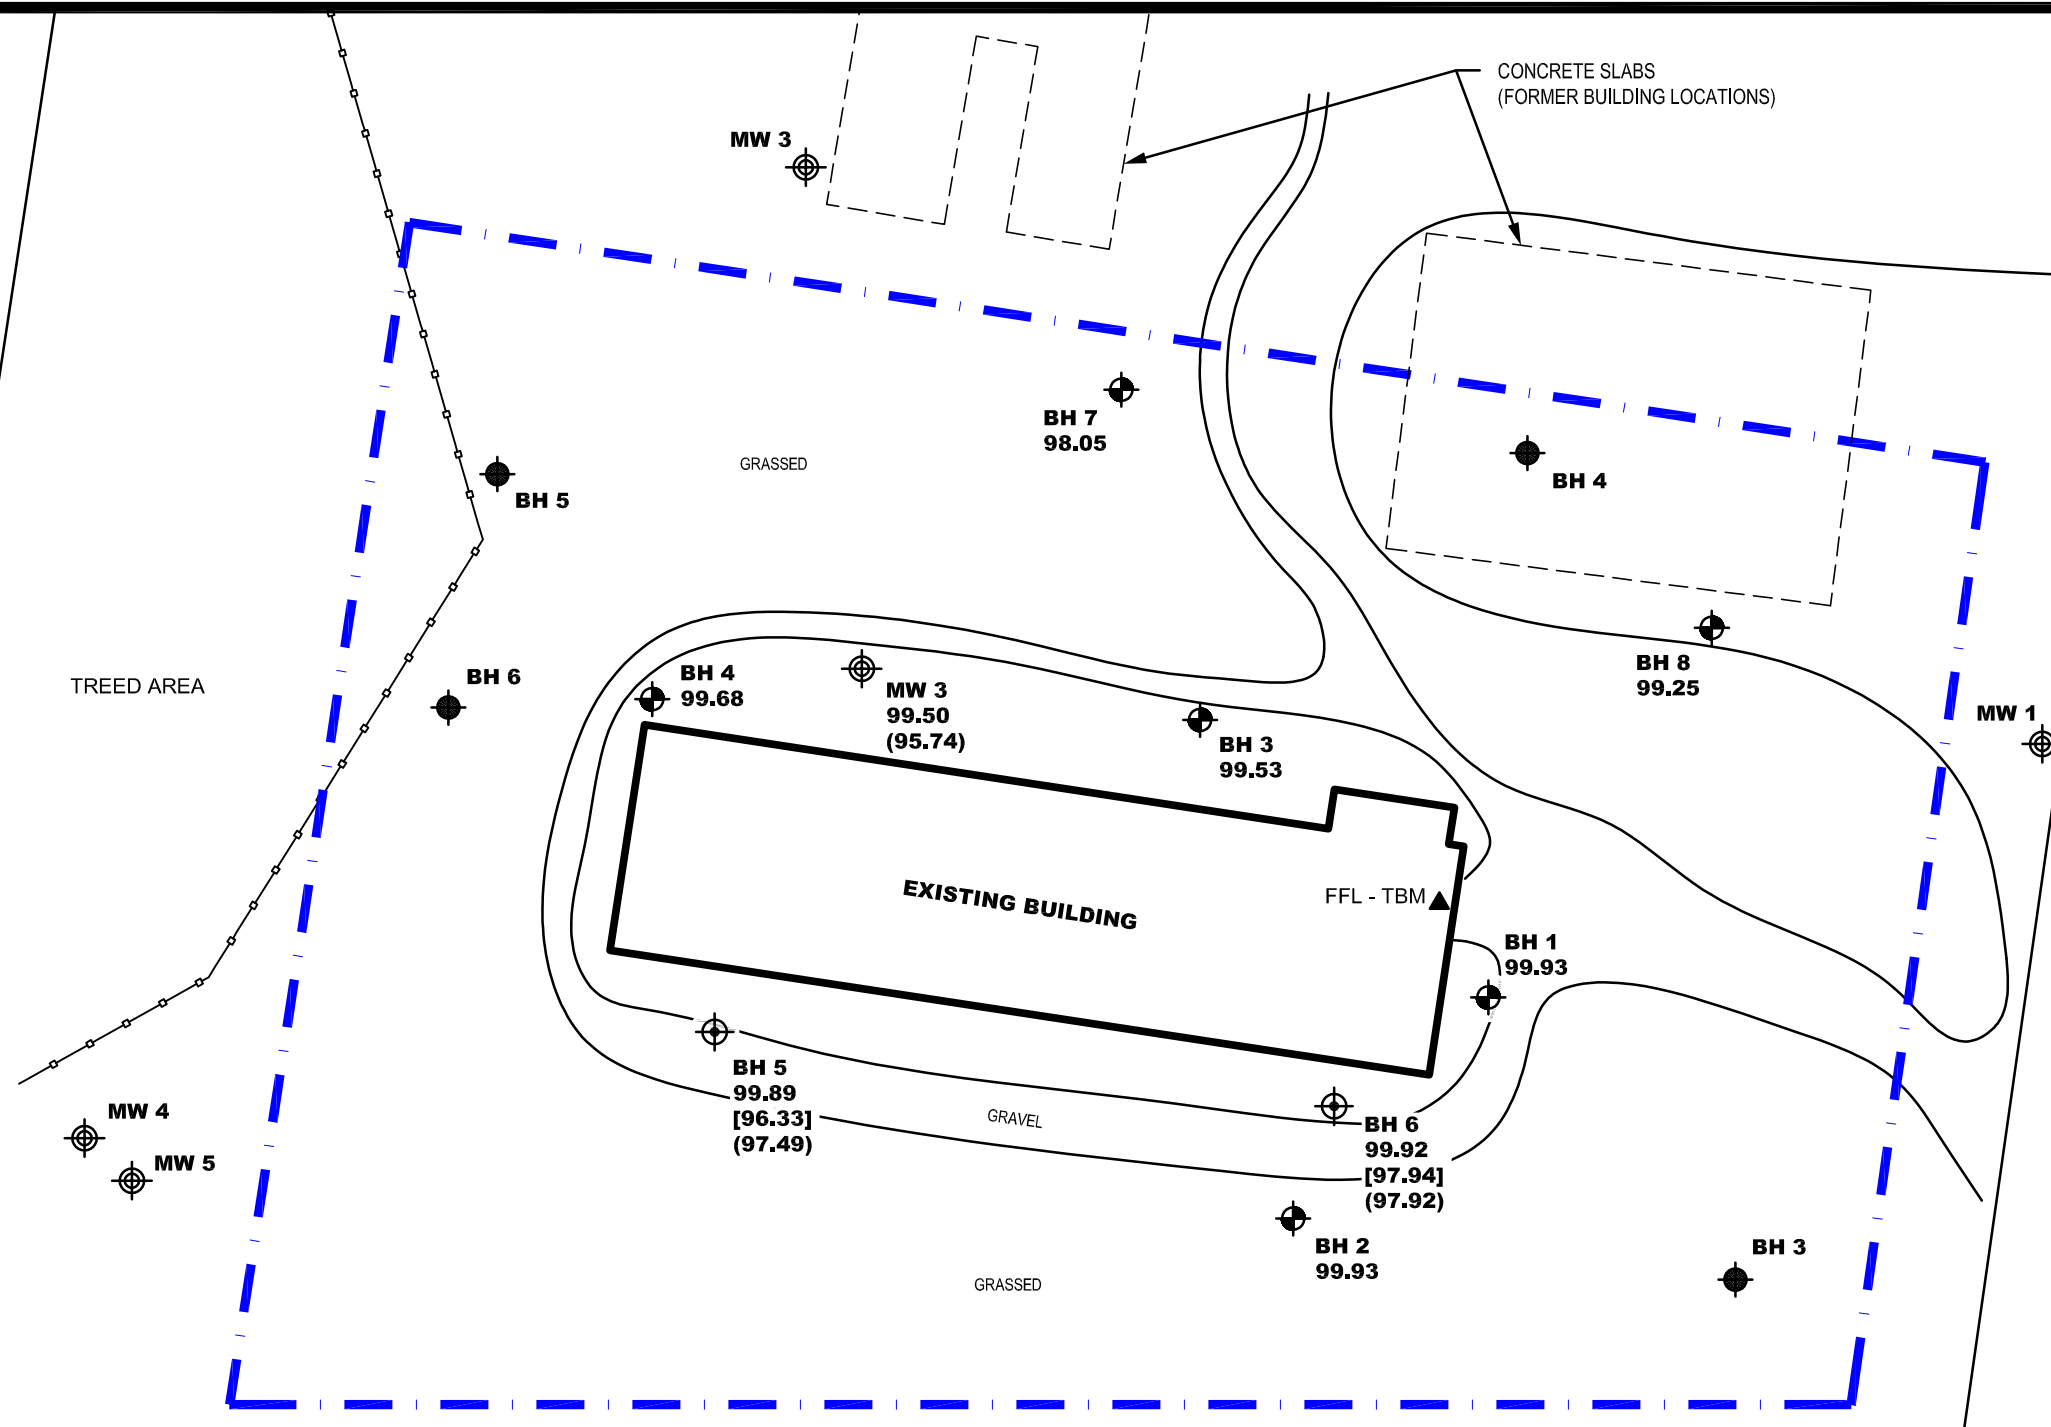
The Phase II ESA Property is designated as the southern part of the property, addressed 1987 Robertson Road, in the City of Ottawa, Ontario. The subject site is occupied by a large storage/warehouse style building, a gravelled laneway around the exterior of the building and is grass covered in the remaining area. The Phase II ESA Property is presented in Drawing PE4378-2 – Test Hole Location Plan, appended to this report.

Boreholes 1 through 3 (BH1-BH3 and BH8) were terminated on the inferred bedrock surface at depths ranging from 1.8 to 2.4 m below the existing grade. Boreholes BH5 and BH6 were subsequently advanced to depths of 7.2 m and 6.3 m below ground surface by means of coring the bedrock, in order to intercept the groundwater table. The locations of the boreholes are illustrated on the enclosed Test Hole Location Plan.
