Project:
1275 SHILLINGTON AVENUE
OTTAWA., ONTARIO

Drawing:
TREE INFORMATION REPORT

Scale: 1:200	Date:
Design By: PG	Drawn By: PG
Project Number: 2112-01	Sheet Number: TIR 01

Scale: 1:200	Date:
Design By: PG	Drawn By: PG
Project Number: 2112-01	Sheet Number: TIR 02

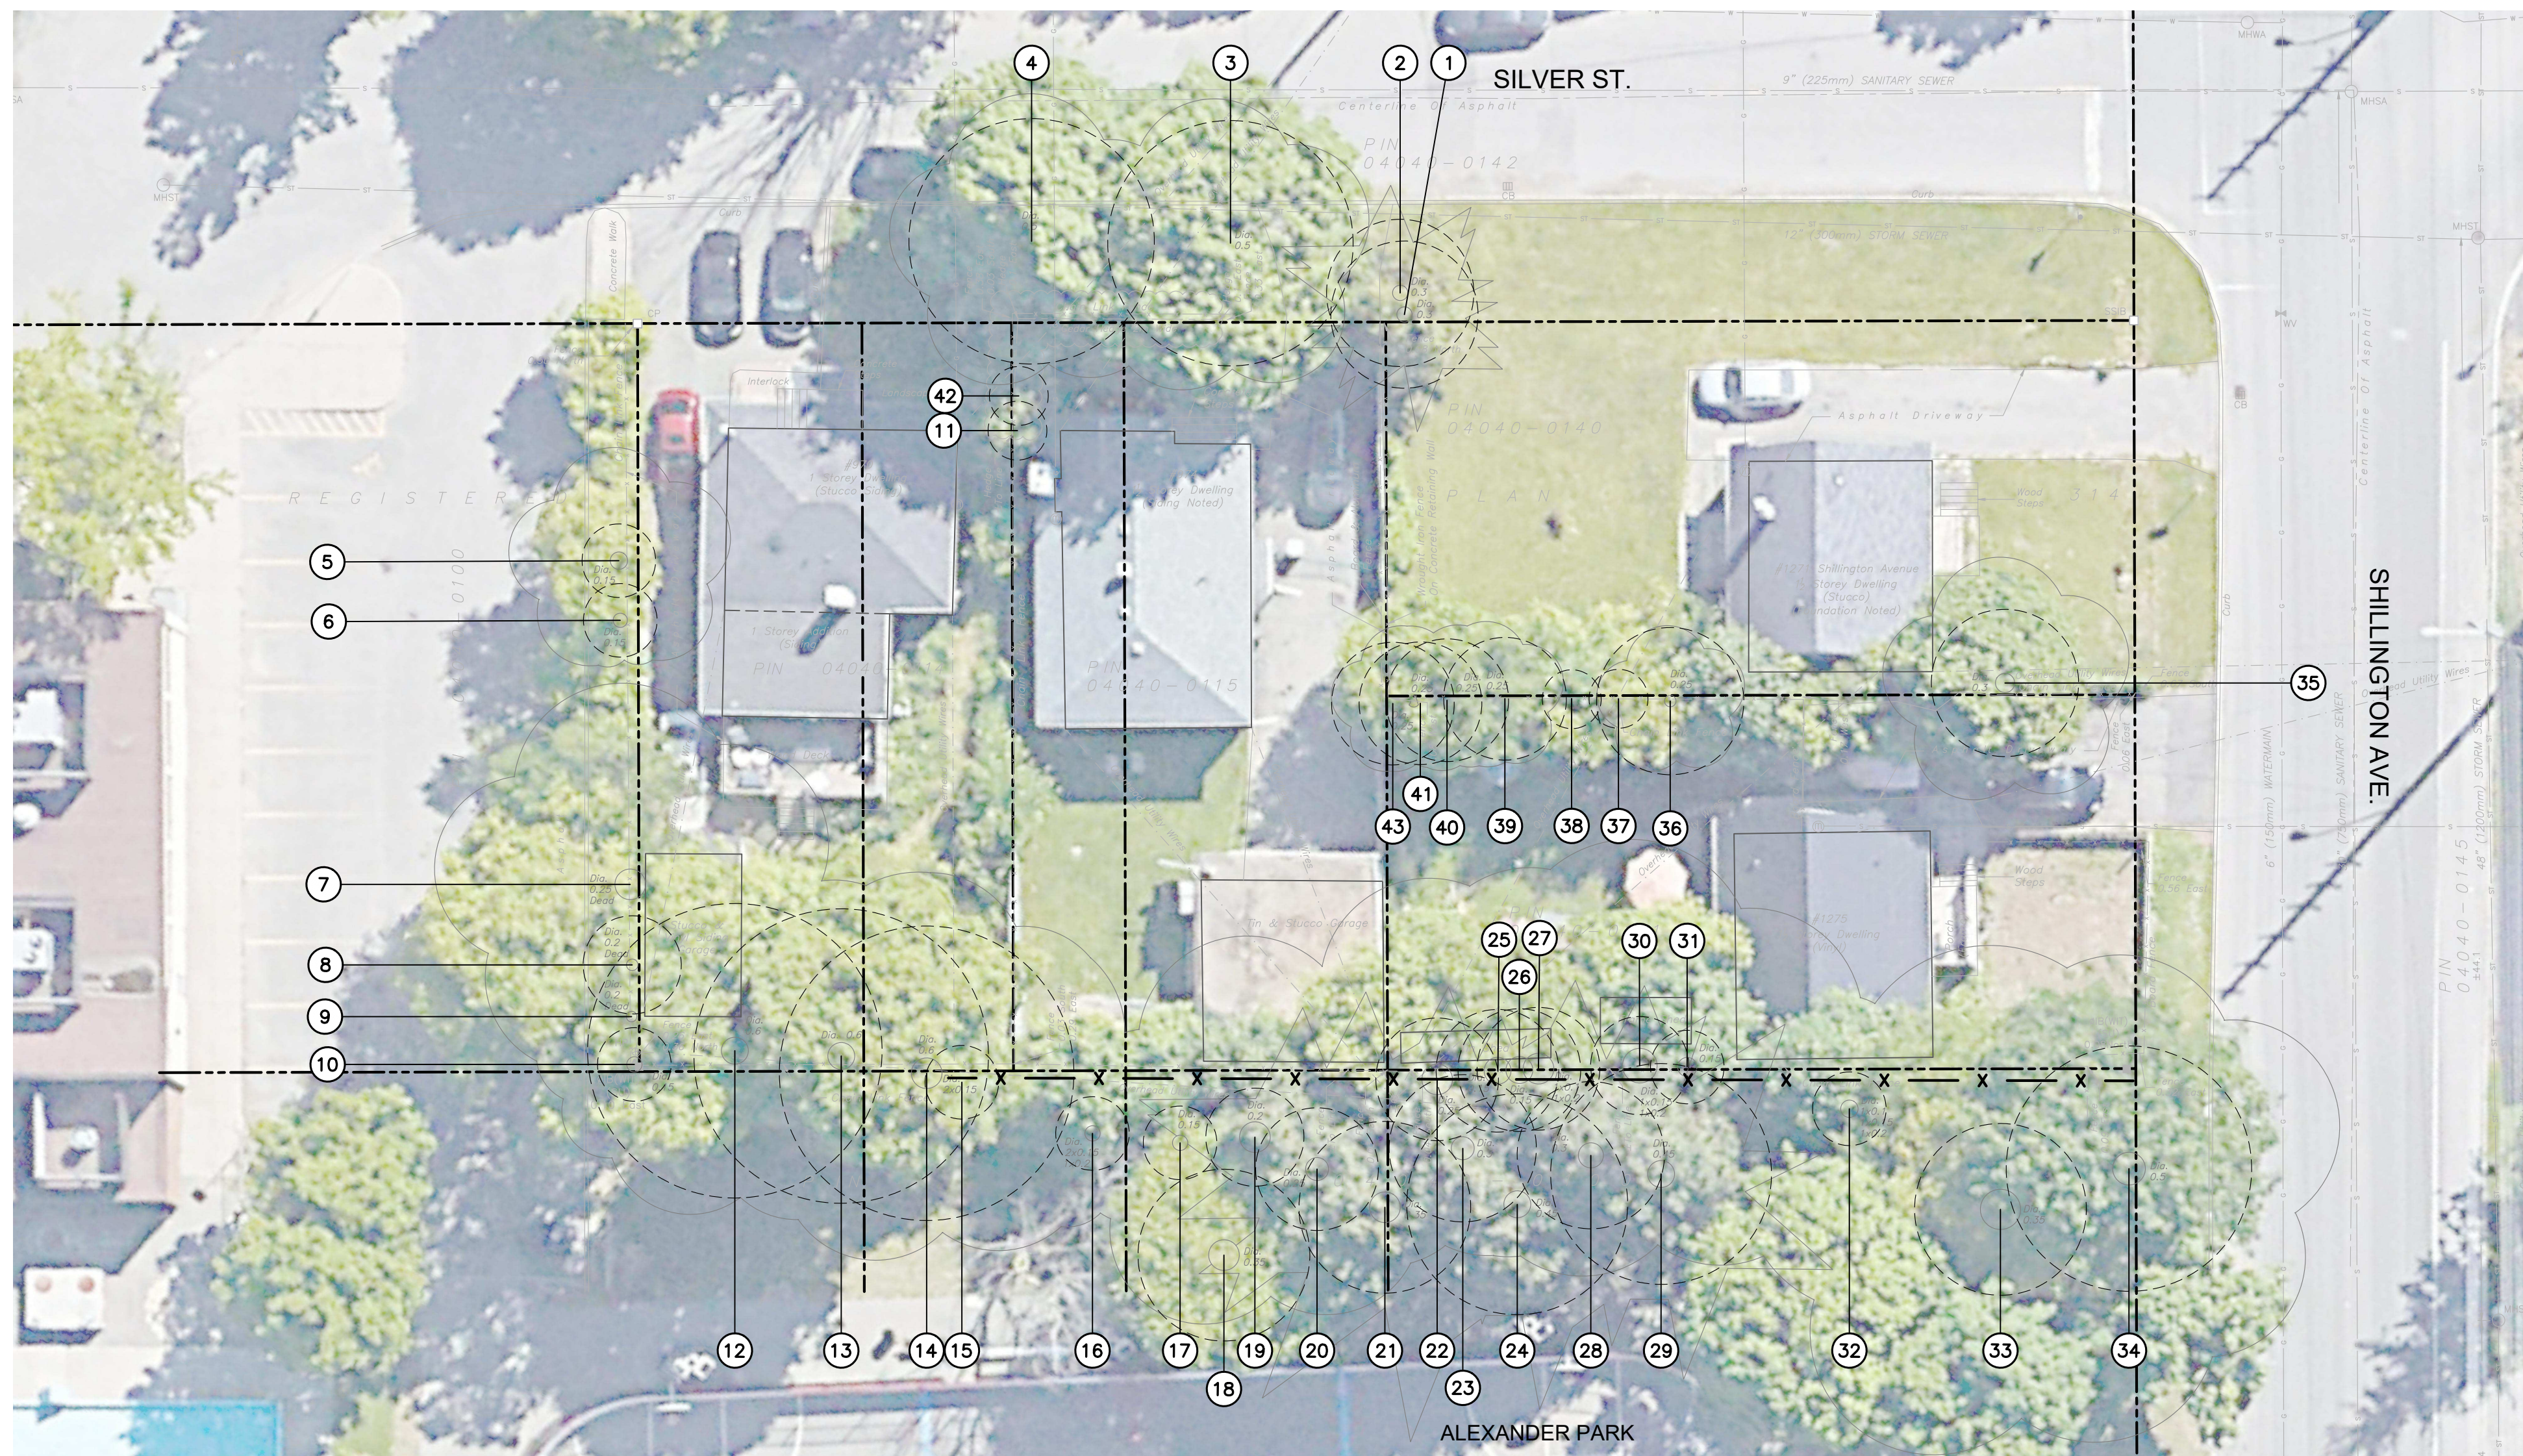
1 EXISTING CONDITIONS Scale: 1:200

- NOTES:**
- 1.0 THE EXISTING PROPERTY IS LOCATED AT THE NORTH-WEST CORNER OF THE SHILLINGTON AVENUE AND SILVER STREET INTERSECTION. THE SITE CURRENTLY CONTAINS FOUR SINGLE STOREY HOMES AND ACCESSORY GARAGES AND SHEDS. THE SITE HAS FLAT TOPOGRAPHY. EXISTING VEGETATION IS PRIMARILY COMPRISED OF A VARIETY OF MAPLE TREE SPECIES. THE ADJACENT PARK PROPERTY HAS A MORE DIVERSE COLLECTION OF TREE SPECIES, SUCH AS PINE, MAPLE AND OAK.

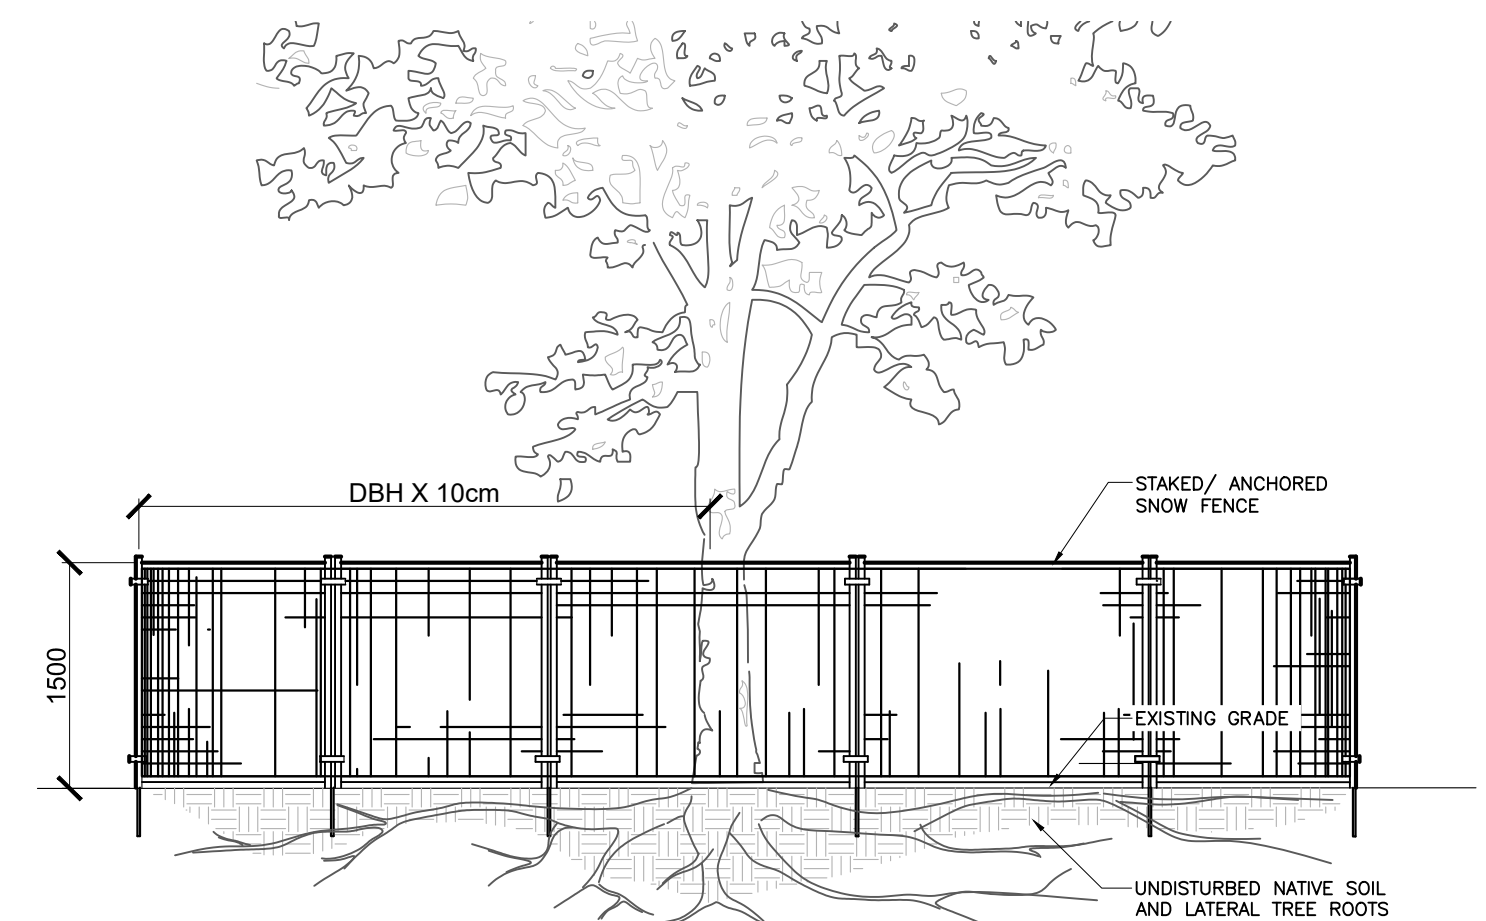
2 TREE PROTECTION FENCING Scale: 1:300

- NOTES:**
THE FOLLOWING PROTECTION MEASURES MUST BE IMPLEMENTED FOR RETAINED TREES, BOTH ON SITE AND ADJACENT SITES, PRIOR TO ANY TREE REMOVAL OR SITE WORKS AND MAINTAINED FOR THE DURATION OF CONSTRUCTION ON SITE.
1. ERECT A FENCE AT THE CRITICAL ROOT ZONE (CRZ) OF TREES WHERE THE CRZ IS ESTABLISHED AS BEING 10 CENTIMETERS FROM THE TRUNK FOR EVERY CENTIMETER OF TRUNK DIAMETER AT BREAST HEIGHT. THE CRZ IS CALCULATED AS DBH X 10cm.
 2. DO NOT PLACE ANY MATERIAL OR EQUIPMENT WITHIN THE CRZ OF THE TREE
 3. DO NOT ATTACH ANY SIGNS, NOTICES OR POSTERS TO ANY TREE
 4. DO NOT RAISE OR LOWER THE GRADE WITHIN THE CRZ WITHOUT APPROVAL
 5. TUNNEL OR BORE WHEN DIGGING WITHIN THE CRZ OF A TREE
 6. DO NOT DAMAGE THE ROOT SYSTEM, TRUNK, OR BRANCHES OF ANY TREE
 7. ENSURE THAT EXHAUST FUMES FROM ALL EQUIPMENT ARE NOT DIRECTED TOWARDS ANY TREE CANOPY

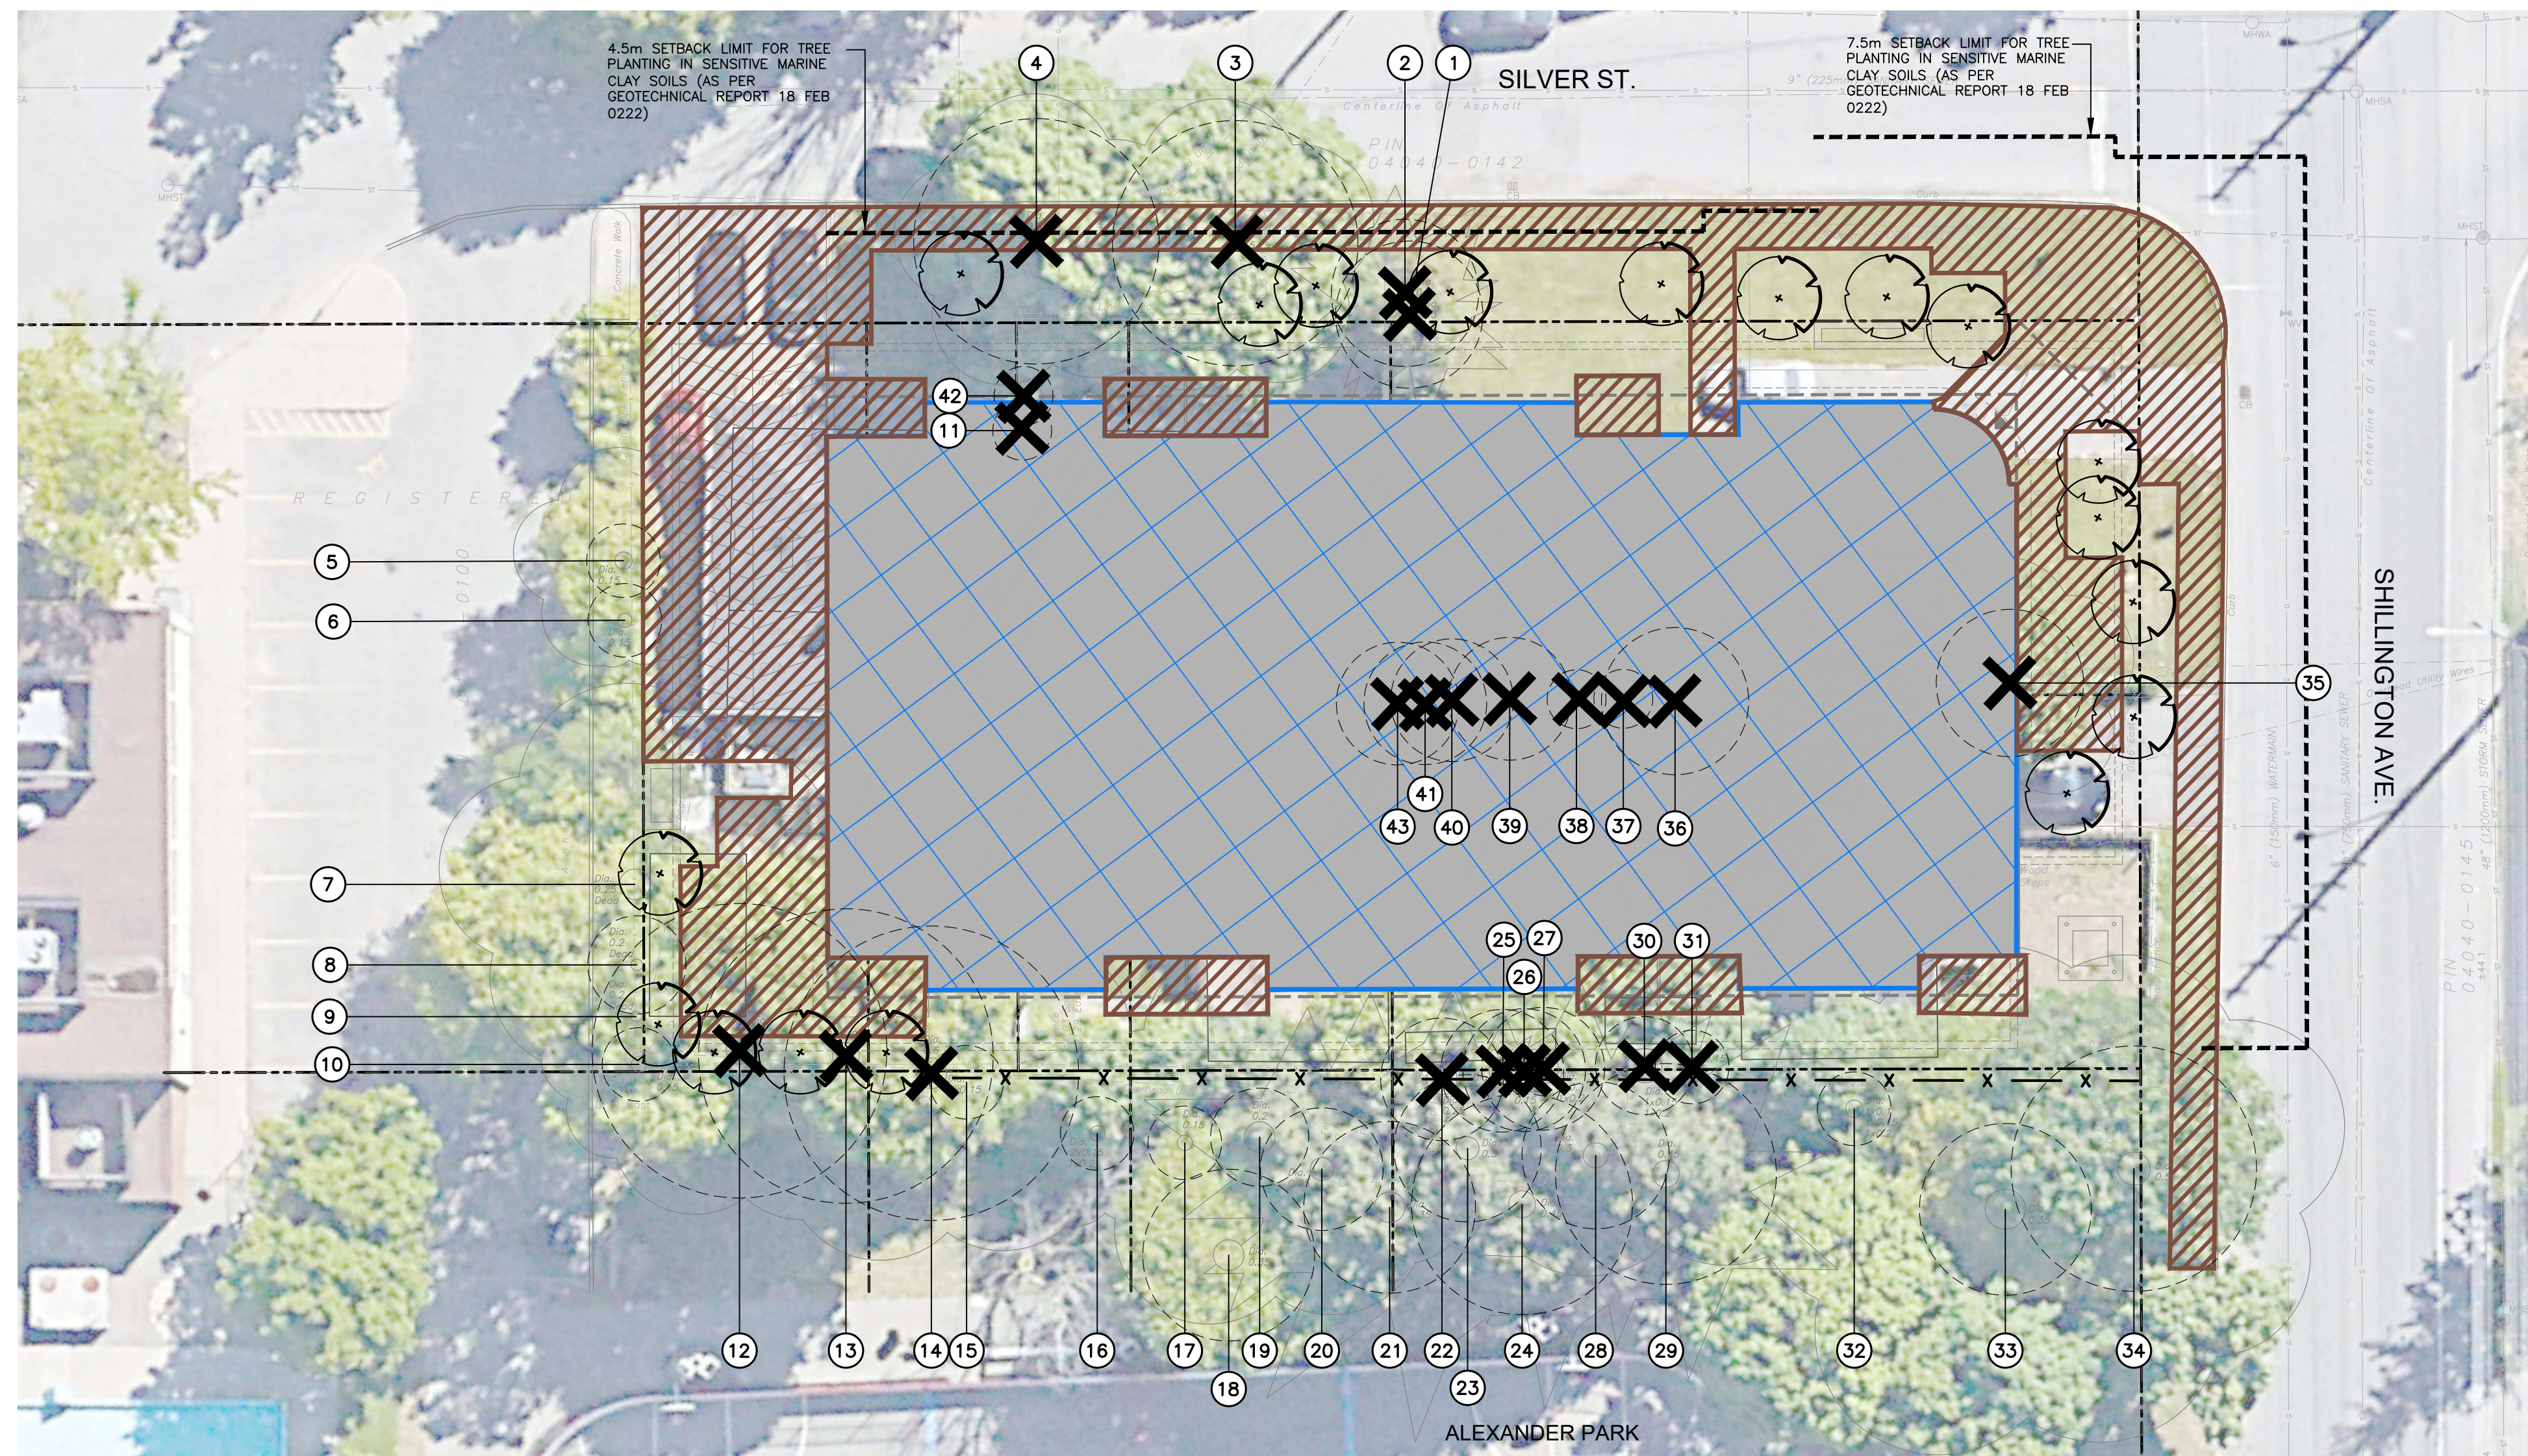
1 PROPOSED DEVELOPMENT

- APPROXIMATELY 1100 m² TO BE COVERED BY THE PROPOSED BUILDING FOOTPRINT.
 - APPROXIMATELY 600 m² TO BE HARD SURFACES.
 - 2.0 THE PROPOSED DEVELOPMENT REQUIRES THE REMOVAL OF TWENTY-THREE (23) TREES.

- 3.0 DUE TO THE SET BACK LIMITS FOR TREE PLANTING IDENTIFIED IN THE GEOTECHNICAL REPORT (DATED 18TH FEB 2022), IT IS NOT POSSIBLE TO PROVIDE ANY NEW TREE PLANTING ON THIS SITE. A NUMBER OF LARGE SHRUBS HAVE BEEN PROPOSED SUCH AS STAGHORN SUMAC OR COMMON LILAC.

Tree #	Botanical Name	Common Name	DBH (cm)	Ownership	Condition	Comments	Arborist Recommendation	Removal Reason
1	Thuja occidentalis	Eastern White Cedar	30	City	Good	Asymmetrical canopy, Single stem.	Remove	Construction
2	Thuja occidentalis	Eastern White Cedar	30	City	Moderate	Asymmetrical canopy, Single stem, Die-back =15% @ canopy.	Remove	Construction
3	Acer platanoides	Norway Maple	50	City	Moderate	Symmetrical canopy, Single stem, Pruned limbs @ O.H Utilities, Broken limbs, Bark rot @ trunk	Remove	Construction
4	Acer platanoides	Norway Maple	50	City	Good	Asymmetrical canopy, Single stem, Co-dominant leaders: 2@=3m above grade, Included bark.	Remove	Construction
5	Acer negundo	Manitoba Maple	15	City	Moderate	Asymmetrical canopy, Single stem, Pruned limbs, Grown into fence.	Remain	
6	Ulmus spp.	Elm	15	City	Moderate	Symmetrical canopy, single stem, Co-dominant leaders: 2@=4m above grade.	Remain

7					Dead		Remain	
8	Acer negundo	Manitoba Maple	20	City	Poor	Asymmetrical canopy, Single stem, Broken limbs, Pruned leader, Poor branch angle.	Remain	
9					Dead		Remain	
10	Acer negundo	Manitoba Maple	15	City	Poor	Asymmetrical canopy, Single stem, Pruned leader, Bark rot @ limbs, Grown into fence.	Remain	
11	Thuja occidentalis	Eastern White Cedar	2 @ 15	Private	Good	Asymmetrical canopy, Multi-stem: 2.	Remove	Construction
12	Acer negundo	Manitoba Maple	60	Private	Moderate	Asymmetrical canopy, Single stem, Co-dominant leaders: 2@=3m above grade, Poor branch angle.	Remove	Construction
13	Acer negundo	Manitoba Maple	60	Private	Moderate	Asymmetrical canopy, Single stem, Pruned limbs, Leaning.	Remove	Construction
14	Acer negundo	Manitoba Maple	60	Boundary	Moderate	Asymmetrical canopy, Single stem.	Remove	Construction
15	Acer negundo	Manitoba Maple	2 @ 15	City	Poor	Asymmetrical canopy, Co-dominant leaders: 2@0m above grade.	Remain

16	Tilia cordata	Little-Leaf Linden	3 @ 20	City	Moderate	Symmetrical canopy, Multi-stem: 3, Broken limbs.	Remain	
17	Acer platanoides	Norway Maple	15	City	Good	Asymmetrical canopy, Single stem, Included bark.	Remain	
18	Acer saccharum	Sugar Maple	35	City	Good	Asymmetrical canopy, Single stem, Pruned limbs, Bark rot @limbs.	Remain	
19	Acer negundo	Manitoba Maple	20	City	Moderate	Asymmetrical canopy, Single stem, Leaning.	Remain	
20	Pinus nigra	Austrian Pine	25	City	Moderate	Symmetrical canopy, Single stem, Pruned: limbed-up.	Remain	
21	Pinus nigra	Austrian Pine	35	City	Good	Asymmetrical canopy, Single stem, Pruned: limbed-up.	Remain	
22	Acer negundo	Manitoba Maple	25	City	Poor	Asymmetrical canopy, Single stem, Pruned limbs, Grown into fence.	Remove	Construction
23	Pinus nigra	Austrian Pine	30	City	Good	Asymmetrical canopy, Single stem, Die-back =5% @ canopy, Pruned: limbed-up.	Remain	
24	Pinus nigra	Austrian Pine	45	City	Good	Asymmetrical canopy, Single stem, Pruned limbs.	Remain

Tree #	Botanical Name	Common Name	DBH (cm)	Ownership	Condition	Comments	Arborist Recommendation	Removal Reason
25	Acer negundo	Manitoba Maple	15	Boundary	Poor	Asymmetrical canopy, Single stem, Broken limbs, Grown into fence.	Remove	Construction
26	Acer negundo	Manitoba Maple	15	Boundary	Poor	Asymmetrical canopy, Single stem, Broken limbs, Leaning.	Remove	Construction
27	Acer negundo	Manitoba Maple	2 @ 20	Boundary	Moderate	Asymmetrical canopy, Single stem, Co-dominant leaders: 2@=3m above grade, Broken limbs, Heart rot @ crotches.	Remove	Construction
28	Pinus nigra	Austrian Pine	30	City	Good	Symmetrical canopy, single stem, Co-dominant leaders: 2@=4m above grade, Pruned: limbed-up.	Remain	
29	Pinus nigra	Austrian Pine	45	City	Good	Asymmetrical canopy, Single stem, Co-dominant leaders: 2@=7m above grade, Pruned: limbed-up.	Remain	
30	Acer negundo	Manitoba Maple	2 @ 15	Boundary	Poor	Asymmetrical canopy, Single stem, Co-dominant leaders: 2@ =1m above grade, Pruned limbs, Leaning, Included bark.	Remove	Construction

31	Acer platanoides	Norway Maple	15	Boundary	Moderate	Asymmetrical canopy, Single stem, Pruned branches, Poor branch angle, Included bark, Grown into fence.	Remove	Construction
32	Acer negundo	Manitoba Maple	3 @ 15	City	Moderate	Asymmetrical canopy, Multi-stem: 3, Broken limbs.	Remain	
33	Quercus rubra	Red Oak	35	City	Good	Asymmetrical canopy, Single stem, Pruned limbs.	Remain	
34	Quercus rubra	Red Oak	50	City	Good	Symmetrical canopy, Single stem, Die-back: 5% @ branches.	Remain	
35	Acer platanoides	Norway Maple	30	Private	Moderate	Symmetrical, single stem, Pruned limbs @ O.H Utilities	Remove	Construction
36	Acer platanoides	Norway Maple	25	Private	Poor	Asymmetrical, single stem, Grown into fence.	Remove	Construction
37	Acer platanoides	Norway Maple	12	Private	Moderate	Symmetrical canopy, Single stem, Grown into fence.	Remove	Construction
38	Acer negundo	Manitoba Maple	12	Private	Moderate	Asymmetrical canopy, Single stem, Broken limbs.	Remove	Construction

39	Tilia cordata	Little-Leaf Linden	25	Private	Moderate	Asymmetrical canopy, Single stem, Single stem, Poor branch angle, Leaning, Grown into fence.	Remove	Construction
40	Acer negundo	Manitoba Maple	25	Private	Moderate	Asymmetrical canopy, Single stem, Co-dominant leaders: 2@=1m above grade, Grown into fence.	Remove	Construction
41	Acer negundo	Manitoba Maple	25	Private	Poor	Asymmetrical canopy, Single stem, Pruned branches, Grown into fence.	Remove	Construction
42	Thuja occidentalis	Eastern White Cedar	2 @15	Private	Good	Asymmetrical canopy, Multi-stem: 2.	Remove	Construction
43	Ulmus spp.	Elm	25	Private	Moderate	Asymmetrical canopy, Single stem, Leaning.	Remove	Construction

- 4.0 FOR RETAINED TREES:
 - ERECT A FENCE AT THE CRITICAL ROOT ZONE (CRZ) OF TREES;
 - DO NOT PLACE ANY MATERIAL OR EQUIPMENT WITHIN THE CRZ OF THE TREE;

- DO NOT ATTACH ANY SIGNS, NOTICES OR POSTERS TO ANY TREE;
 - DO NOT RAISE OR LOWER THE EXISTING GRADE WITHIN THE CRZ WITHOUT APPROVAL;
 - TUNNEL OR BORE WHEN DIGGING WITHIN THE CRZ OF A TREE

- DO NOT DAMAGE THE ROOT SYSTEM, TRUNK OR BRANCHES OF ANY TREE;
 - ENSURE THAT EXHAUST FUMES FROM ALL EQUIPMENT ARE NOT DIRECTED TOWARDS ANY TREE'S CANOPY.
