**Phase Two Environmental Site Assessment
393 McArthur Avenue
Proposed Residential Development
Ottawa, Ontario**

June 2, 2022
Project: 64819.22 - V02

**Re: Phase Two Environmental Site Assessment
393 McArthur Avenue
Ottawa, ON**

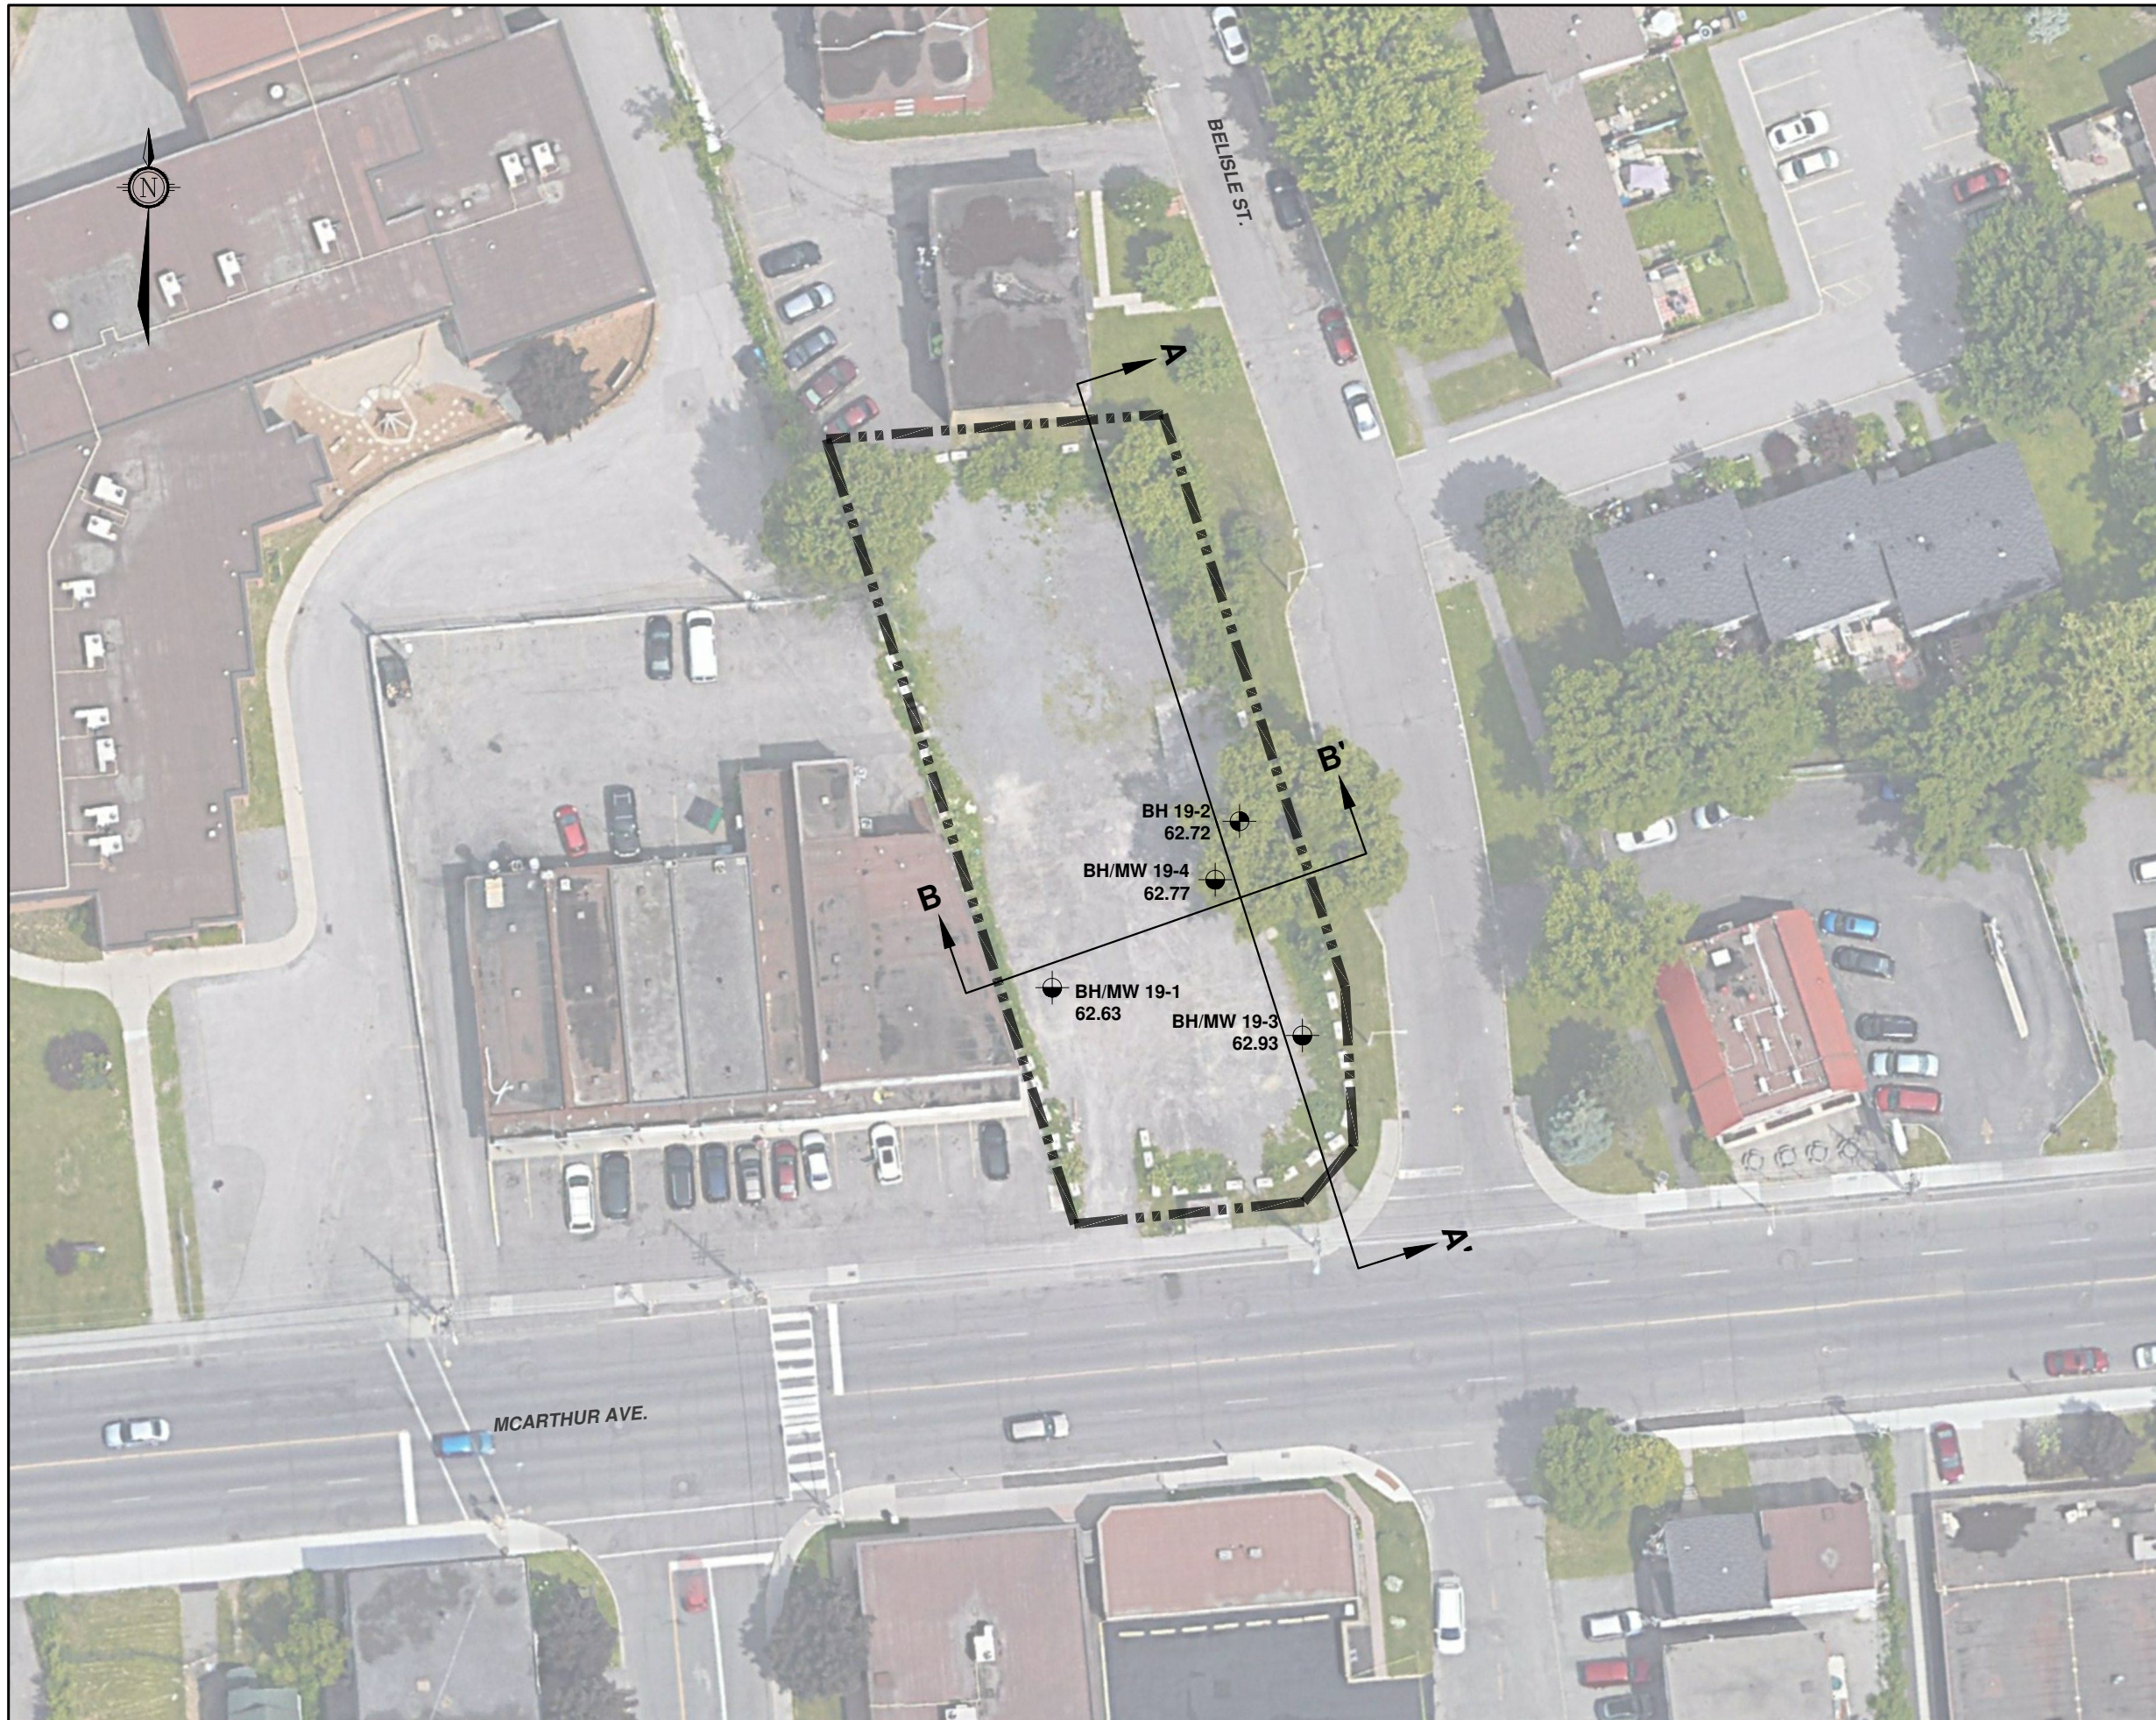
Drawing		SITE LAYOUT		
Client		NOVATECH		
Project	64819.22	PHASE TWO ESA/RECORD OF SITE CONDITION 393 MCARTHUR AVENUE OTTAWA, ONTARIO		
Drwn by	P.C.			Chkd by
Date	JUNE 2020	Rev.	2	FIGURE 9.2

Four boreholes, including three monitoring wells were advanced at the site to assess the soil and groundwater conditions in accordance with the sampling plan described in the Drilling Program from the Phase Two ESA Sampling and Analysis Plan. All boreholes were completed by George Downing Estate Drilling Ltd. All drilling was completed using hollow-stem auger, split-spoon techniques and coring methods. Monitoring wells were installed at three of the boreholes. The installed boreholes/monitoring wells are illustrated on Figure 9.2.

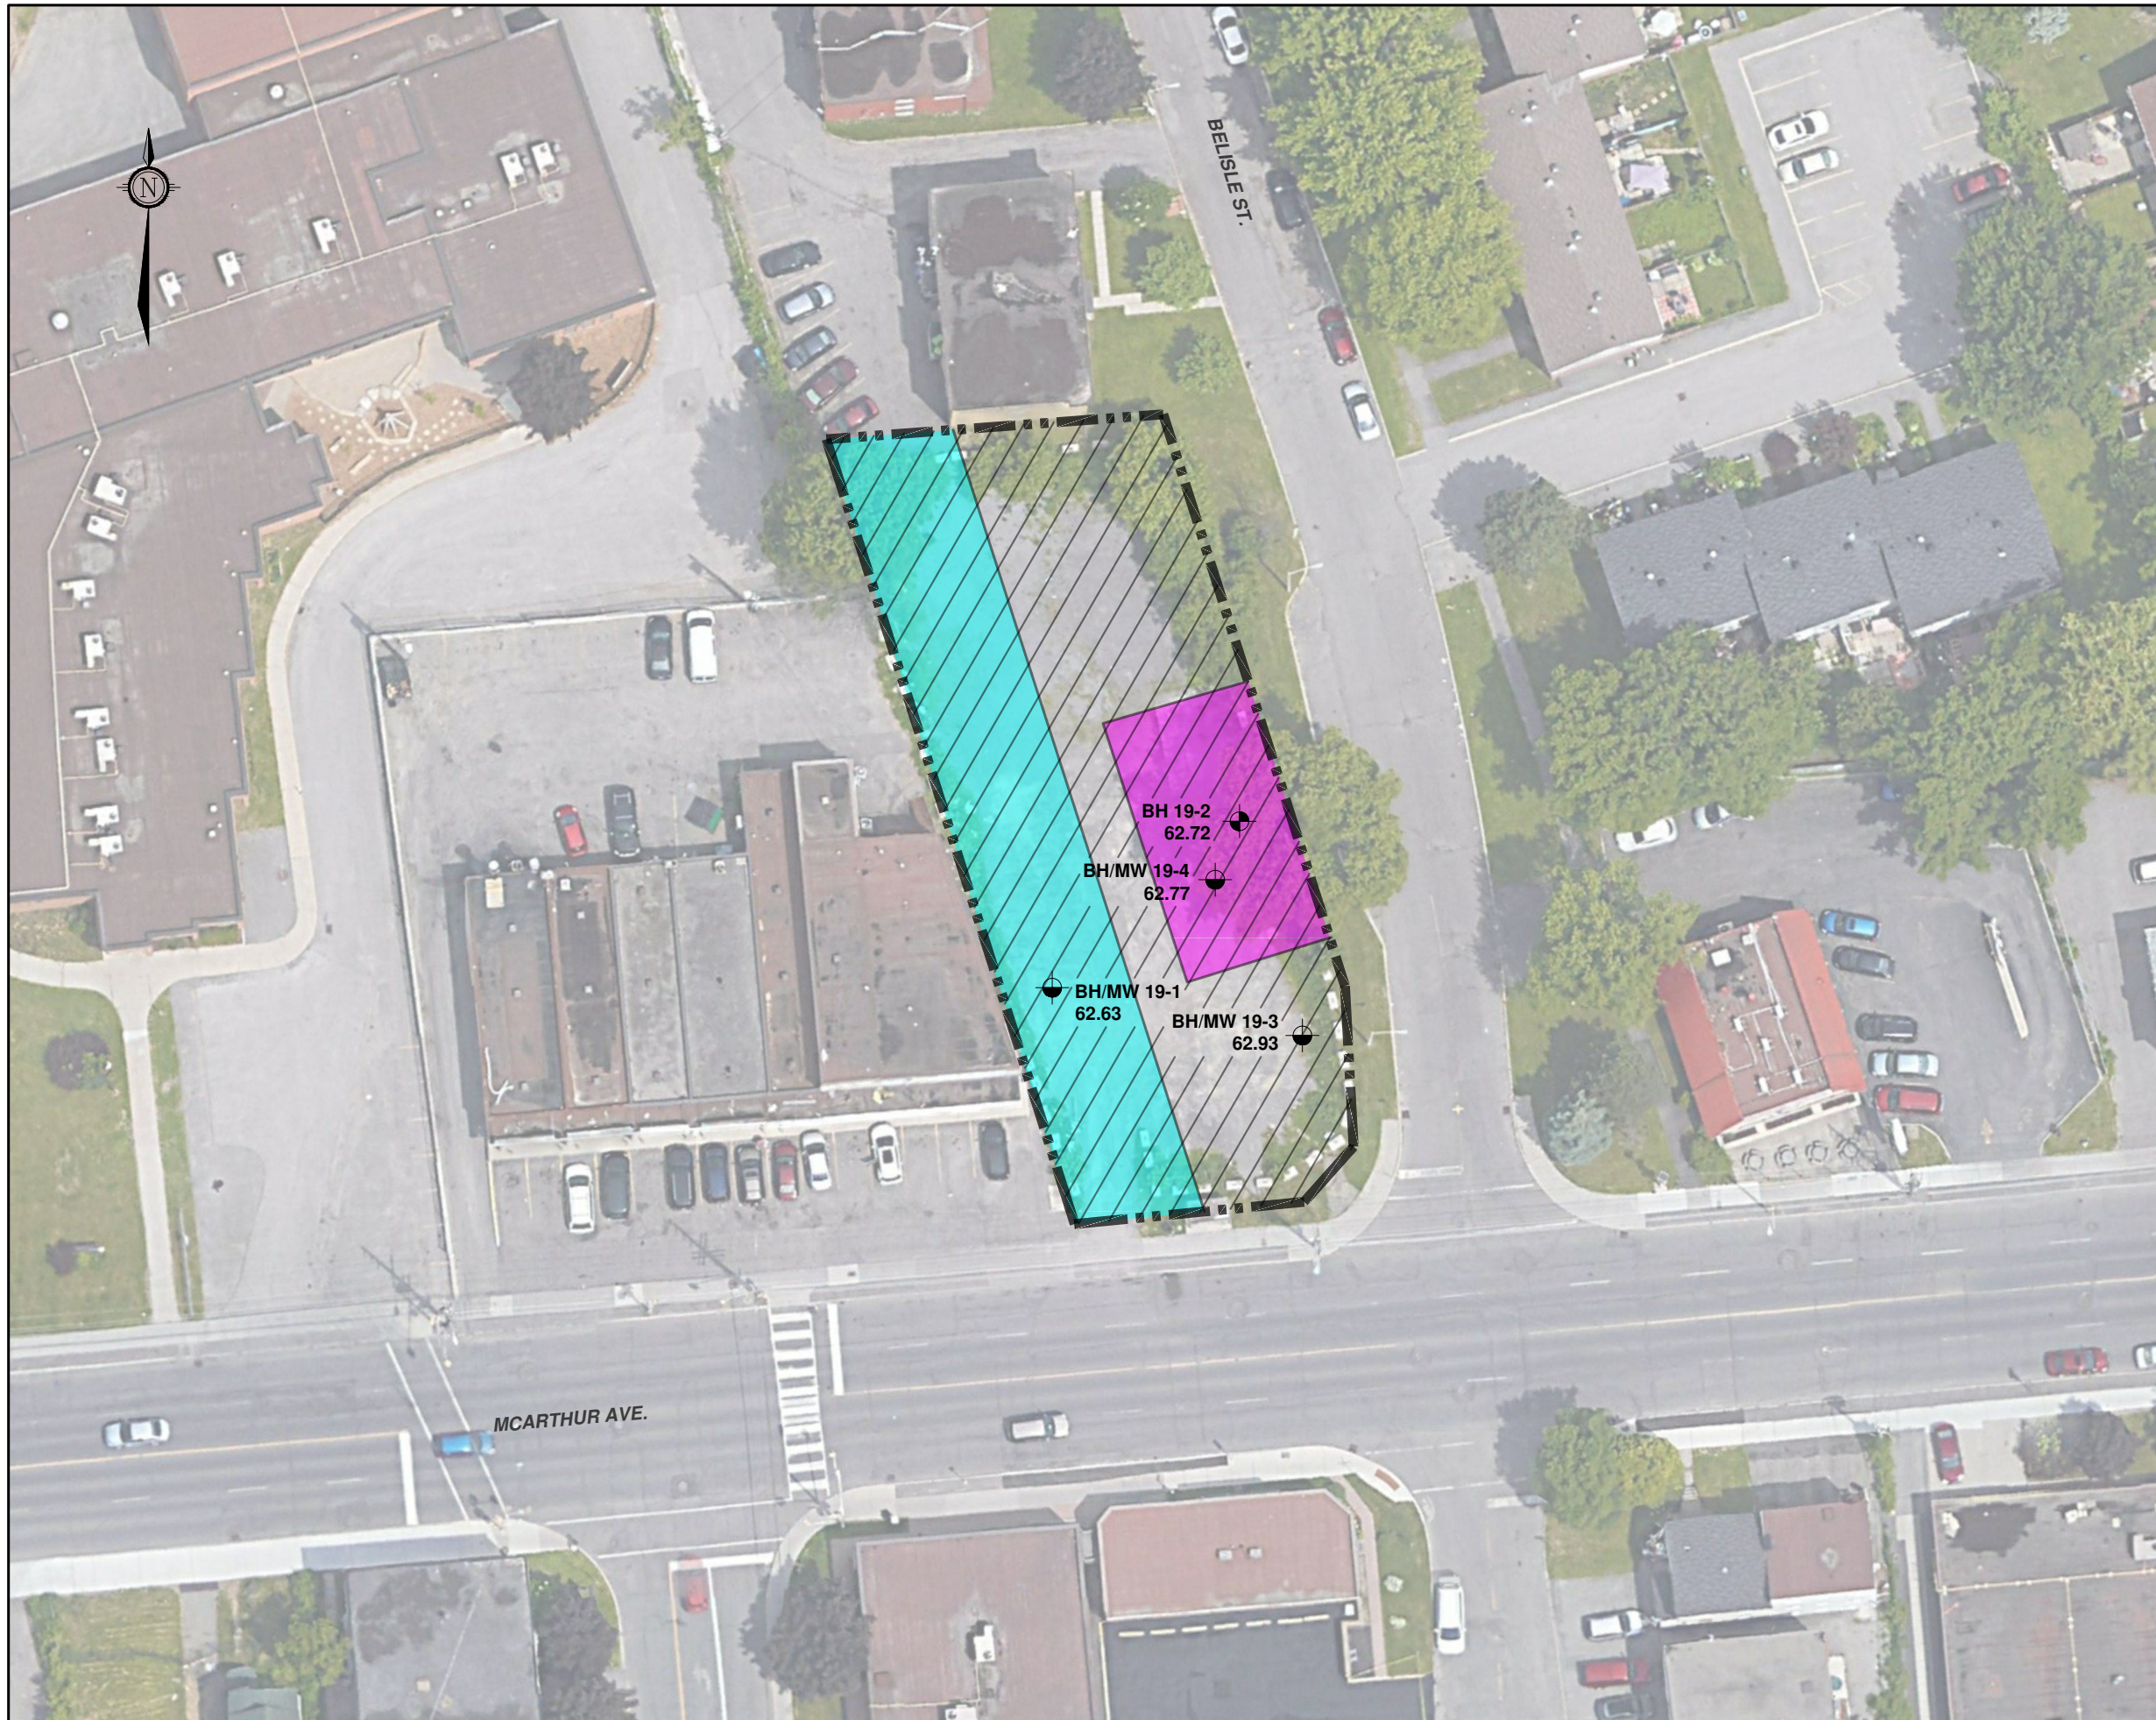
Drawing		APECs & PHASE TWO ESA SAMPLING LOCATIONS	
Client		NOVATECH	
Project	64819.22	PHASE TWO ESA/RECORD OF SITE CONDITION 393 MCARTHUR AVENUE OTTAWA, ONTARIO	
Drwn by	P.C.		
Chkd by	N.S.	Date	JUNE 2020
Rev.	2	FIGURE 9.4

Based on the findings of the Phase One and Phase Two ESA reports, the applicable Site Condition Standards for the future use of the site is Table 3 Generic Site Condition Standards for use in a Non-Potable Ground Water Condition, Course Textured Soils (MOE, 2011a). Environmental conditions at the subject site, as part of the Phase Two CSM are illustrated in plan view on Figure 9.4 and in cross sections A-A' and B-B', Figures 9.6 and 9.7, respectively.

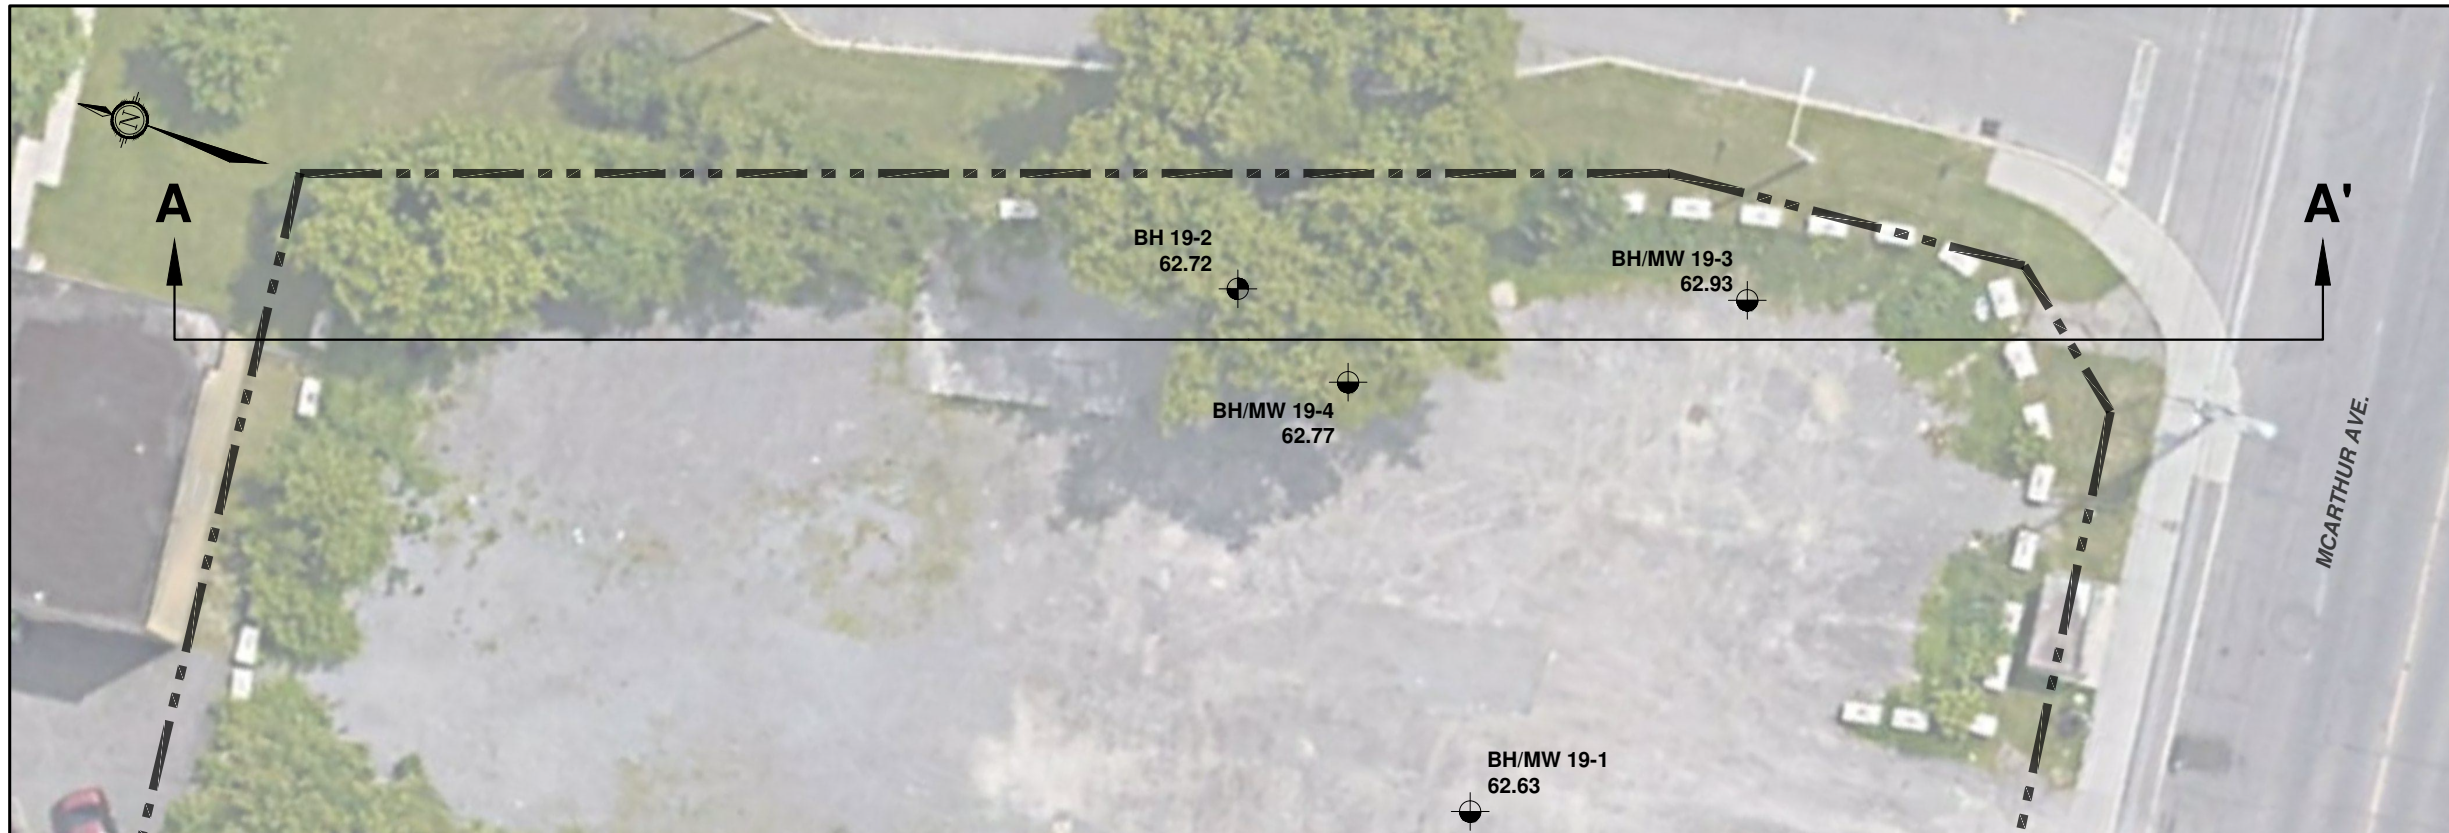
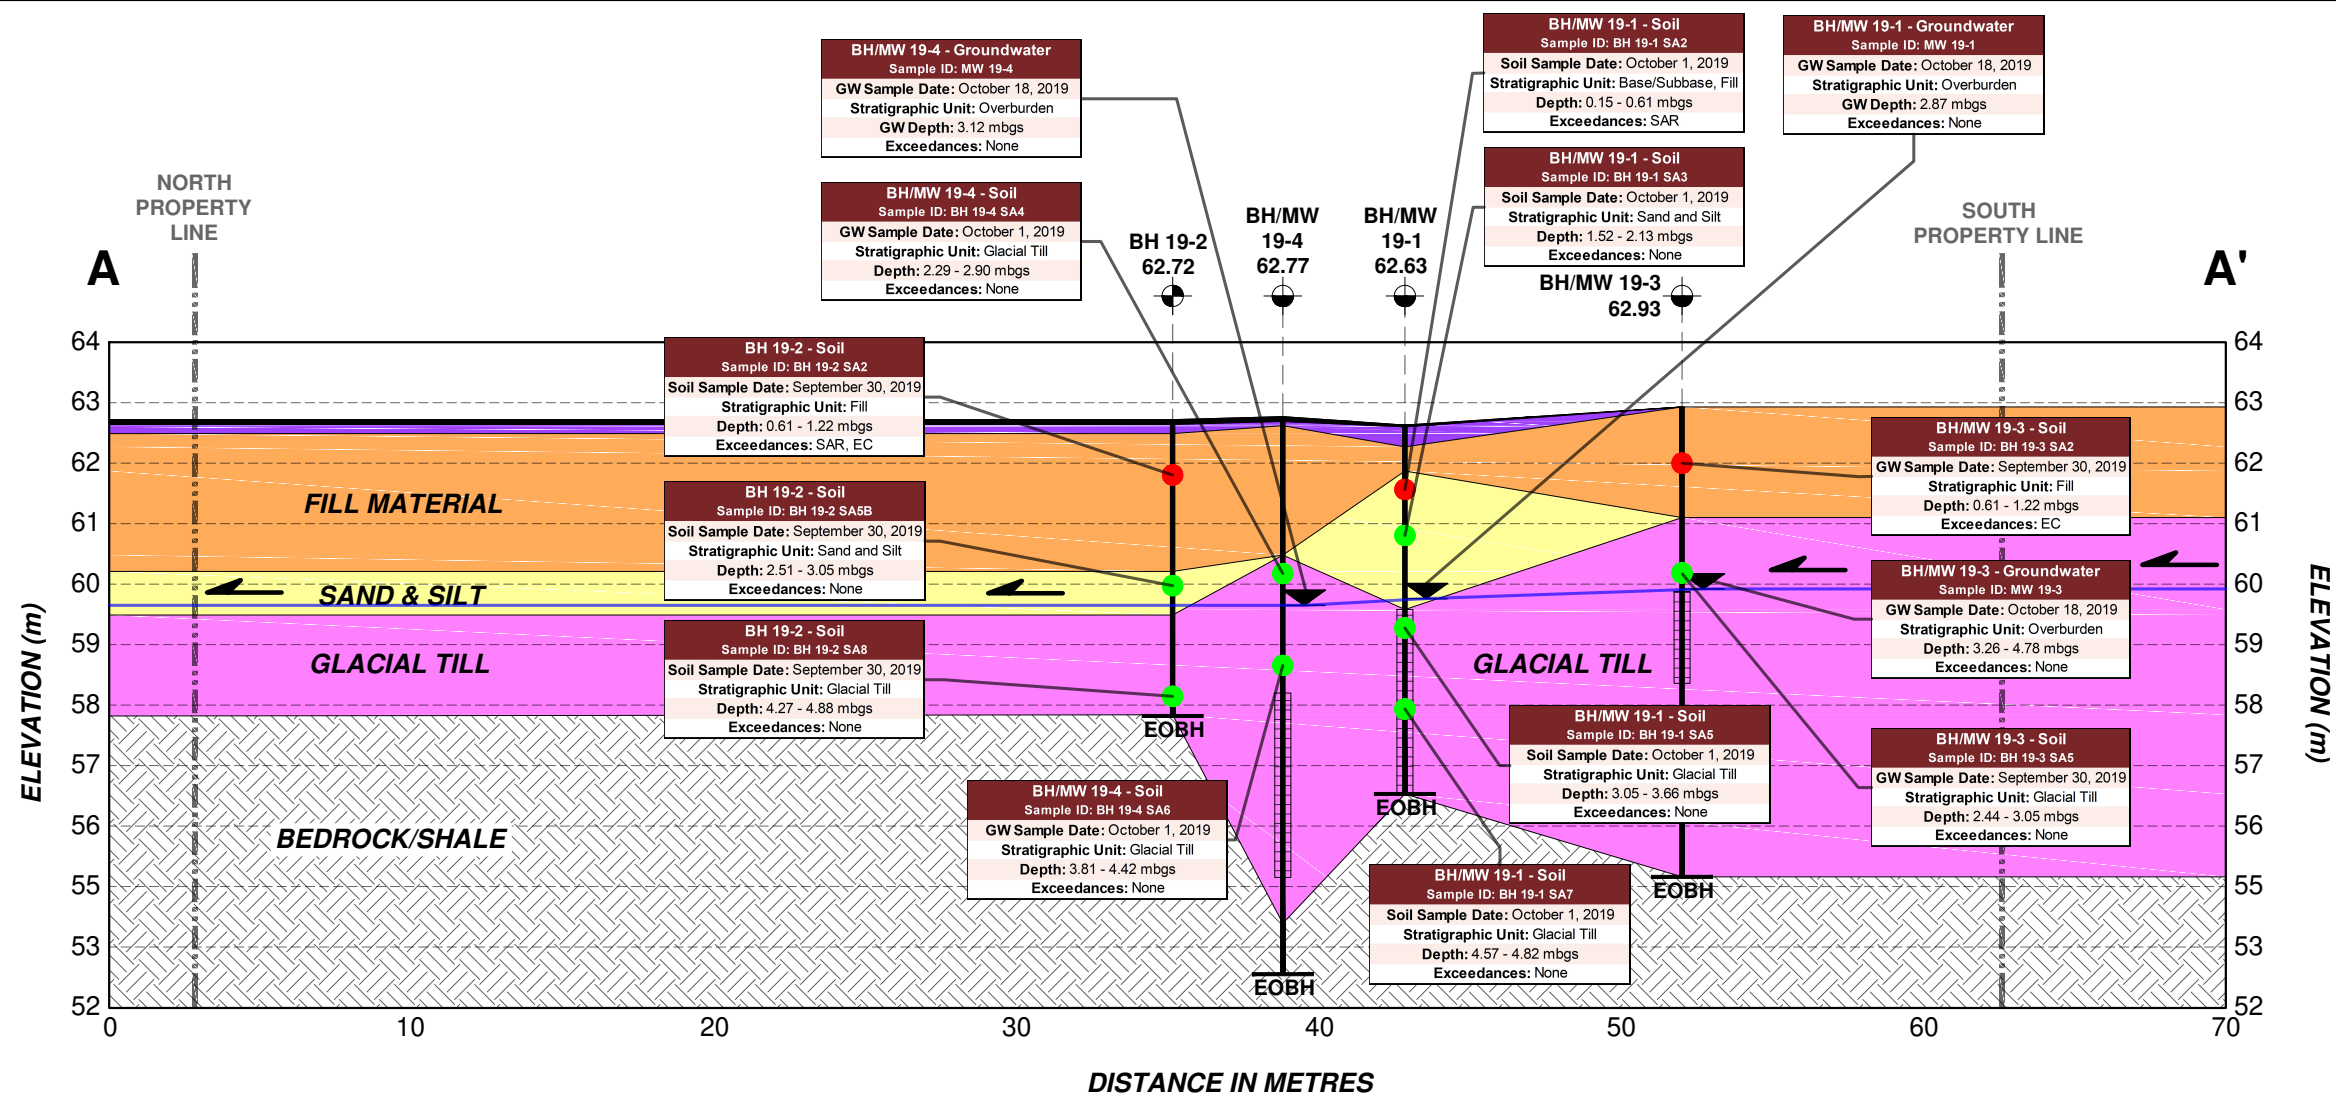
Drawing		CROSS SECTION A-A' SOIL QUALITY EXCEEDANCES	
Client		NOVATECH	
Project	64819.22	PHASE TWO ESA/RECORD OF SITE CONDITION 393 MCARTHUR AVENUE OTTAWA, ONTARIO	
Drwn by	P.C.	Chkd by	N.S.
Date	JUNE 2020	Rev.	2
			FIGURE 9.6

BH/MW 19-3					
Sample Type	ID	Depth/ Screened Interval (mbgs)	Date	Stratigraphic Unit	Exceedances
Groundwater	MW19-3	3.26 - 4.78	Jan-18-2019	Overburden	None
Soil	BH19-3 SA2	0.61 - 1.22	Sept-30-2019	Fill	EC
Soil	BH19-3 SA5	2.44 - 3.05	Sept-30-2019	Glacial Till	None

It is interpreted that elevated SAR and EC within the fill materials in BH19-2 and BH19-3 originate from the subject property are due to substances that have been applied to surfaces for the safety of vehicular or pedestrian traffic under conditions of snow or ice or both. Accordingly, as indicated above according to Section 20 (2) of O.Reg 407/19, MECP SCS exceedances of SAR, and EC in are not considered to be contamination within the project limits. As such, no further work is recommended.
