Geotechnical Investigation Proposed Commercial Development

444 Citigate Drive & 560 Dealership Drive Ottawa, Ontario

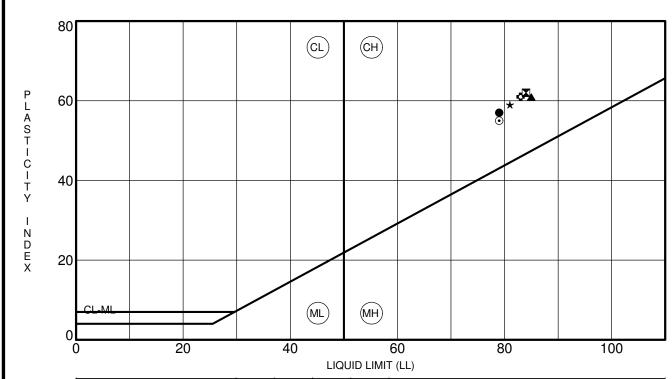
3	Specimen Identi	ification	LL	PL	PI	Fines	Classification
•	BH 1-22	SS2	79	22	57		CH - Inorganic clay of high plasticity
X	BH 5-22	SS3	84	22	62		CH - Inorganic clay of high plasticity
	BH 6-22	SS3	85	24	61		CH - Inorganic clay of high plasticity
*	BH 8-22	SS2	81	22	59		CH - Inorganic clay of high plasticity
0	BH10-22	SS3	79	24	55		CH - Inorganic clay of high plasticity
0	BH11-22	SS3	83	22	61		CH - Inorganic clay of high plasticity

In accordance with the City of Ottawa Tree Planting in Sensitive Marine Clay Soils (2017 Guidelines), Paterson completed a soils review for samples taken from 444 Citigate Drive to determine applicable tree planting setbacks. Atterberg limits testing, grain size distribution and hydrometer testing were completed for recovered silty clay samples at selected locations throughout the subject site. The above noted soil samples were recovered from elevations below the anticipated design underside of footing elevation and 3.5 m depth below anticipated finished grade. The results of our testing are presented in Subsection 4.2 and in Appendix 1.
