# Assessment of Adequacy of Servicing Report

2545 9th Line Road Metcalfe, Ontario

ASB Greenworld Ltd

December 20, 2022

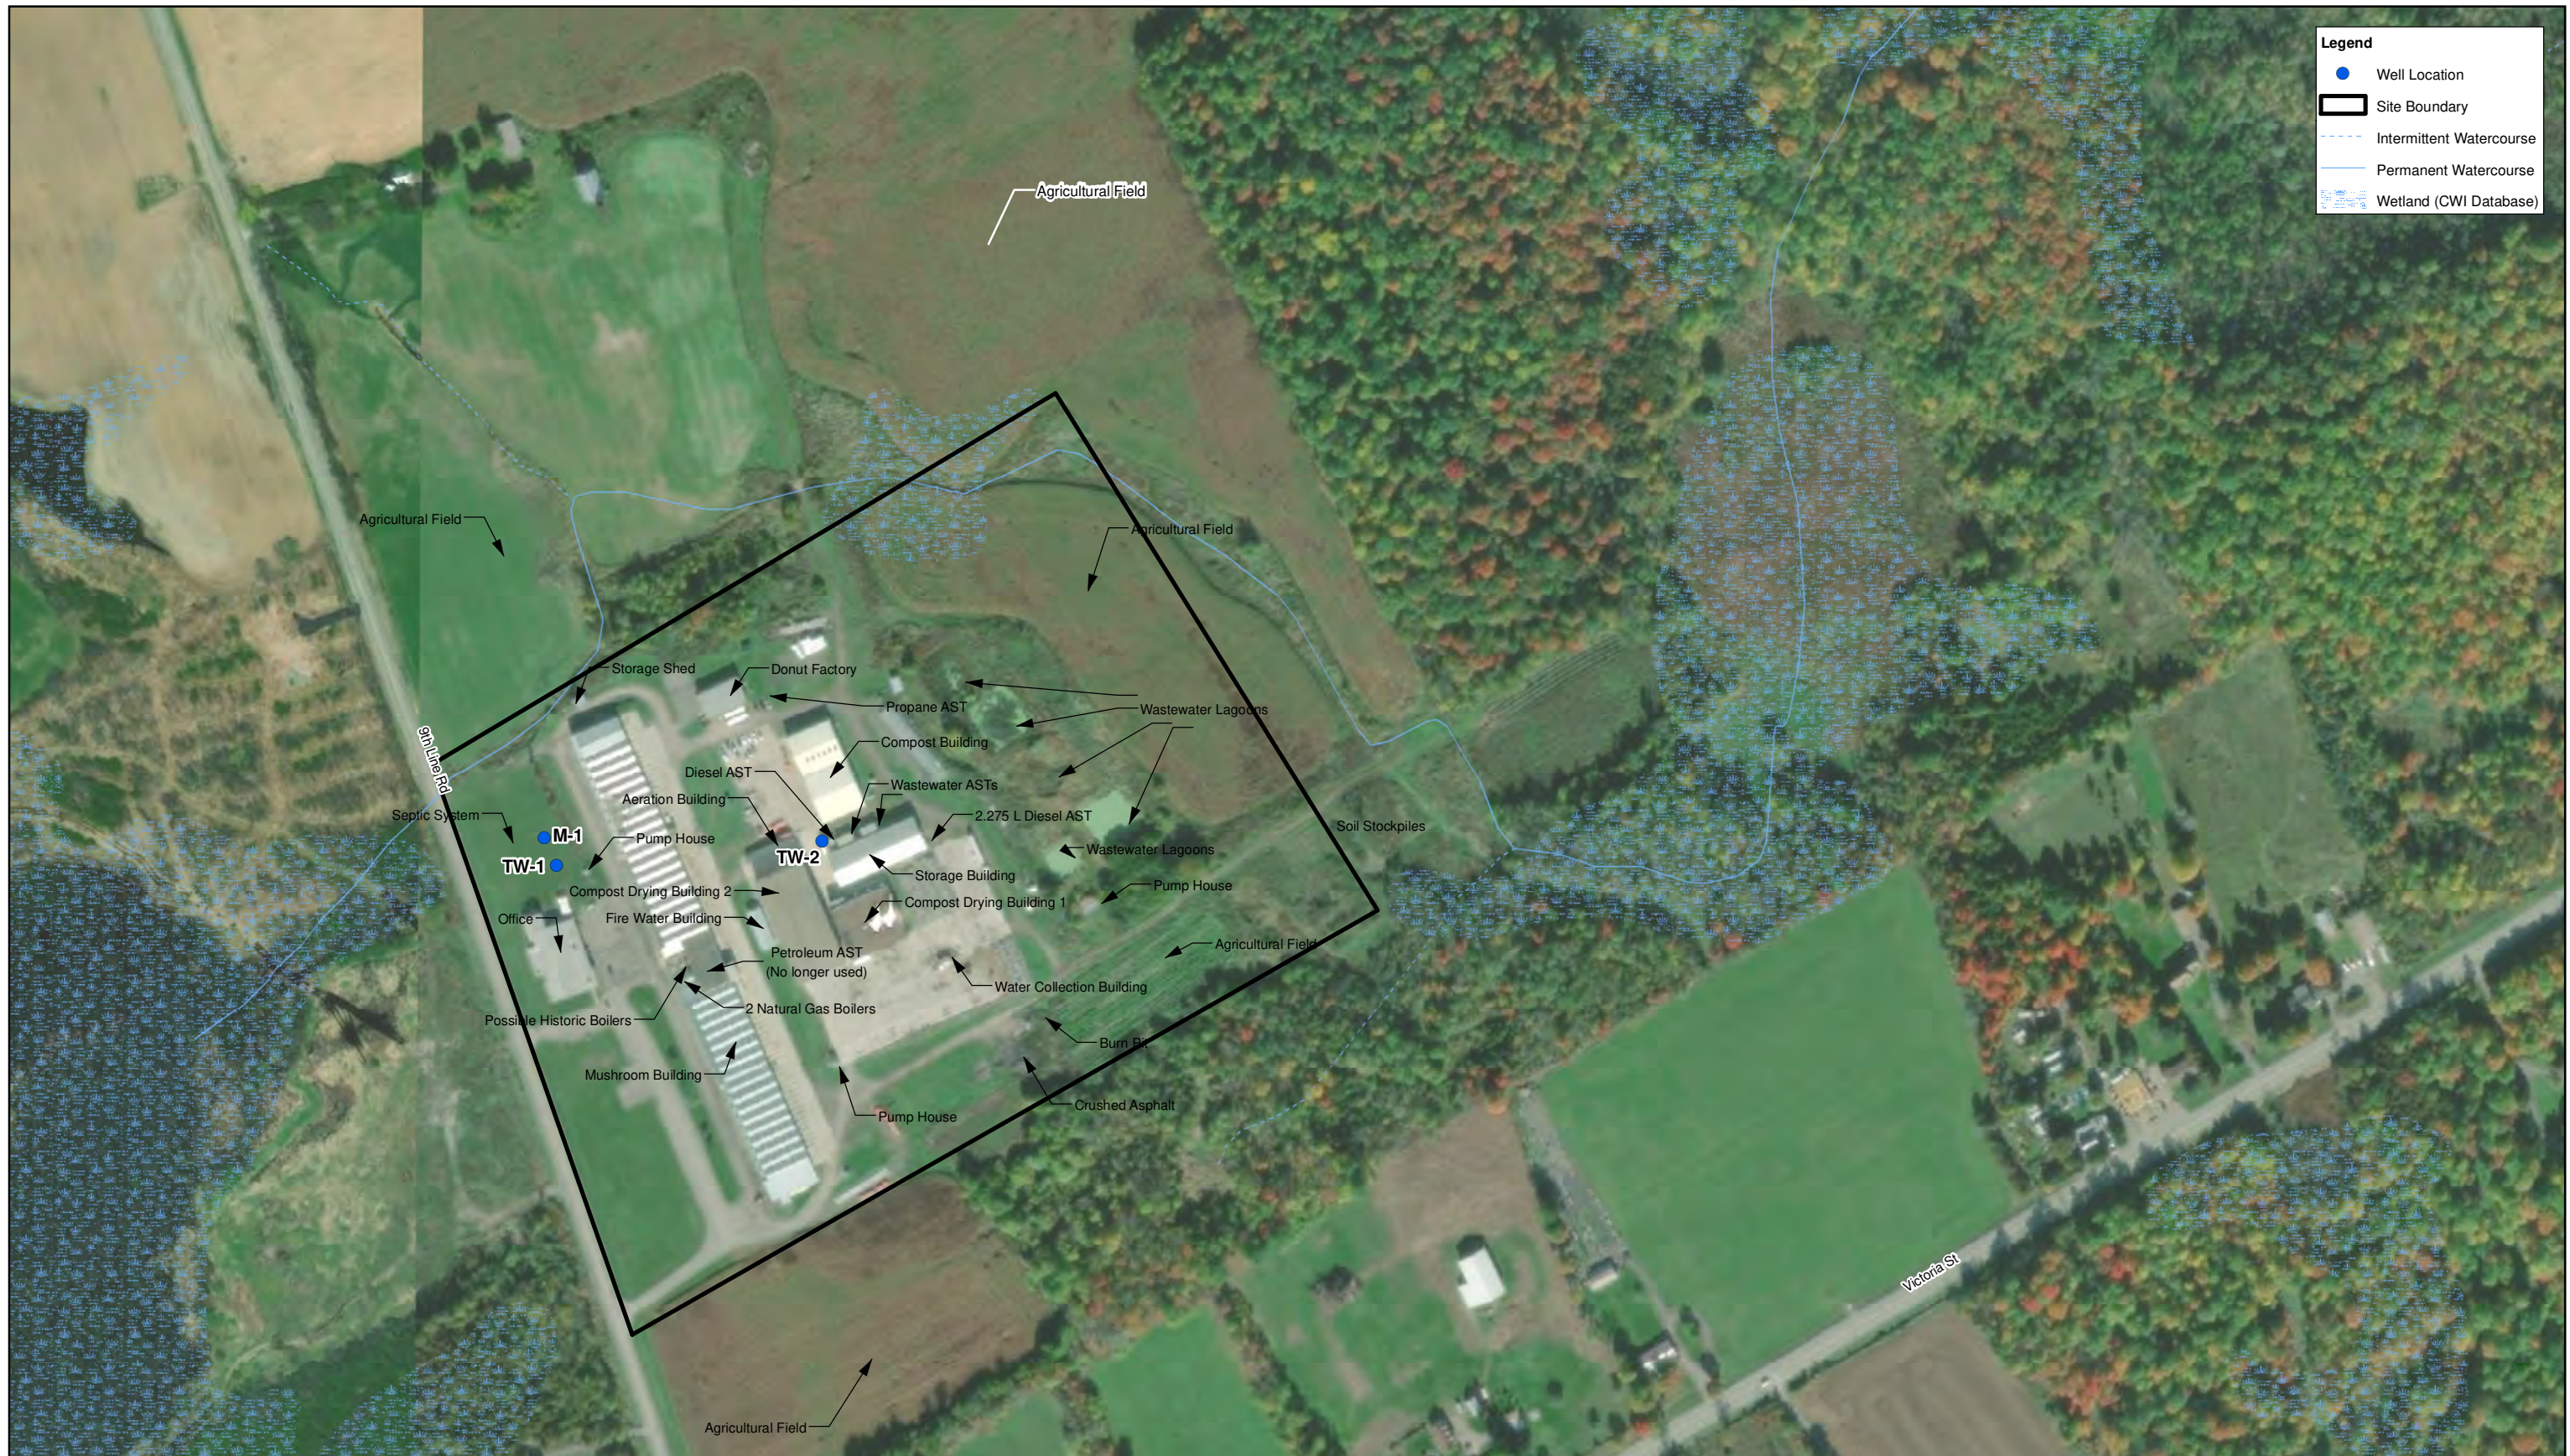
**FIGURE 1**

A Site Location Map and a Site Plan are provided on **Figure 1** and **Figure 2**, respectively.

The Site is serviced with an approximately 200 cubic metre (m<sup>3</sup>) (200,000 L) concrete basin inside the Fire Water Building located in the centre of the Site (refer to Figure 2). Water for the basin is supplied from water supply well TW-2, with an assumed pumping capacity of 75 L/min. Assuming a typical fire truck can spray approximately 950 to 3,785 L/min, the estimated time before the basin would empty is approximately 3.8 to 0.9 hours.

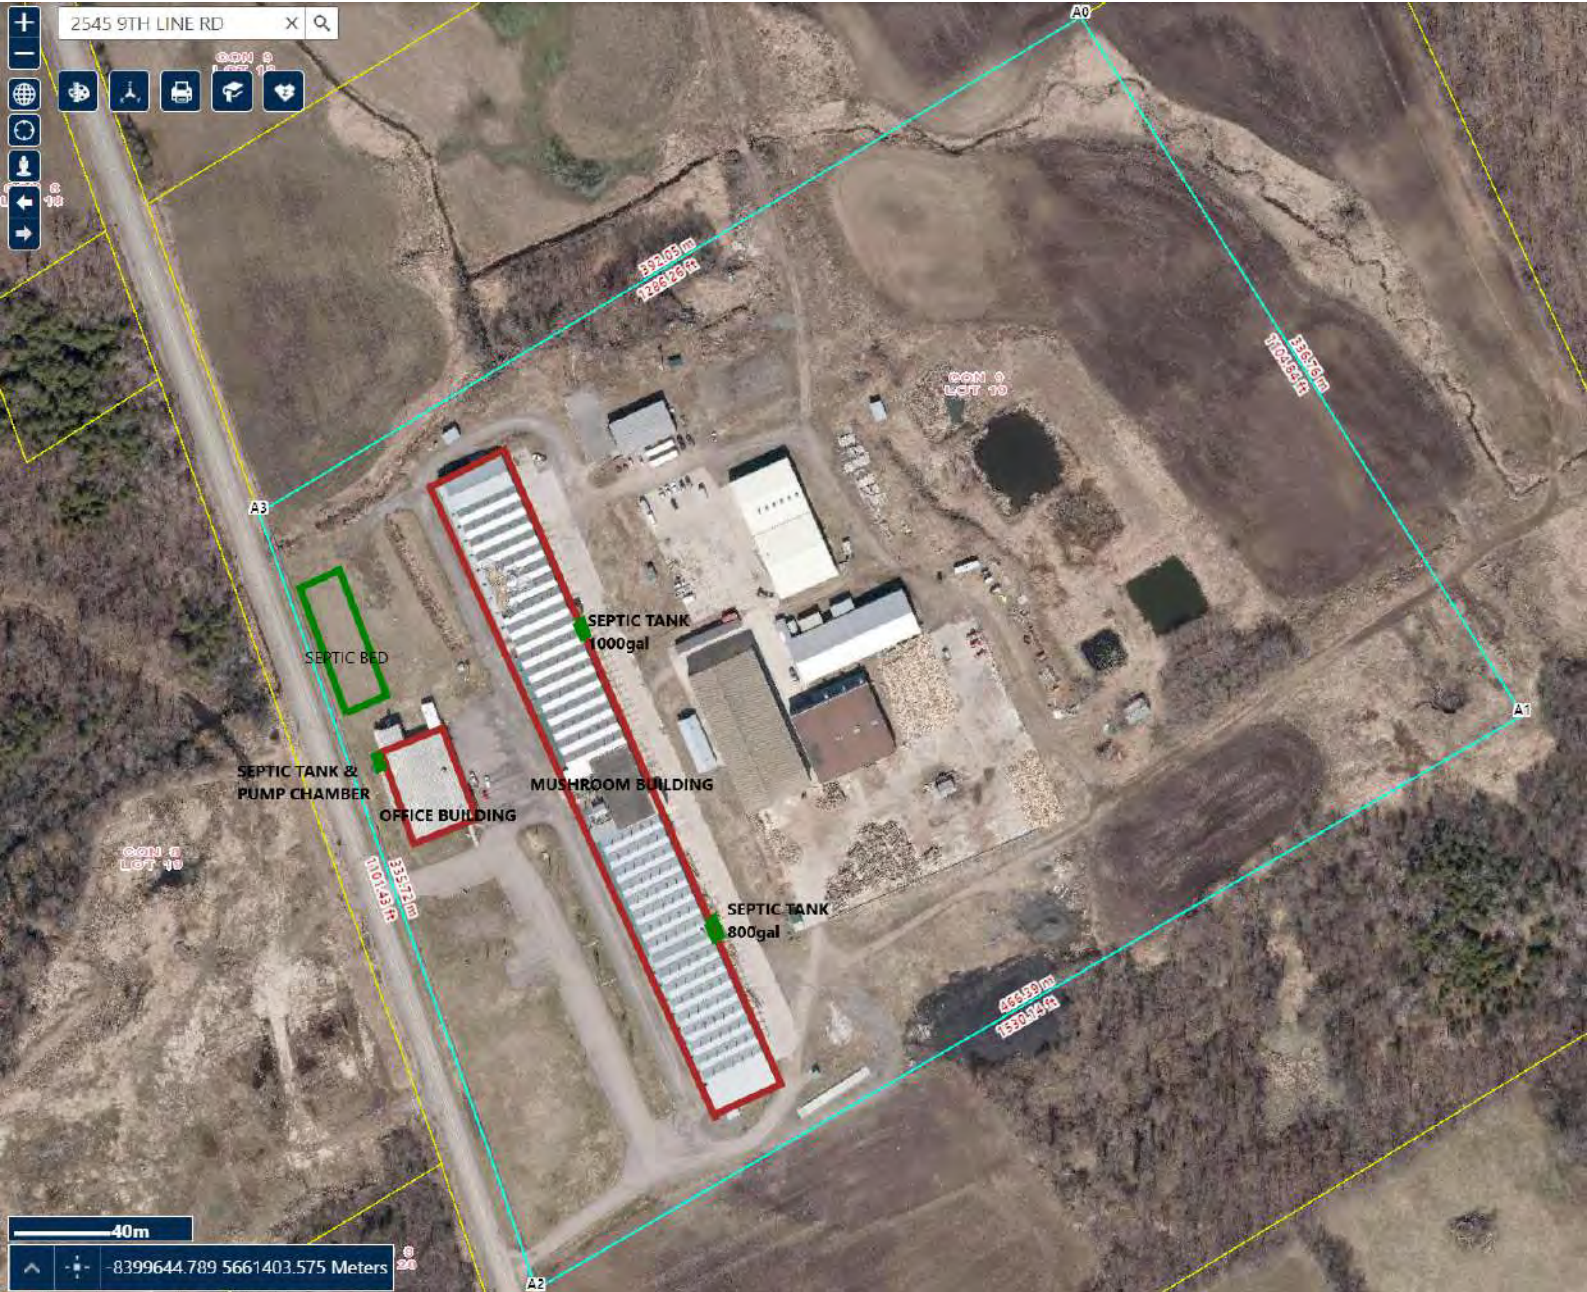
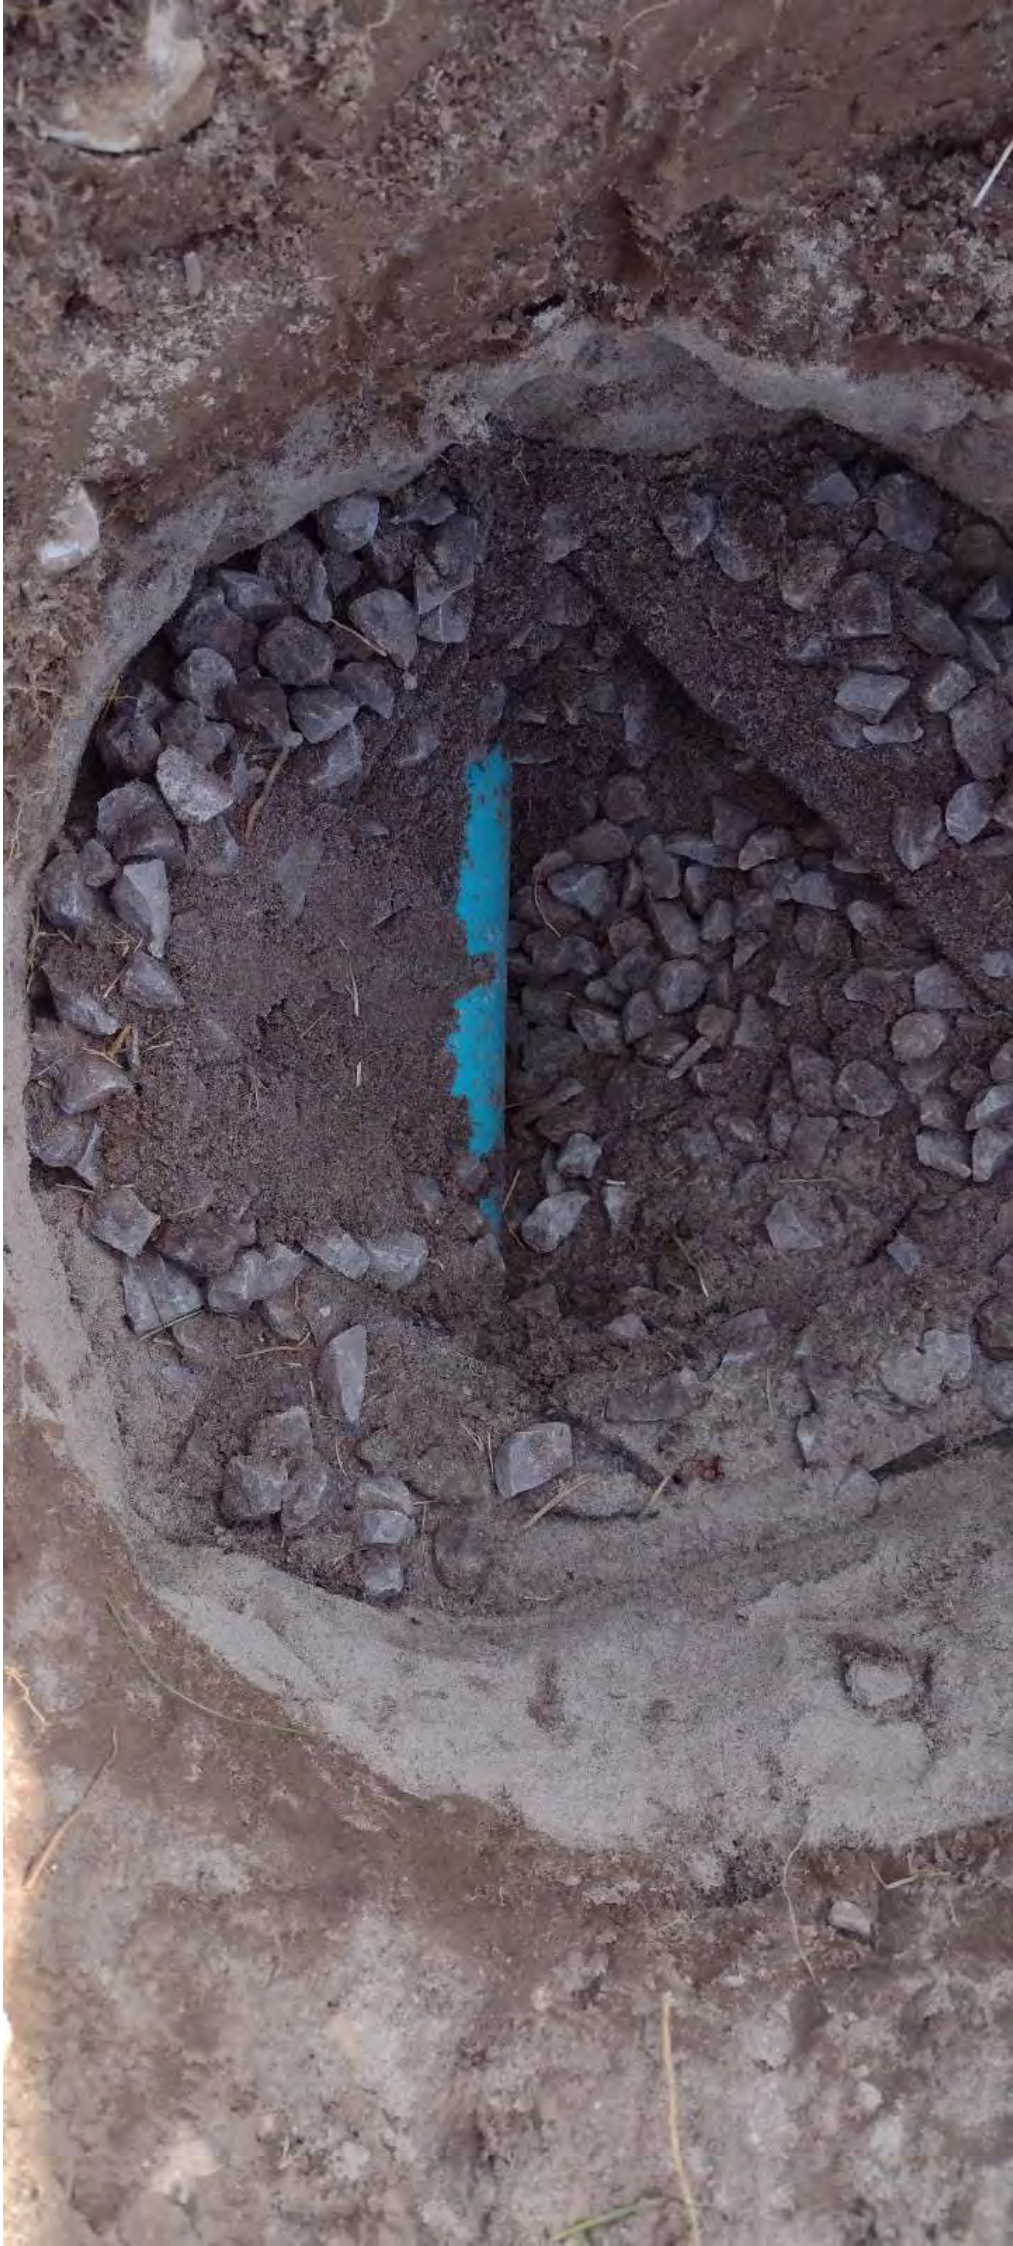
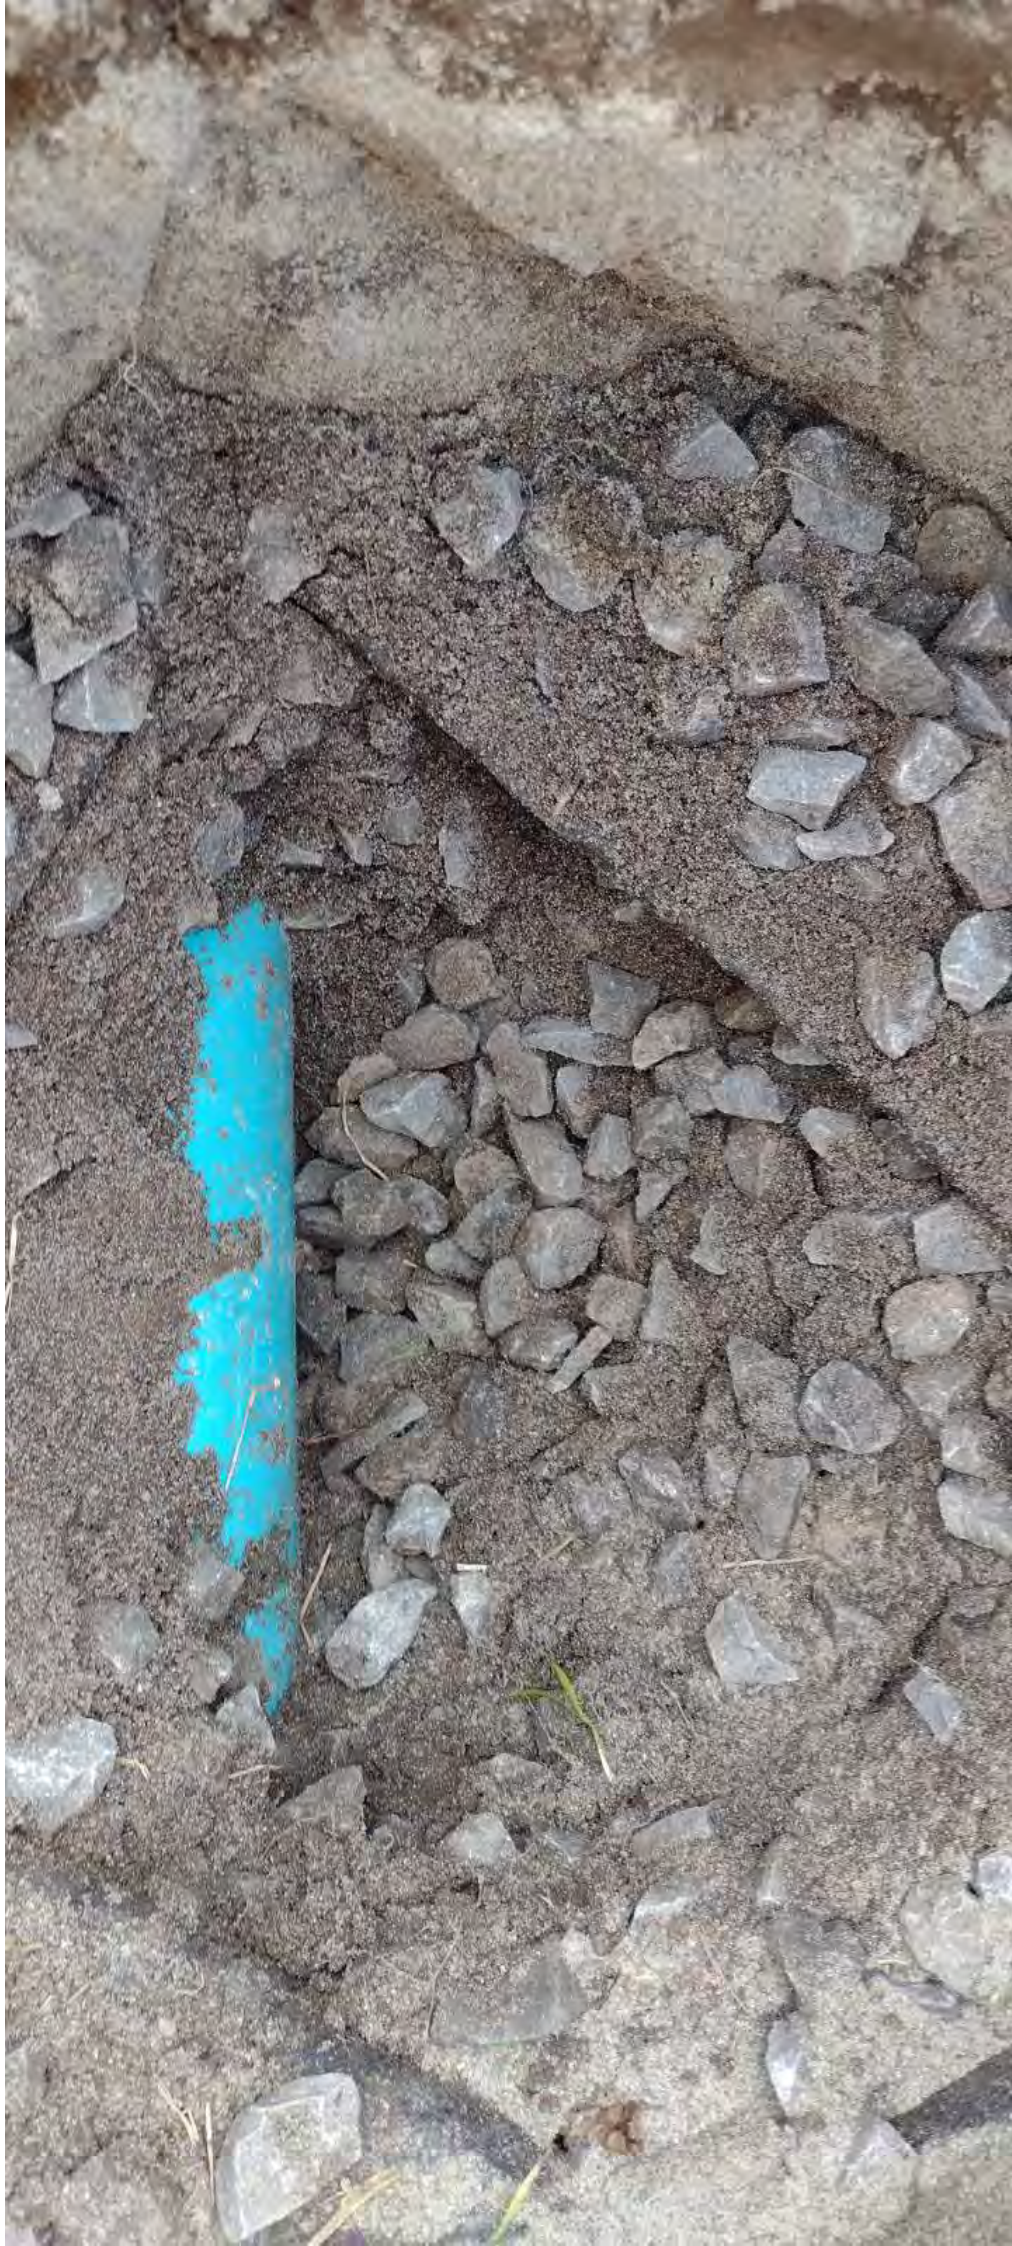
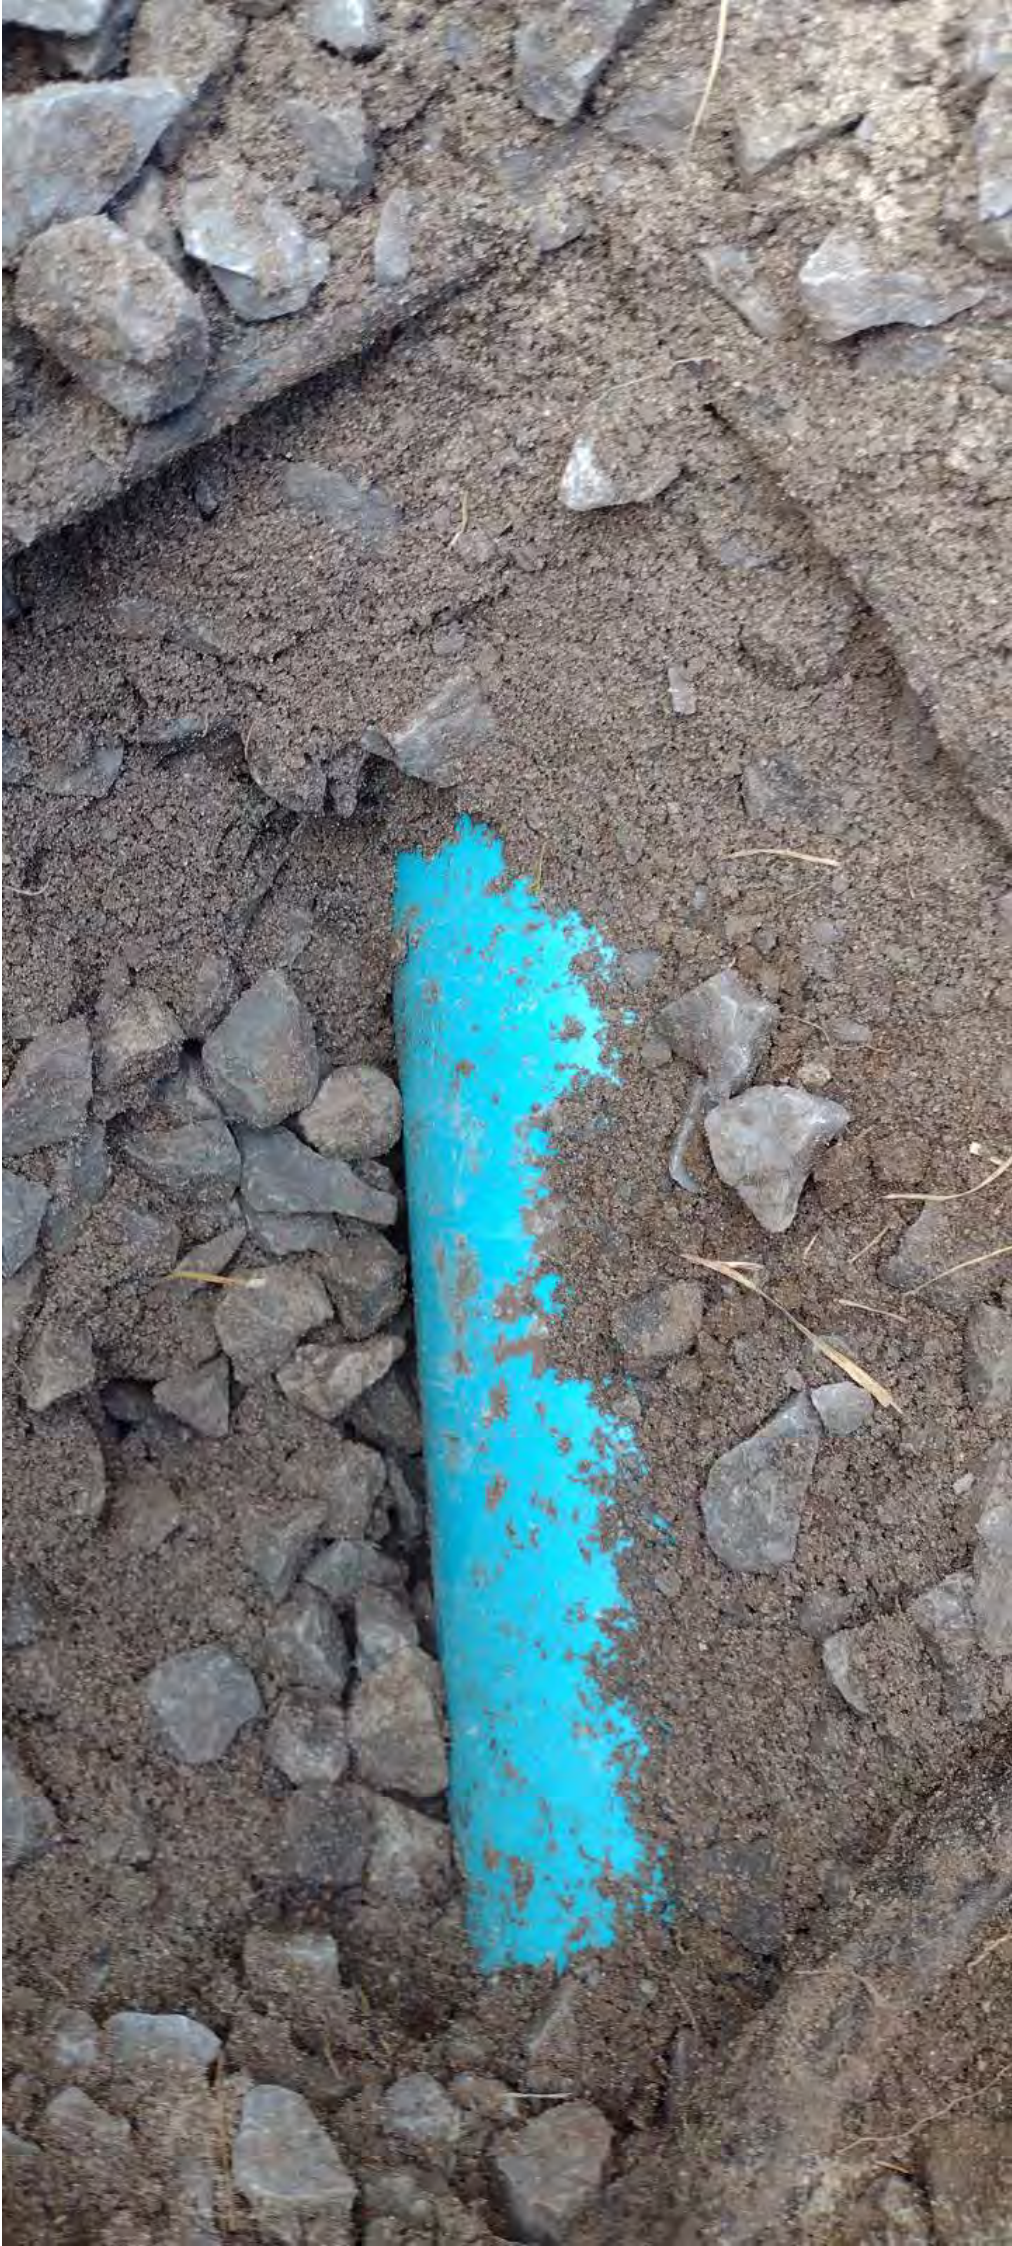
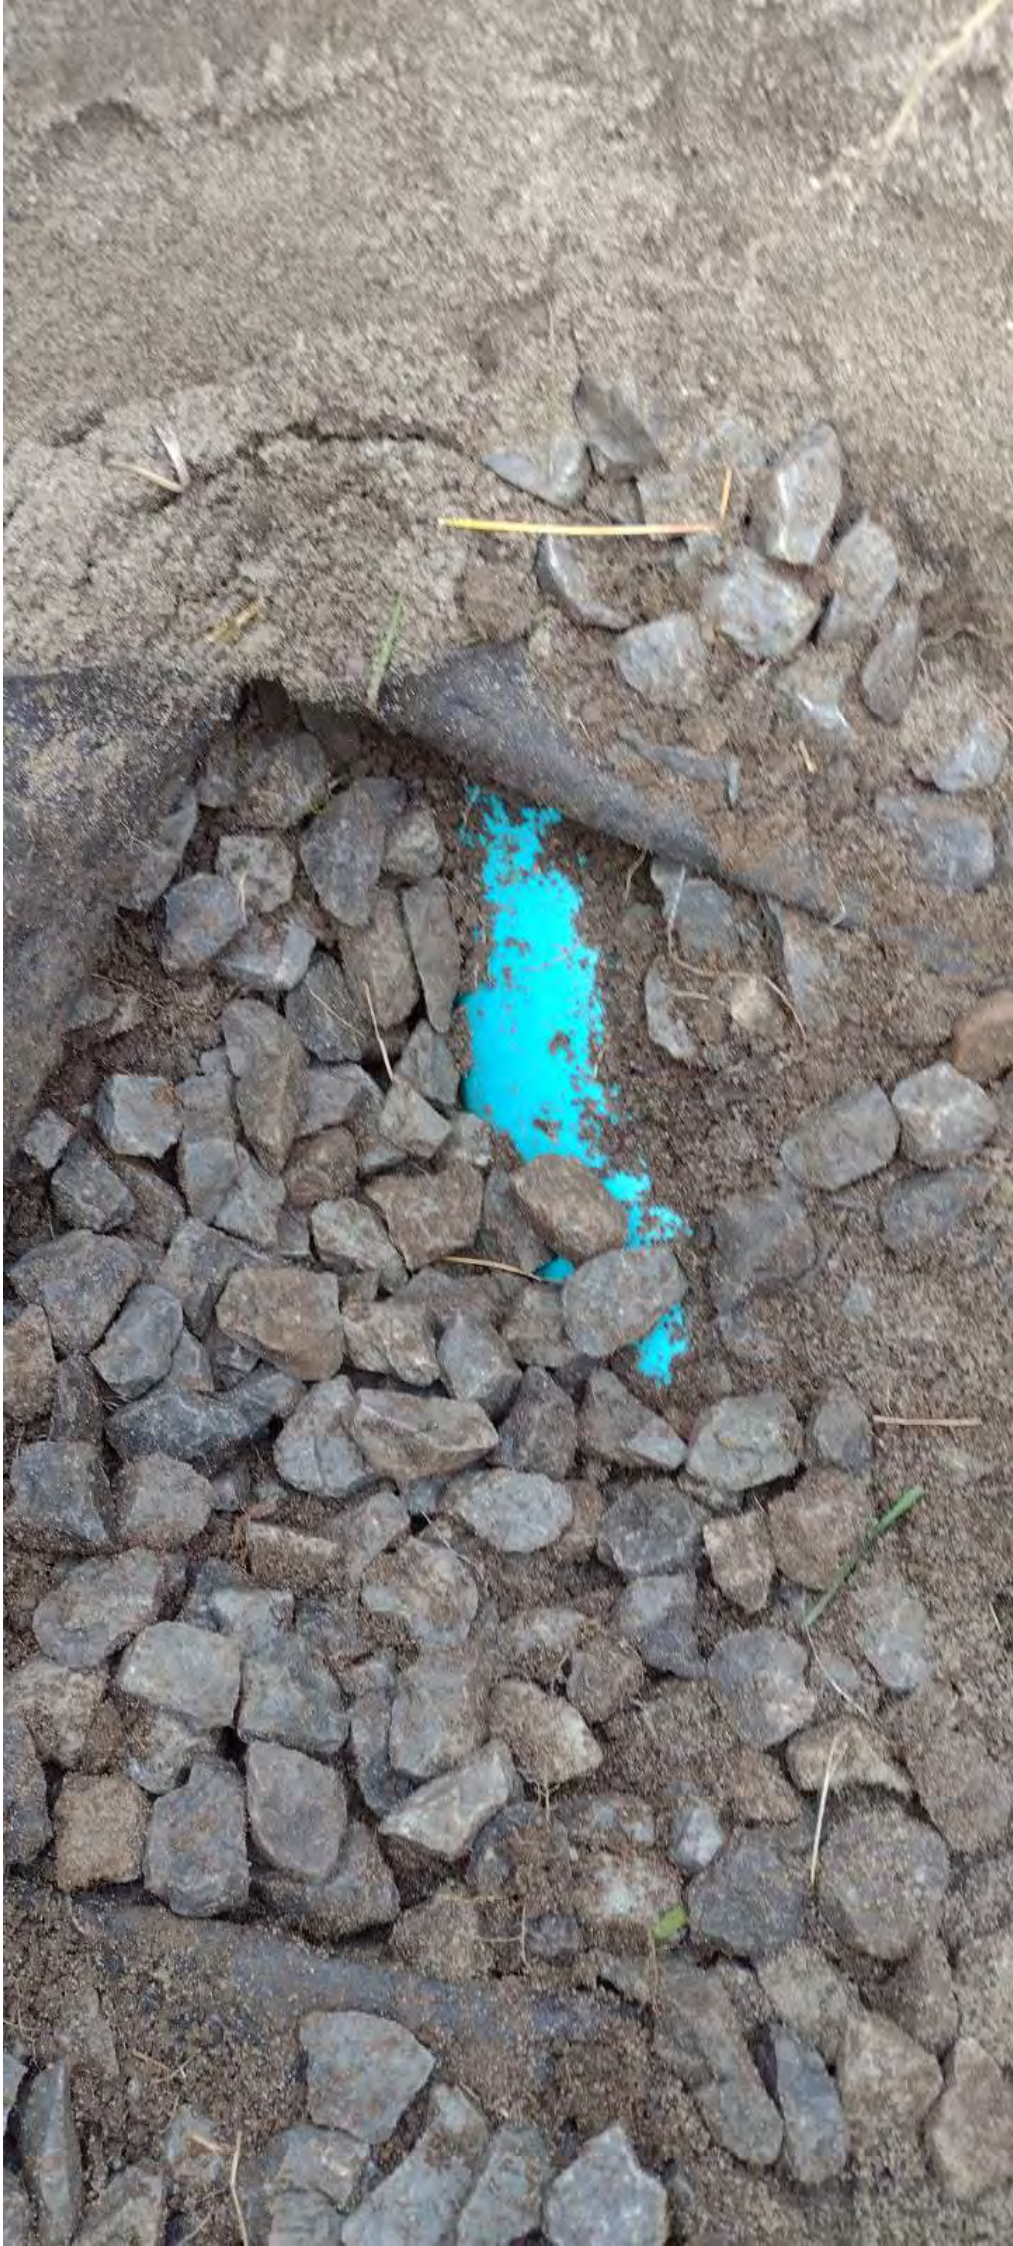
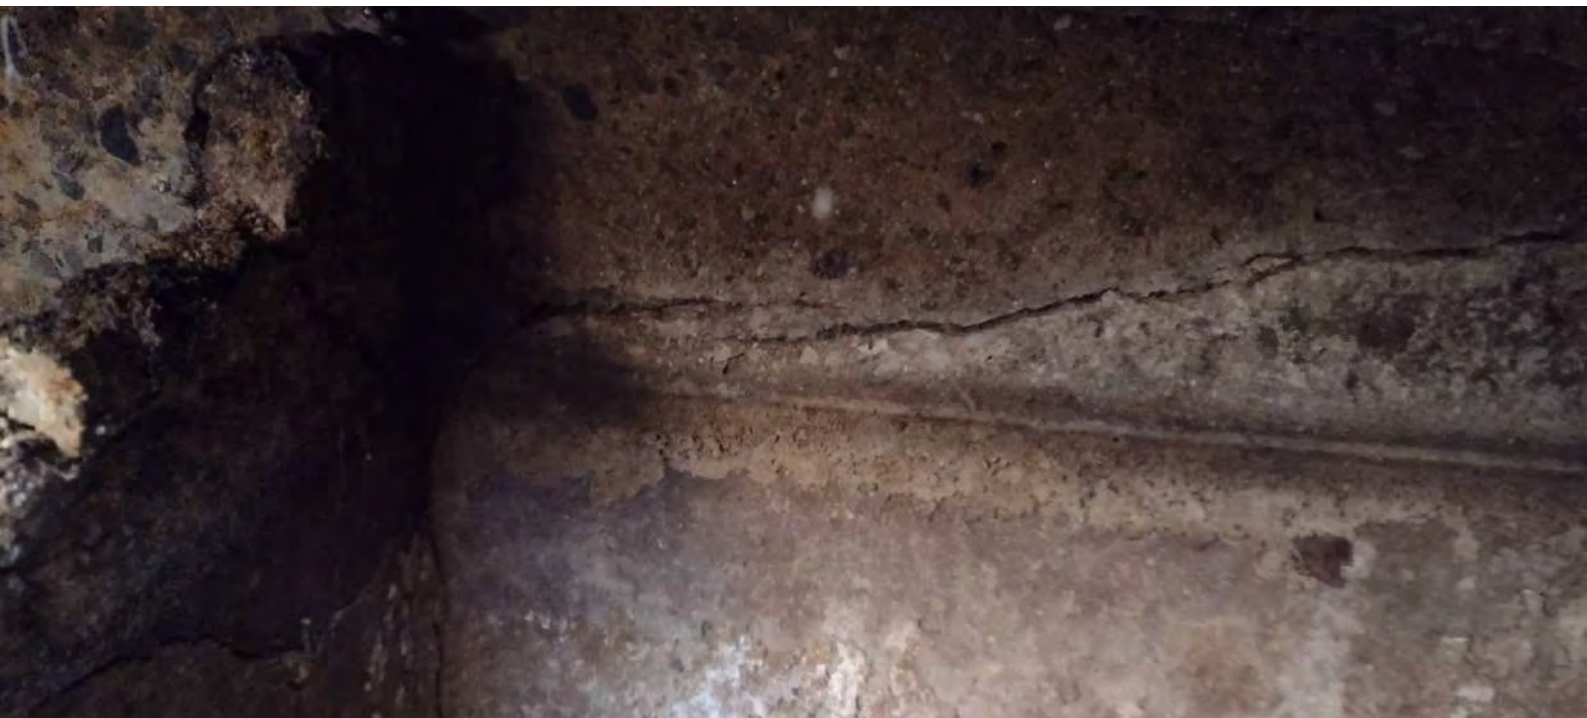
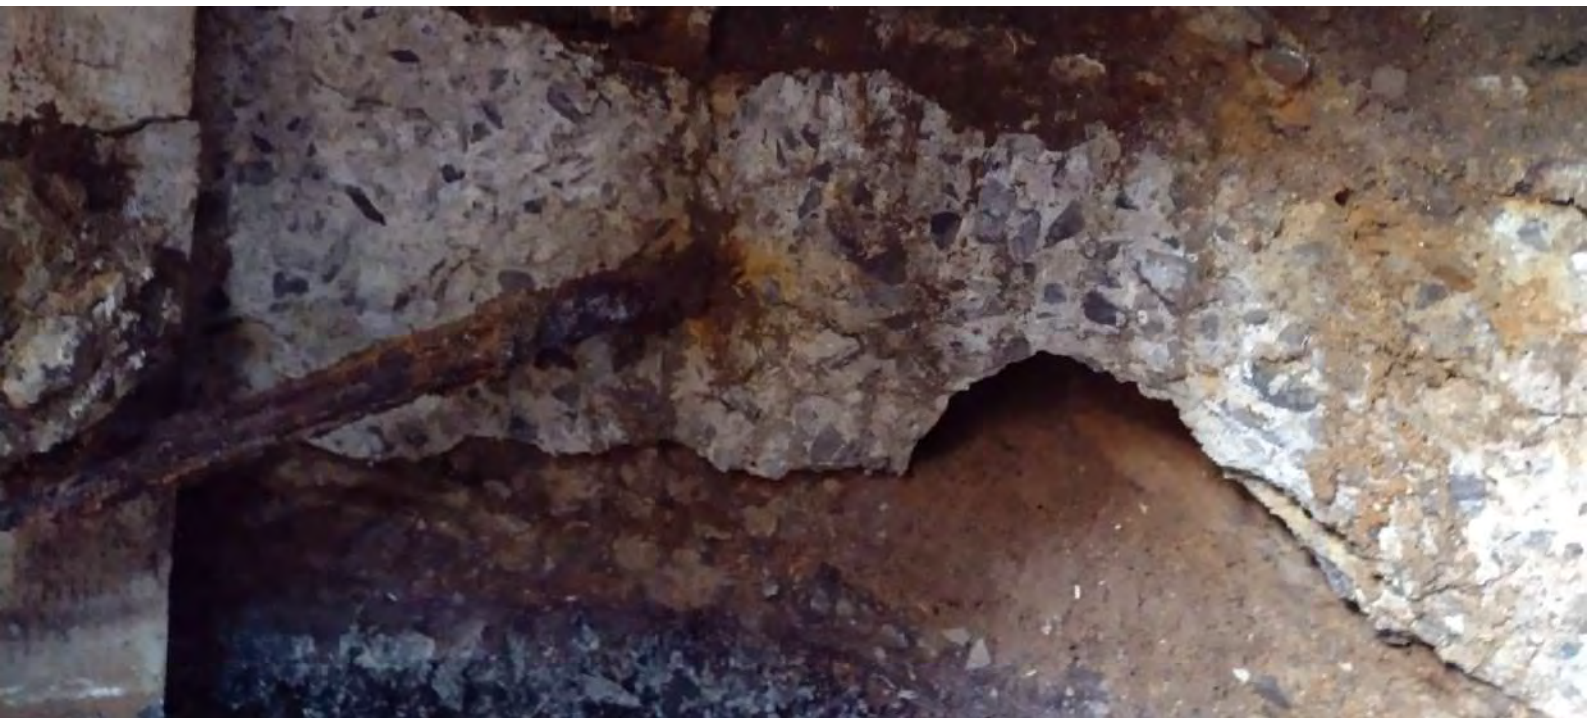
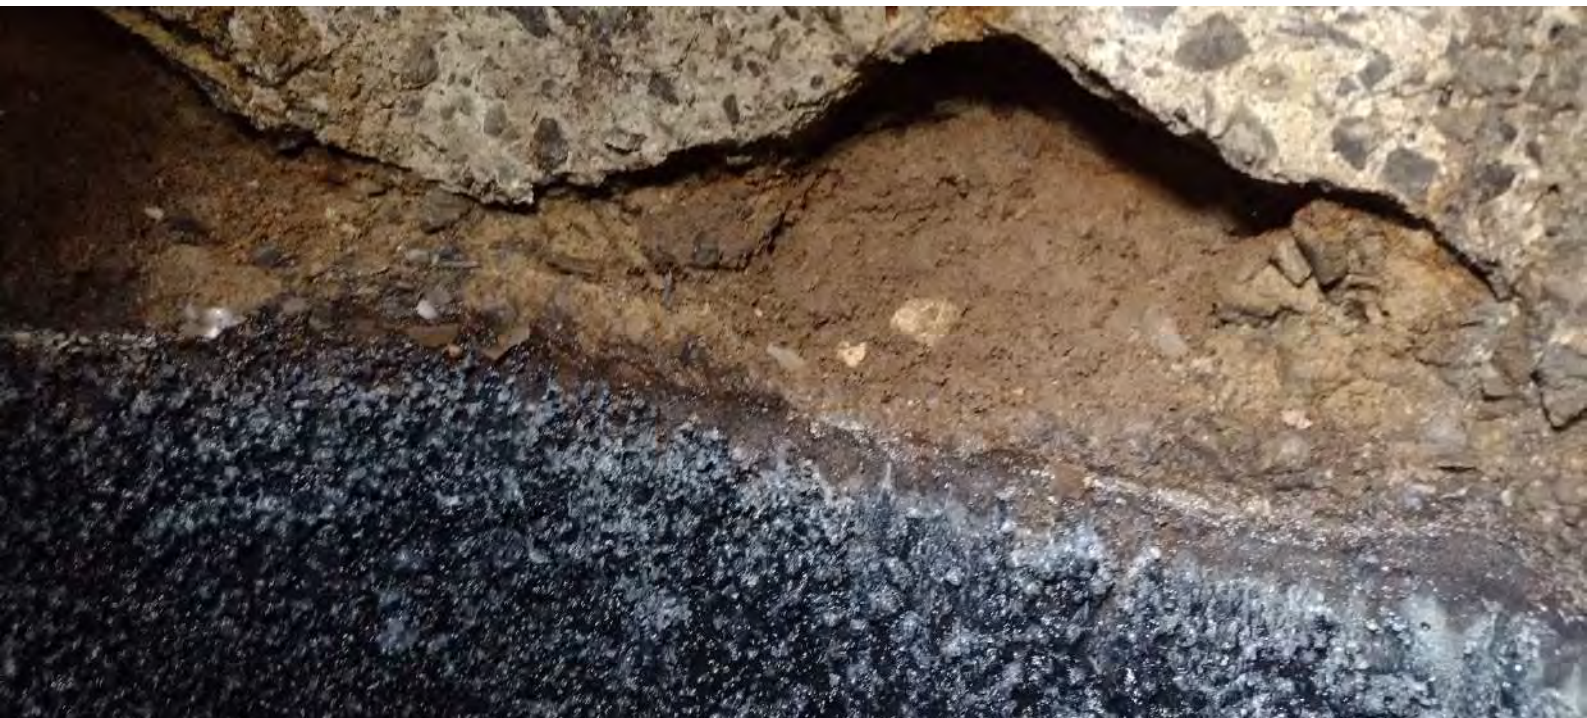
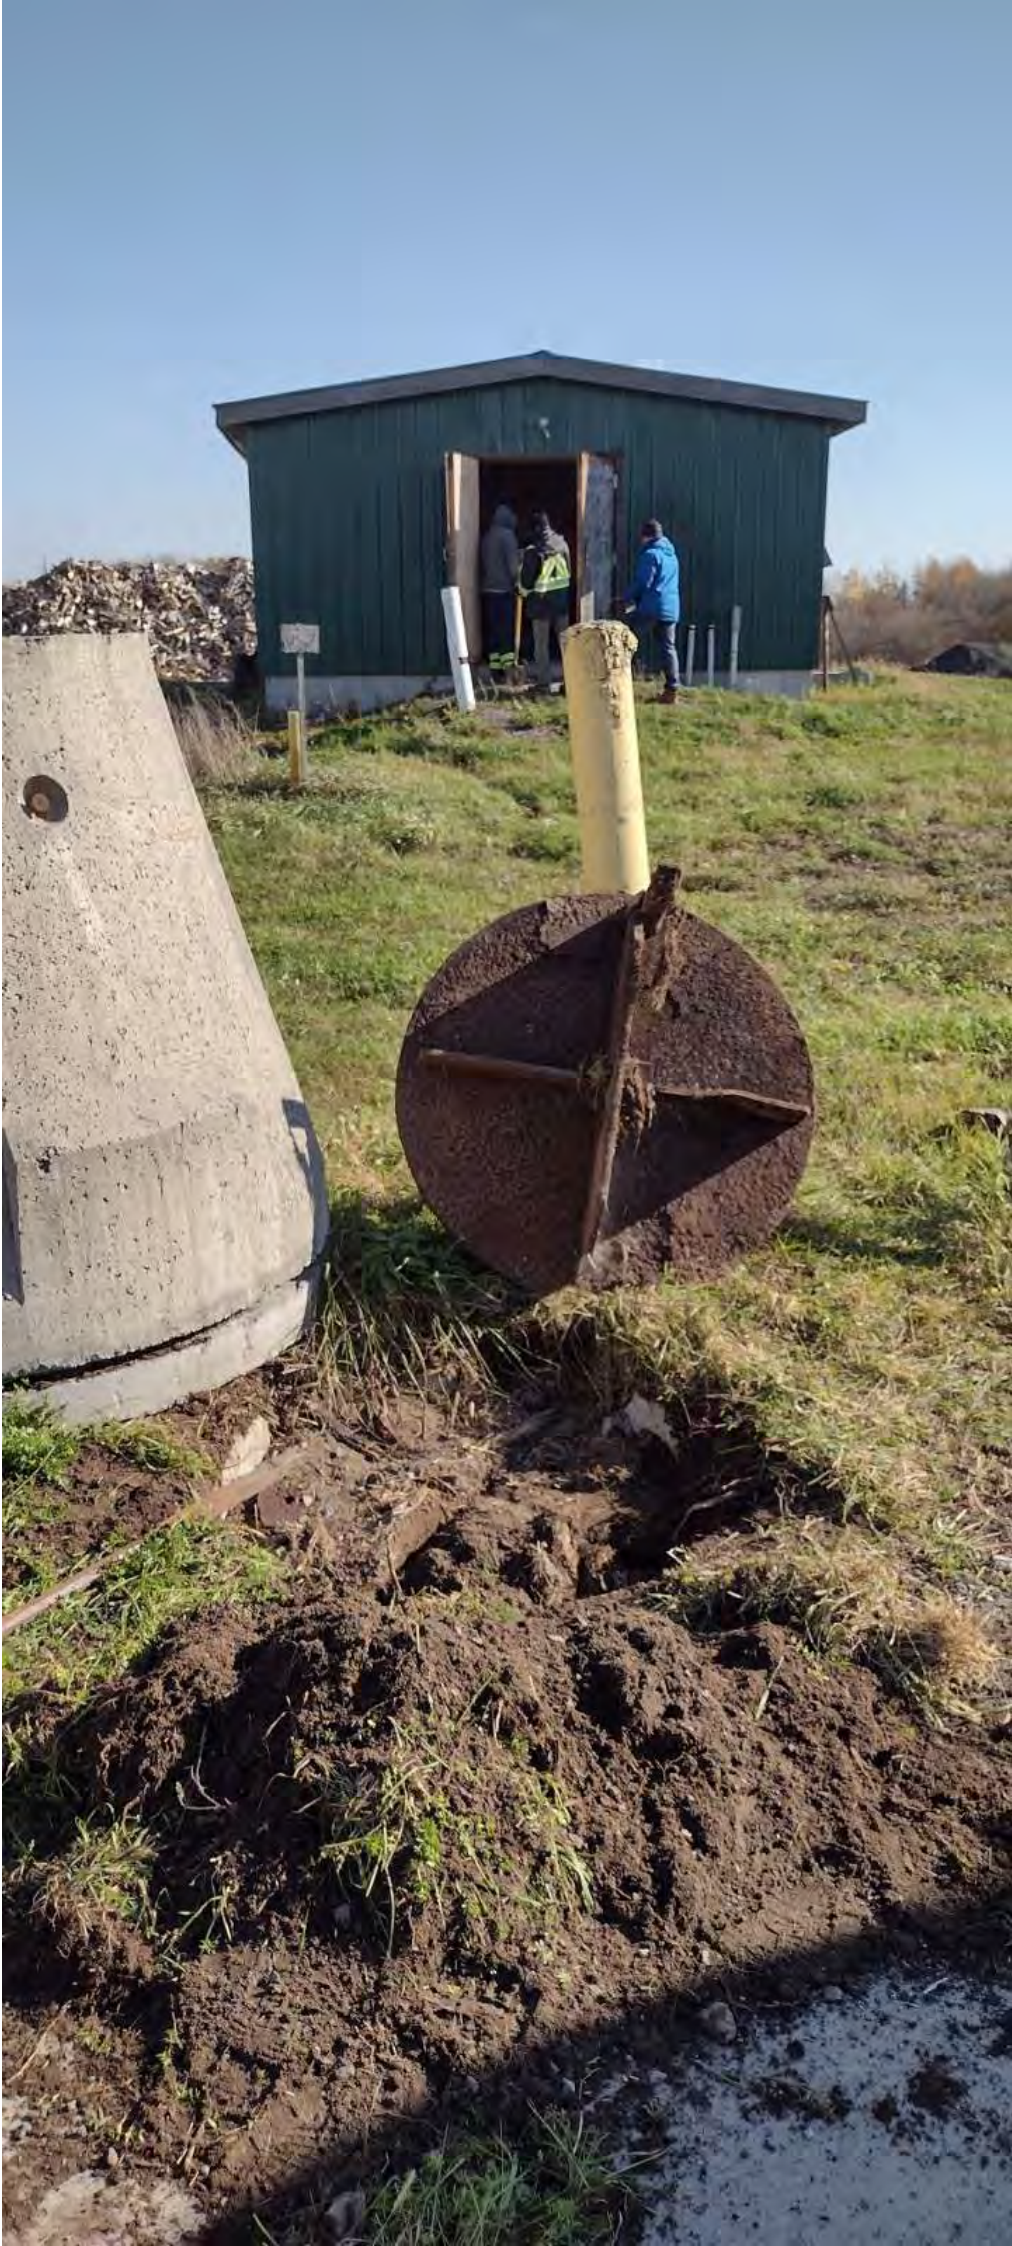
- \* 1, 2, 3, 4 — Test holes looks good. No bio-mat found
- \* Septic Tank needs repair on the inside and new risers and lids required.
- \* Pump Chambers not in good condition. Unknown connection of the pump chamber/pump to the septic Bed.
