**Preliminary Geotechnical Investigation
Report**

Proposed Development – 1495 Heron Road

Project No. 160410368

November 2022

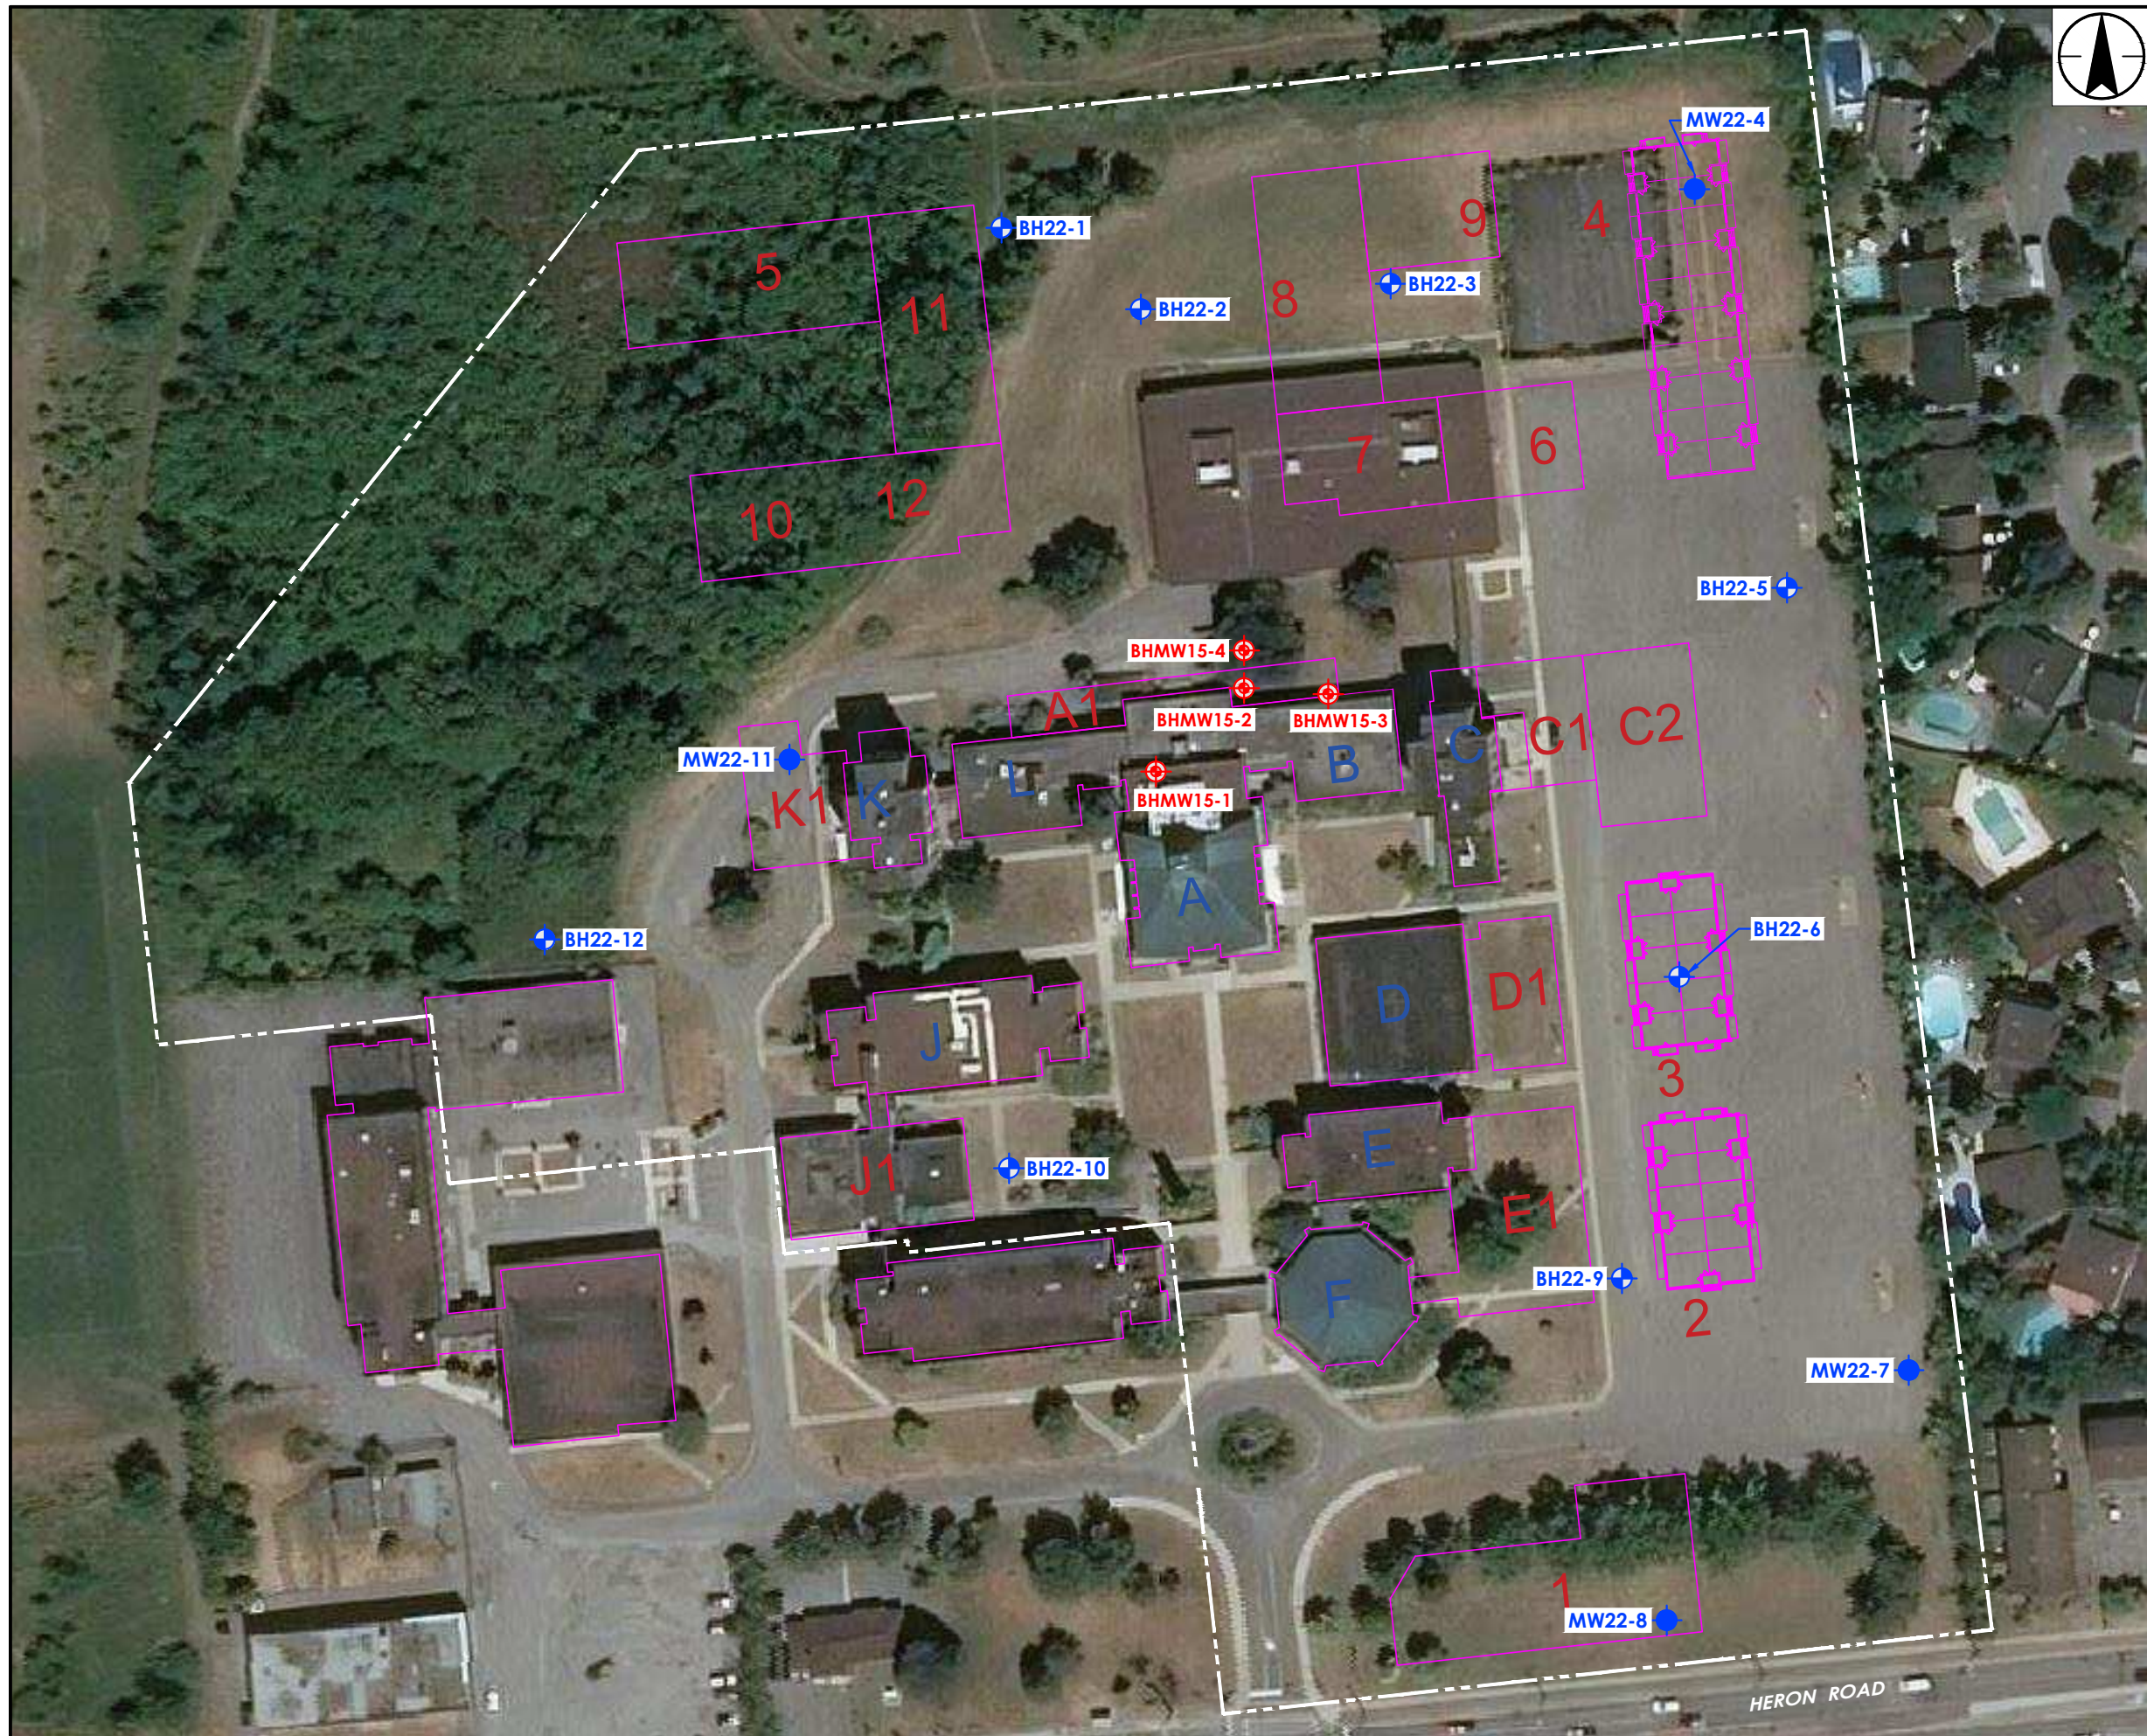
C:\CAD Drawings\Acad2019 Drawings\2022\160410368\160410368_Boreholes Locations.dwg
 2022/08/05 10:55 AM By: Briones, Gliceria

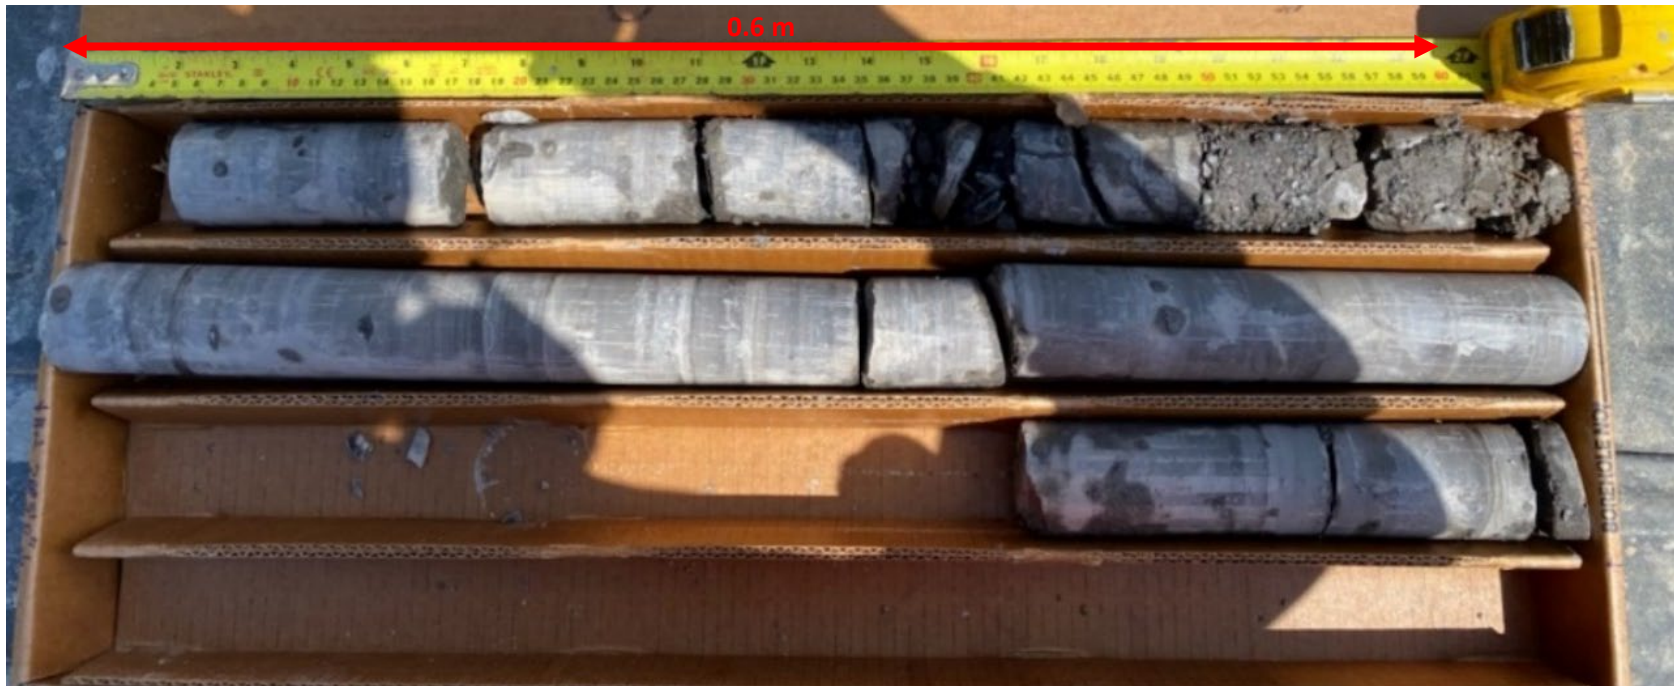
Rock Core Photo No.: 1

Borehole: BH22-1

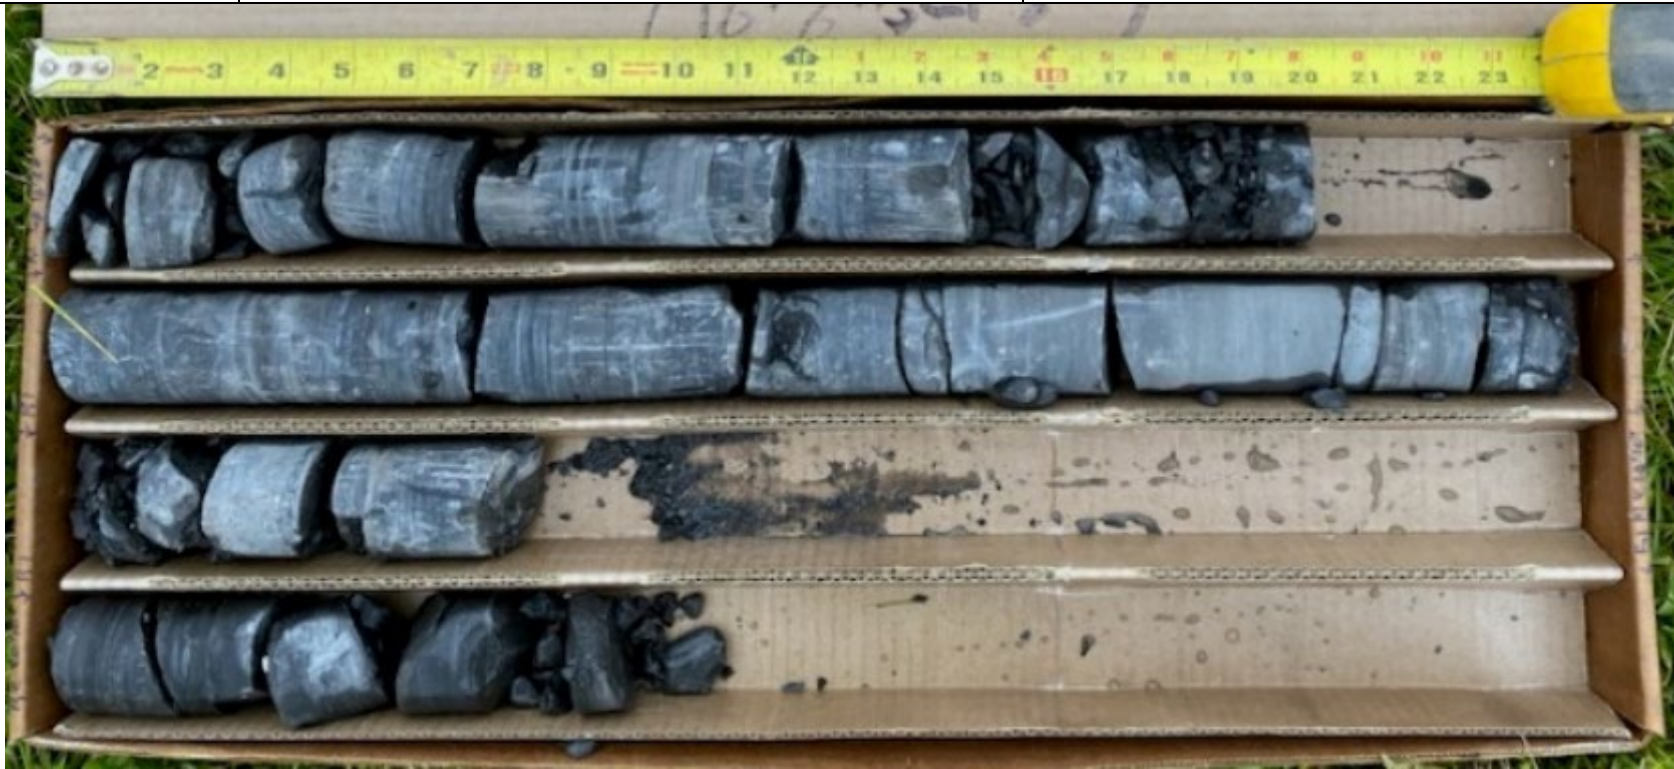
Rock Core Photo No.: 2

Borehole: BH22-3

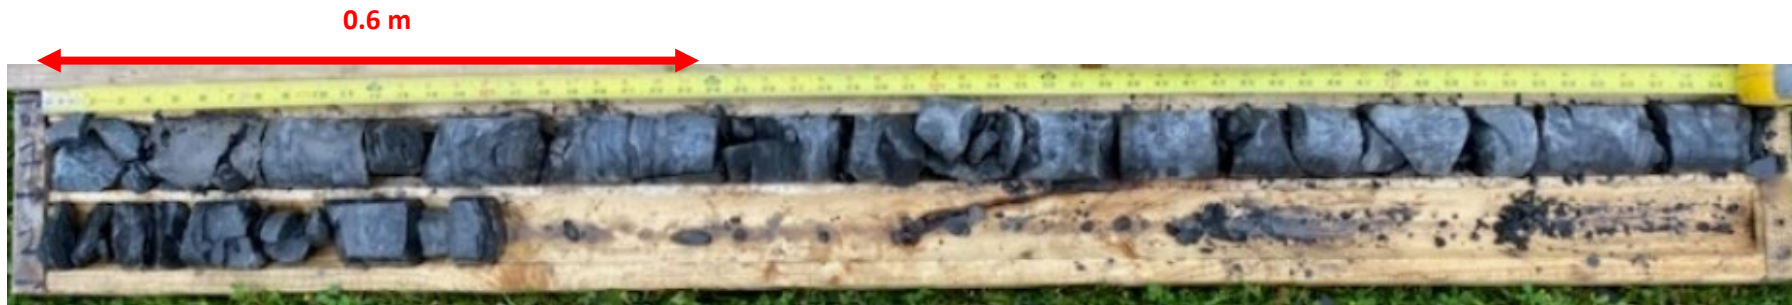
Rock Core Photo No.: 3

Borehole: MW22-4

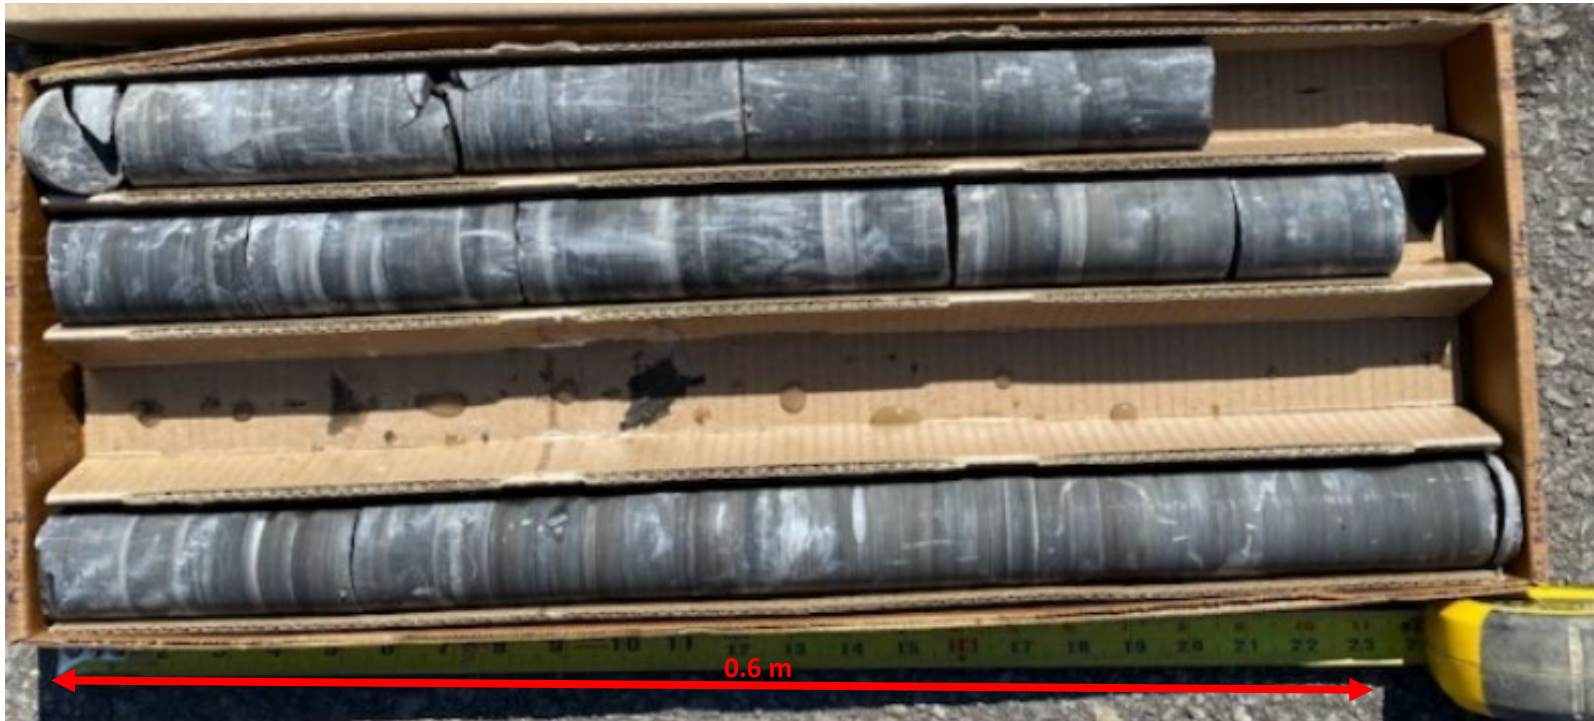
Rock Core Photo No.: 4

Borehole: BH22-6

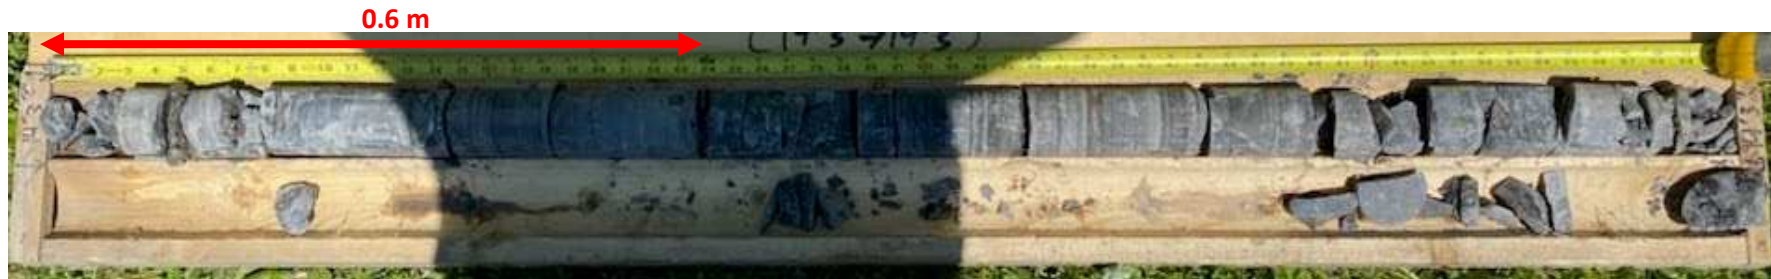
Rock Core Photo No.: 5

Borehole: MW22-8

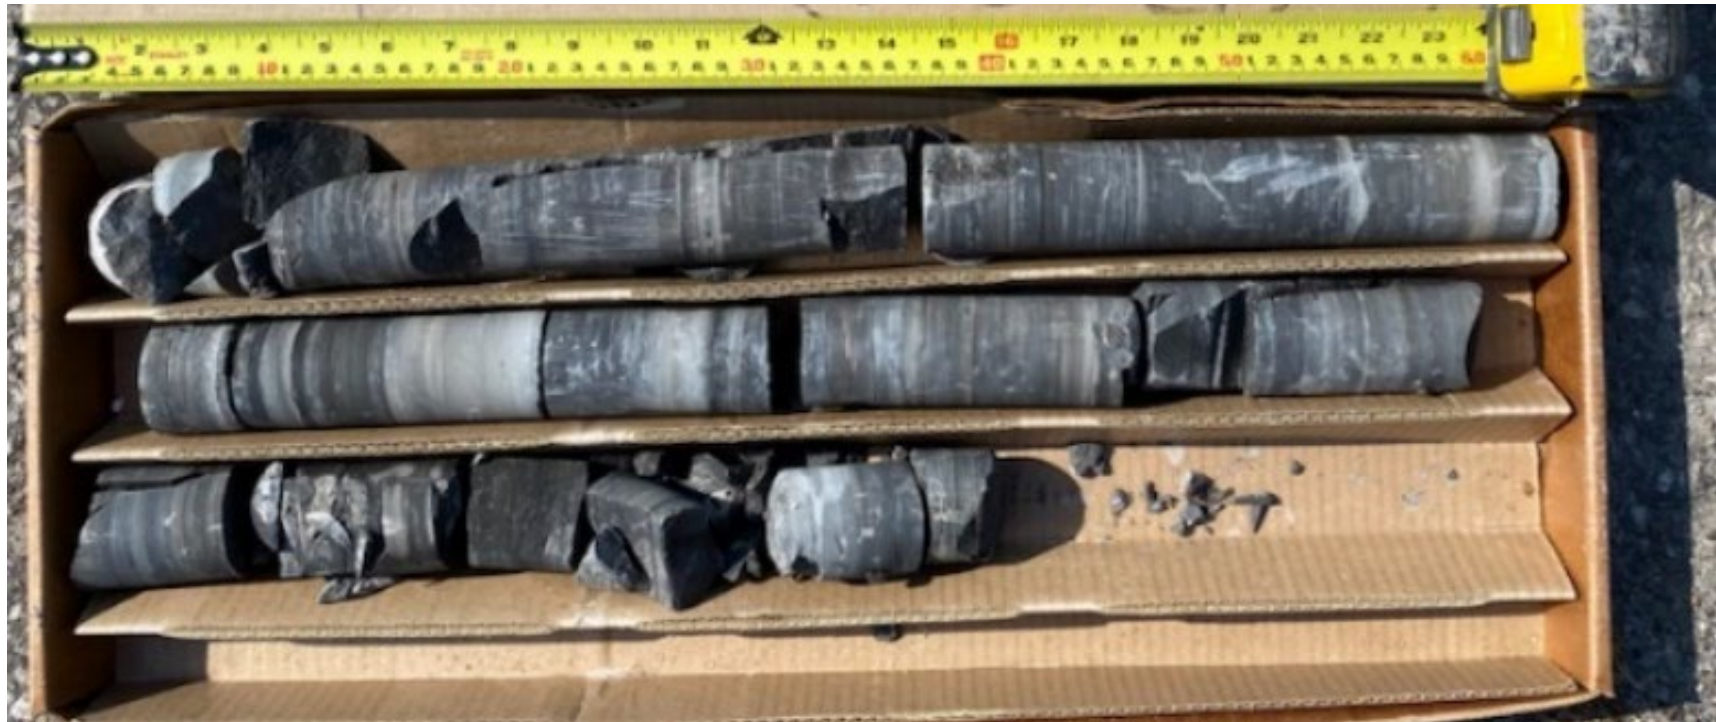
Rock Core Photo No.: 6

Borehole: BH22-9

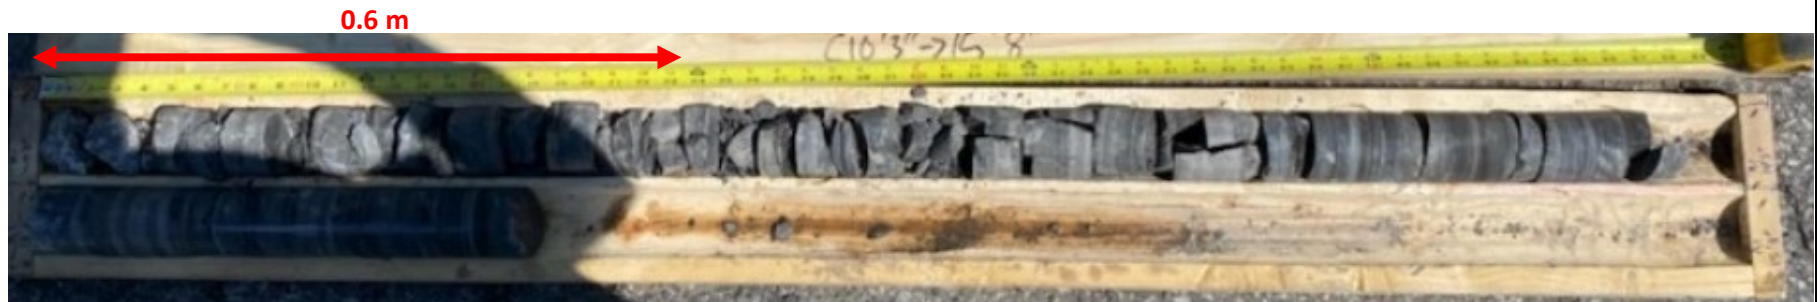
Rock Core Photo No.: 7

Borehole: MW22-11

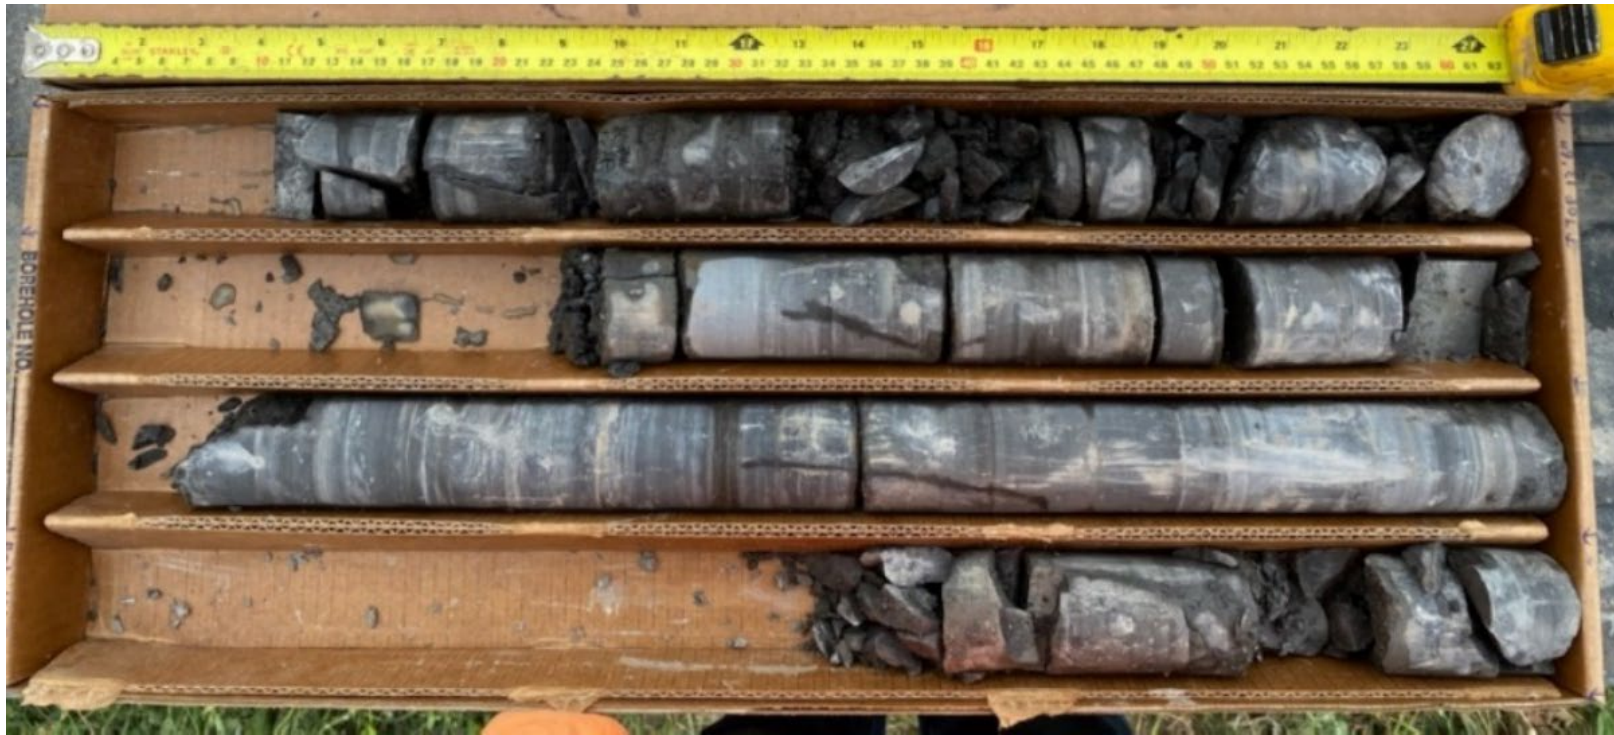
Rock Core Photo No.: 8

Borehole: BH22-12
