Project Name: **Geotechnical Investigation – Slope Stability Analysis in Support of Zoning By-Law Amendment, 4380 Trail Road, Ottawa, Ontario**

EXP Project Number: **OTT-21023795-A0**

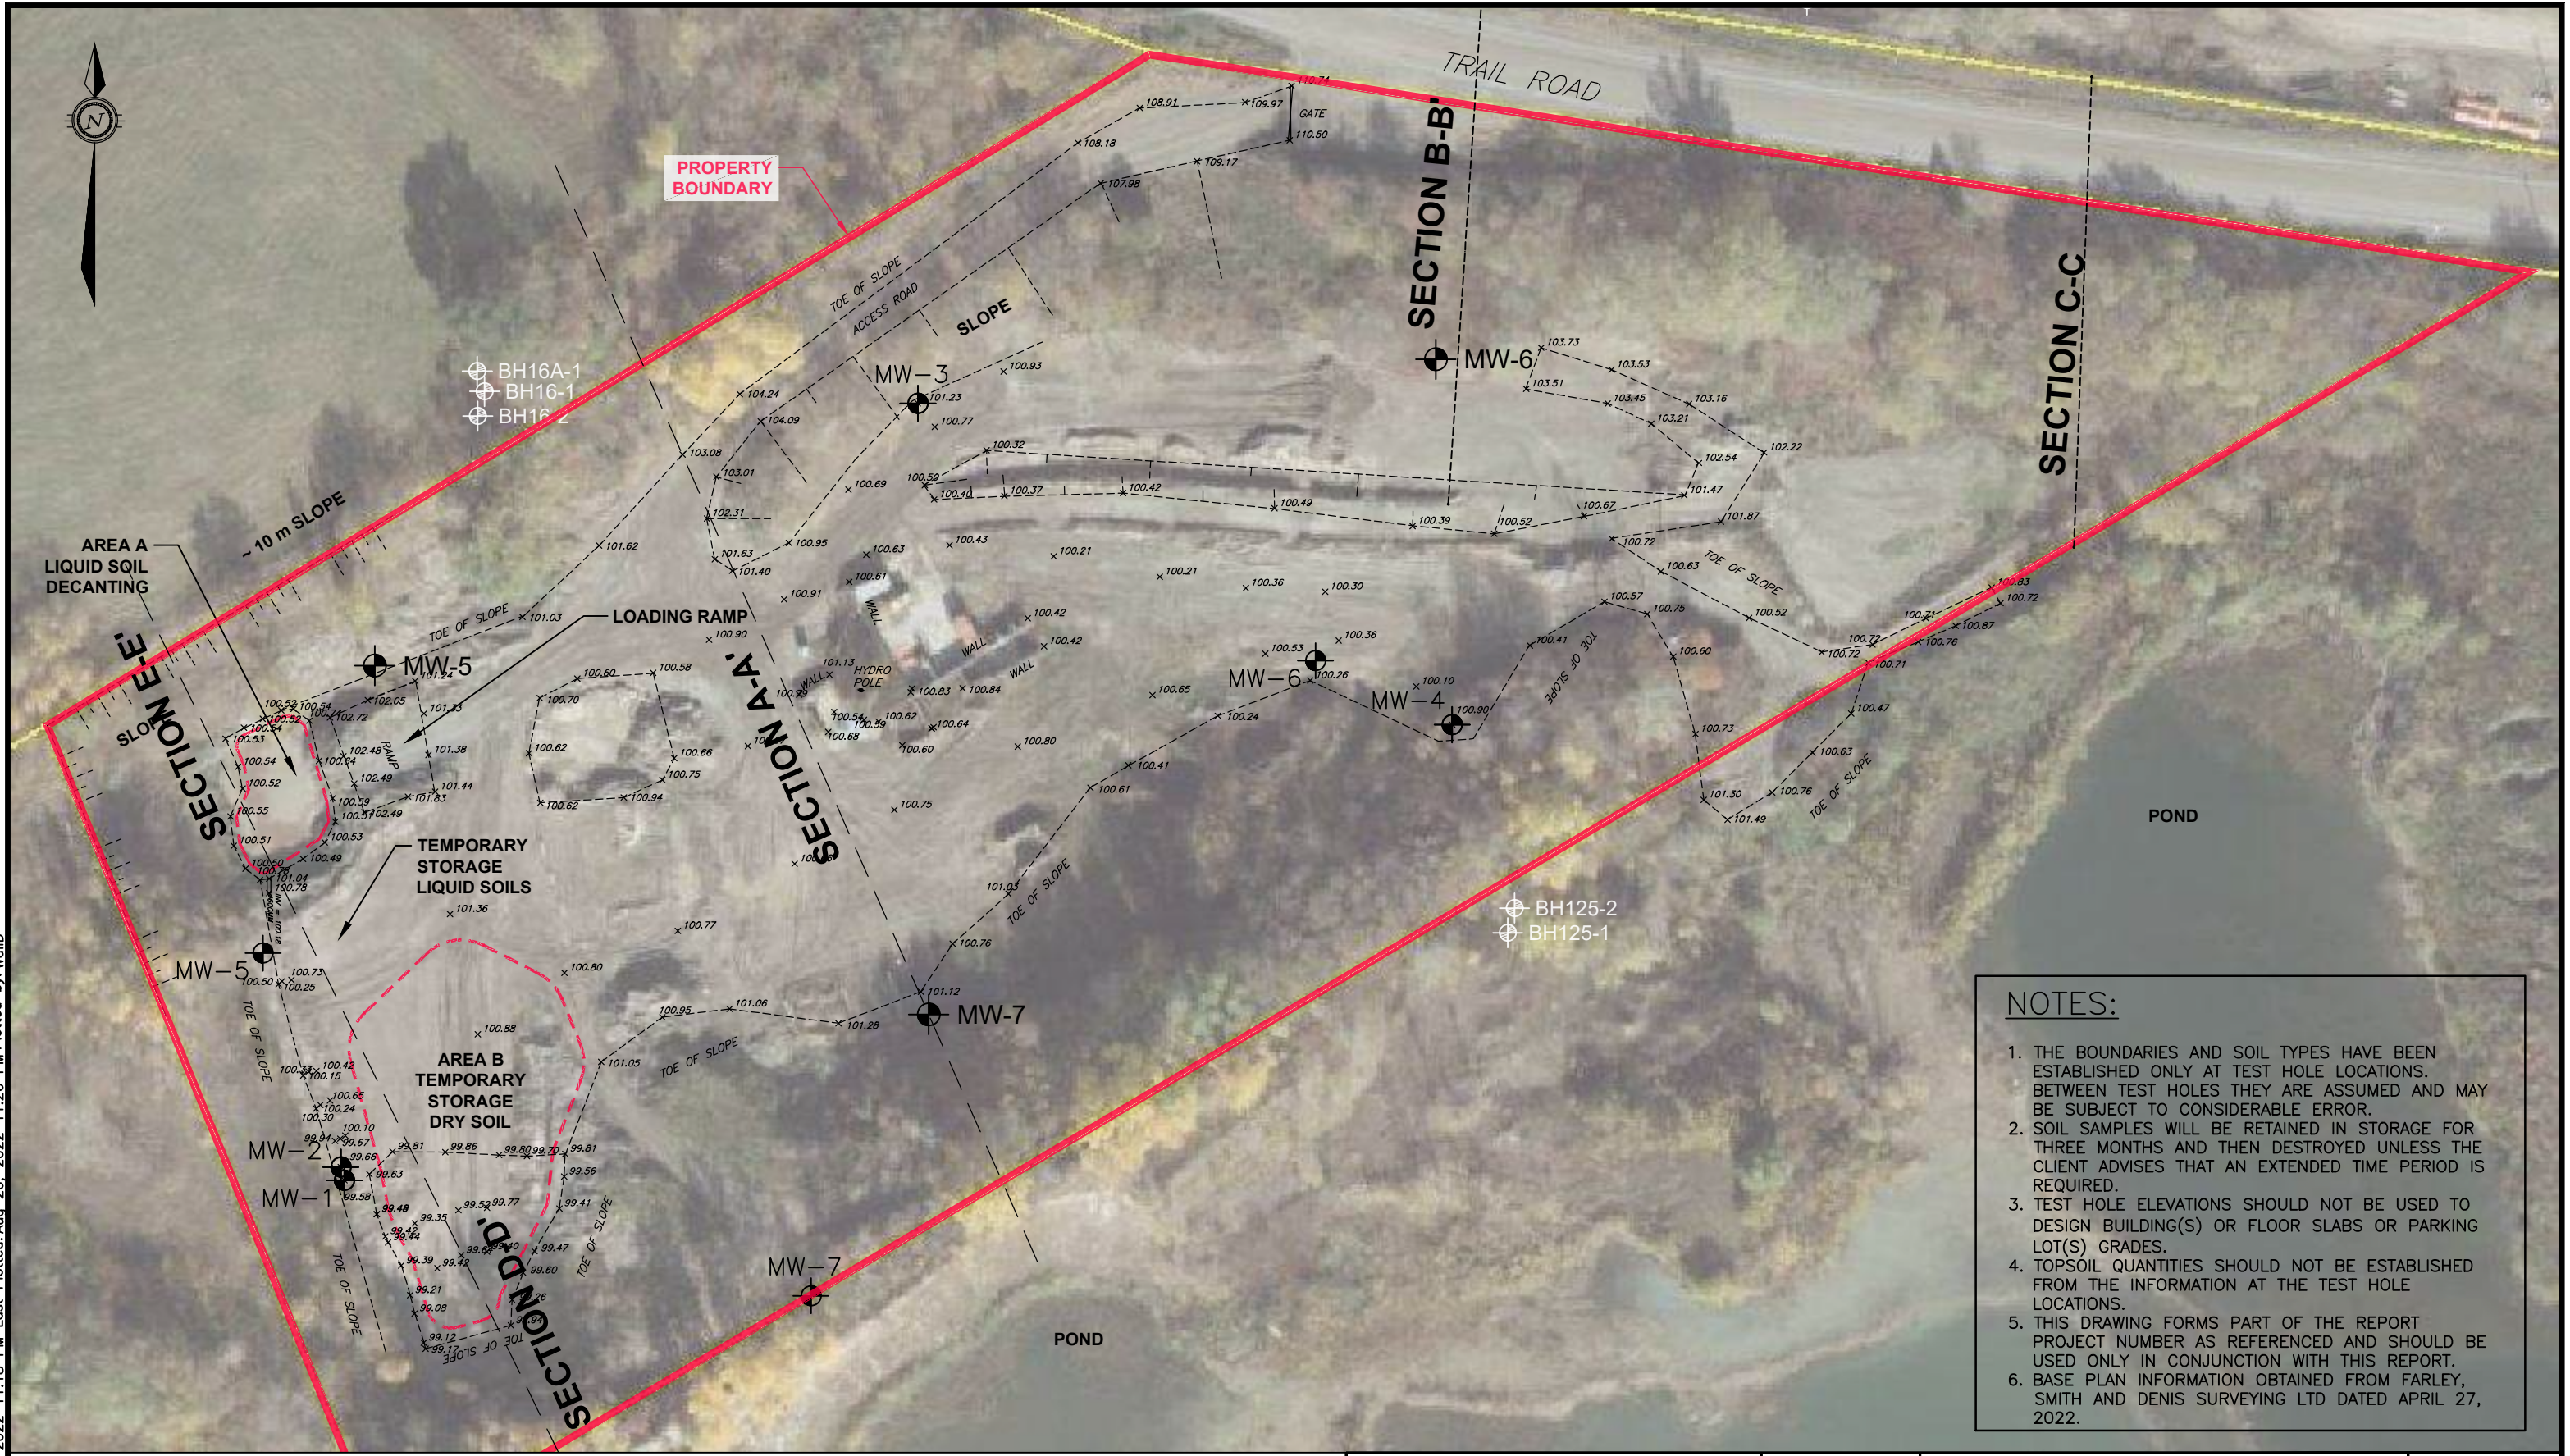
SCALE 1:1000
SKETCH NO
FIG 2

The stability of the existing slopes at the site under consideration were analysed using Morgenstern-Price Method, GeoStudio/Geo-slope office, Version 10.2.1 computerized system. The purpose of the analysis was to assess the stability of the existing slopes. A total of five cross-sections were analysed. These cross-sections have been shown as Sections A-A to E-E on Figure 2.

PHASE ONE ENVIRONMENTAL SITE ASSESSMENT 4380 TRAIL ROAD, OTTAWA, ONTARIO
SITE LAYOUT

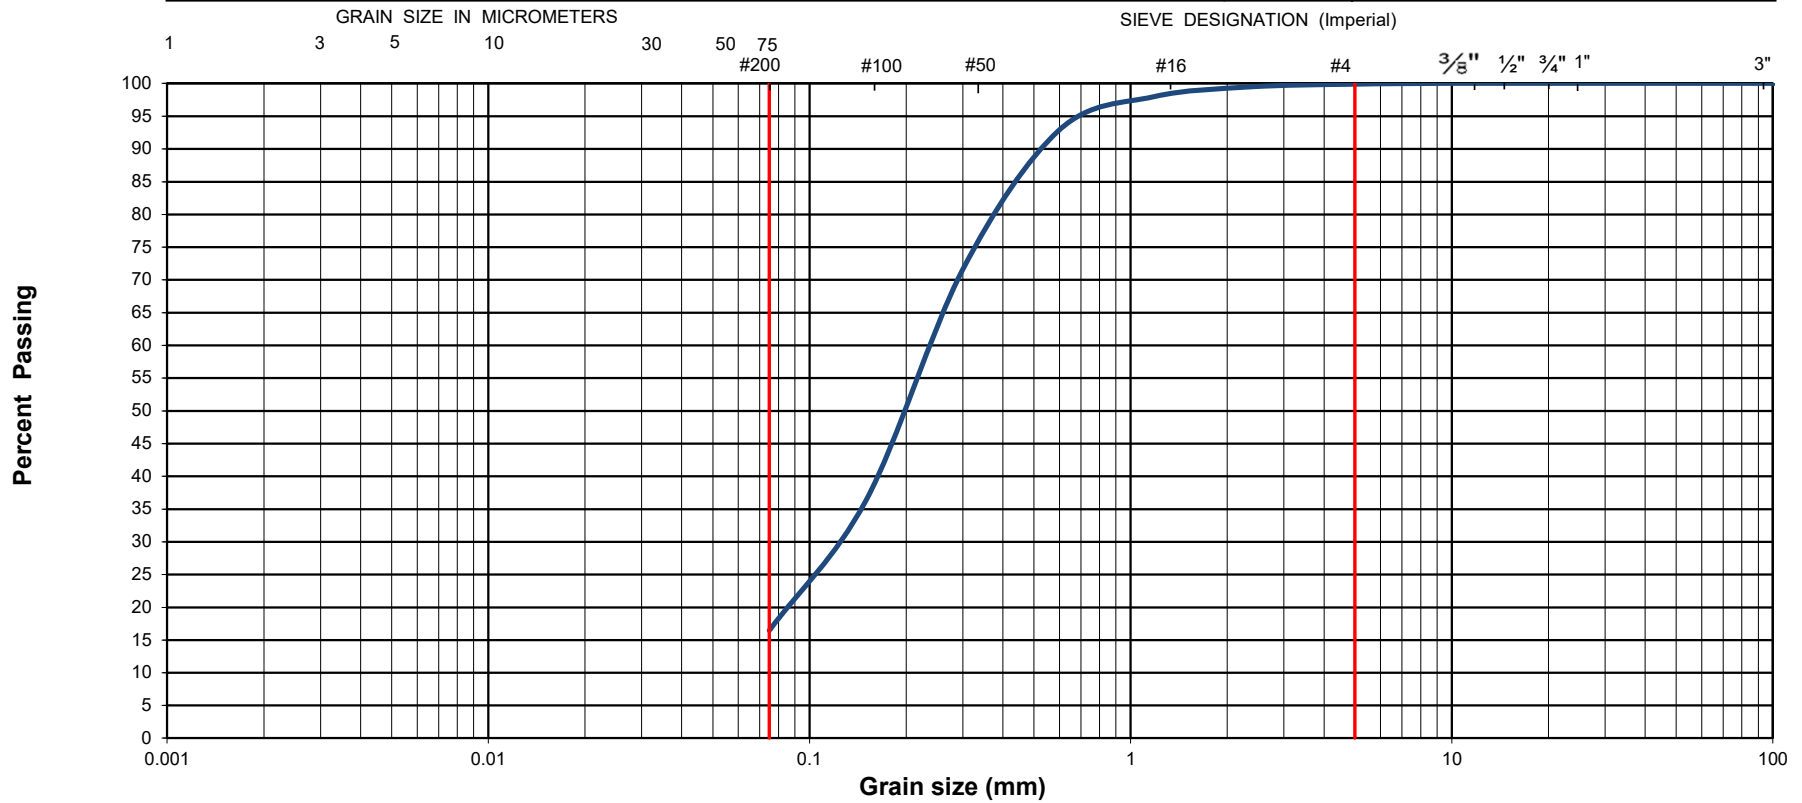
EXP Project No.:	OTT-21023795-A0	Project Name :	Geotechnical Investigation - Slope Stability Trail Road			
Client :	Drain-All Ltd.	Project Location :	4380 Trail Road, Ottawa, Ontario			
Date Sampled :	May 13, 2022	Borehole No:	MW5	Sample:	SS6	
Sample Composition :		Gravel (%)	0	Sand (%)	84	
Sample Description :	Silty Sand (SM)				Silt & Clay (%)	16
					Depth (m) :	3.8 - 4.4
					Figure :	6

The fill in boreholes MW-05 and MW-06 and the sandy gravel in borehole MW-07 are underlain by a layer of sand which extends to the entire depth investigated in all three boreholes, i.e., from 6.7 m to 9.8 m depth (Elevation 94.1 m to Elevation 93.3 m). It is brown in colour and becomes grey at 5.3 m to 7.6 m depth (Elevation 96.2 m to Elevation 95.2 m). Based on standard penetration N-values of 4 to 48 for 300 mm of sampler penetration, the sand is considered to be in a loose to dense state. The natural moisture content of the sand is 2 to 26 percent. It comprises of 5 to 16 percent clay and silt, 84 to 92 percent sand and 0 to 3 percent gravel. (Figures 7 to 9). The results of the grain size analyses have been summarized on Table 2.

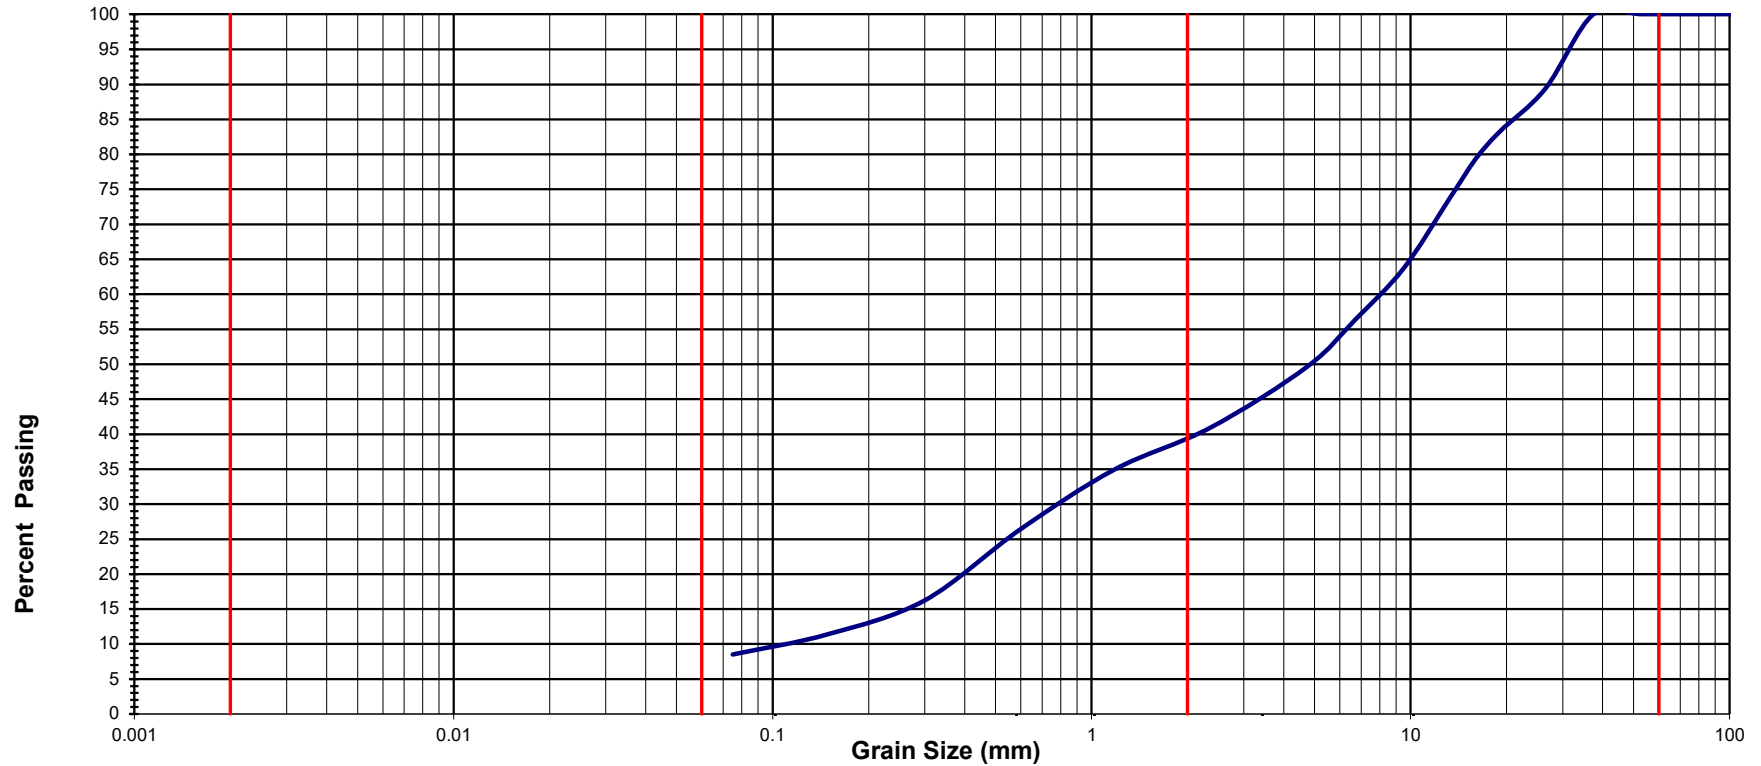
EXP Project No.:	OTT-21023795-A0	Project Name :	Geotechnical Investigation - Slope Stability Trail Road			
Client :	Drain-All Ltd.	Project Location :	4380 Trail Road, Ottawa, Ontario			
Date Sampled :	May 12, 2022	Borehole No:	MW7	Sample:	SS2	
		Depth (m) :	0.8 - 1.4			
Sample Composition :	Gravel (%)	61	Sand (%)	31	Silt & Clay (%)	8
Sample Description :	Poorly Graded Sandy Gravel (SP)				Figure :	7

This stratum comprises of 8 percent clay and silt, 31 percent sand and 61 percent gravel. (Figure 6). This stratum was not encountered in boreholes MW-05 or MW-06.

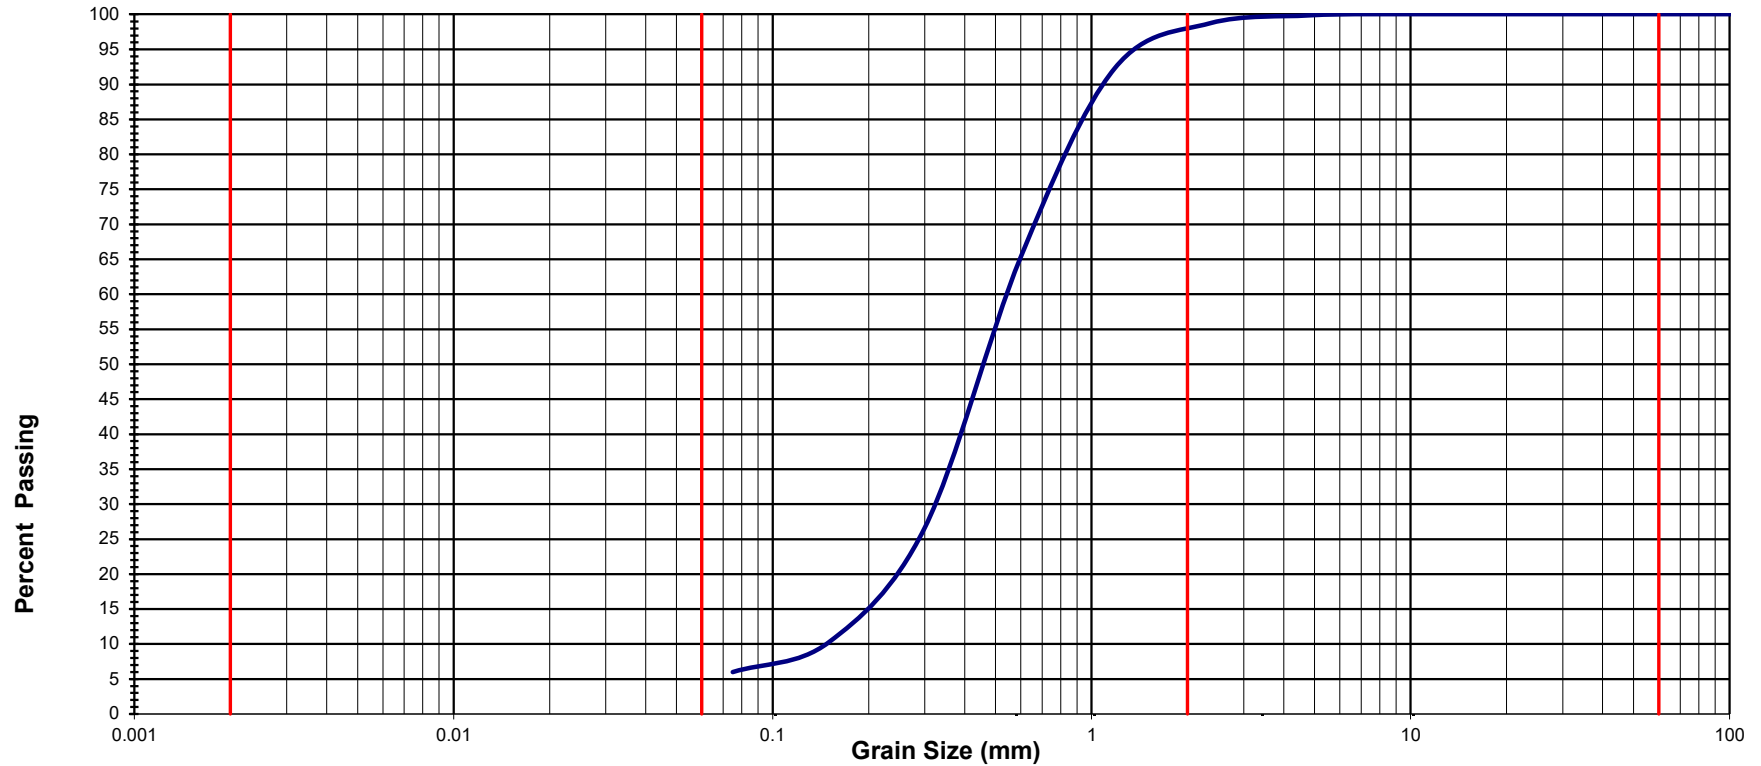
EXP Project No.:	OTT-21023795-A0	Project Name :	Geotechnical Investigation - Slope Stability Trail Road			
Client :	Drain-All Ltd.	Project Location :	4380 Trail Road, Ottawa, Ontario			
Date Sampled :	May 12, 2022	Borehole No:	MW7	Sample:	SS3	
Sample Composition :		Gravel (%)	3	Sand (%)	92	
Sample Description :	Poorly Graded Sand (SP)				Depth (m) :	1.5 - 2.1
		Silt & Clay (%)	5	Figure :	8

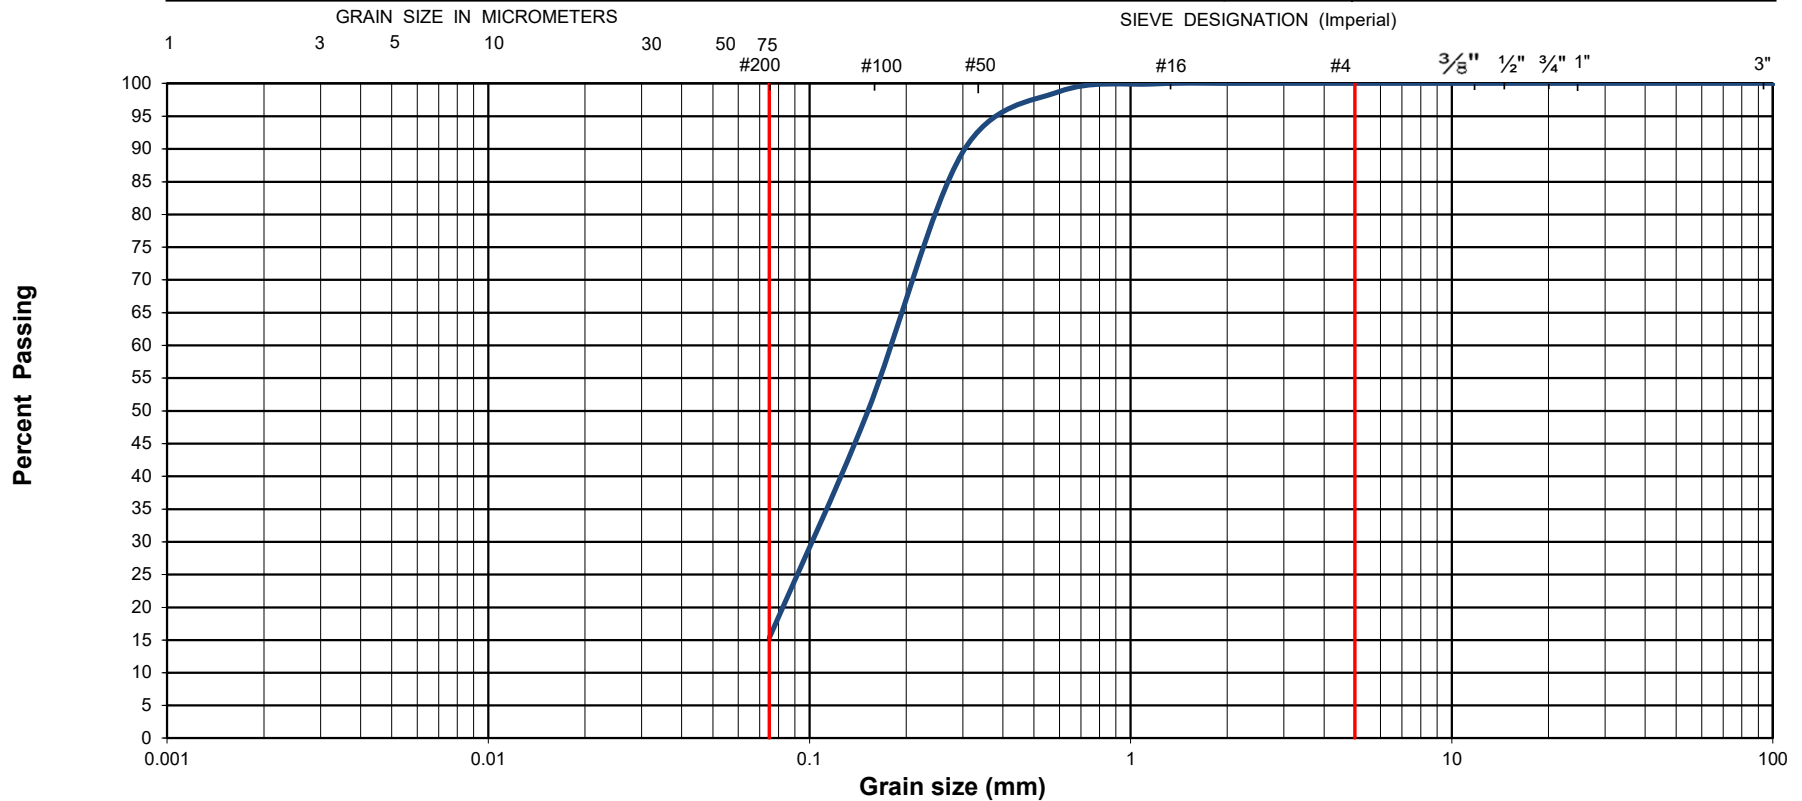
EXP Project No.:	OTT-21023795-A0	Project Name :	Geotechnical Investigation - Slope Stability Trail Road		
Client :	Drain-All Ltd.	Project Location :	4380 Trail Road, Ottawa, Ontario		
Date Sampled :	May 12, 2022	Borehole No:	MW6	Sample: SS12	
Sample Composition :	Gravel (%)	0	Sand (%)	85	
Sample Description :	Silty Sand (SM)			Silt & Clay (%)	15
				Depth (m) :	8.4 - 9.0
				Figure :	9

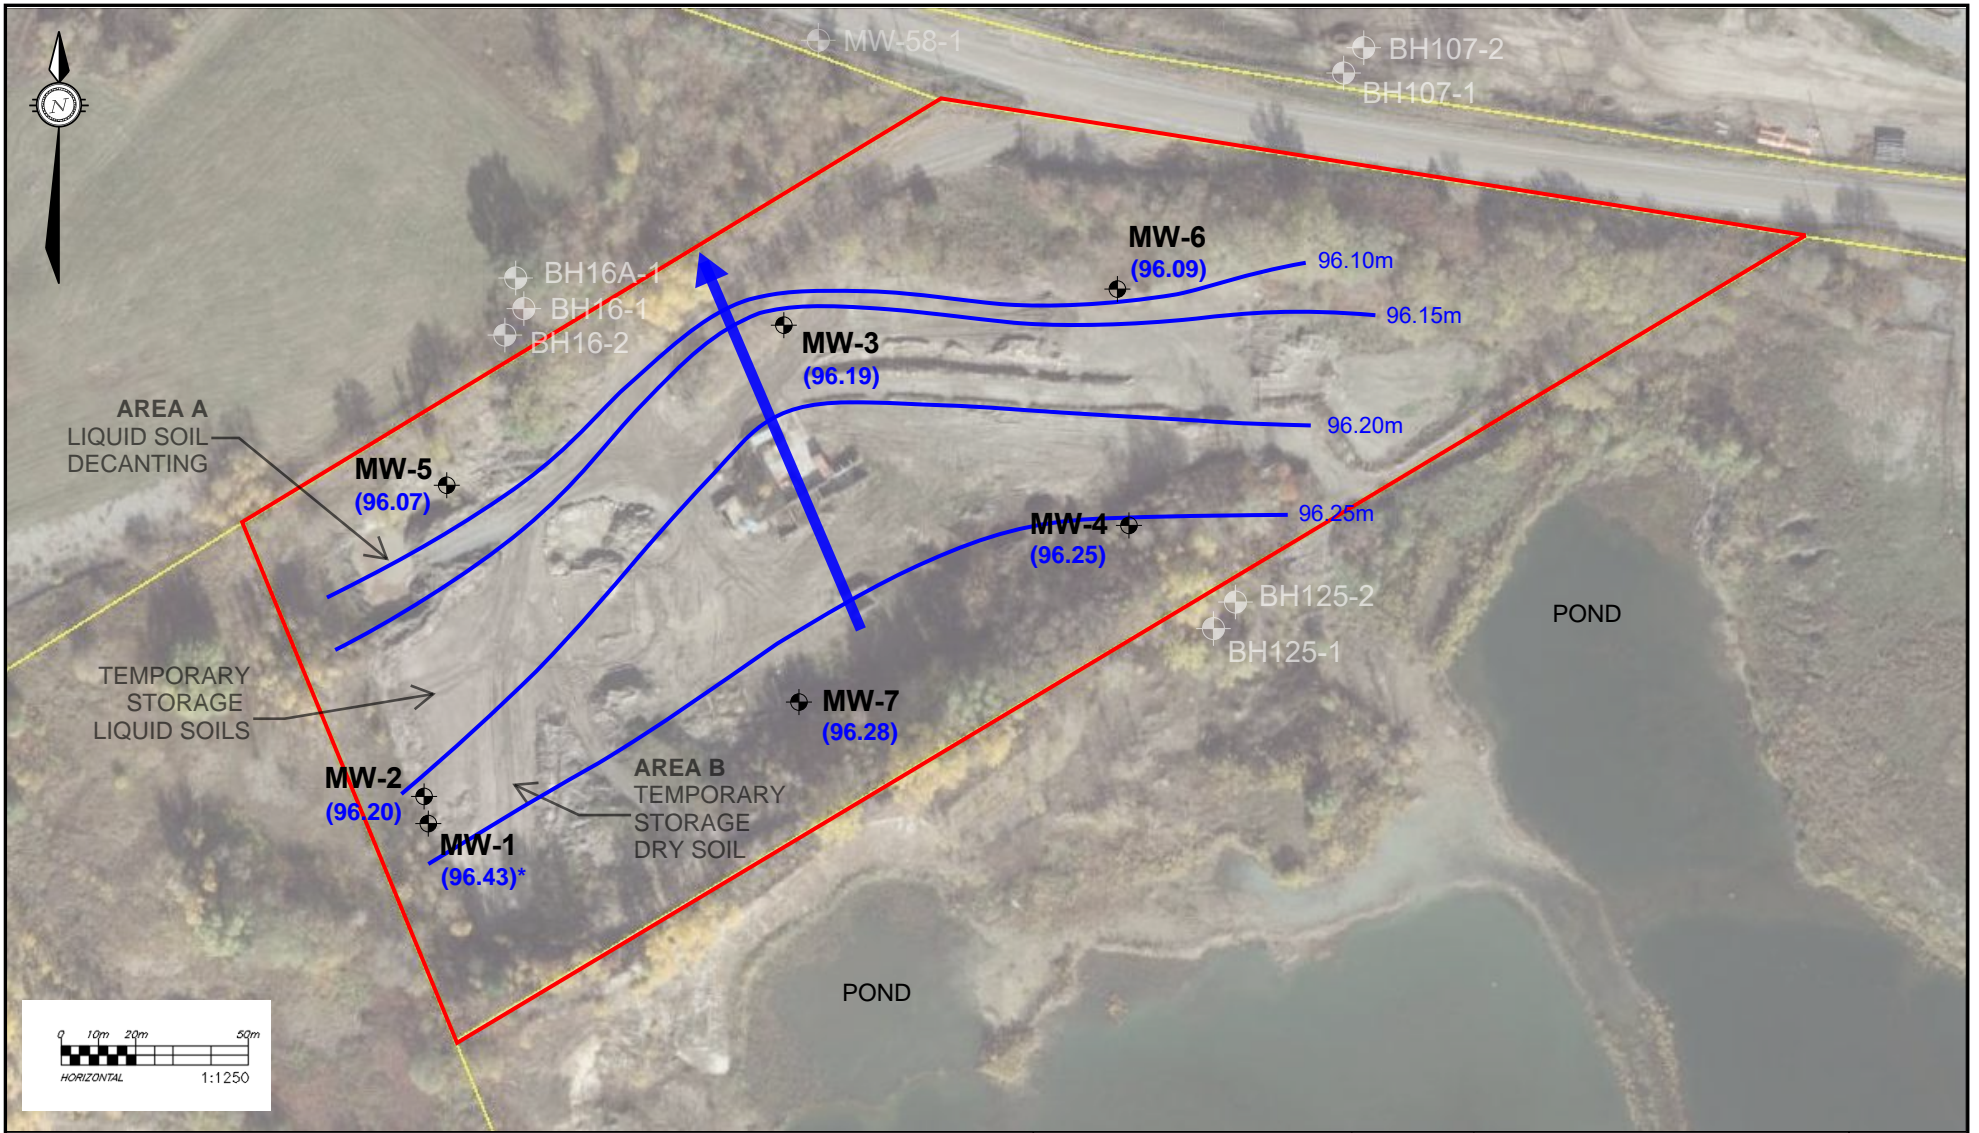
FIG 10

A groundwater contour plan is shown in Figure 10.

The groundwater elevation recorded in the wells ranged from 3.2 m to 7.0 m depth (Elevation 96.4 m to Elevation 96.1 m). Based on the above water levels, groundwater flow direction on the Site is to the north.

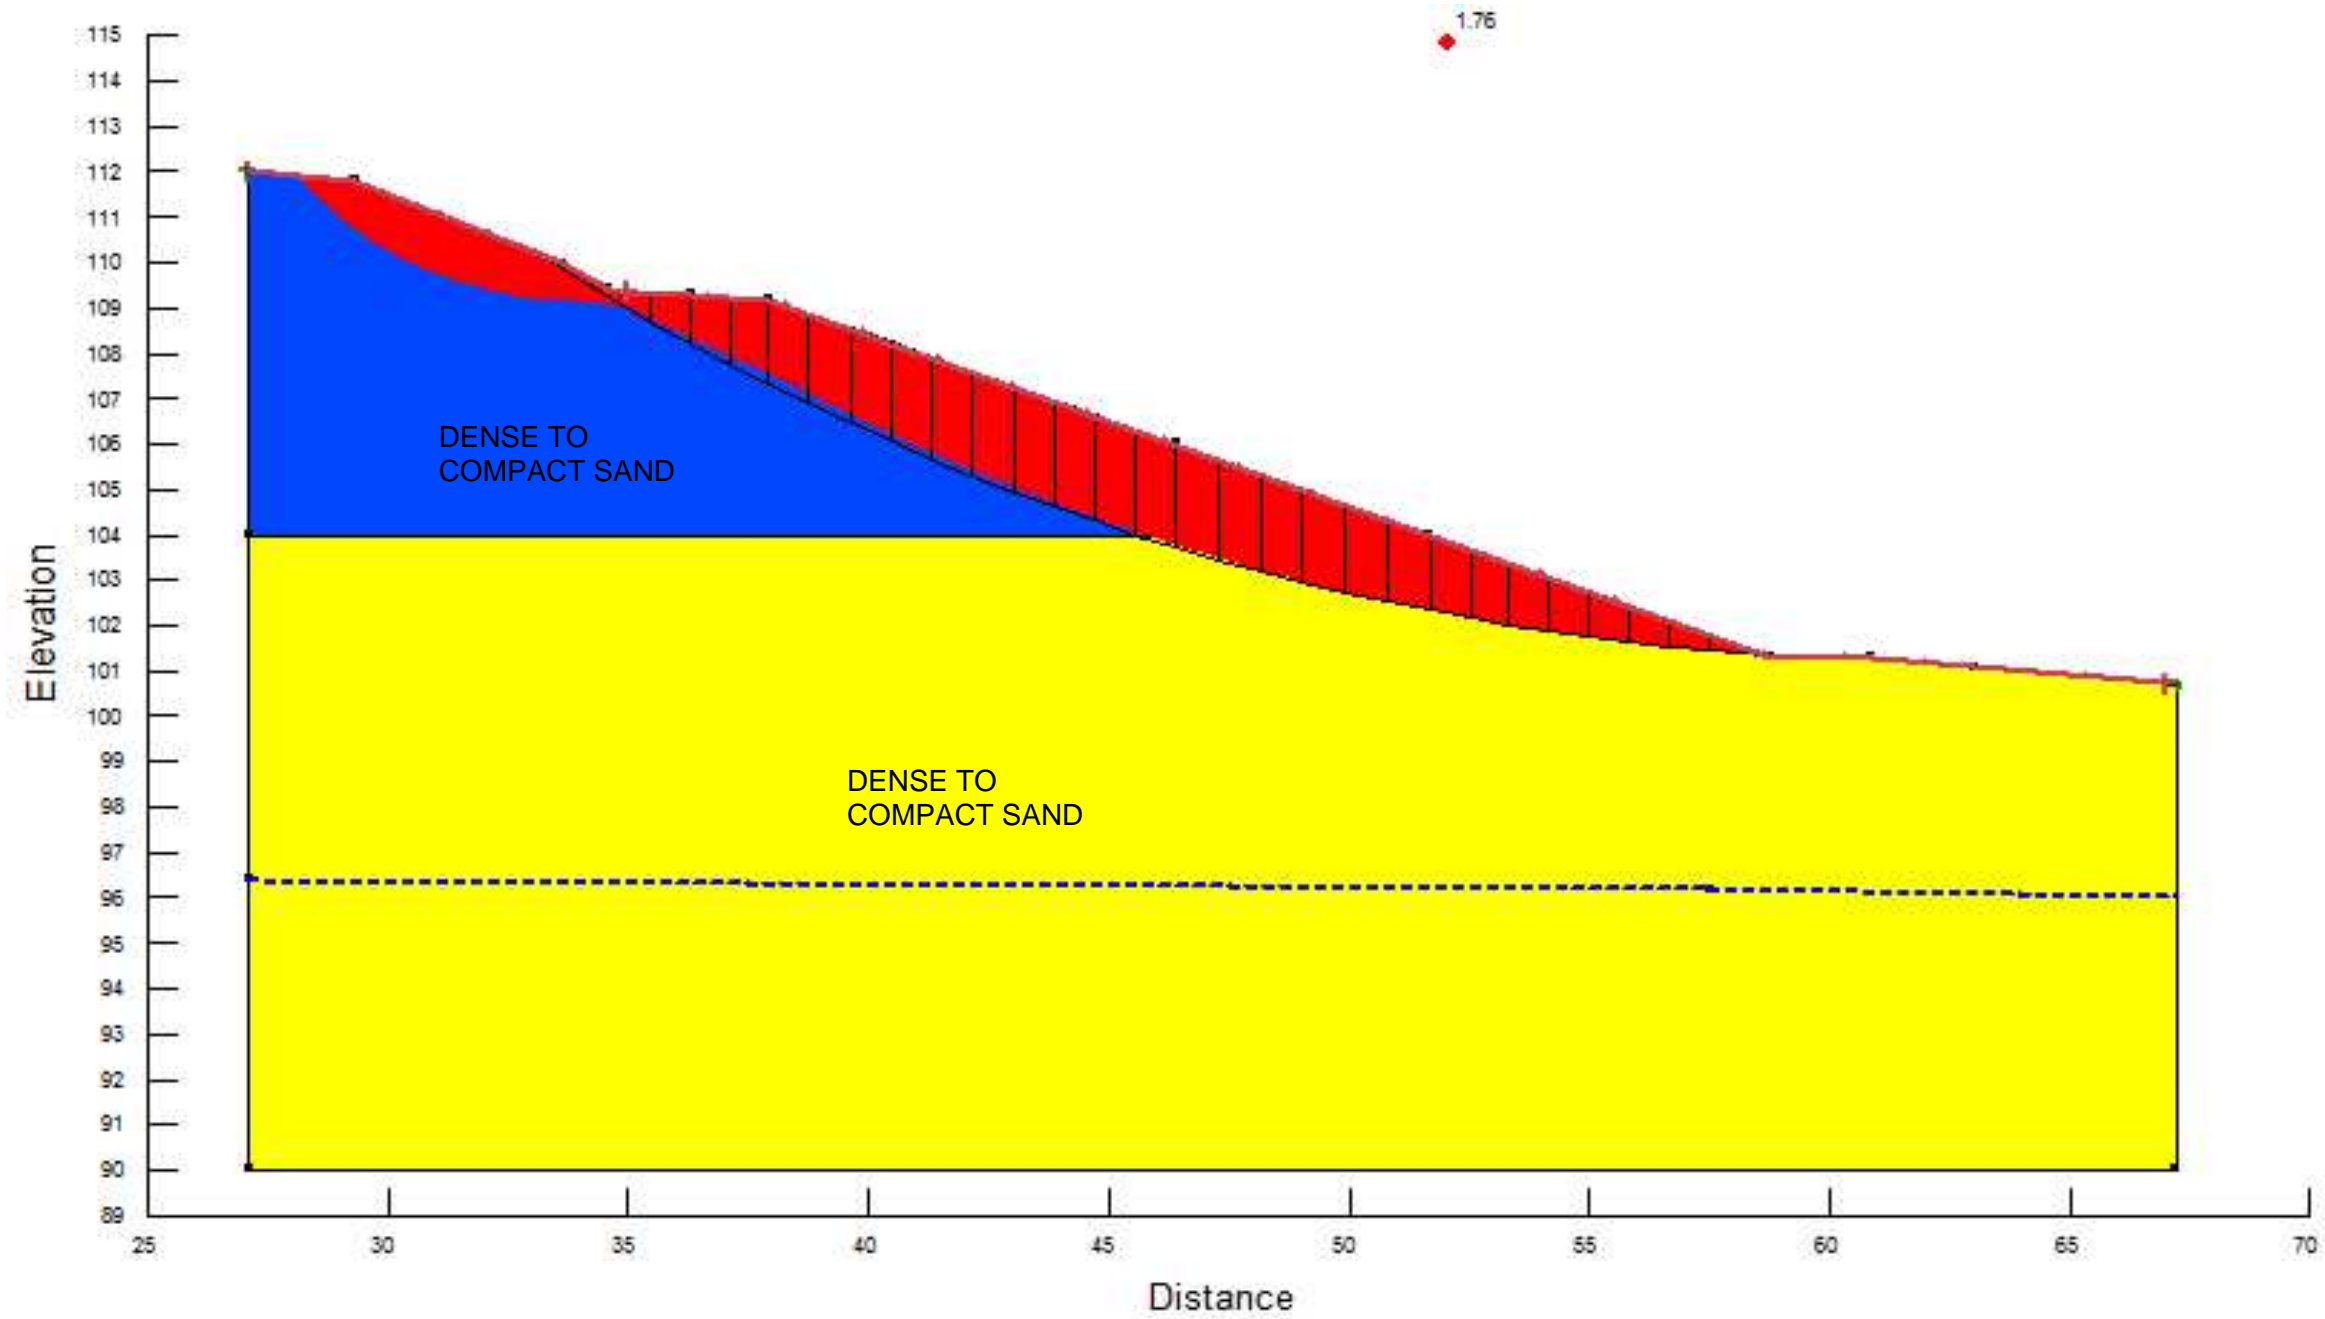
Color	Name	Model	Unit Weight (kN/m ³)	Cohesion' (kPa)	Phi' (°)
Blue	Compact to dense sand	Mohr-Coulomb	19.7	0	31
Yellow	Dense to compact sand	Mohr-Coulomb	19.7	0	31

DATE Aug 26, 2022	CLIENT: DRAIN-ALL LTD.	project no. OTT-21023795-A0
DESIGN DW	CHECKED SA	scale Not to scale
DRAWN BY DW		TITLE: STATIC SLOPE STABILITY ANALYSIS 4380 Trail Road, Ottawa, Ontario
		Figure 11A

The results of the slope stability analyses for Sections A-A to E-E have been summarized on Table 6 and are given on Figures 11A and 11B to 15A and 15B inclusive.

Table 6: Results of Slope Stability Analyses			
Section	Loading Condition	Factor of Safety	Figure No.
Section A-A	Effective Stress Analysis	1.76	11A
	Effective Stress Analysis with seismic loading	1.1	11B
Section B-B	Effective Stress Analysis	1.73	12A
	Effective Stress Analysis with seismic loading	1.1	12B
Section C-C	Effective Stress Analysis	1.38	13A
	Effective Stress Analysis with seismic loading	0.93	13B
Section D-D	Effective Stress Analysis	1.11	14A
	Effective Stress Analysis with seismic loading	0.76	14B
Section E-E	Effective Stress Analysis	1.42	15A
	Effective Stress Analysis with seismic loading	0.92	15B

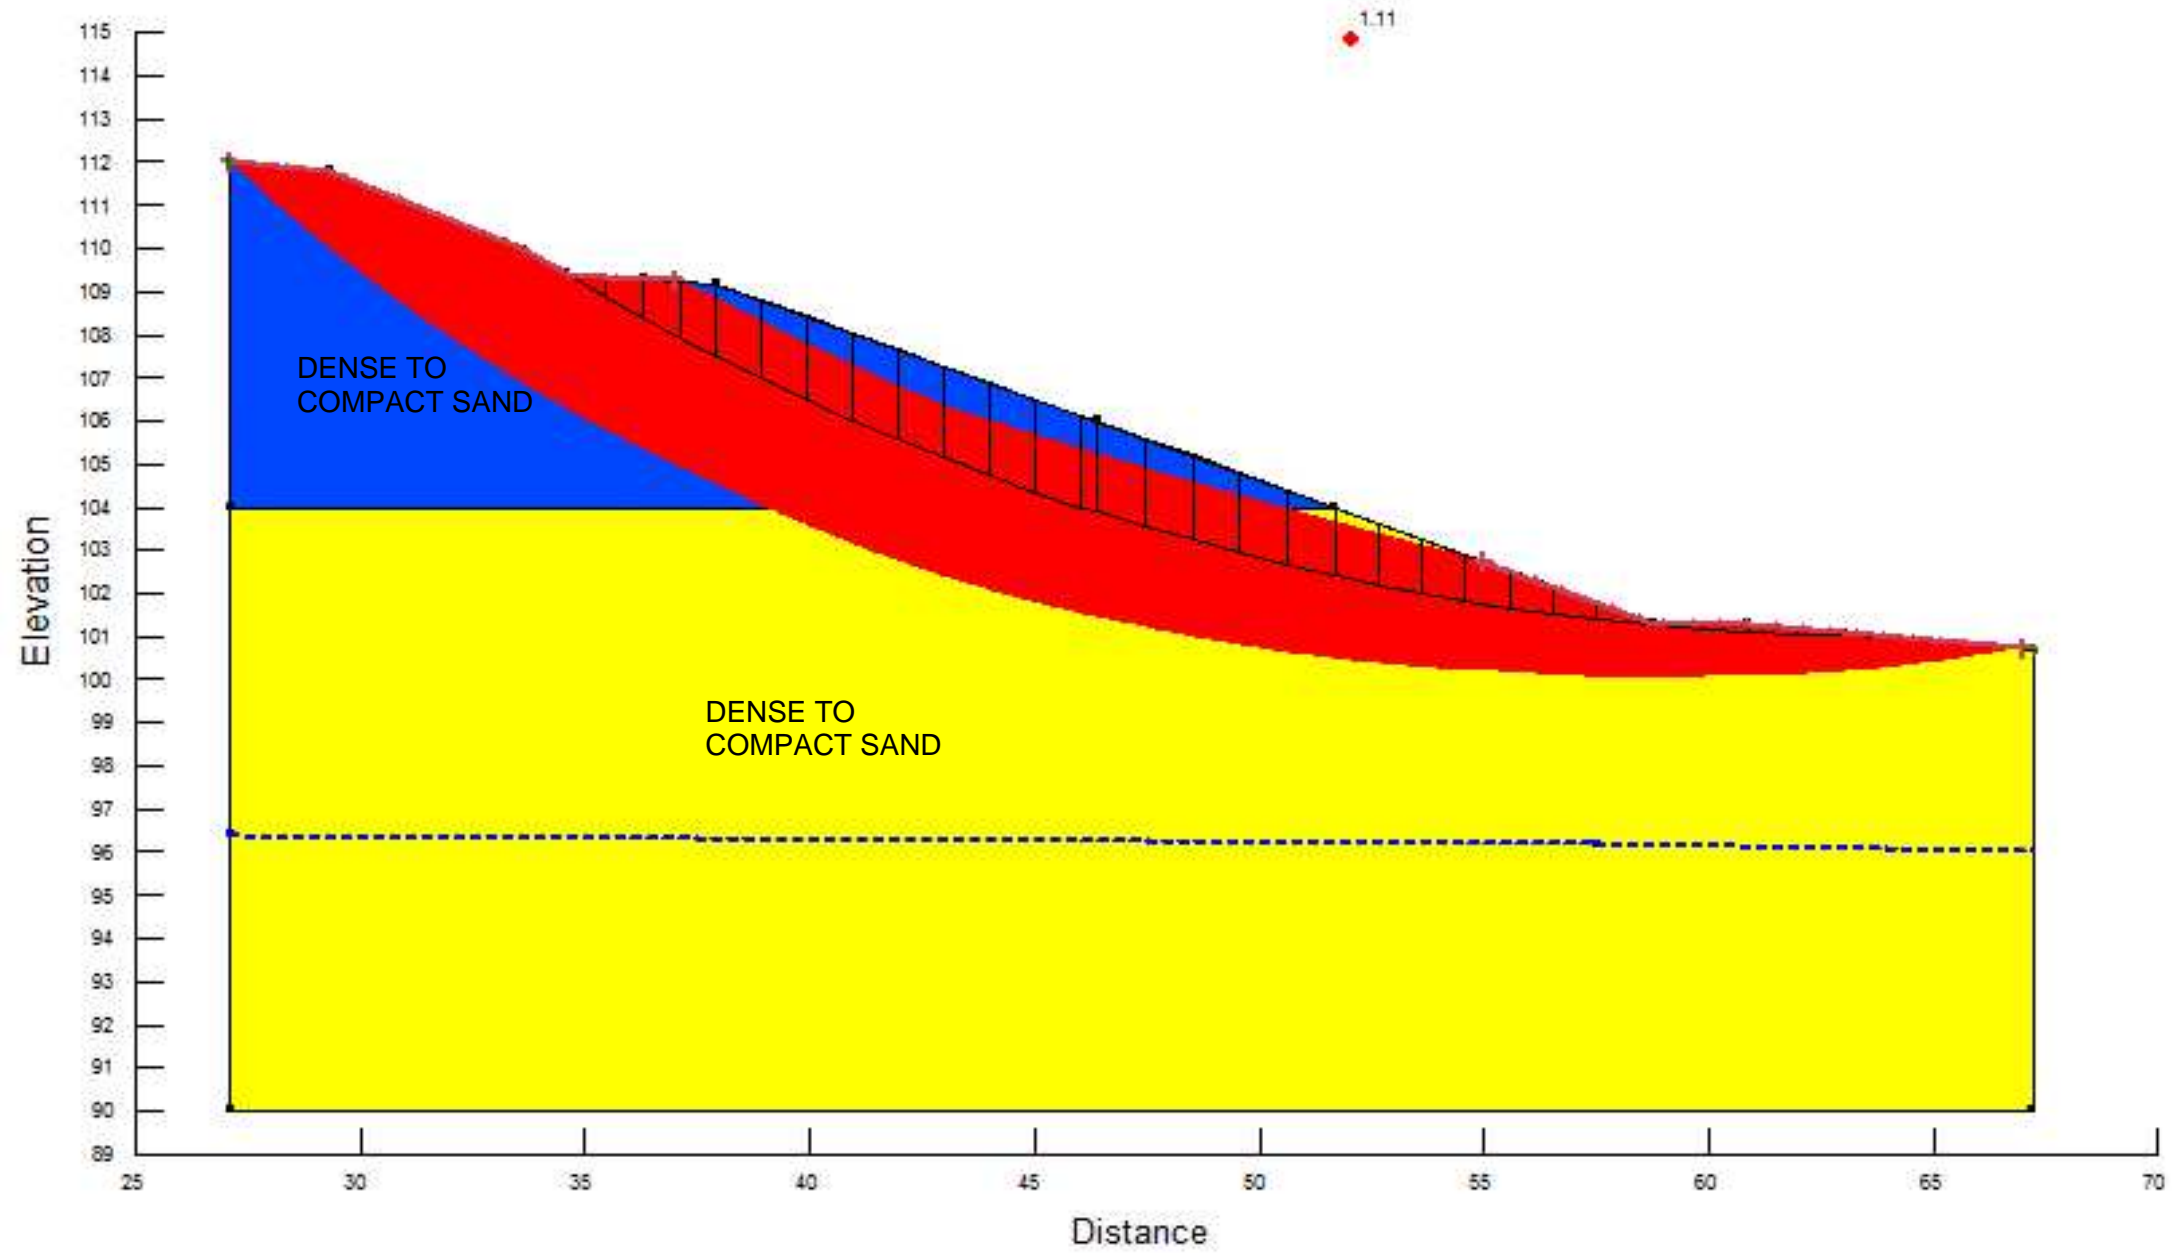
Color	Name	Model	Unit Weight (kN/m ³)	Cohesion' (kPa)	Phi' (°)
Blue	Compact to dense sand	Mohr-Coulomb	19.7	0	31
Yellow	Dense to compact sand	Mohr-Coulomb	19.7	0	31

DATE	Aug 26, 2022	CLIENT:	DRAIN-ALL LTD.	project no.	OTT-21023795-A0
DESIGN	DW	CHECKED	SA	TITLE:	PSEUDO-STATIC SLOPE STABILITY ANALYSIS
DRAWN BY	DW	4380 Trail Road, Ottawa, Ontario		scale	Not to scale
					Figure 11B

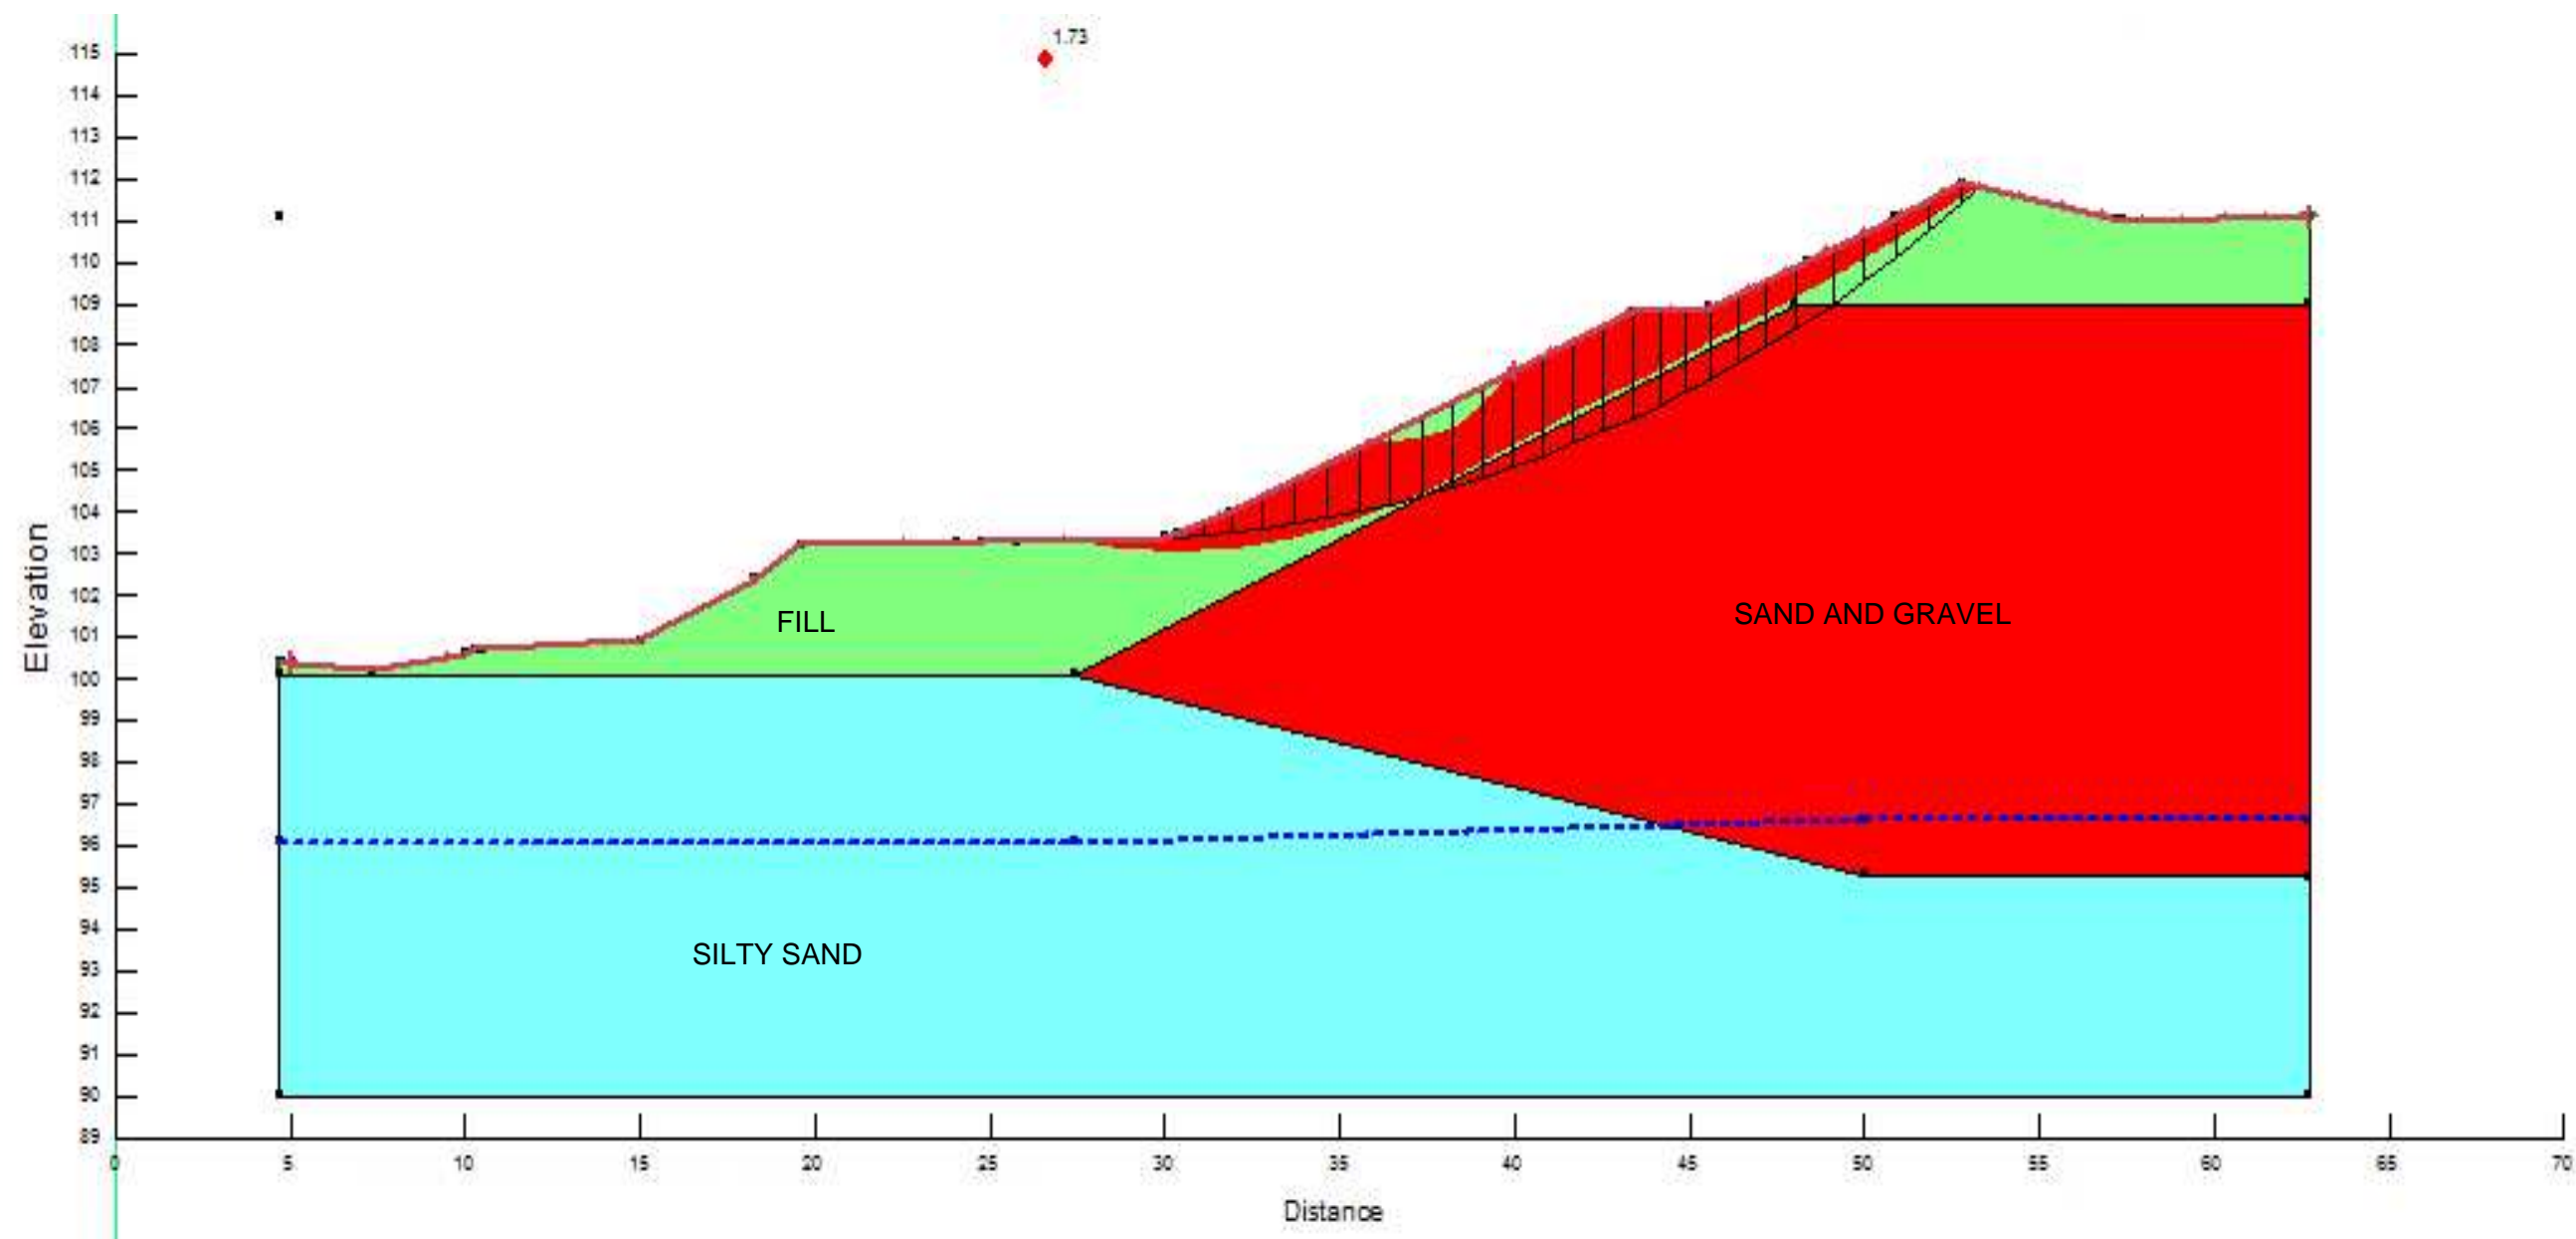
Figure 12A

Color	Name	Model	Unit Weight (kN/m ³)	Cohesion' (kPa)	Phi' (°)
Green	FILL	Mohr-Coulomb	19	0	27
Red	Sand and Gravel	Mohr-Coulomb	22	0	33
Cyan	Silty Sand	Mohr-Coulomb	19.8	0	30
