Project Name: **Geotechnical Investigation – Slope Stability Analysis in Support of Zoning By-Law Amendment, 4380 Trail Road, Ottawa, Ontario**

EXP Project Number: **OTT-21023795-A0**

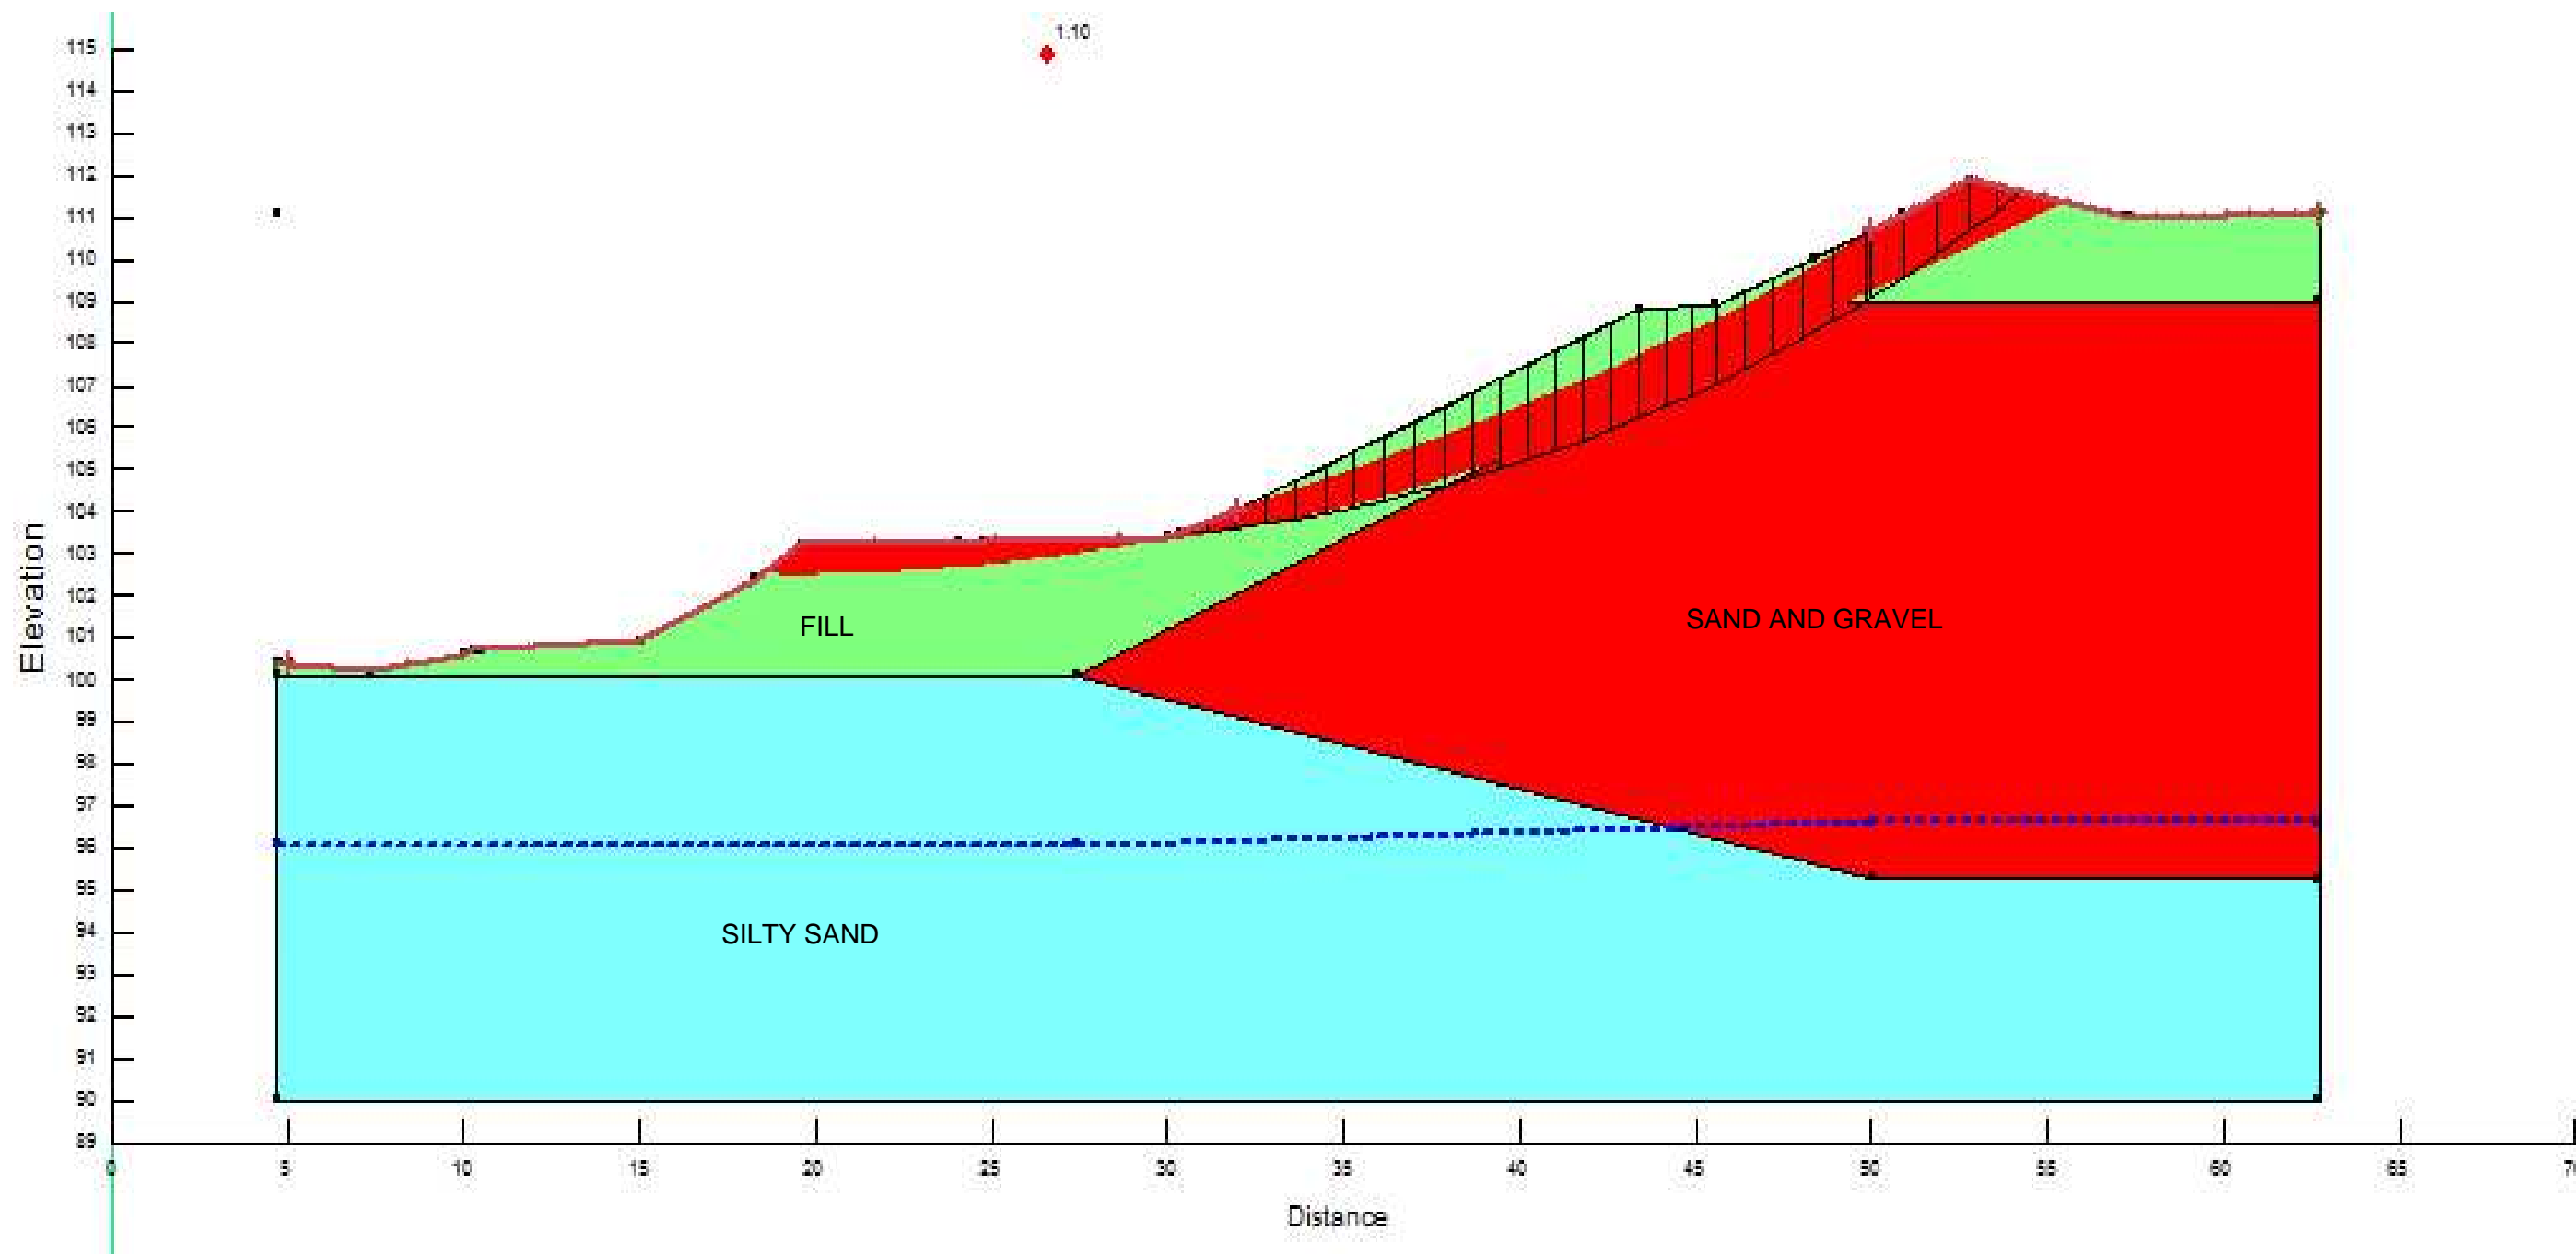
Color	Name	Model	Unit Weight (kN/m ³)	Cohesion' (kPa)	Phi' (°)
Green	FILL	Mohr-Coulomb	19	0	27
Red	Sand and Gravel	Mohr-Coulomb	22	0	33
Cyan	Silty Sand	Mohr-Coulomb	19.8	0	30

DATE Aug 26, 2022	CLIENT: DRAIN-ALL LTD.	project no. OTT-21023795-A0
DESIGN DW	CHECKED SA	scale Not to scale
DRAWN BY DW		TITLE: PSEUDO-STATIC SLOPE STABILITY ANALYSIS 4380 Trail Road, Ottawa, Ontario
		Figure 12B

The results of the slope stability analyses for Sections A-A to E-E have been summarized on Table 6 and are given on Figures 11A and 11B to 15A and 15B inclusive.

Table 6: Results of Slope Stability Analyses			
Section	Loading Condition	Factor of Safety	Figure No.
Section A-A	Effective Stress Analysis	1.76	11A
	Effective Stress Analysis with seismic loading	1.1	11B
Section B-B	Effective Stress Analysis	1.73	12A
	Effective Stress Analysis with seismic loading	1.1	12B
Section C-C	Effective Stress Analysis	1.38	13A
	Effective Stress Analysis with seismic loading	0.93	13B
Section D-D	Effective Stress Analysis	1.11	14A
	Effective Stress Analysis with seismic loading	0.76	14B
Section E-E	Effective Stress Analysis	1.42	15A
	Effective Stress Analysis with seismic loading	0.92	15B

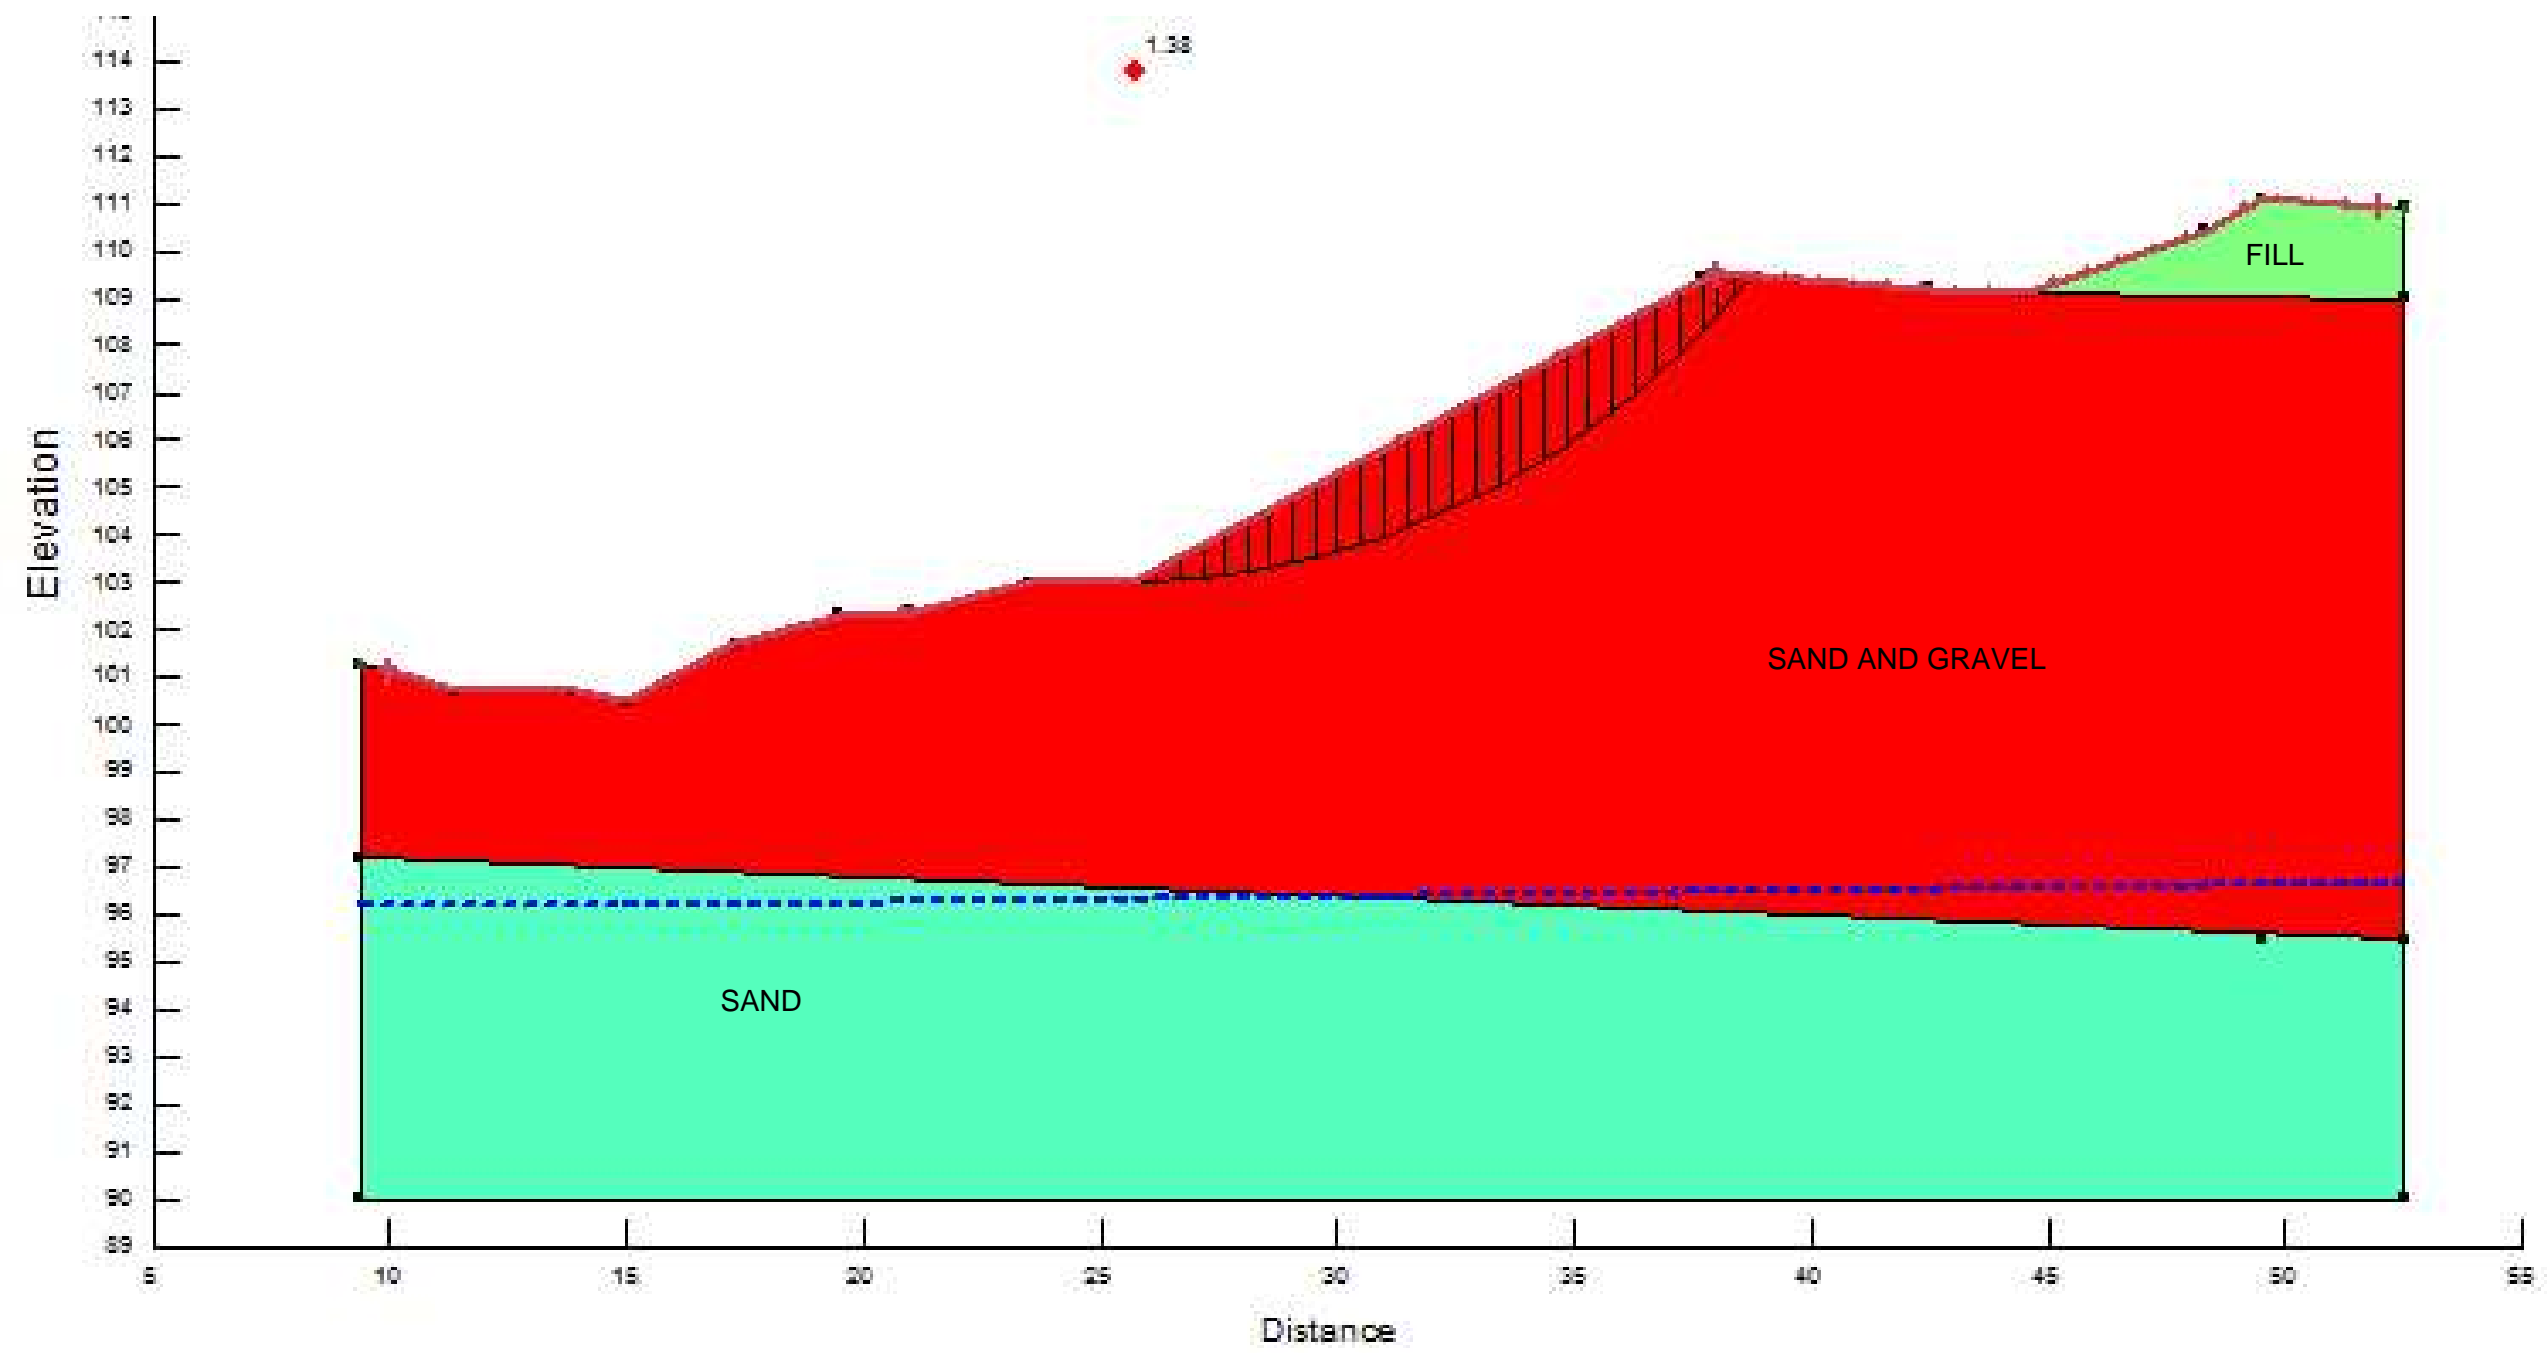
Color	Name	Model	Unit Weight (kN/m ³)	Cohesion' (kPa)	Phi' (°)
■	FILL	Mohr-Coulomb	19	0	27
■	Sand	Mohr-Coulomb	19.8	0	30
■	Sand and Gravel	Mohr-Coulomb	22	0	33

DATE Aug 26, 2022	CLIENT: DRAIN-ALL LTD.	project no. OTT-21023795-A0
DESIGN DW	CHECKED SA	scale Not to scale
DRAWN BY DW		TITLE: STATIC SLOPE STABILITY ANALYSIS 4380 Trail Road, Ottawa, Ontario
		Figure 13A

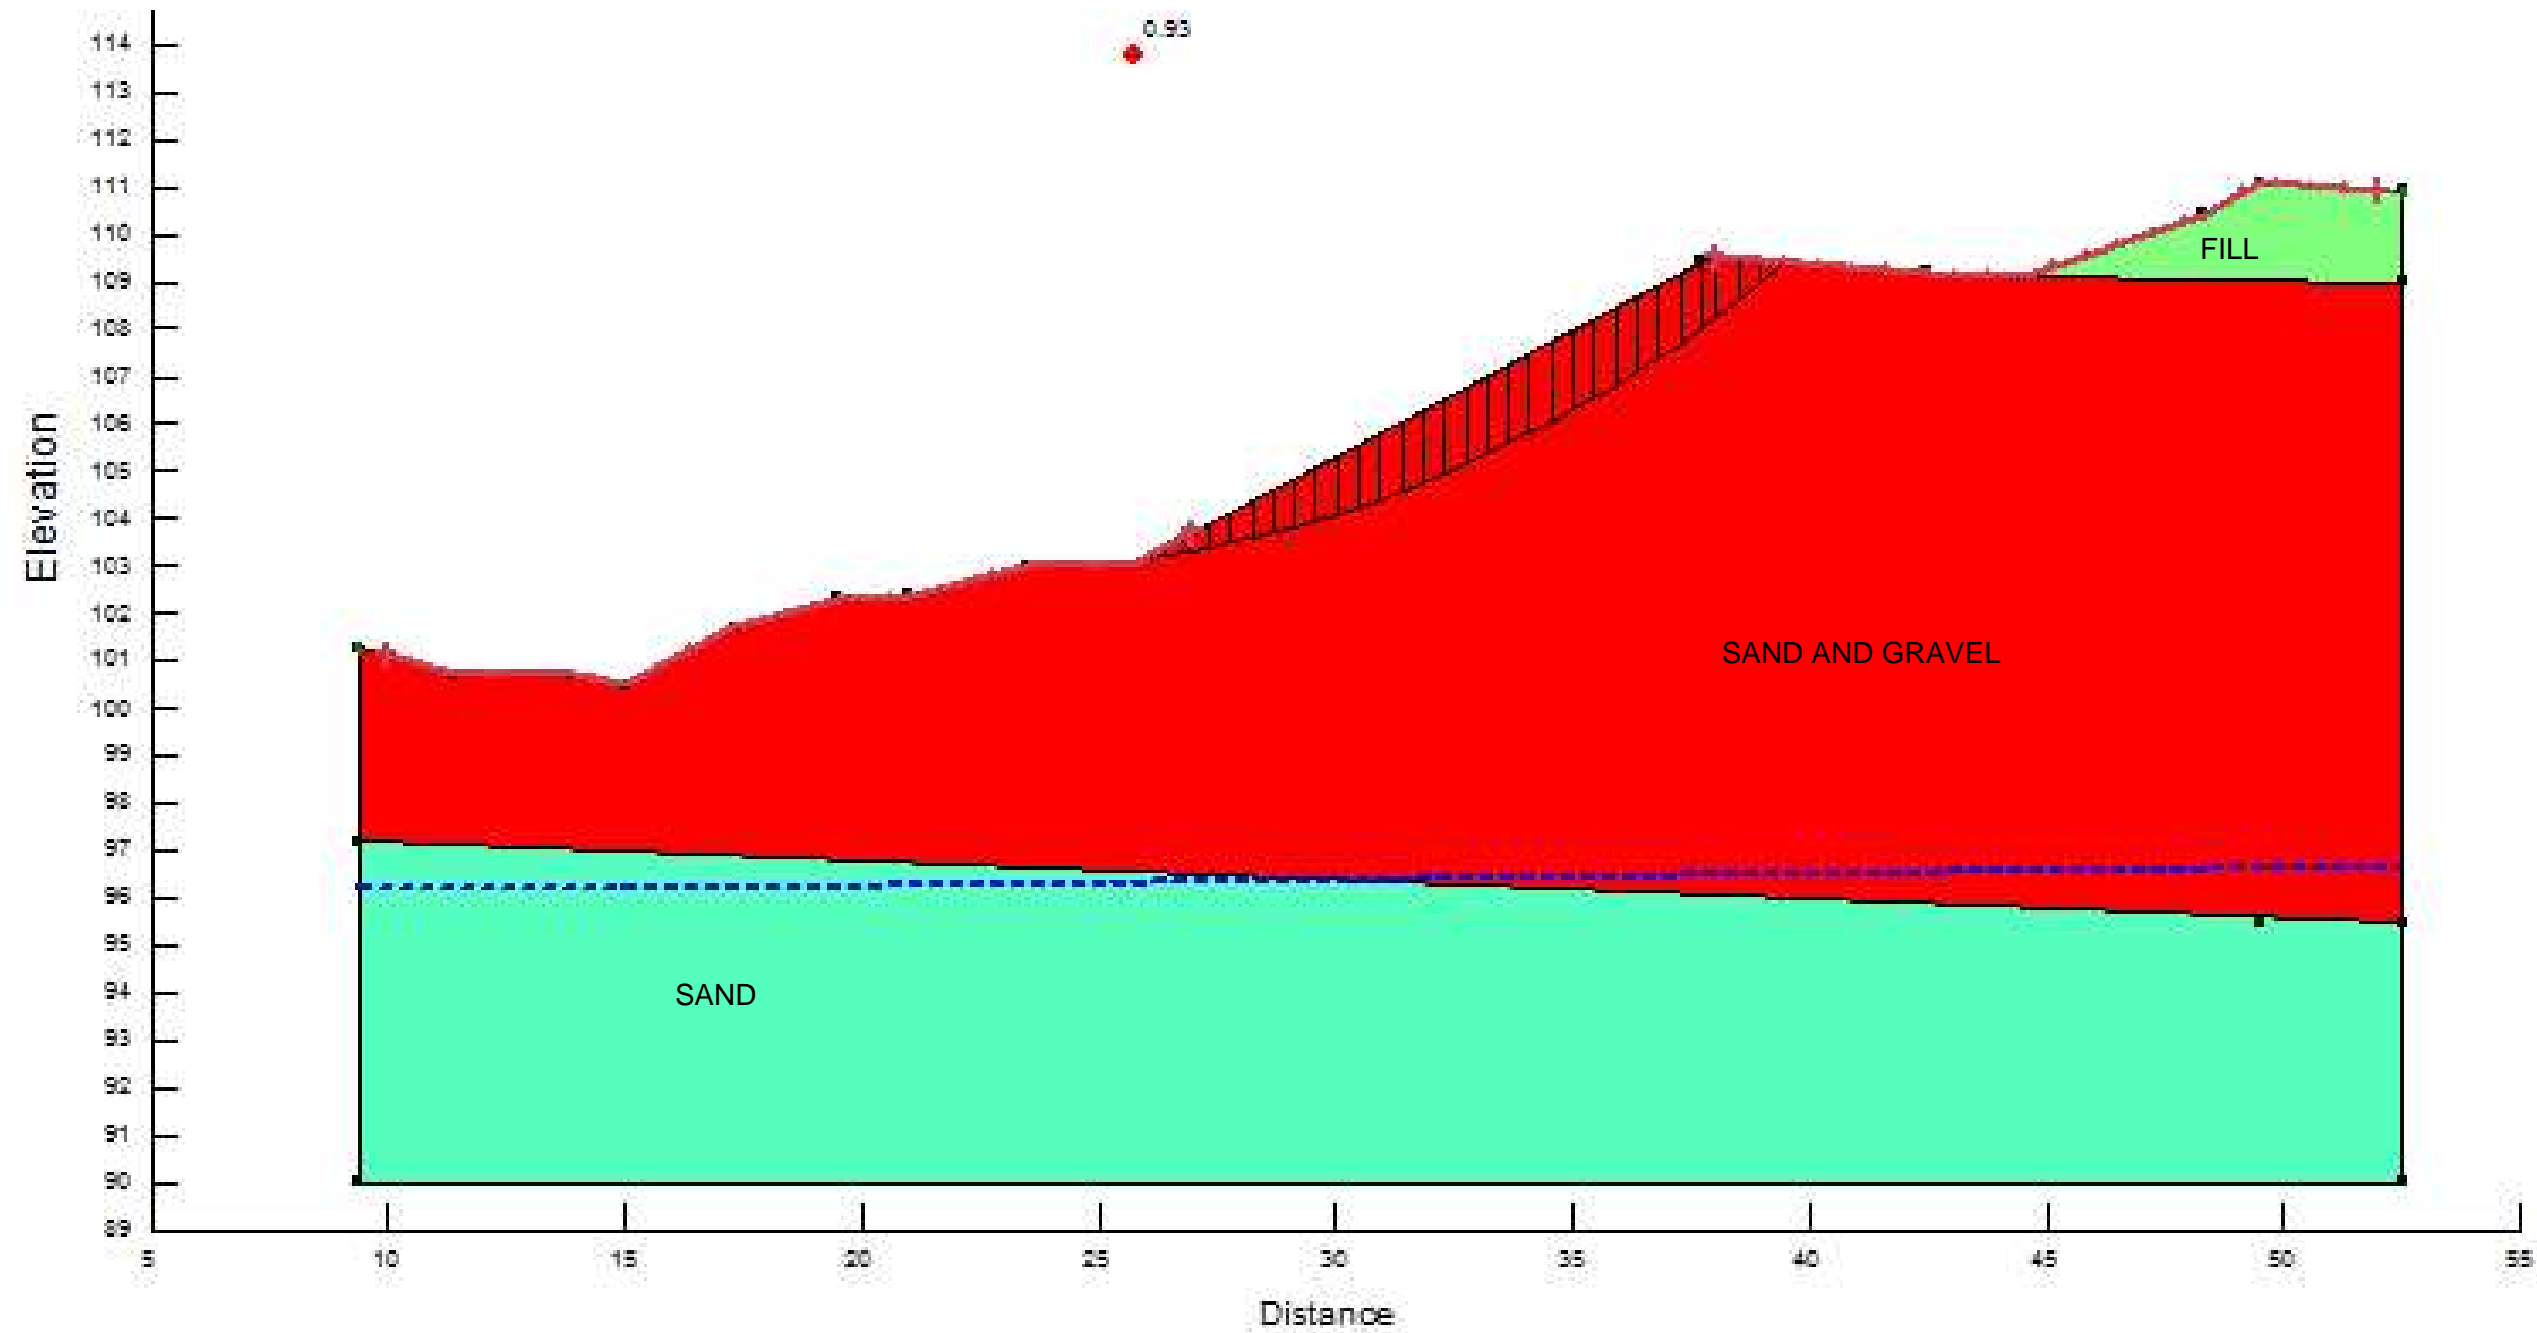
Color	Name	Model	Unit Weight (kN/m ³)	Cohesion' (kPa)	Phi' (°)
■	FILL	Mohr-Coulomb	19	0	27
■	Sand	Mohr-Coulomb	19.8	0	30
■	Sand and Gravel	Mohr-Coulomb	22	0	33

DATE Aug 26, 2022	CLIENT: DRAIN-ALL LTD.	project no. OTT-21023795-A0
DESIGN DW	CHECKED SA	scale Not to scale
DRAWN BY DW		TITLE: PSEUDO-STATIC SLOPE STABILITY ANALYSIS 4380 Trail Road, Ottawa, Ontario
		Figure 13B

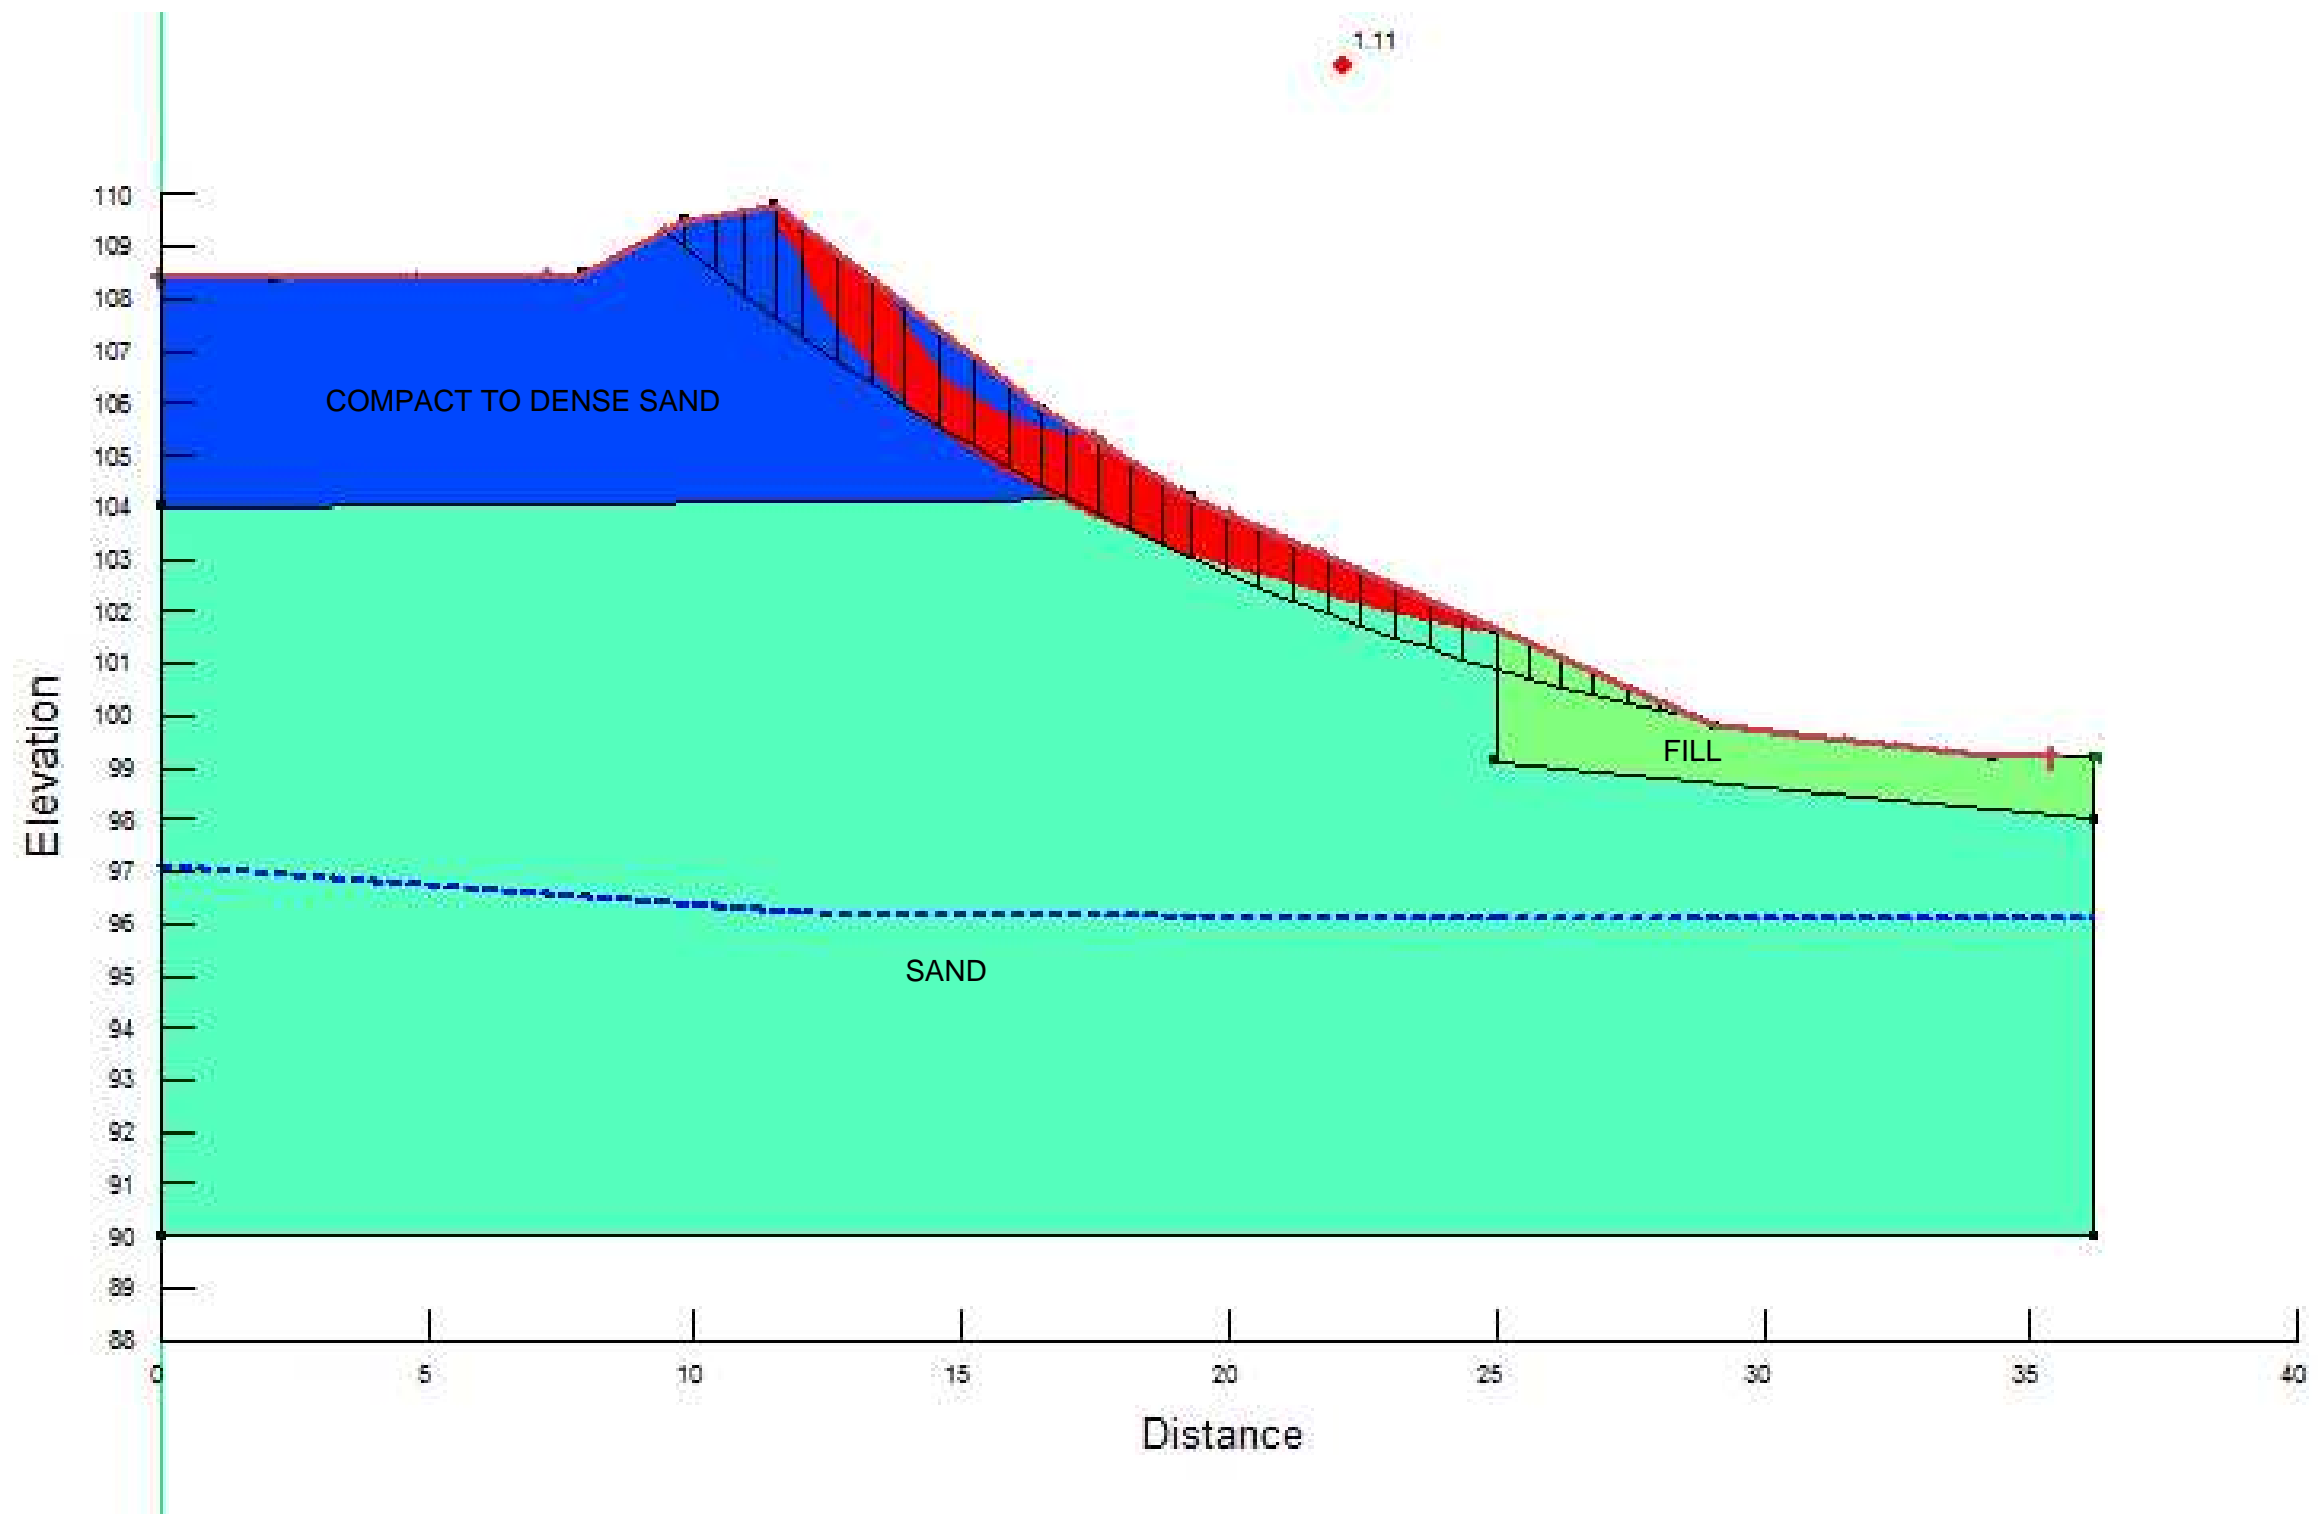
Figure 14A

Color	Name	Model	Unit Weight (kN/m ³)	Cohesion' (kPa)	Phi' (°)
Blue	Compact to dense sand	Mohr-Coulomb	19.7	0	31
Green	FILL	Mohr-Coulomb	19	0	27
Cyan	Sand	Mohr-Coulomb	19.8	0	30

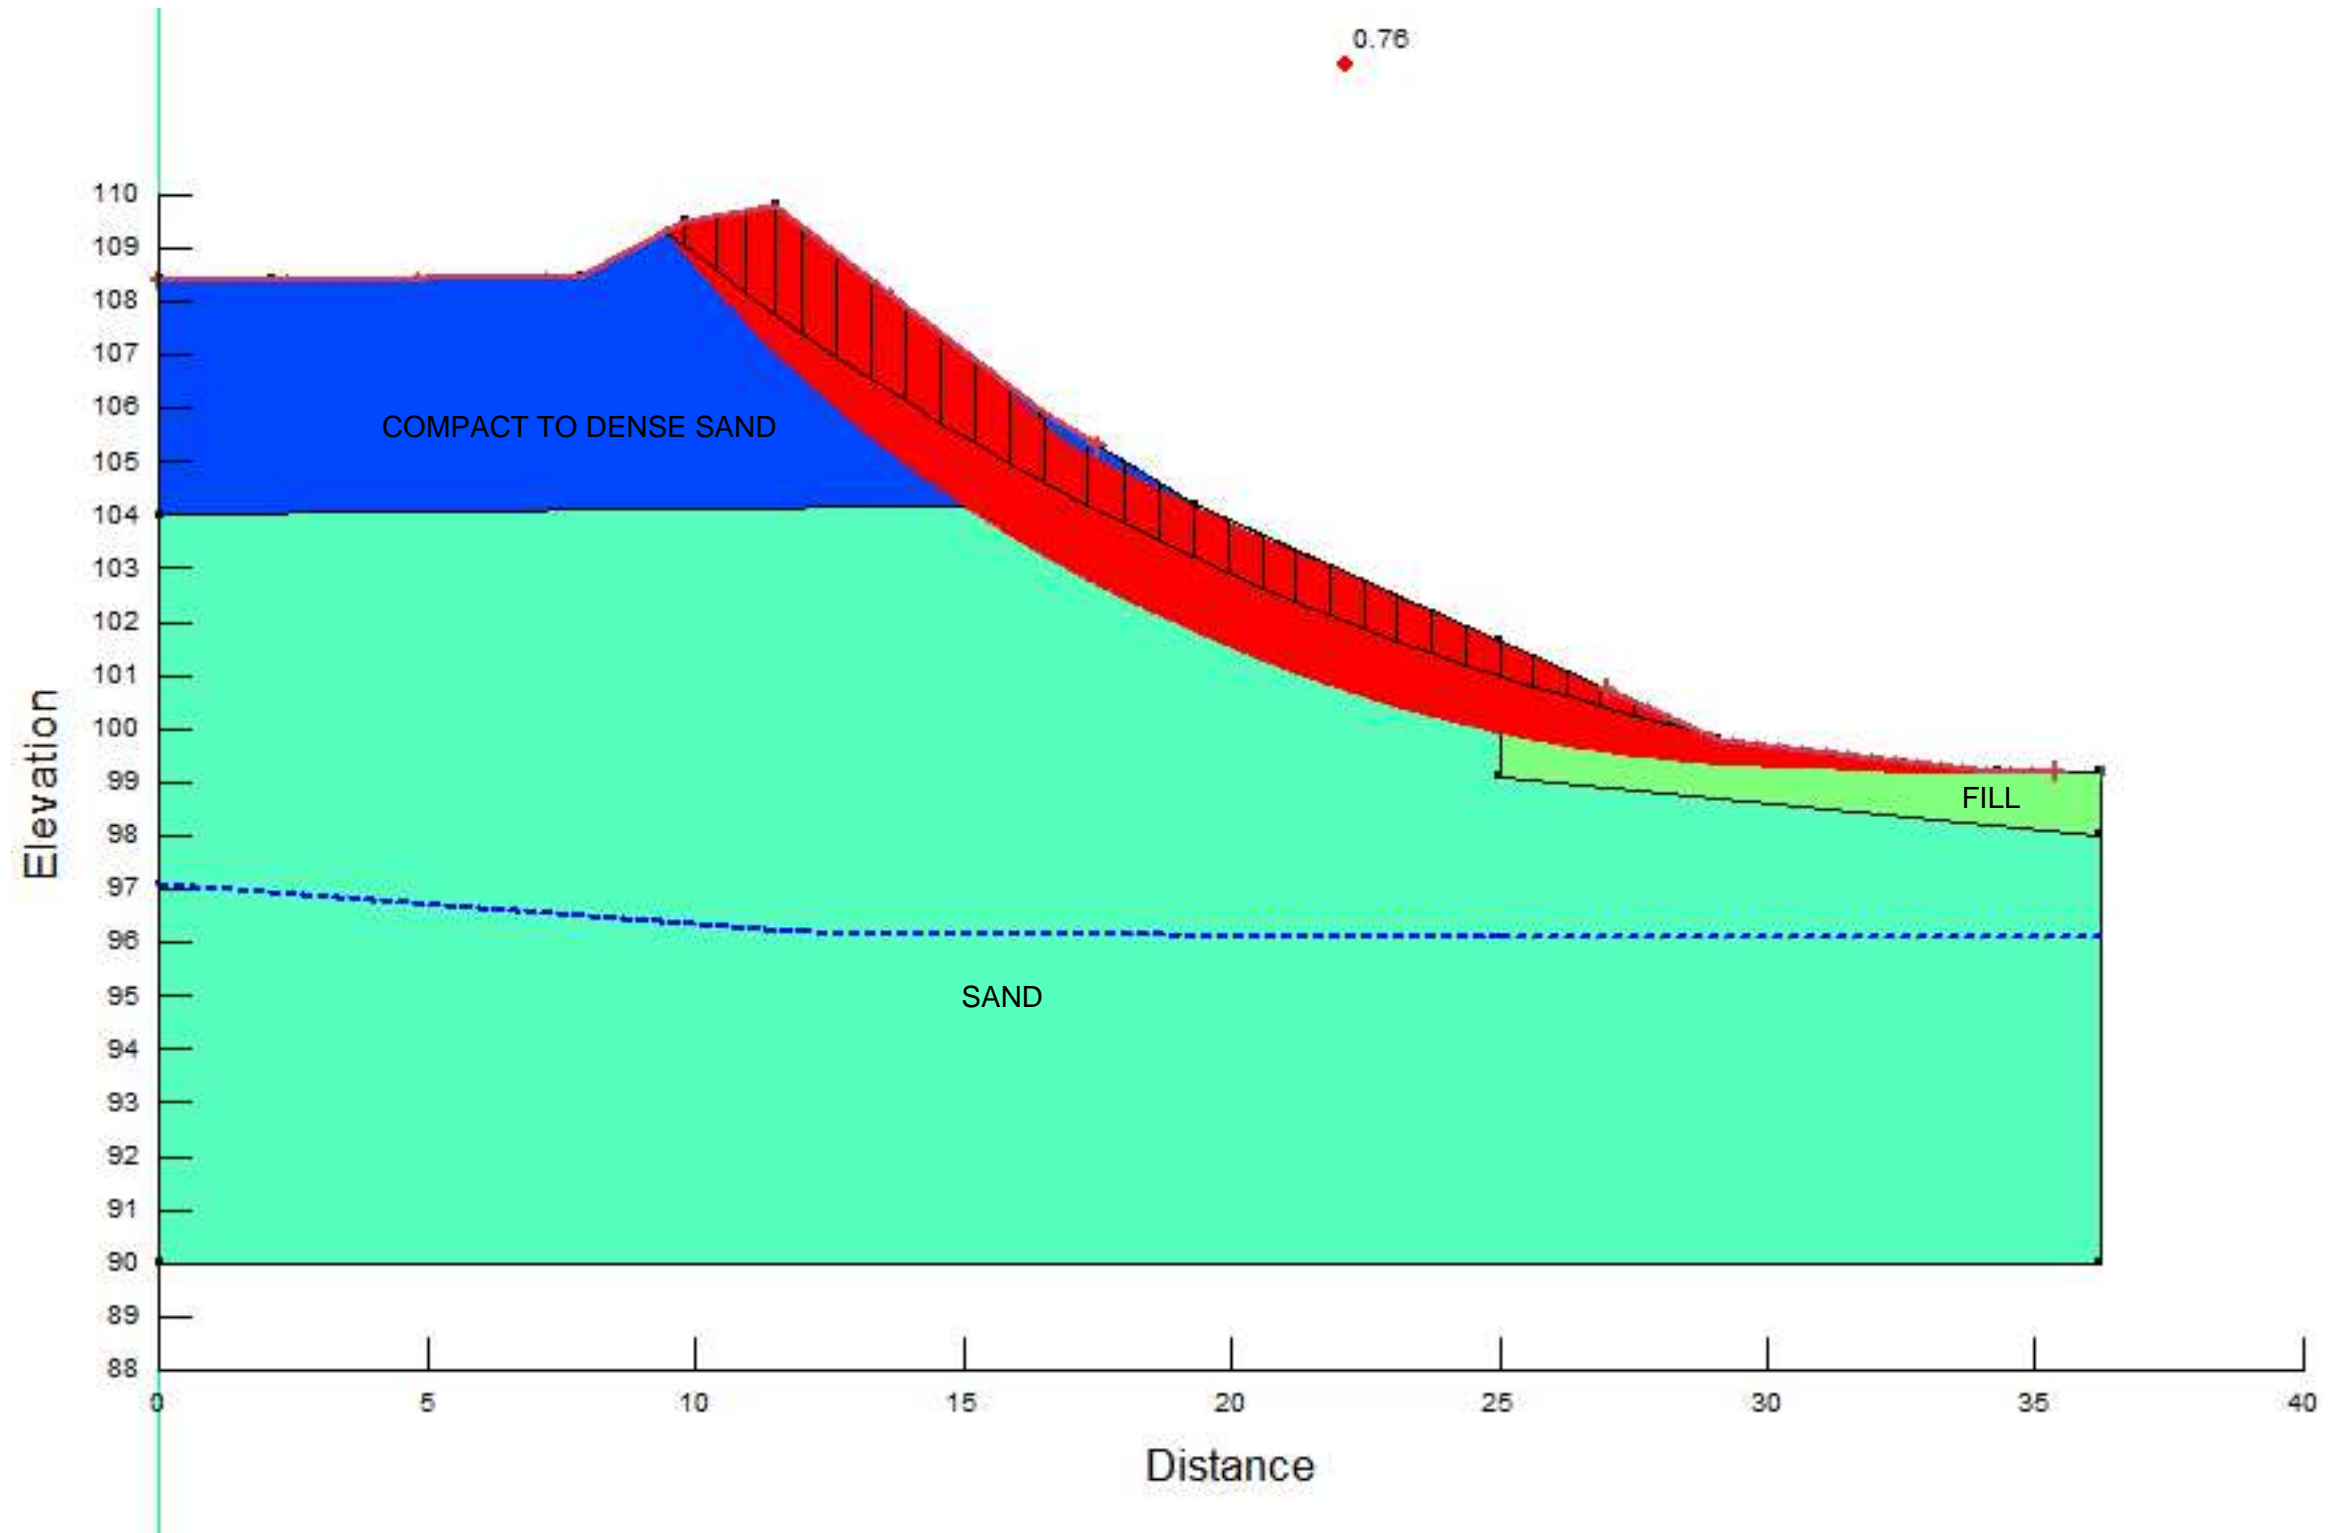
Figure 14B

Color	Name	Model	Unit Weight (kN/m ³)	Cohesion' (kPa)	Phi' (°)
Blue	Compact to dense sand	Mohr-Coulomb	19.7	0	31
Light Green	FILL	Mohr-Coulomb	19	0	27
Cyan	Sand	Mohr-Coulomb	19.8	0	30

DATE Aug 26, 2022	CLIENT: DRAIN-ALL LTD.	project no. OTT-21023795-A0
DESIGN DW	CHECKED SA	scale Not to scale
DRAWN BY DW		TITLE: PSEUDO-STATIC SLOPE STABILITY ANALYSIS 4380 Trail Road, Ottawa, Ontario

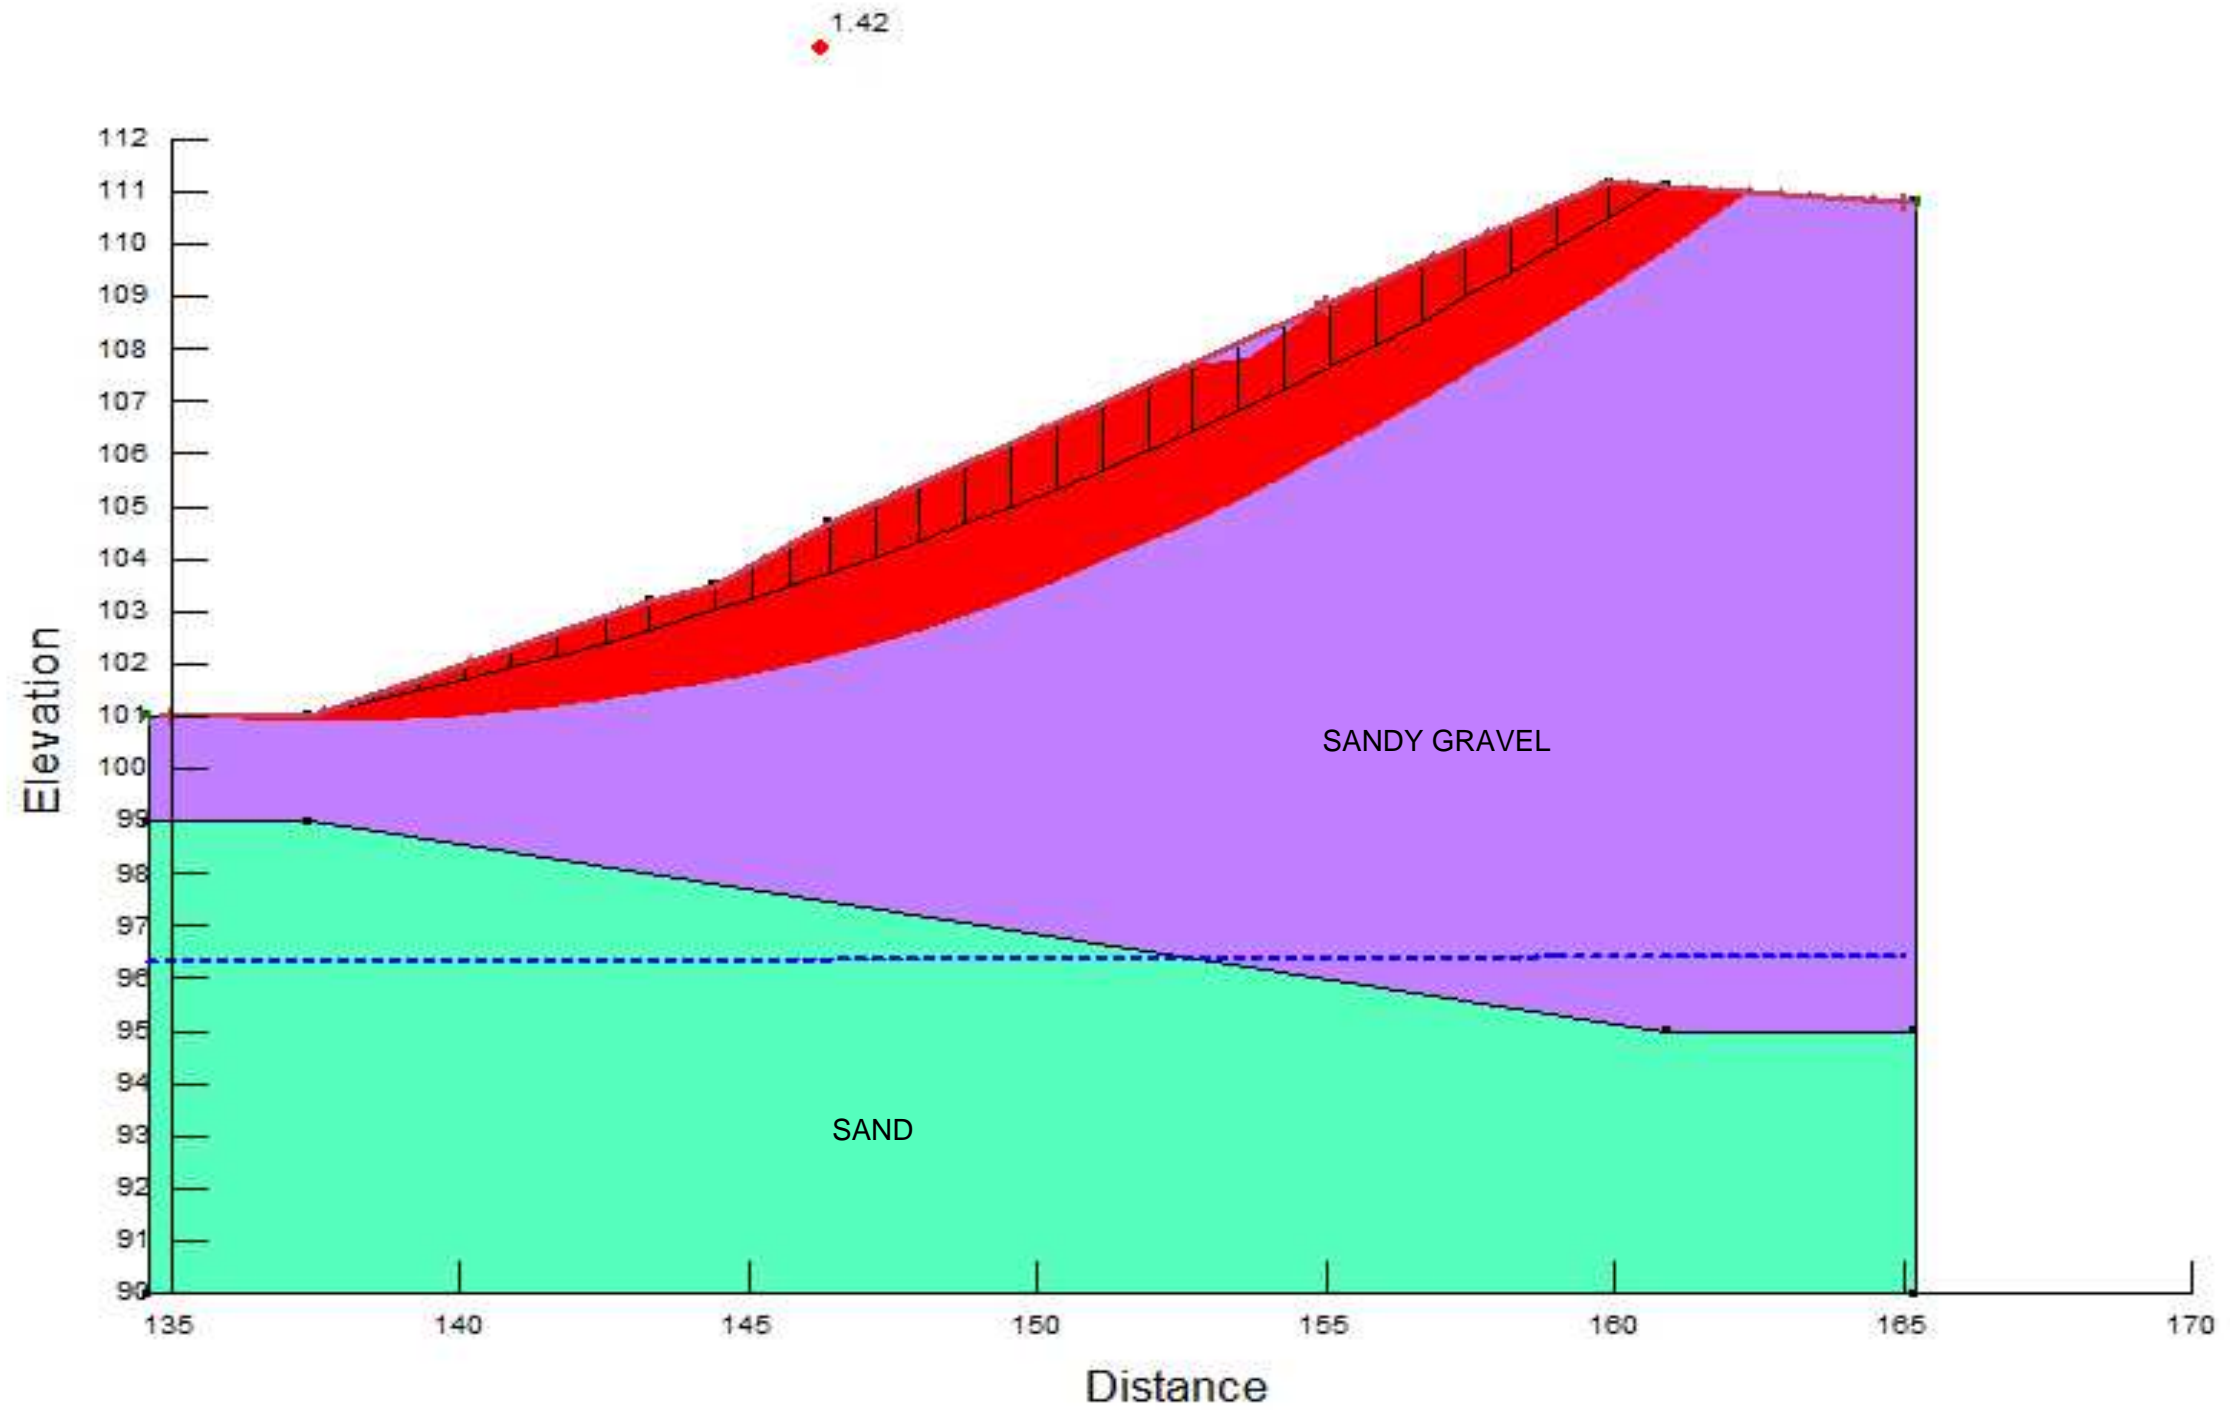
Color	Name	Model	Unit Weight (kN/m ³)	Cohesion' (kPa)	Phi' (°)
	Sand	Mohr-Coulomb	19.8	0	30
	Sandy Gravel	Mohr-Coulomb	22	0	33

DATE Aug 26, 2022	CLIENT: DRAIN-ALL LTD.	project no. OTT-21023795-A0
DESIGN DW	CHECKED SA	scale Not to scale
DRAWN BY DW		TITLE: STATIC SLOPE STABILITY ANALYSIS 4380 Trail Road, Ottawa, Ontario
		Figure 15A
