Project Name: **Geotechnical Investigation – Slope Stability Analysis in Support of Zoning By-Law Amendment, 4380 Trail Road, Ottawa, Ontario**

EXP Project Number: **OTT-21023795-A0**

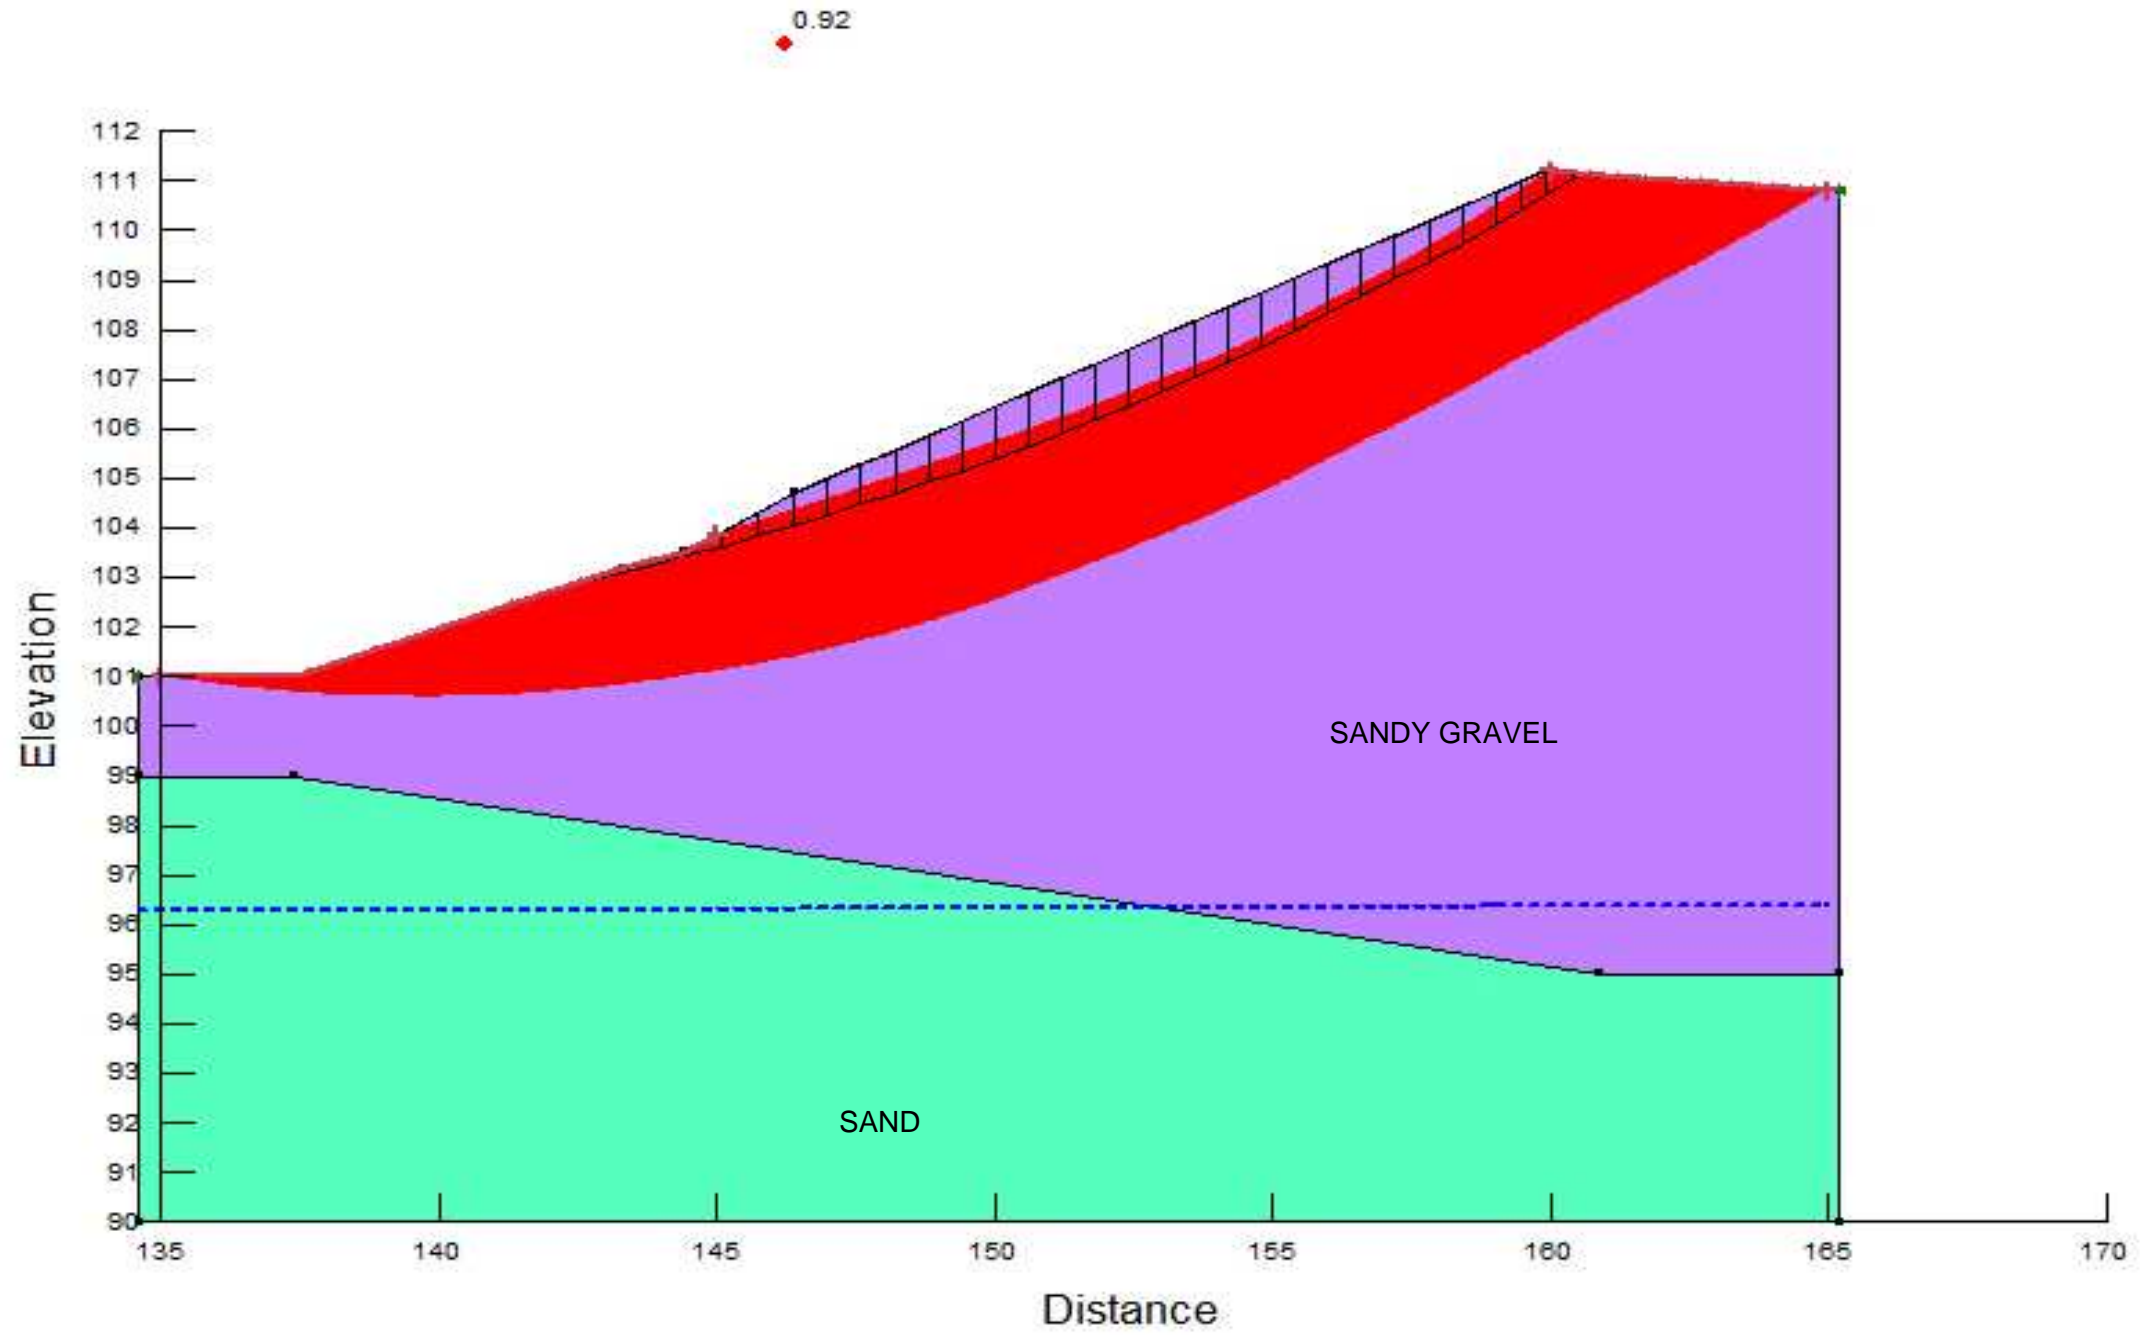
Color	Name	Model	Unit Weight (kN/m ³)	Cohesion' (kPa)	Phi' (°)
■	Sand	Mohr-Coulomb	19.8	0	30
■	Sandy Gravel	Mohr-Coulomb	22	0	33

The results of the slope stability analyses for Sections A-A to E-E have been summarized on Table 6 and are given on Figures 11A and 11B to 15A and 15B inclusive.

Table 6: Results of Slope Stability Analyses			
Section	Loading Condition	Factor of Safety	Figure No.
Section A-A	Effective Stress Analysis	1.76	11A
	Effective Stress Analysis with seismic loading	1.1	11B
Section B-B	Effective Stress Analysis	1.73	12A
	Effective Stress Analysis with seismic loading	1.1	12B
Section C-C	Effective Stress Analysis	1.38	13A
	Effective Stress Analysis with seismic loading	0.93	13B
Section D-D	Effective Stress Analysis	1.11	14A
	Effective Stress Analysis with seismic loading	0.76	14B
Section E-E	Effective Stress Analysis	1.42	15A
	Effective Stress Analysis with seismic loading	0.92	15B
