# Phase I Environmental Site Assessment

1531 St. Laurent Boulevard, Ottawa, ON

**KATASA Groupe + Développement**  
Final Report

June 7, 2023  
02305731.000

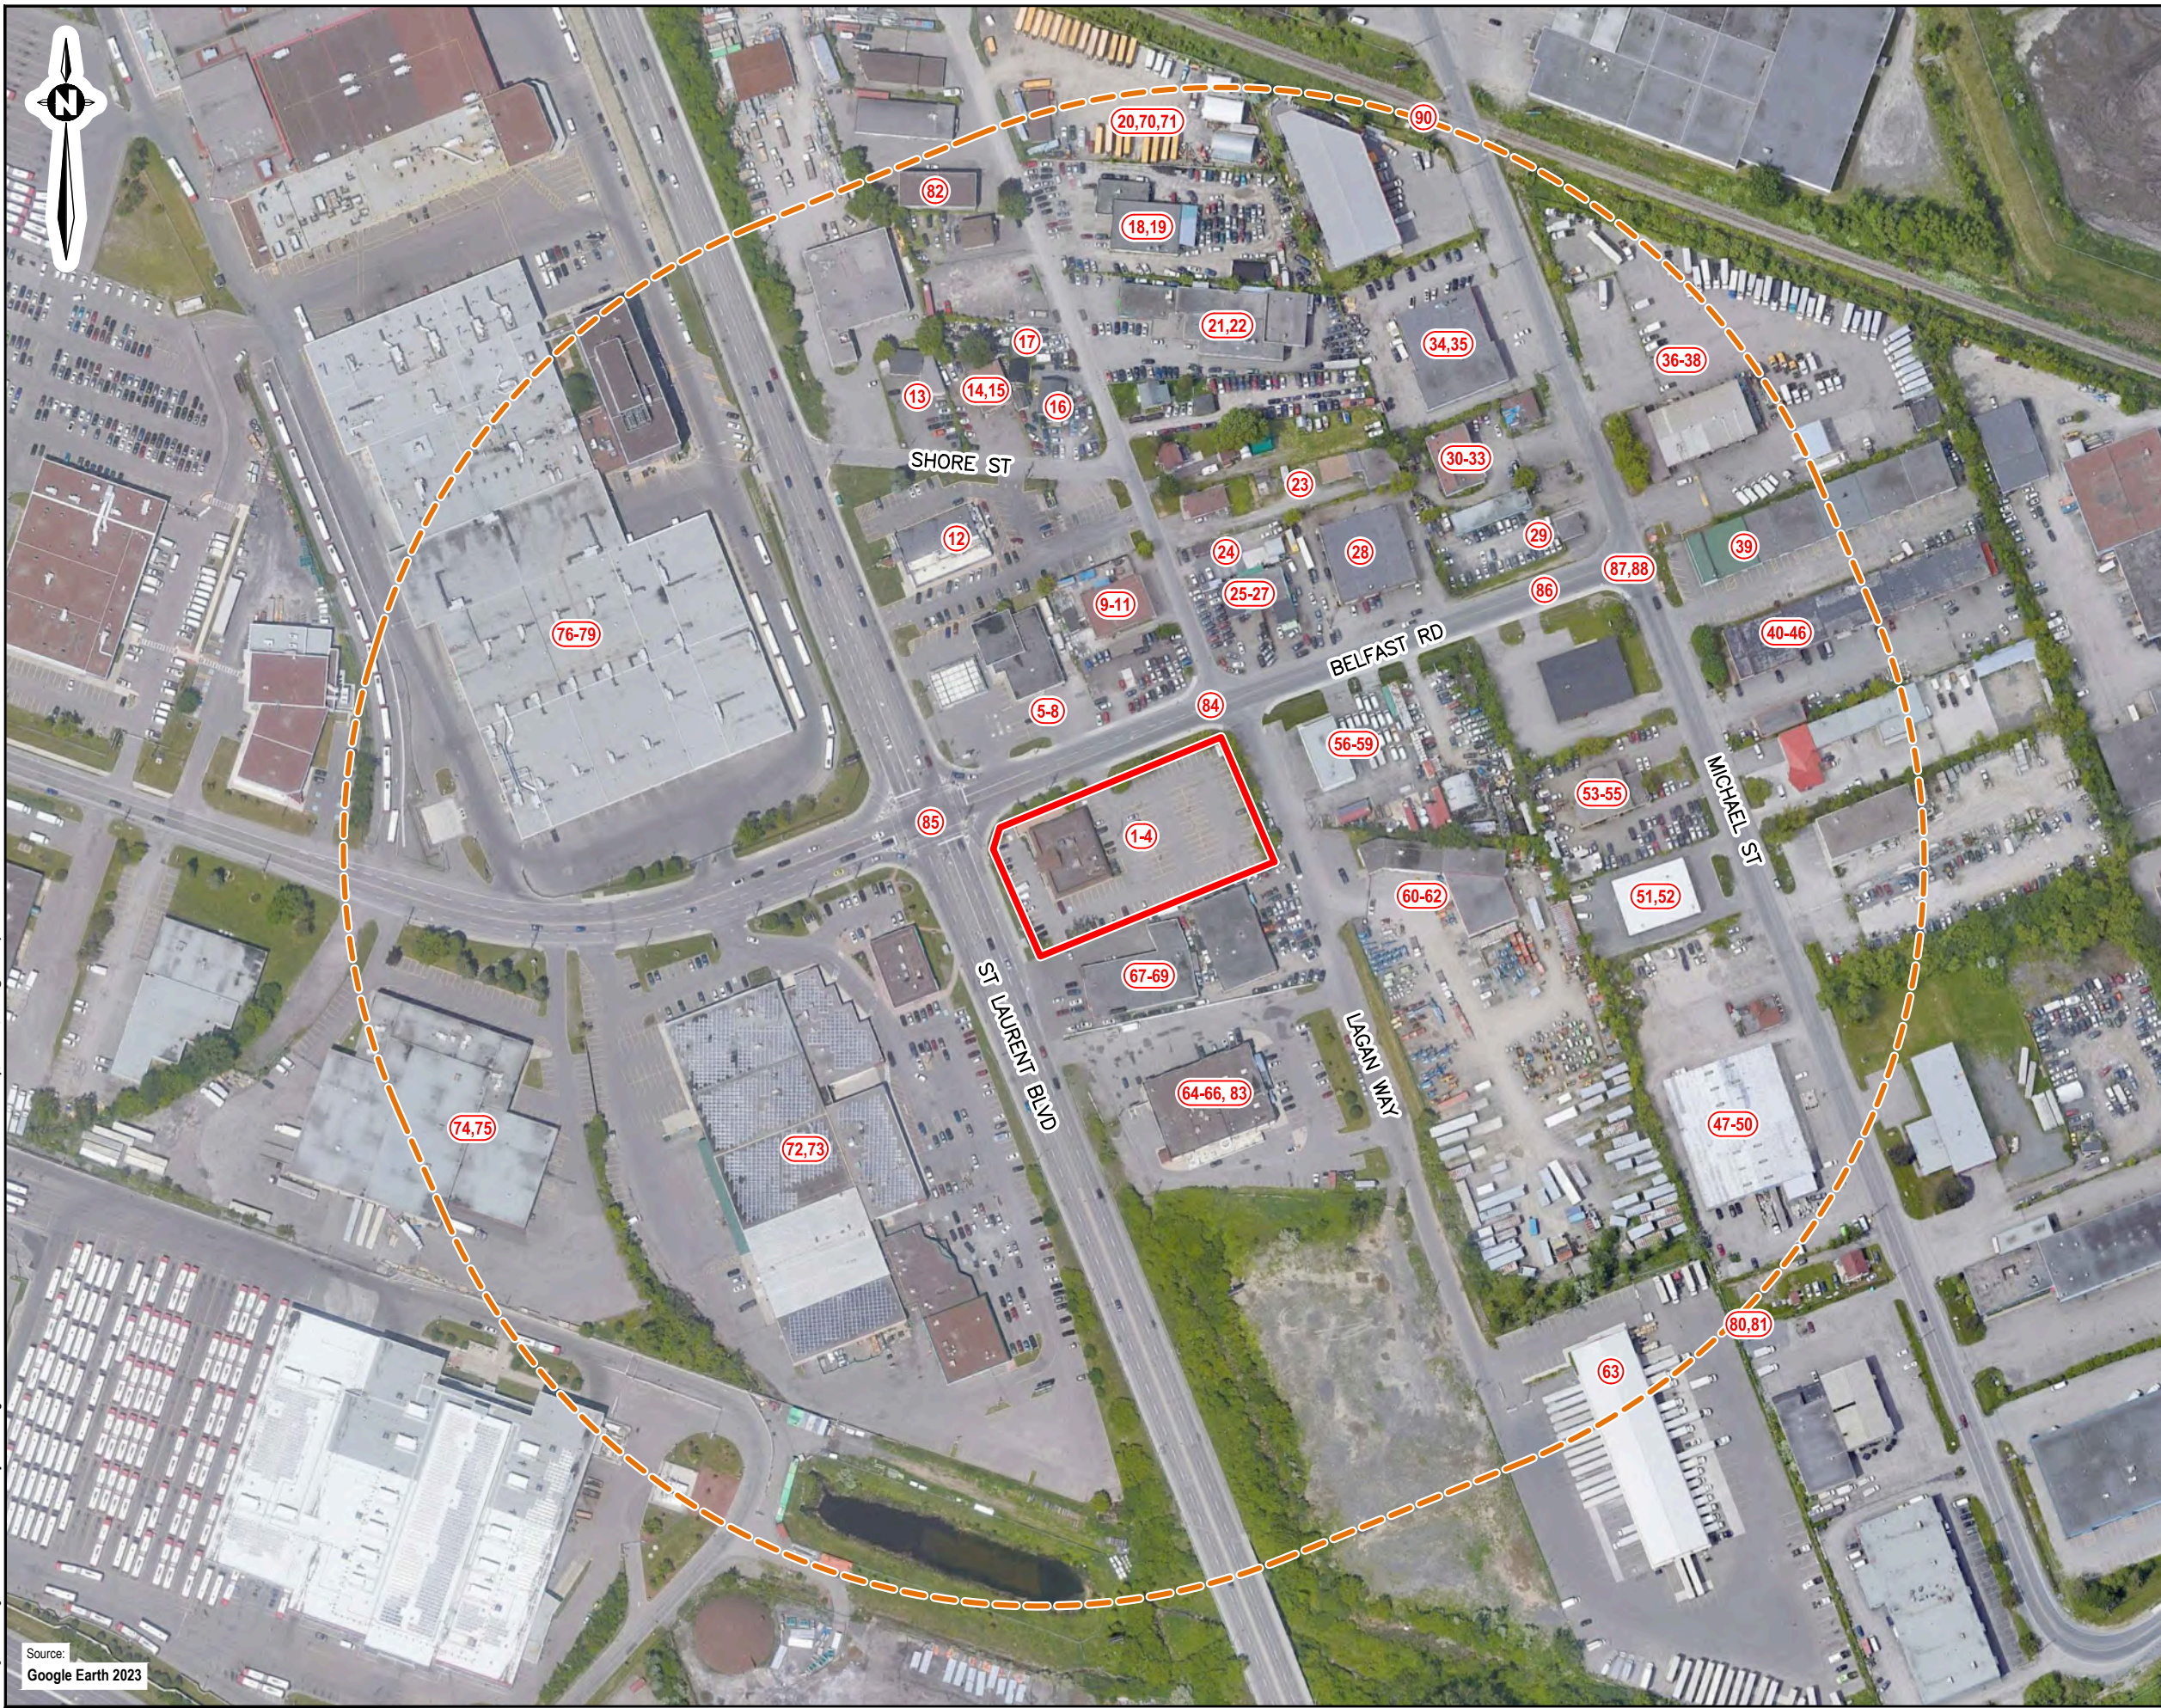
**Legend**  
 — Phase I Property  
 - - - 250 m Study Area  
 ① Potentially Contaminating Activities (PCAs)

Potentially Contaminating Activity (PCA)			
PCA No.	O. Reg. 153/04 PCA Item No.	Property Address	Historical and/or Current Activities
1	Undefined No. 1. Known soil contamination	1531 St. Laurent Boulevard	Known soil contamination on Site in vicinity of MW1-21 and MW22-02
2	52. Storage, maintenance, fuelling and repair of equipment, vehicles, and material used to maintain transportation systems	1531 St. Laurent Boulevard	Husband Transport historically operated on Site
3	Undefined No. 2. Application of salt for de-icing purposes for the safety of vehicular or pedestrian traffic	1531 St. Laurent Boulevard	Application of salt for de-icing purposes for the safety of vehicular or pedestrian traffic
4	28. Gasoline and Associated Products Storage in Fixed Tanks	1531 St. Laurent Boulevard	Diesel and gasoline UST records associated with Husband Transport
5	28. Gasoline and Associated Products Storage in Fixed Tanks	1515 St. Laurent Boulevard	Retail fuel outlet

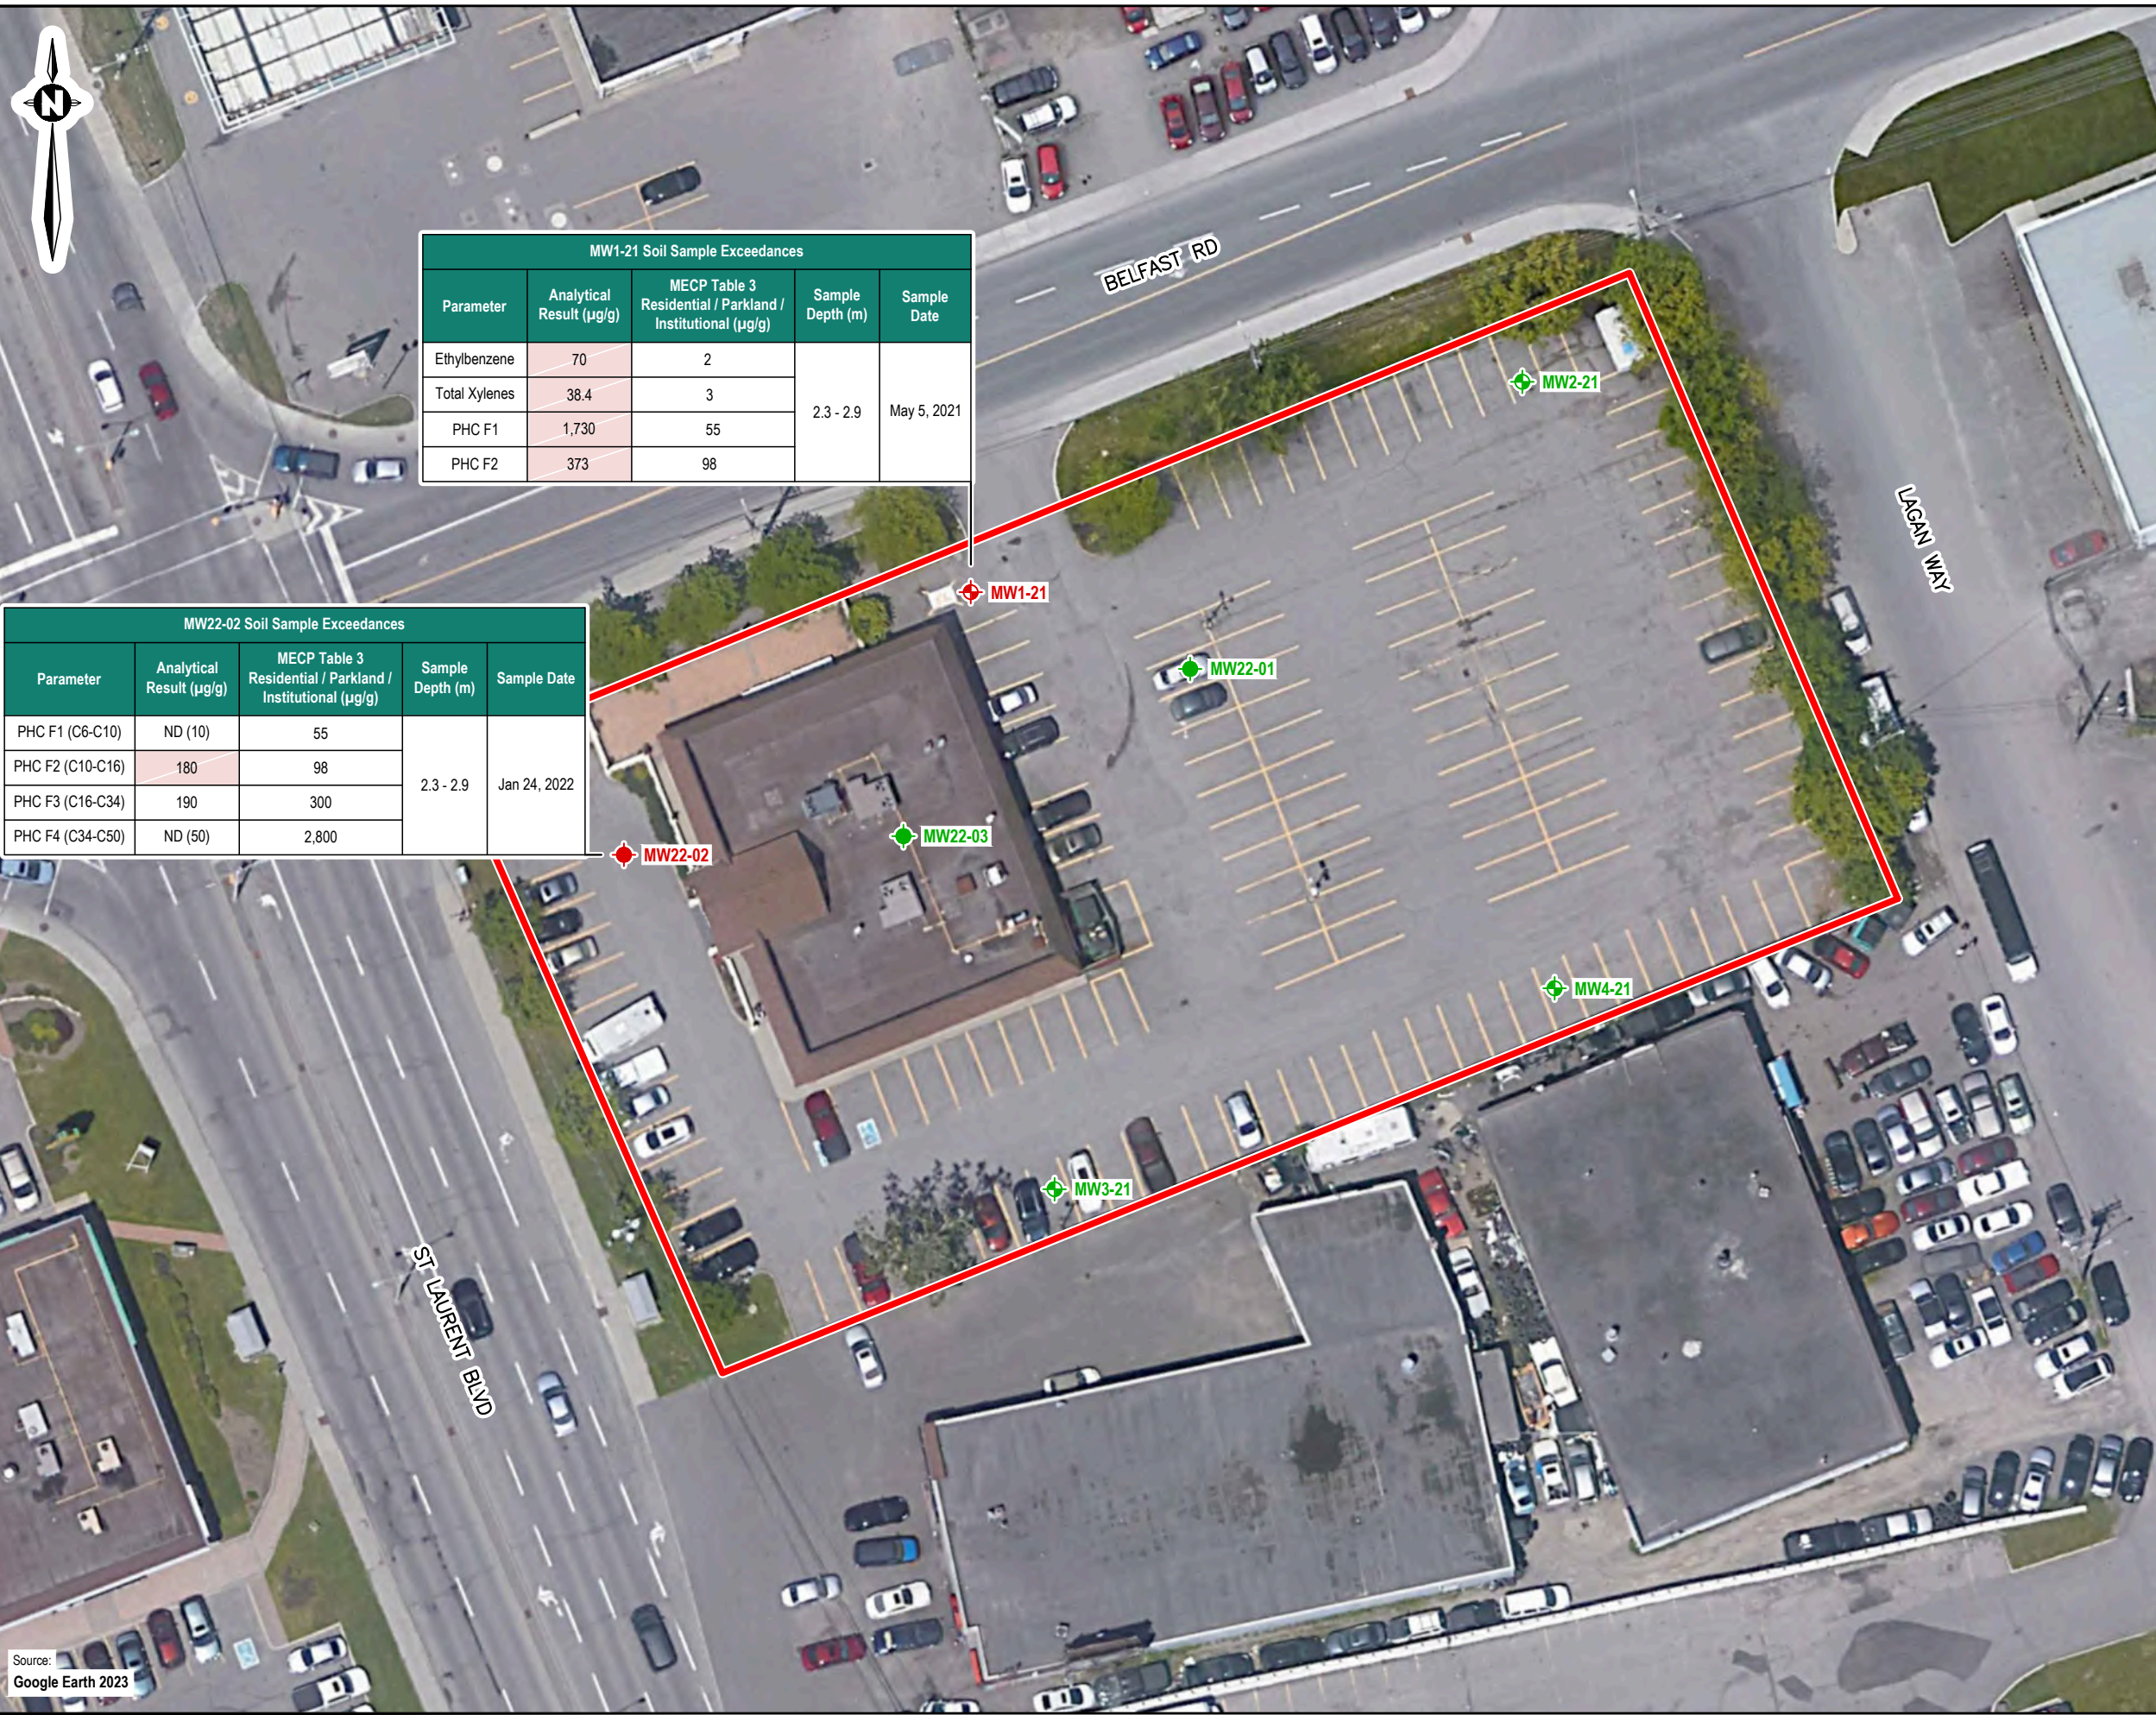
Further to the completion of the Phase I and II ESAs, the assessment identified impacts to the soil quality at borehole location MW1-21, which is located to the north of the building footprint. The subject impacts at this borehole location were likely attributed to off-Site sources potentially linked to one or more of the previously noted PCAs within the Phase I Study Area.

It was inferred that existing soils to the north of the Site building, up to the northern property boundary, contain impacts above the applicable MECP Table 3 standards, from a depth of approximately 1.0 metres below ground surface (m bgs) to 3.0 m bgs. Further investigation was recommended to the south and east of borehole location MW1-21 in order to confirm the horizontal and vertical extents of the soil impacts in the vicinity of the subject borehole location.

- Legend**
- ▬ Phase I Property
  - ◆ Borehole / MW (DST, 2021) Meets Applicable MECP Table 3 Standards (Residential / Parkland / Institutional)
  - ◆ Borehole / MW (DST, 2021) Exceeds Applicable MECP Table 3 Standards (Residential / Parkland / Institutional)
  - ◆ Borehole / MW (Englobe, 2022) Meets Applicable MECP Table 3 Standards (Residential / Parkland / Institutional)
  - ◆ Borehole / MW (Englobe, 2022) Exceeds Applicable MECP Table 3 Standards (Residential / Parkland / Institutional)

It is recommended that PHC-impacted soils in the vicinity of MW1-21 and MW22-02 be excavated from the Site and disposed of at an MECP-licensed waste disposal facility during the planned construction/ Site development activities. Additional delineation may be warranted at the time to delineate the previously-confirmed PHC impacts in soil, to attempt to minimize soil disposal costs for the building construction project and/or to fully remediate the contaminated soils on Site, as required. Any excess soils shall be handled in accordance with O. Reg. 406/19, at the time of Site development.

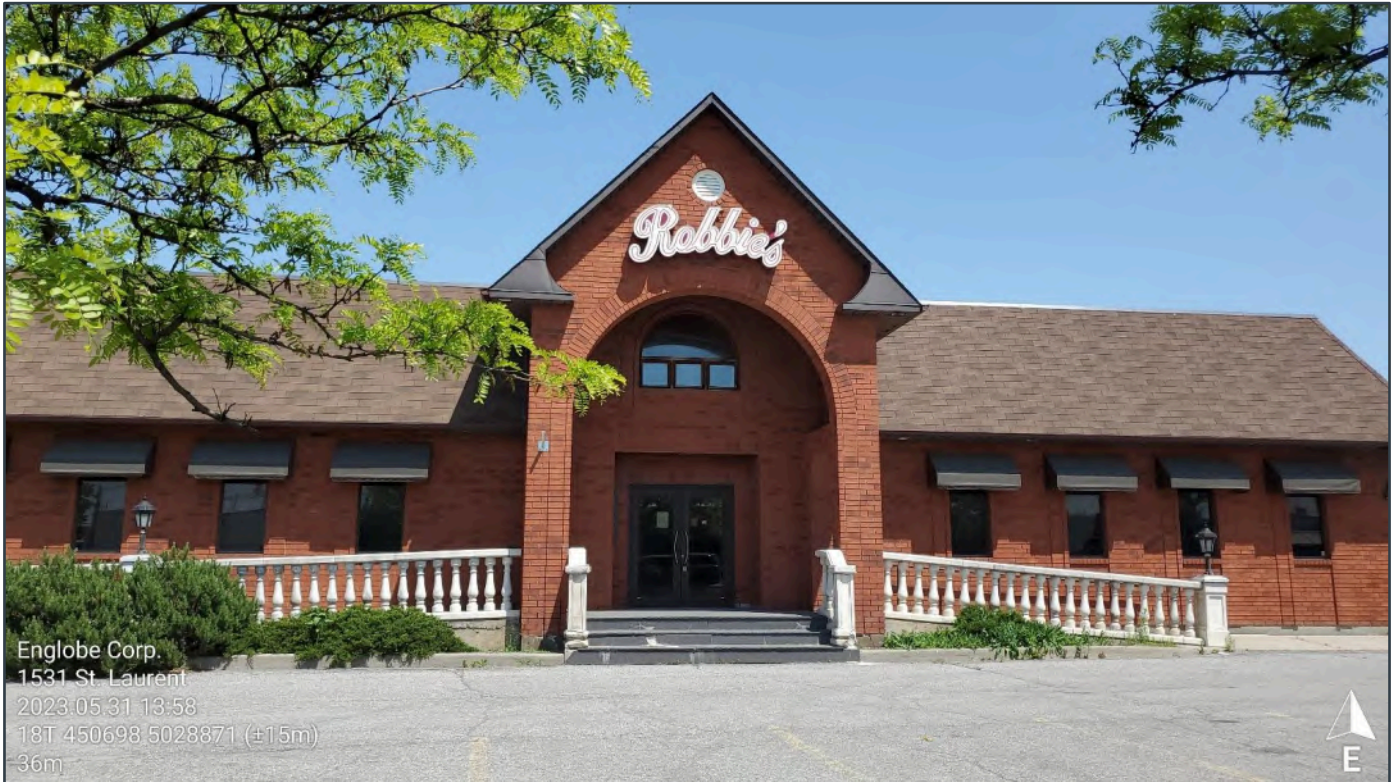
**Site Photograph 1: Overview of the Site.**

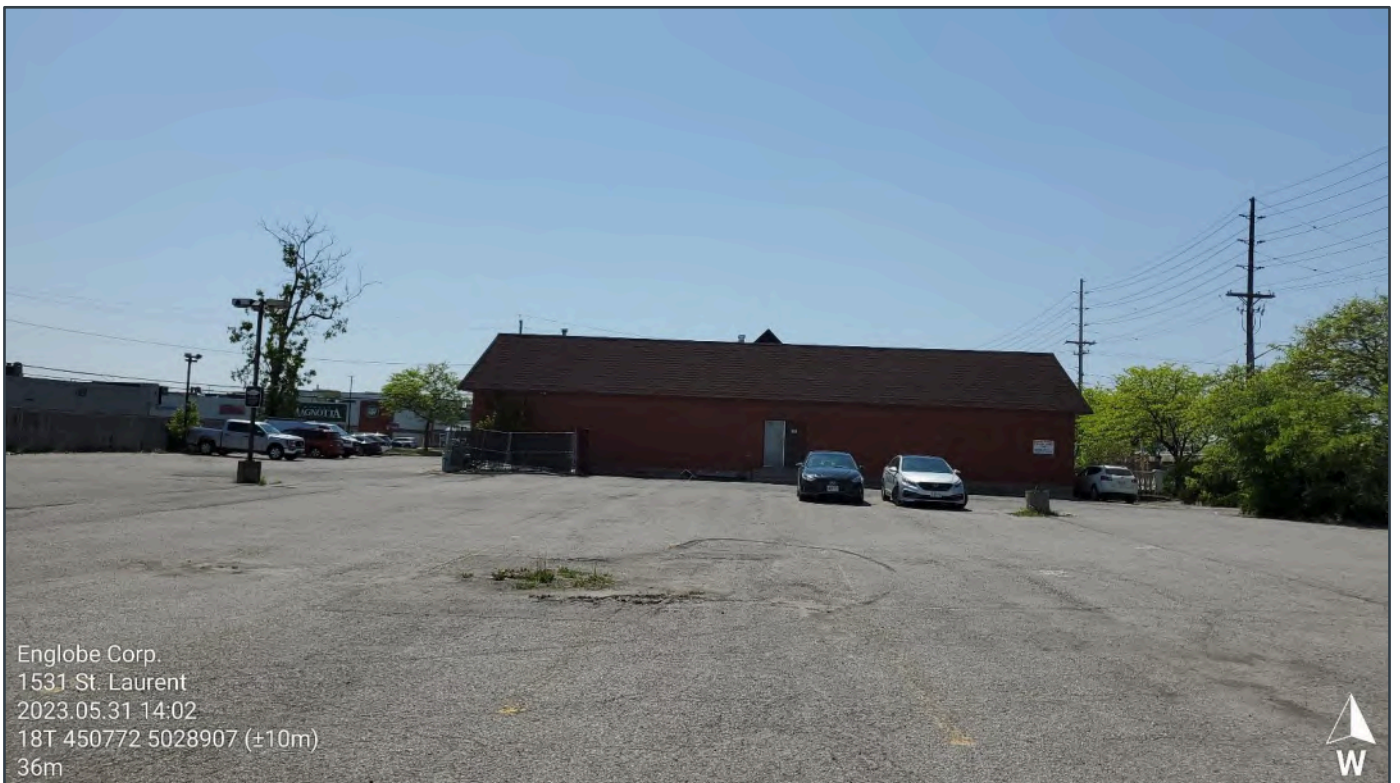
**Site Photograph 2: Overview of the rear of the building.**

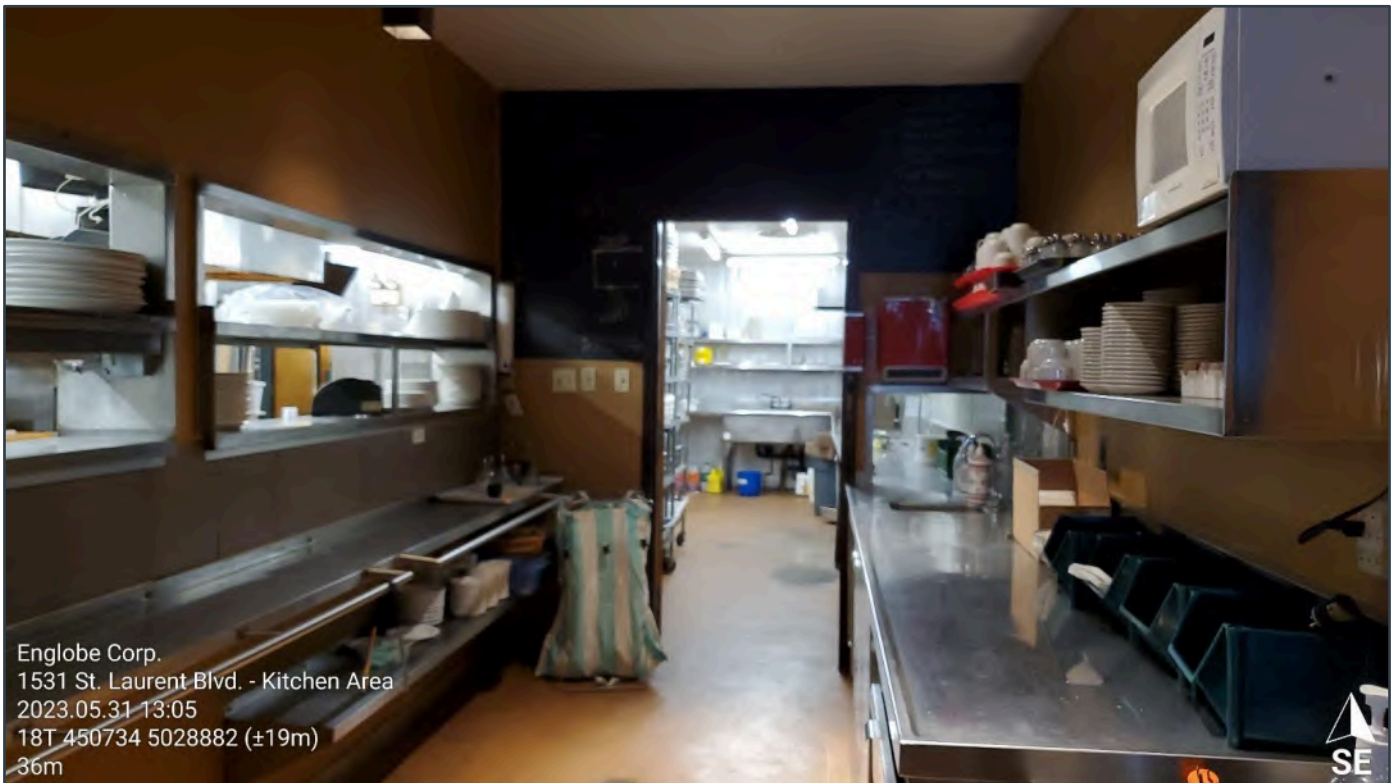
Site Photograph 4: Overview of the kitchen areas.
