## Geotechnical Investigation

Proposed Residential Development  
2009-2013 Prince of Wales Drive  
Ottawa, Ontario  
*Revision 1*

LRL File No.: 220528

December 2022, *Revised: January 2023*

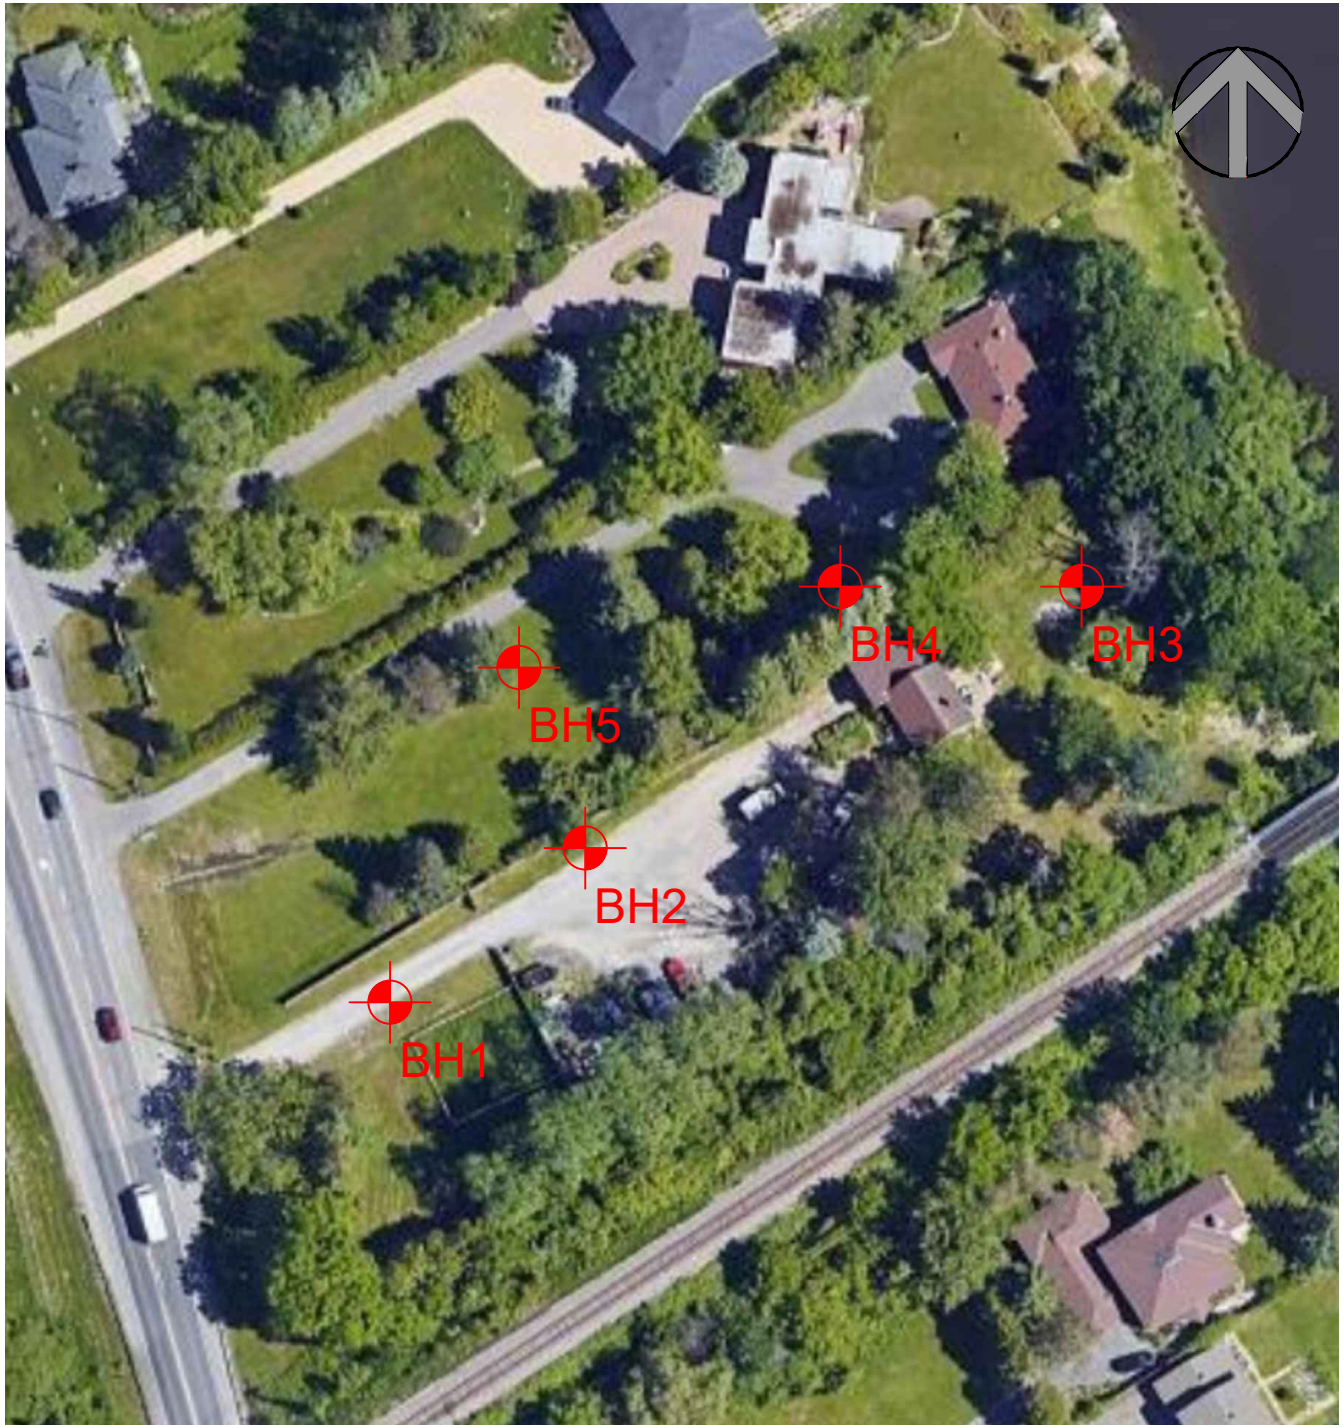
**FIGURE 2**

The fieldwork for this investigation was carried out on November 28, 2022. Prior to the fieldwork, the site was cleared for the presence of any underground services and utilities. A total of five (5) boreholes were drilled onsite to get a general representation of the site's underlying soil conditions, and labelled BH1 through BH5. The approximate locations of the boreholes are shown in Figure 2 included in **Appendix A**.

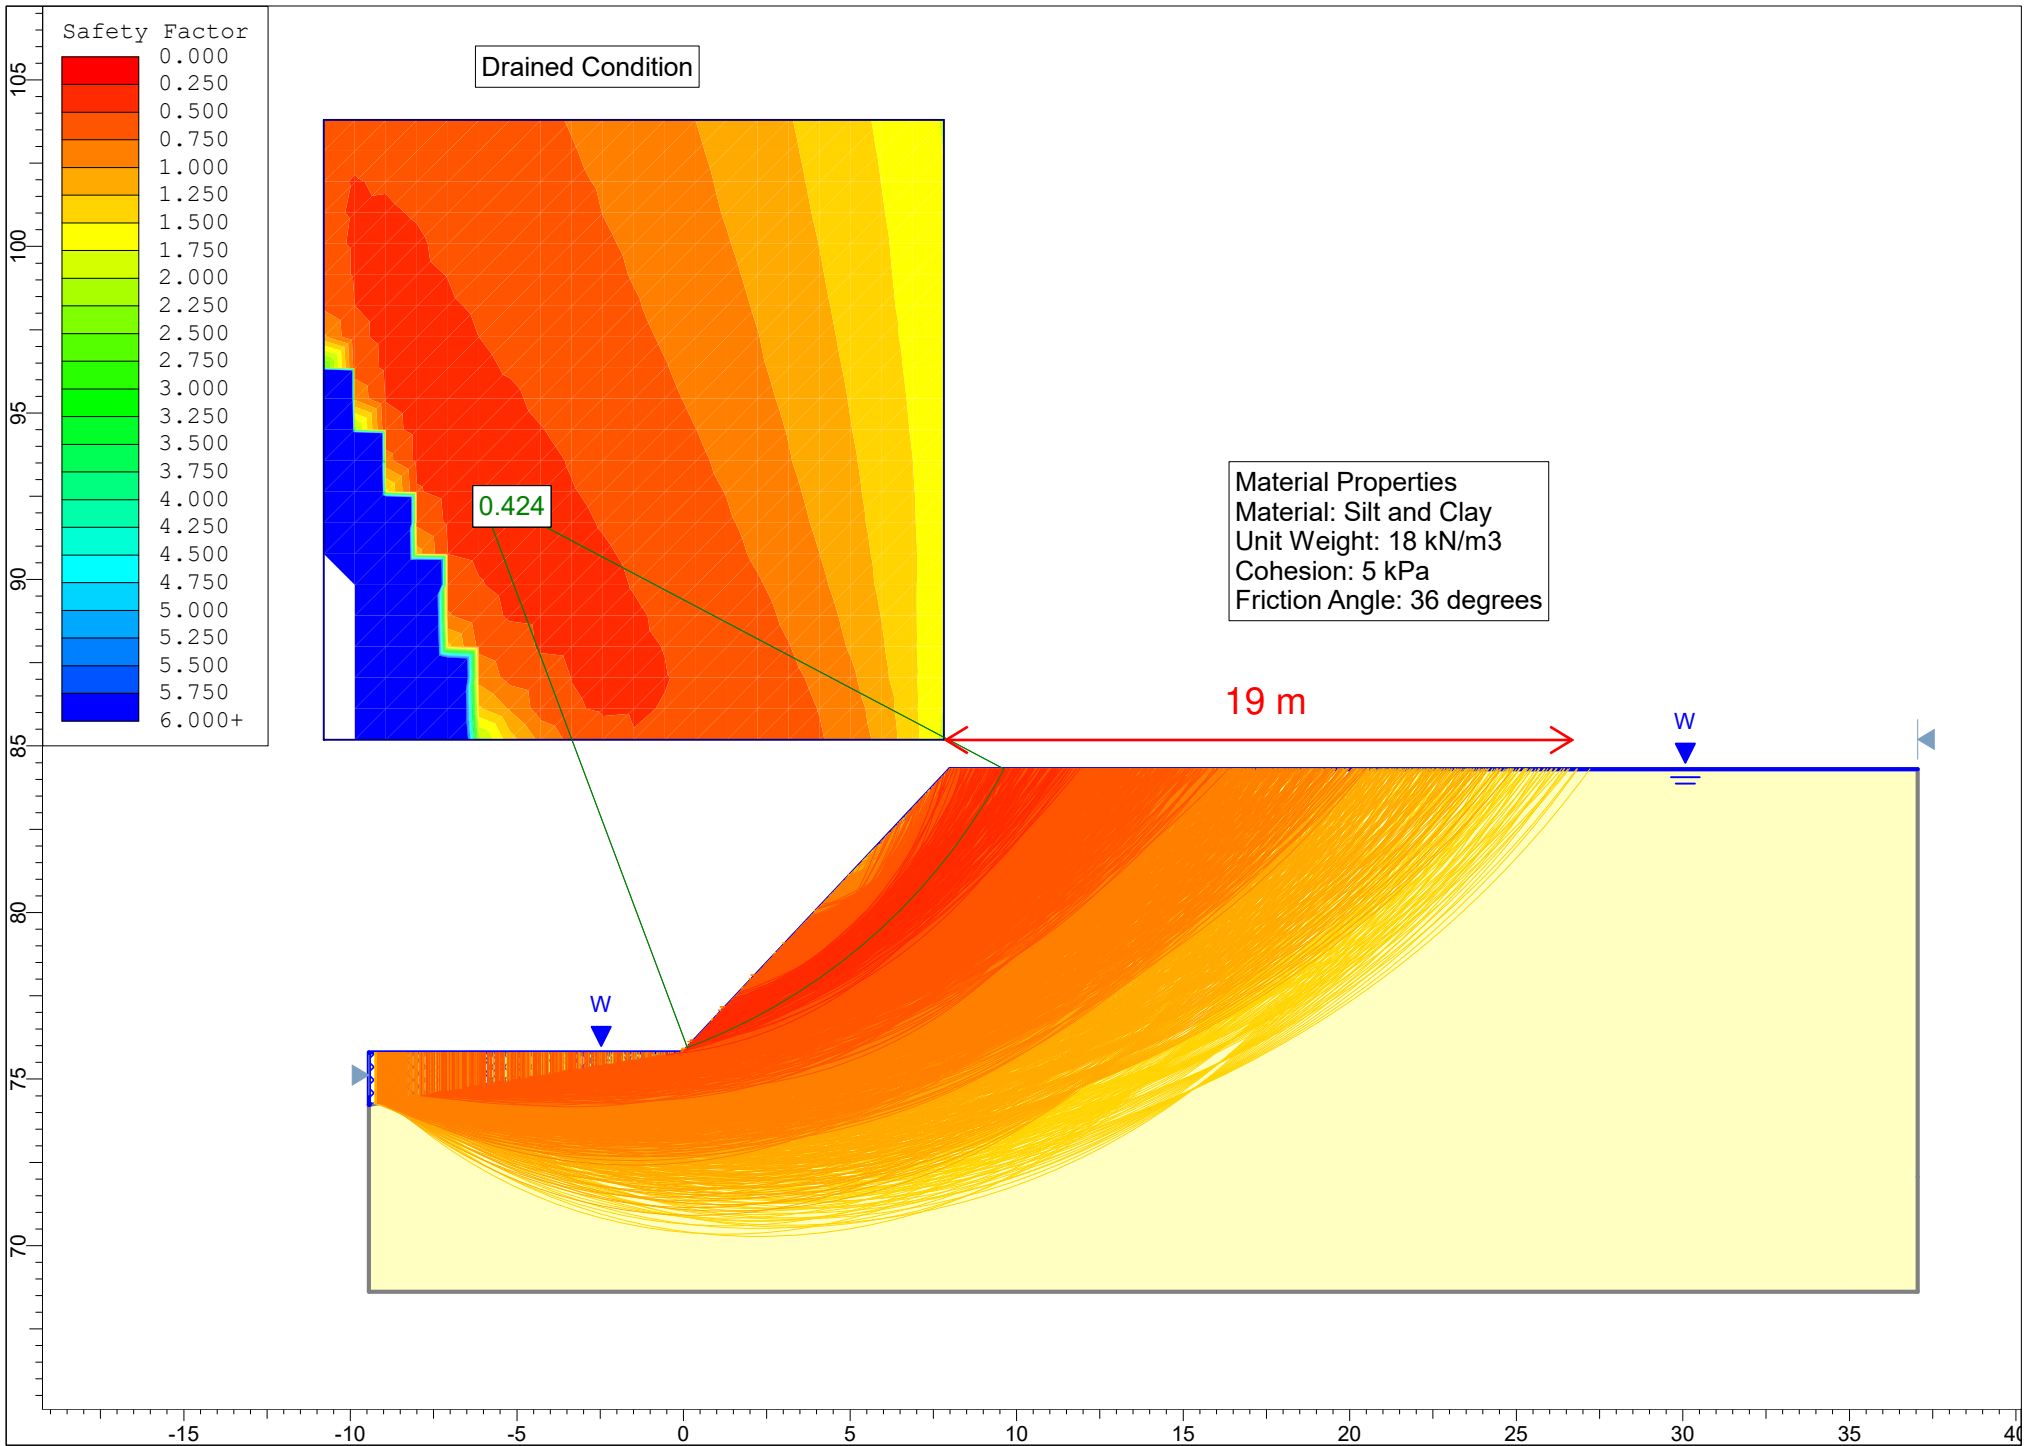
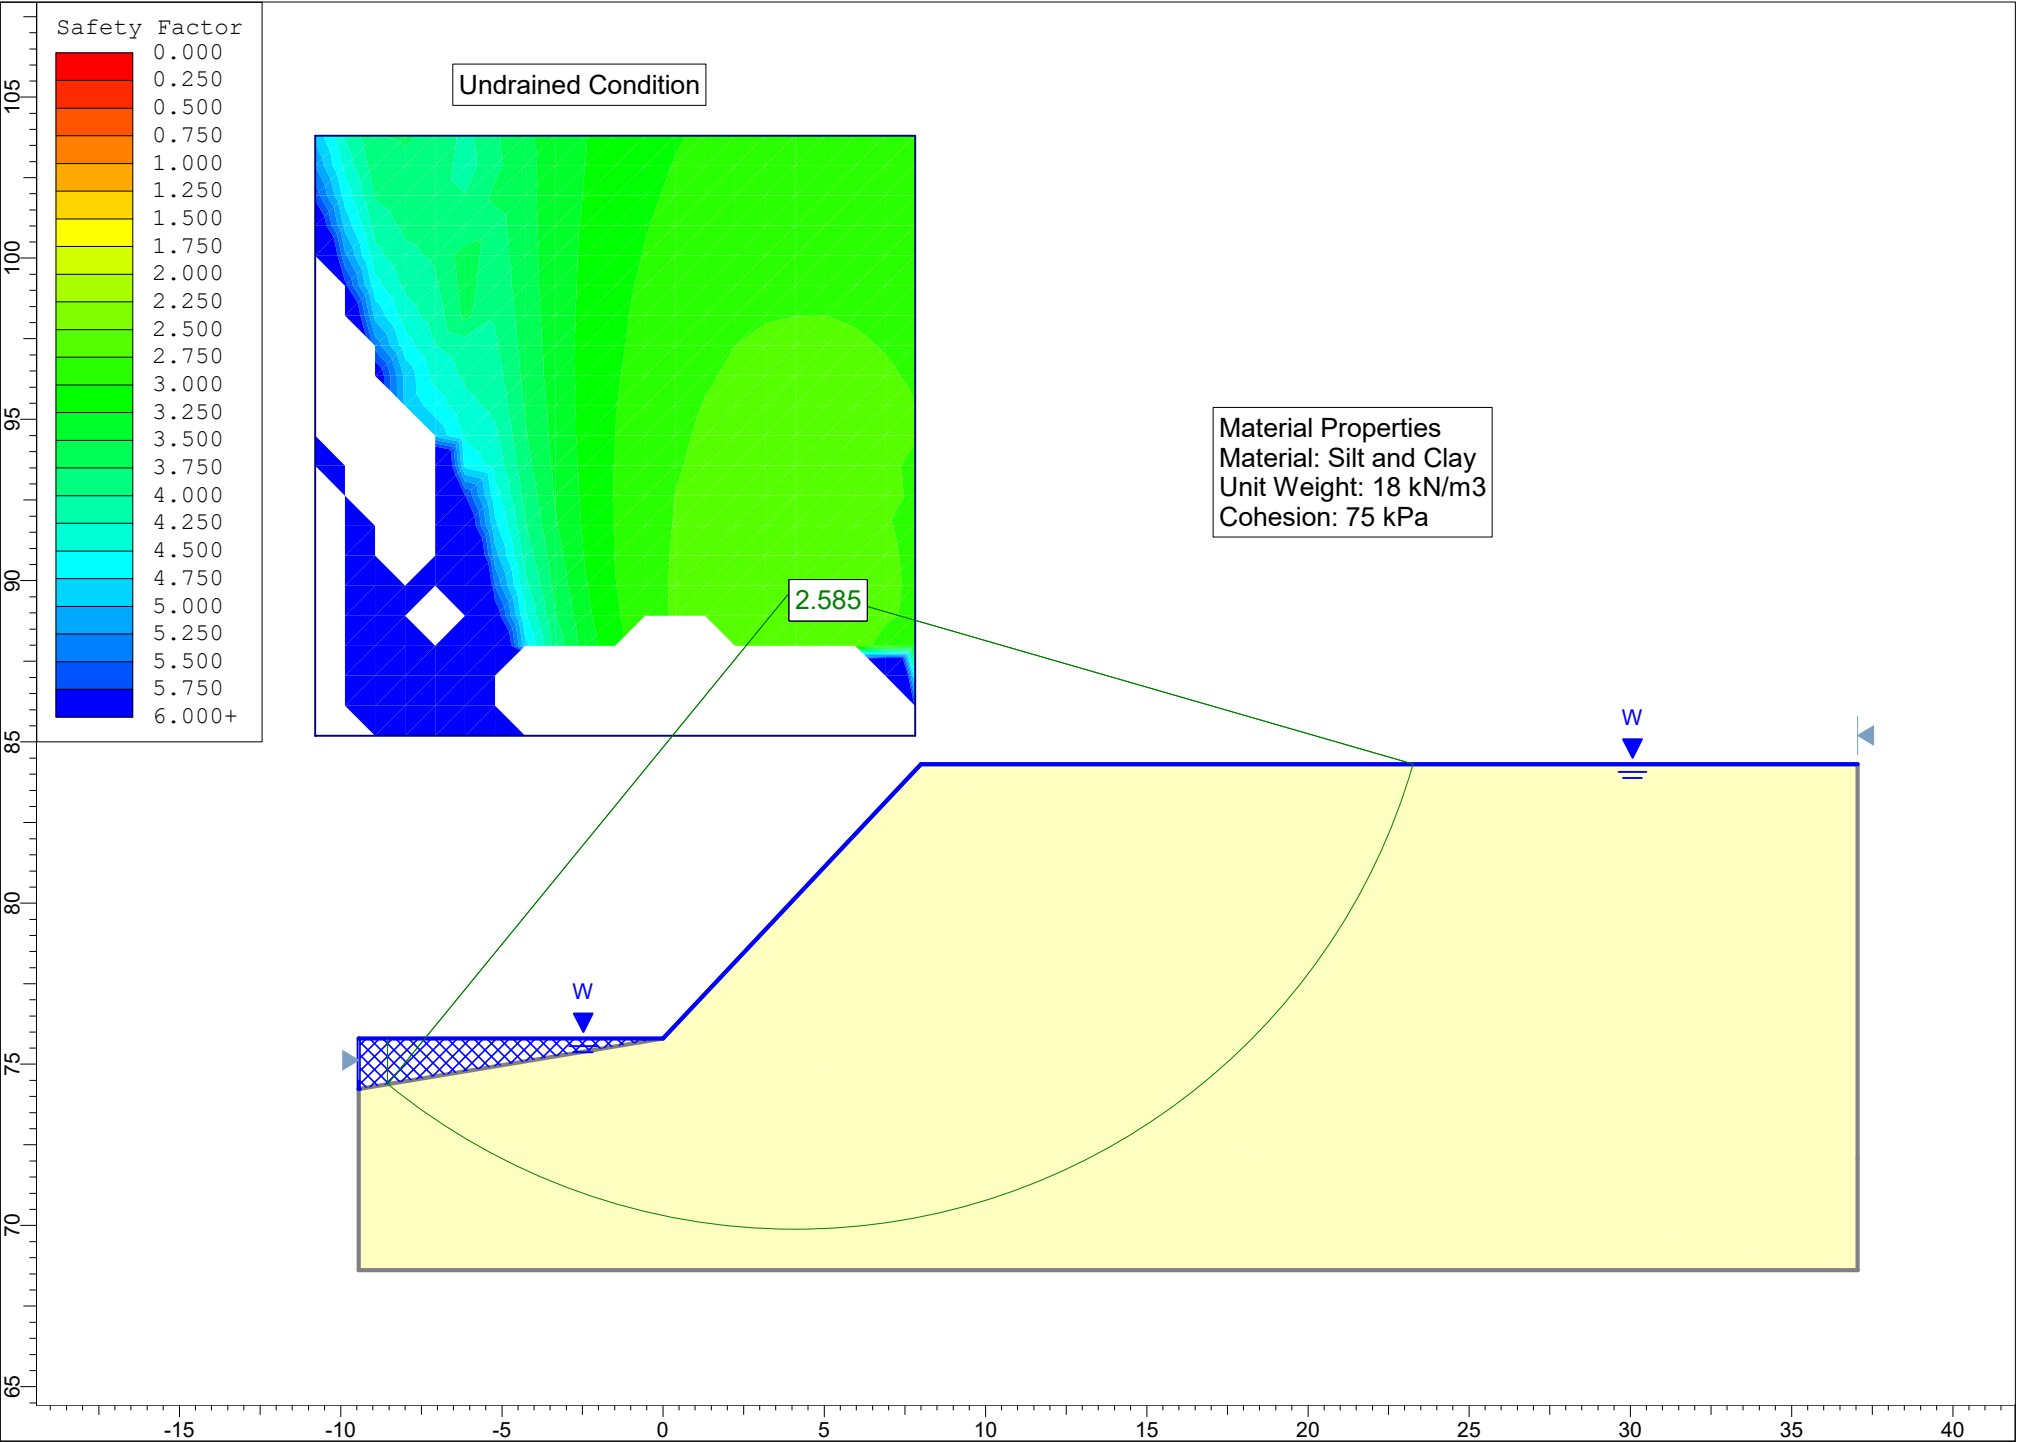
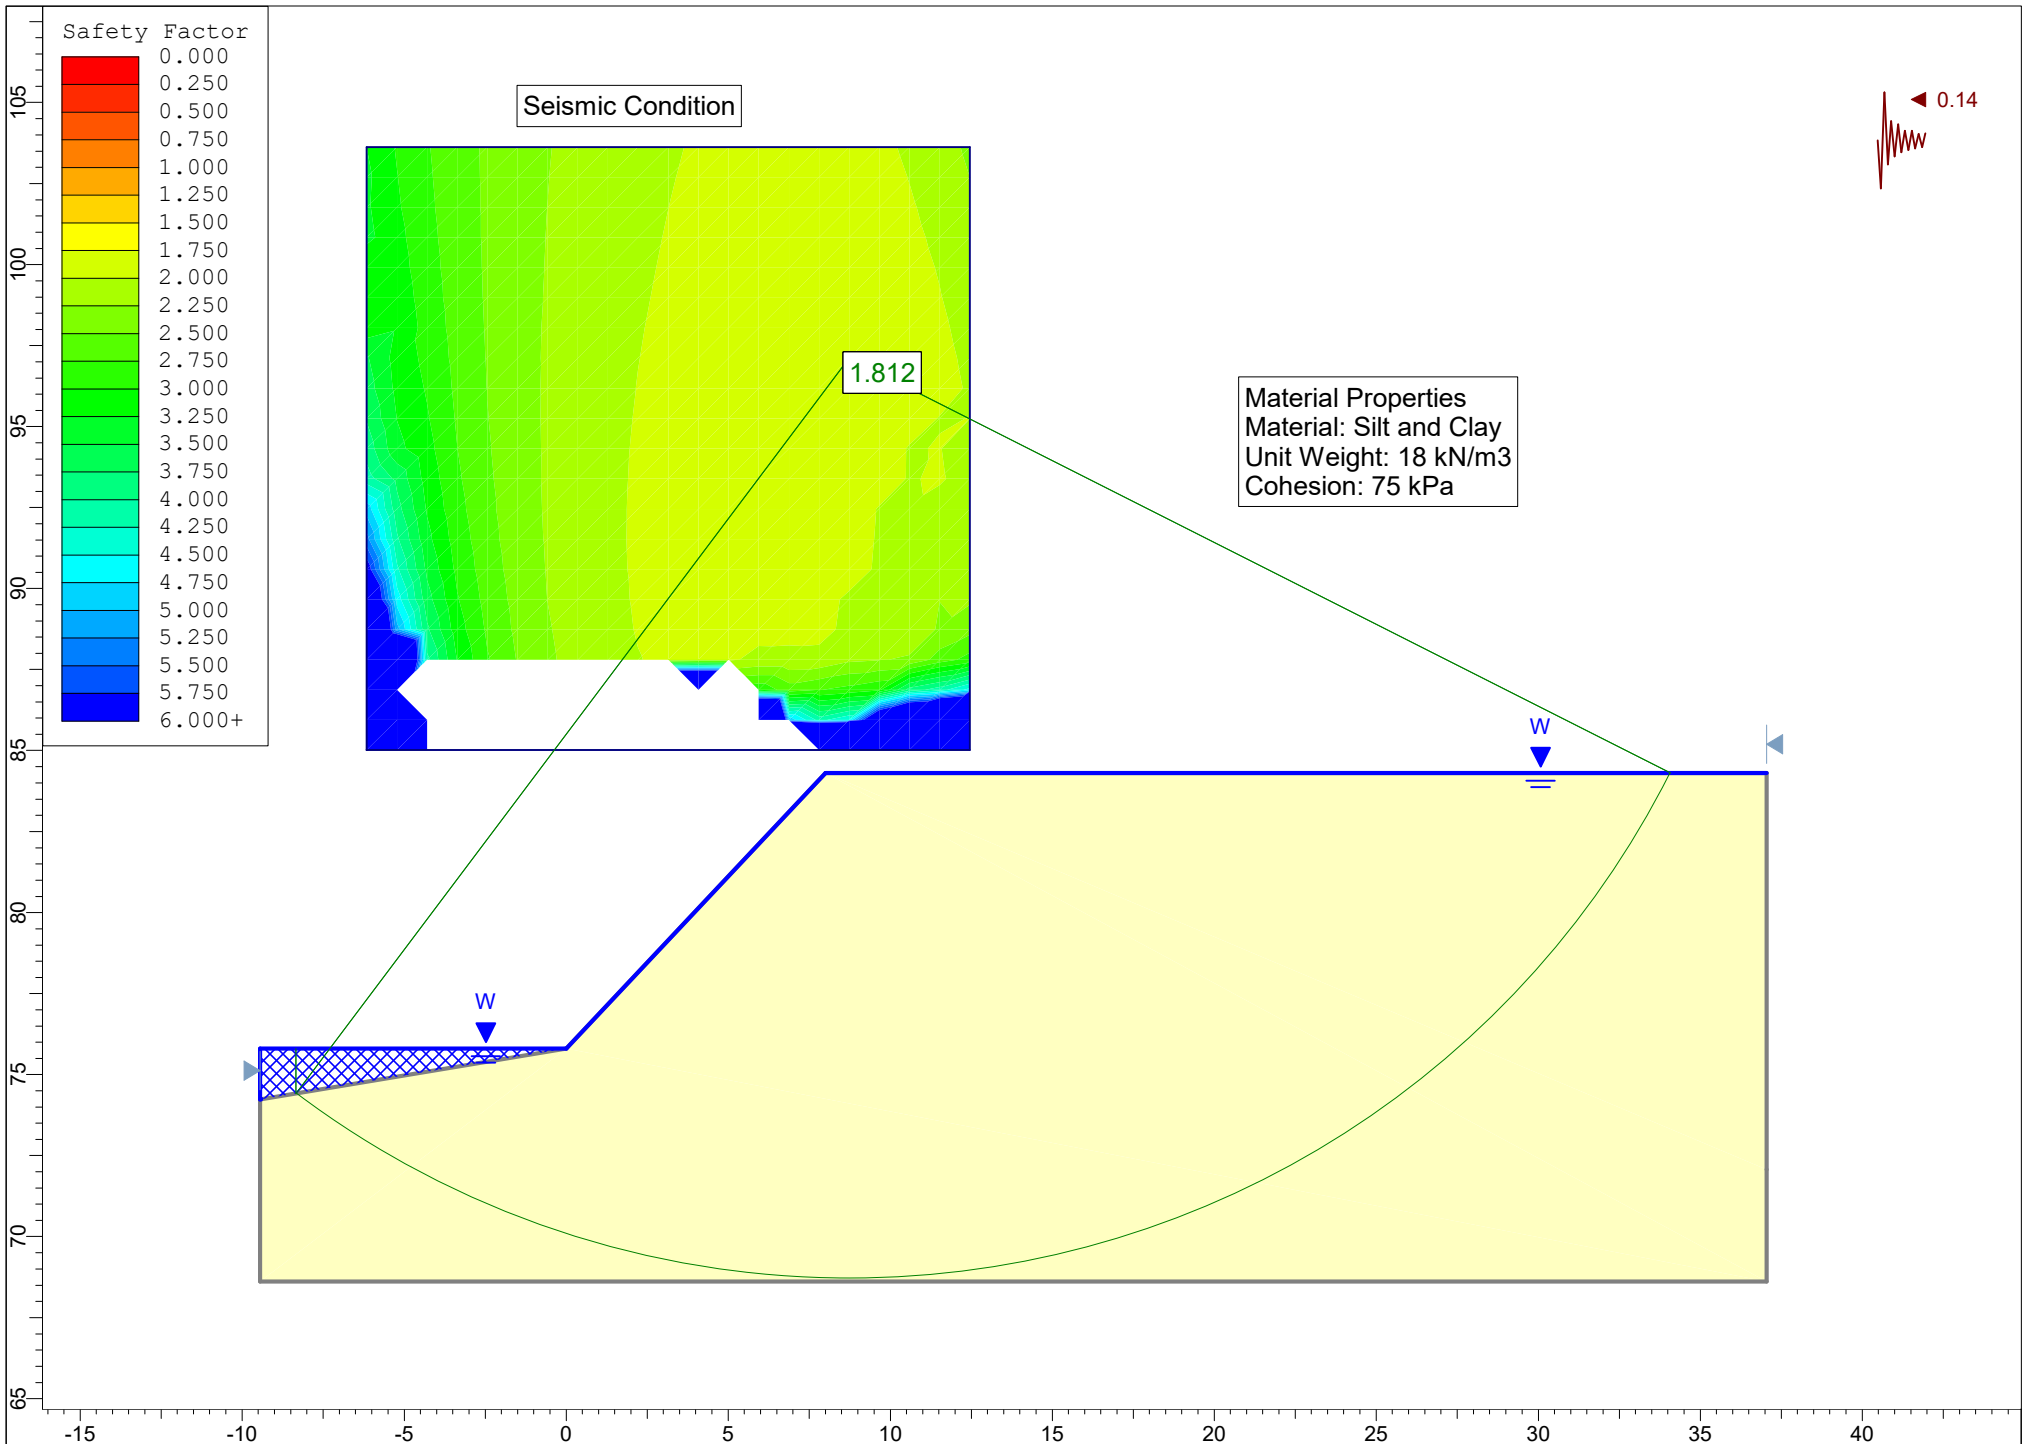
**APPENDIX E**  
**Slope Stability Modeling Results**

The slope modelling program, Slide 5.0 (Rocscience), was used to implement the Bishop simplified method of slices. A slope profile, considered to be the steepest onsite (worst case scenario) was selected and modeled to check the conditions of the slope. The slope was analyzed under both the undrained (short term failure) and drained (long term failure) conditions.

The seismic analysis was performed by incorporating the seismic coefficient ( $k_h$ ) into the modelling. The peak ground acceleration (PGA) for this area is equal to 0.28 for the 2% in 50 year probability of exceedance as per the NBC 2015. The value for  $k_h$  was taken as 50% of the PGA, which equates to 0.14. The minimum factor of safety (FoS) with regards to seismic condition is 1.10.

Drained Condition	Undrained Condition	Seismic
Factor of Safety	0.42	2.59	1.81
<b>Min. Requirement</b>	<b>1.50</b>	<b>1.50</b>	<b>1.10</b>

**These results indicate that the slope is unstable in the rain long-term condition. A setback or a permanent structure from the top of the slope is required to ensure that in the event of a slope failure, the structure will be unharmed. The model was altered to illustrate the failure surface with a Factor of Safety of 1.50.**

A Stable Slope Allowance is the area where a factor of safety is less than 1.50 against overall rotational failure. As indicated in the attached model, a **1.0 m setback** from the top of slope is required.
