## Geotechnical Investigation

Proposed Residential Development  
2009-2013 Prince of Wales Drive  
Ottawa, Ontario  
*Revision 4*

LRL File No.: 220528

December 2022, Revised: January 2026

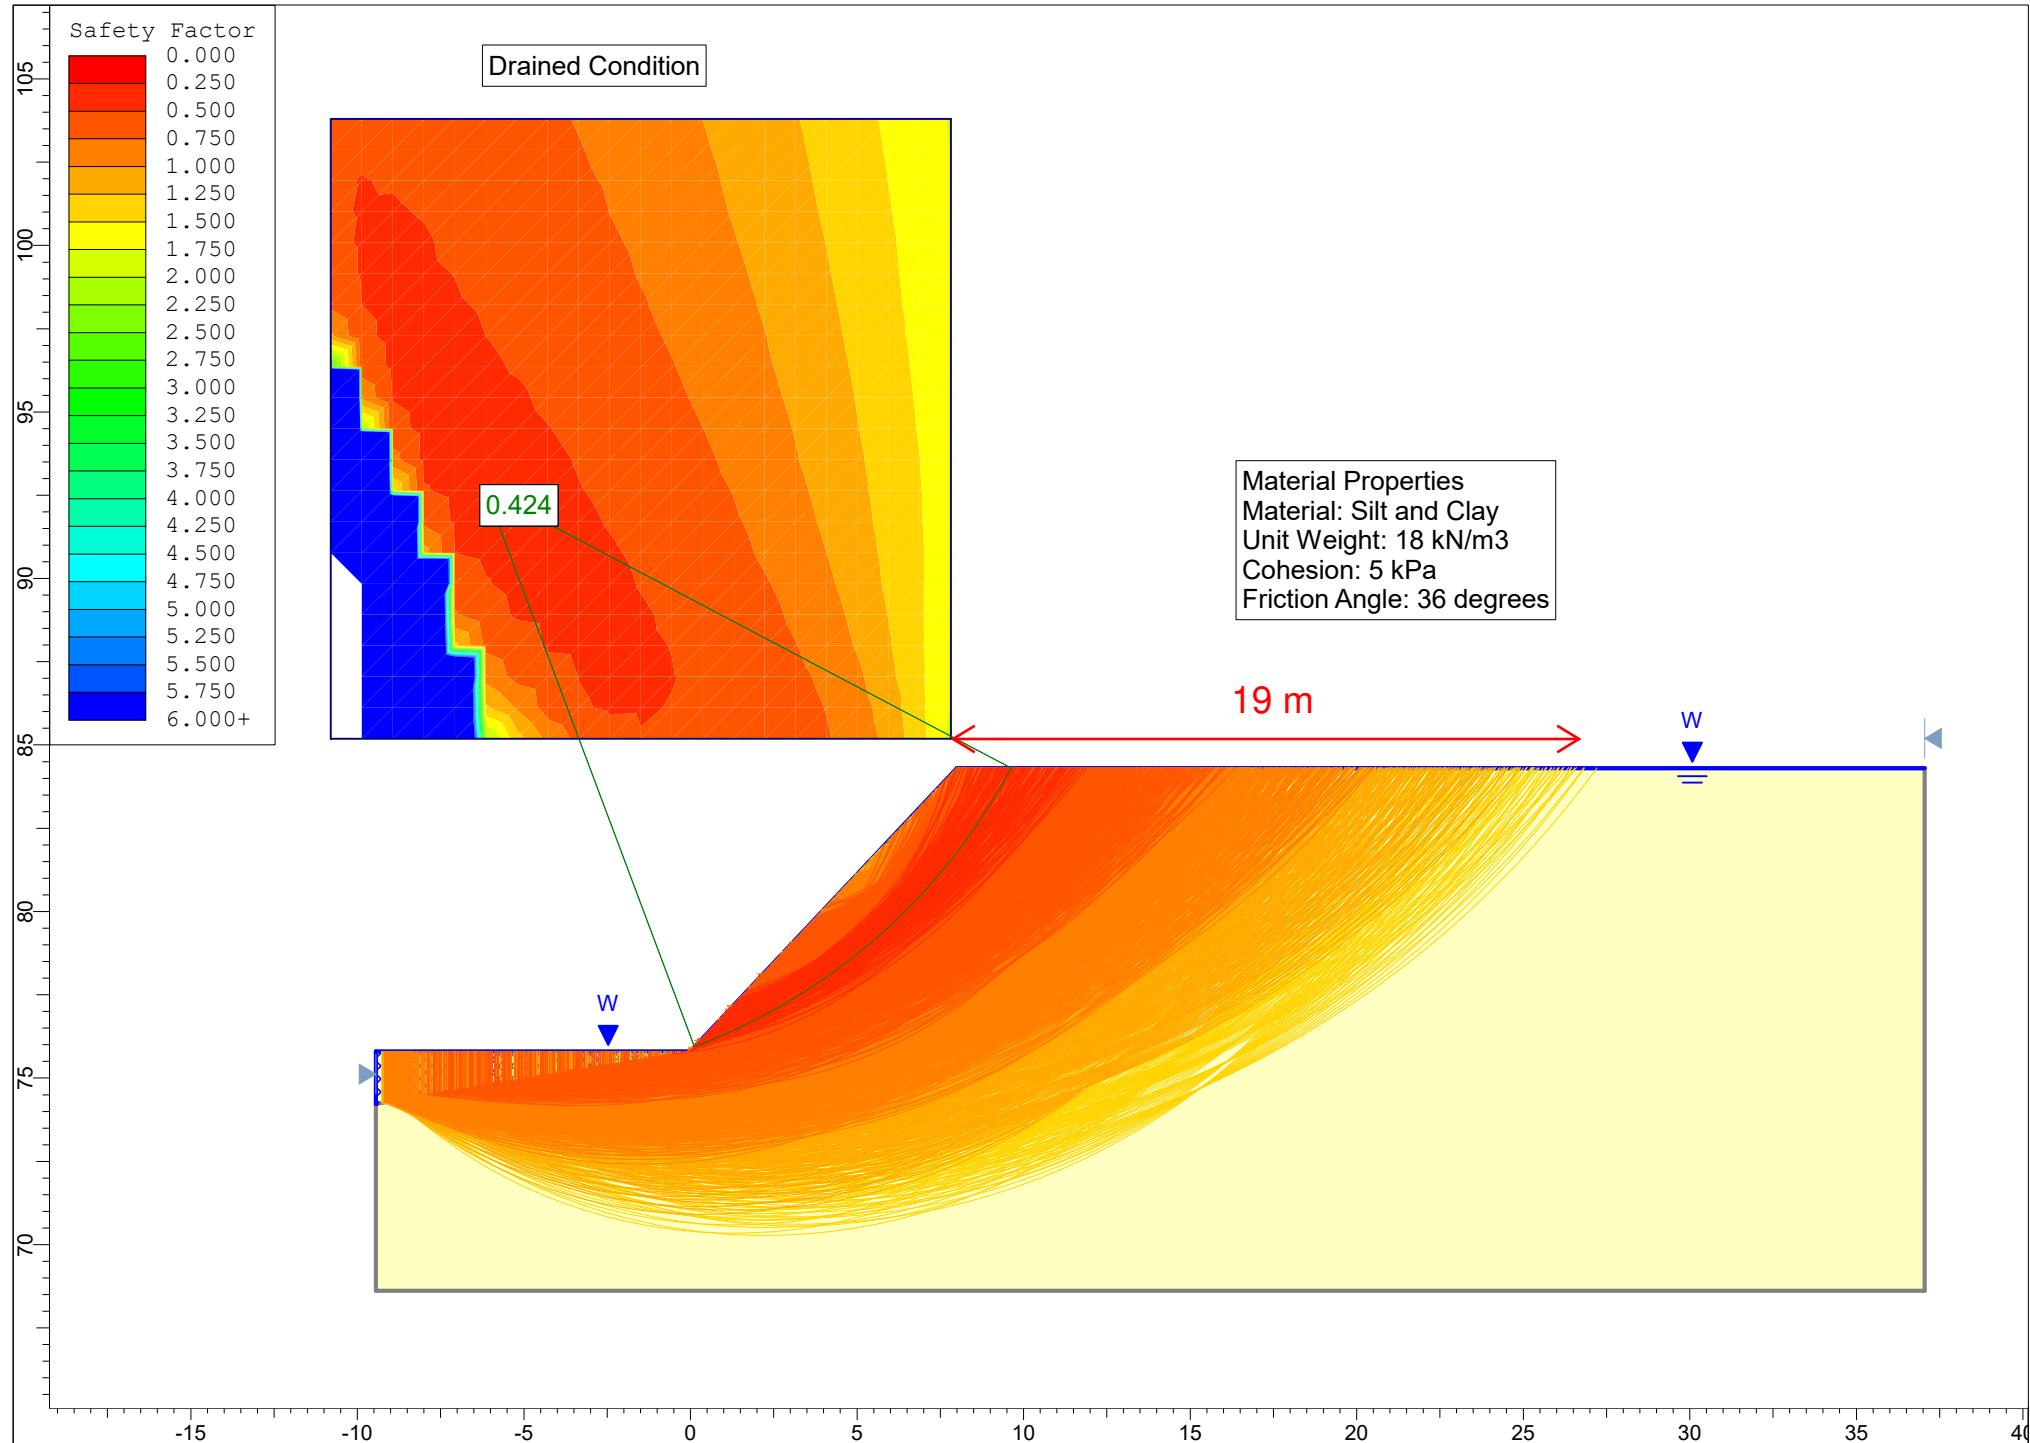
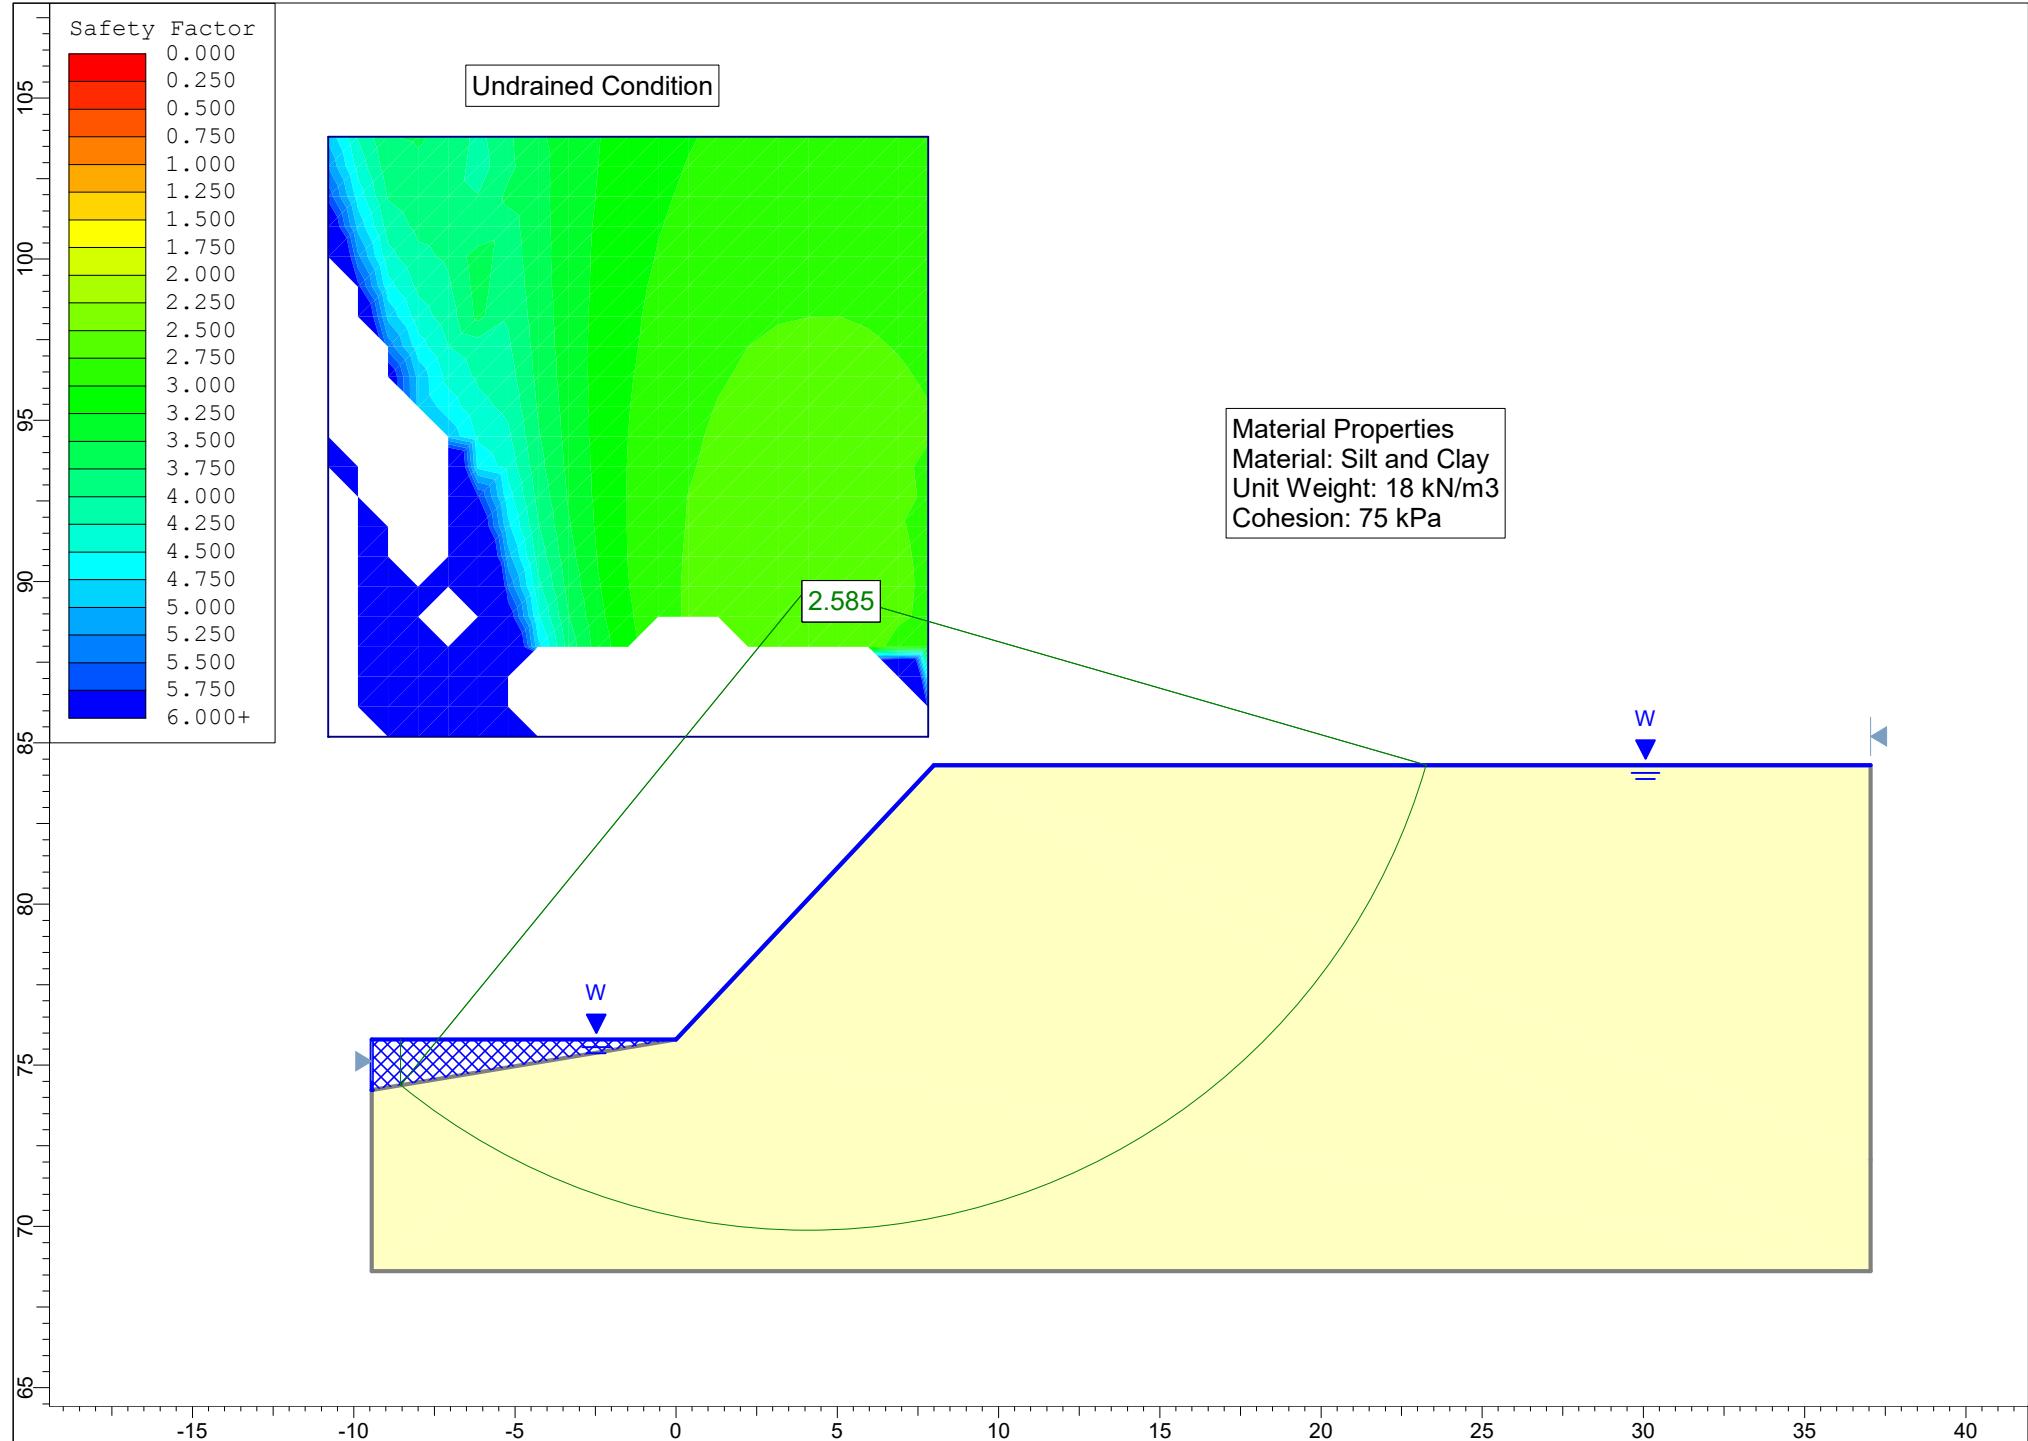
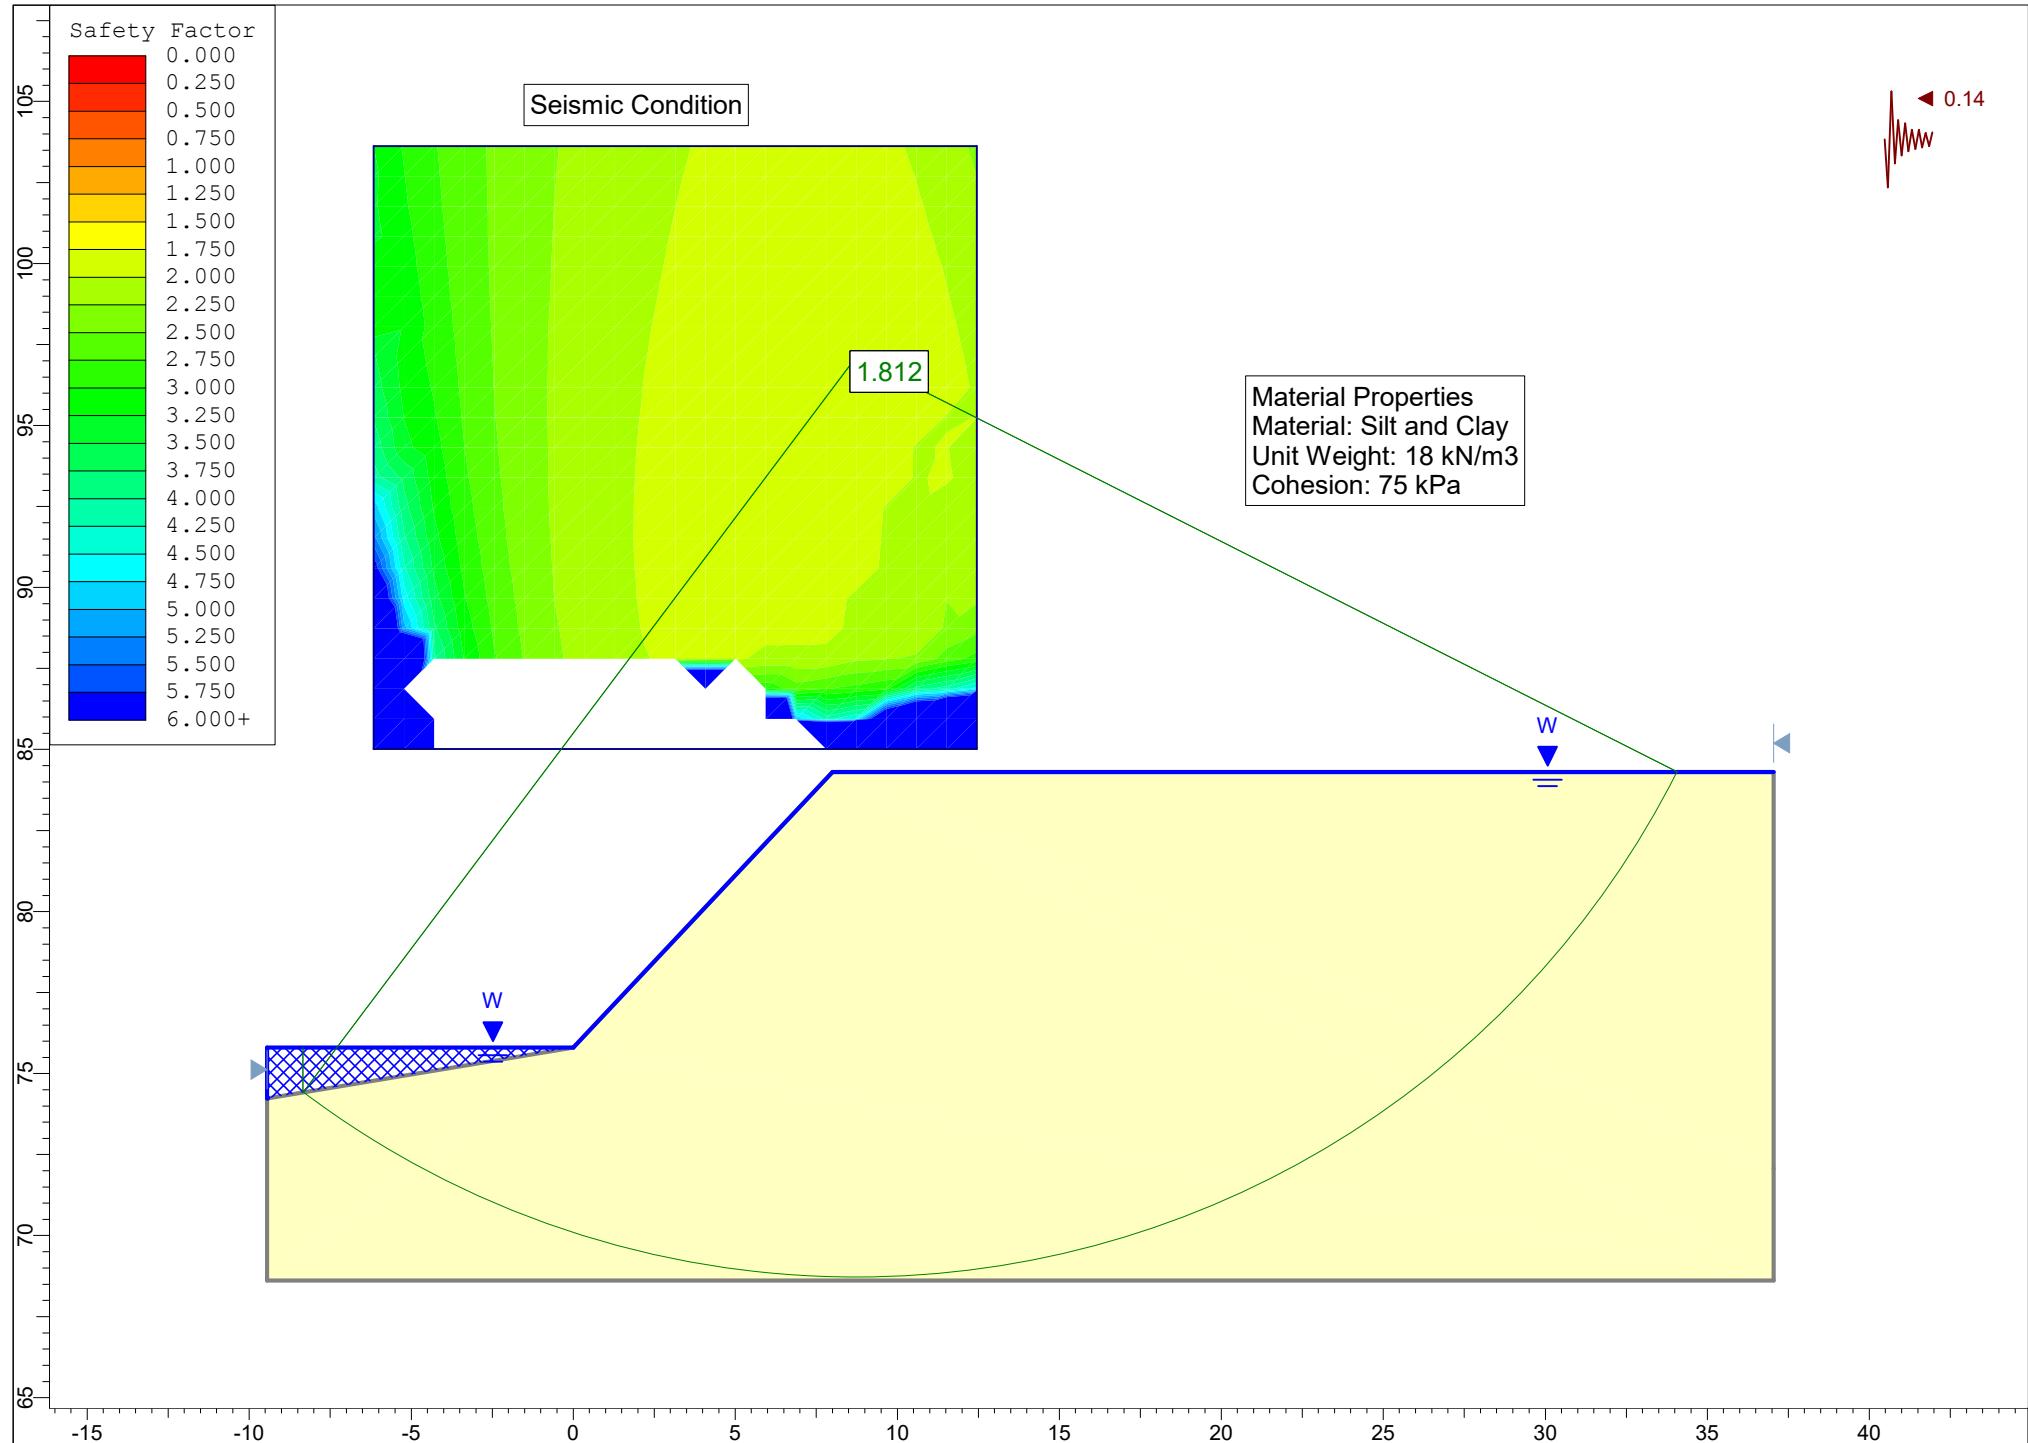
**APPENDIX E**  
**Slope Stability Modelling Results**

The slope modelling program, Slide 5.0 (Rocscience), was used to implement the Bishop simplified method of slices. A slope profile, considered to be the steepest onsite (worst case scenario) was selected and modeled to check the conditions of the slope. The slope was analyzed under both the undrained (short term failure) and drained (long term failure) conditions.

The seismic analysis was performed by incorporating the seismic coefficient ( $k_h$ ) into the modelling. The peak ground acceleration (PGA) for this area is equal to 0.28 for the 2% in 50 year probability of exceedance as per the NBC 2015. The value for  $k_h$  was taken as 50% of the PGA, which equates to 0.14. The minimum factor of safety (FoS) with regards to seismic condition is 1.10.

Drained Condition	Undrained Condition	Seismic
Factor of Safety	0.42	2.59	1.81
Min. Required	<b>1.50</b>	<b>1.50</b>	<b>1.10</b>

These results indicate that the slope is unstable in the drained (long-term) condition. A setback for any permanent structure(s) (dwellings, decks, sheds, gazebos, pools, etc.) from the top of the slope is required to ensure that in the event of a slope failure, the structure(s) will be unharmed. The model was filtered to illustrate the failure surface with a FOS below 1.50.

The Stable Slope Allowance is the area where a factor of safety is less than 1.50 against overall rotational failure. As indicated in the attached model, **a 19.0 m setback is required for Stable Slope Allowance**.
