# Phase Two Environmental Site Assessment

*30 Cleary Avenue, Ottawa Ontario*

CA0008376.9447-Rev0

November 2023

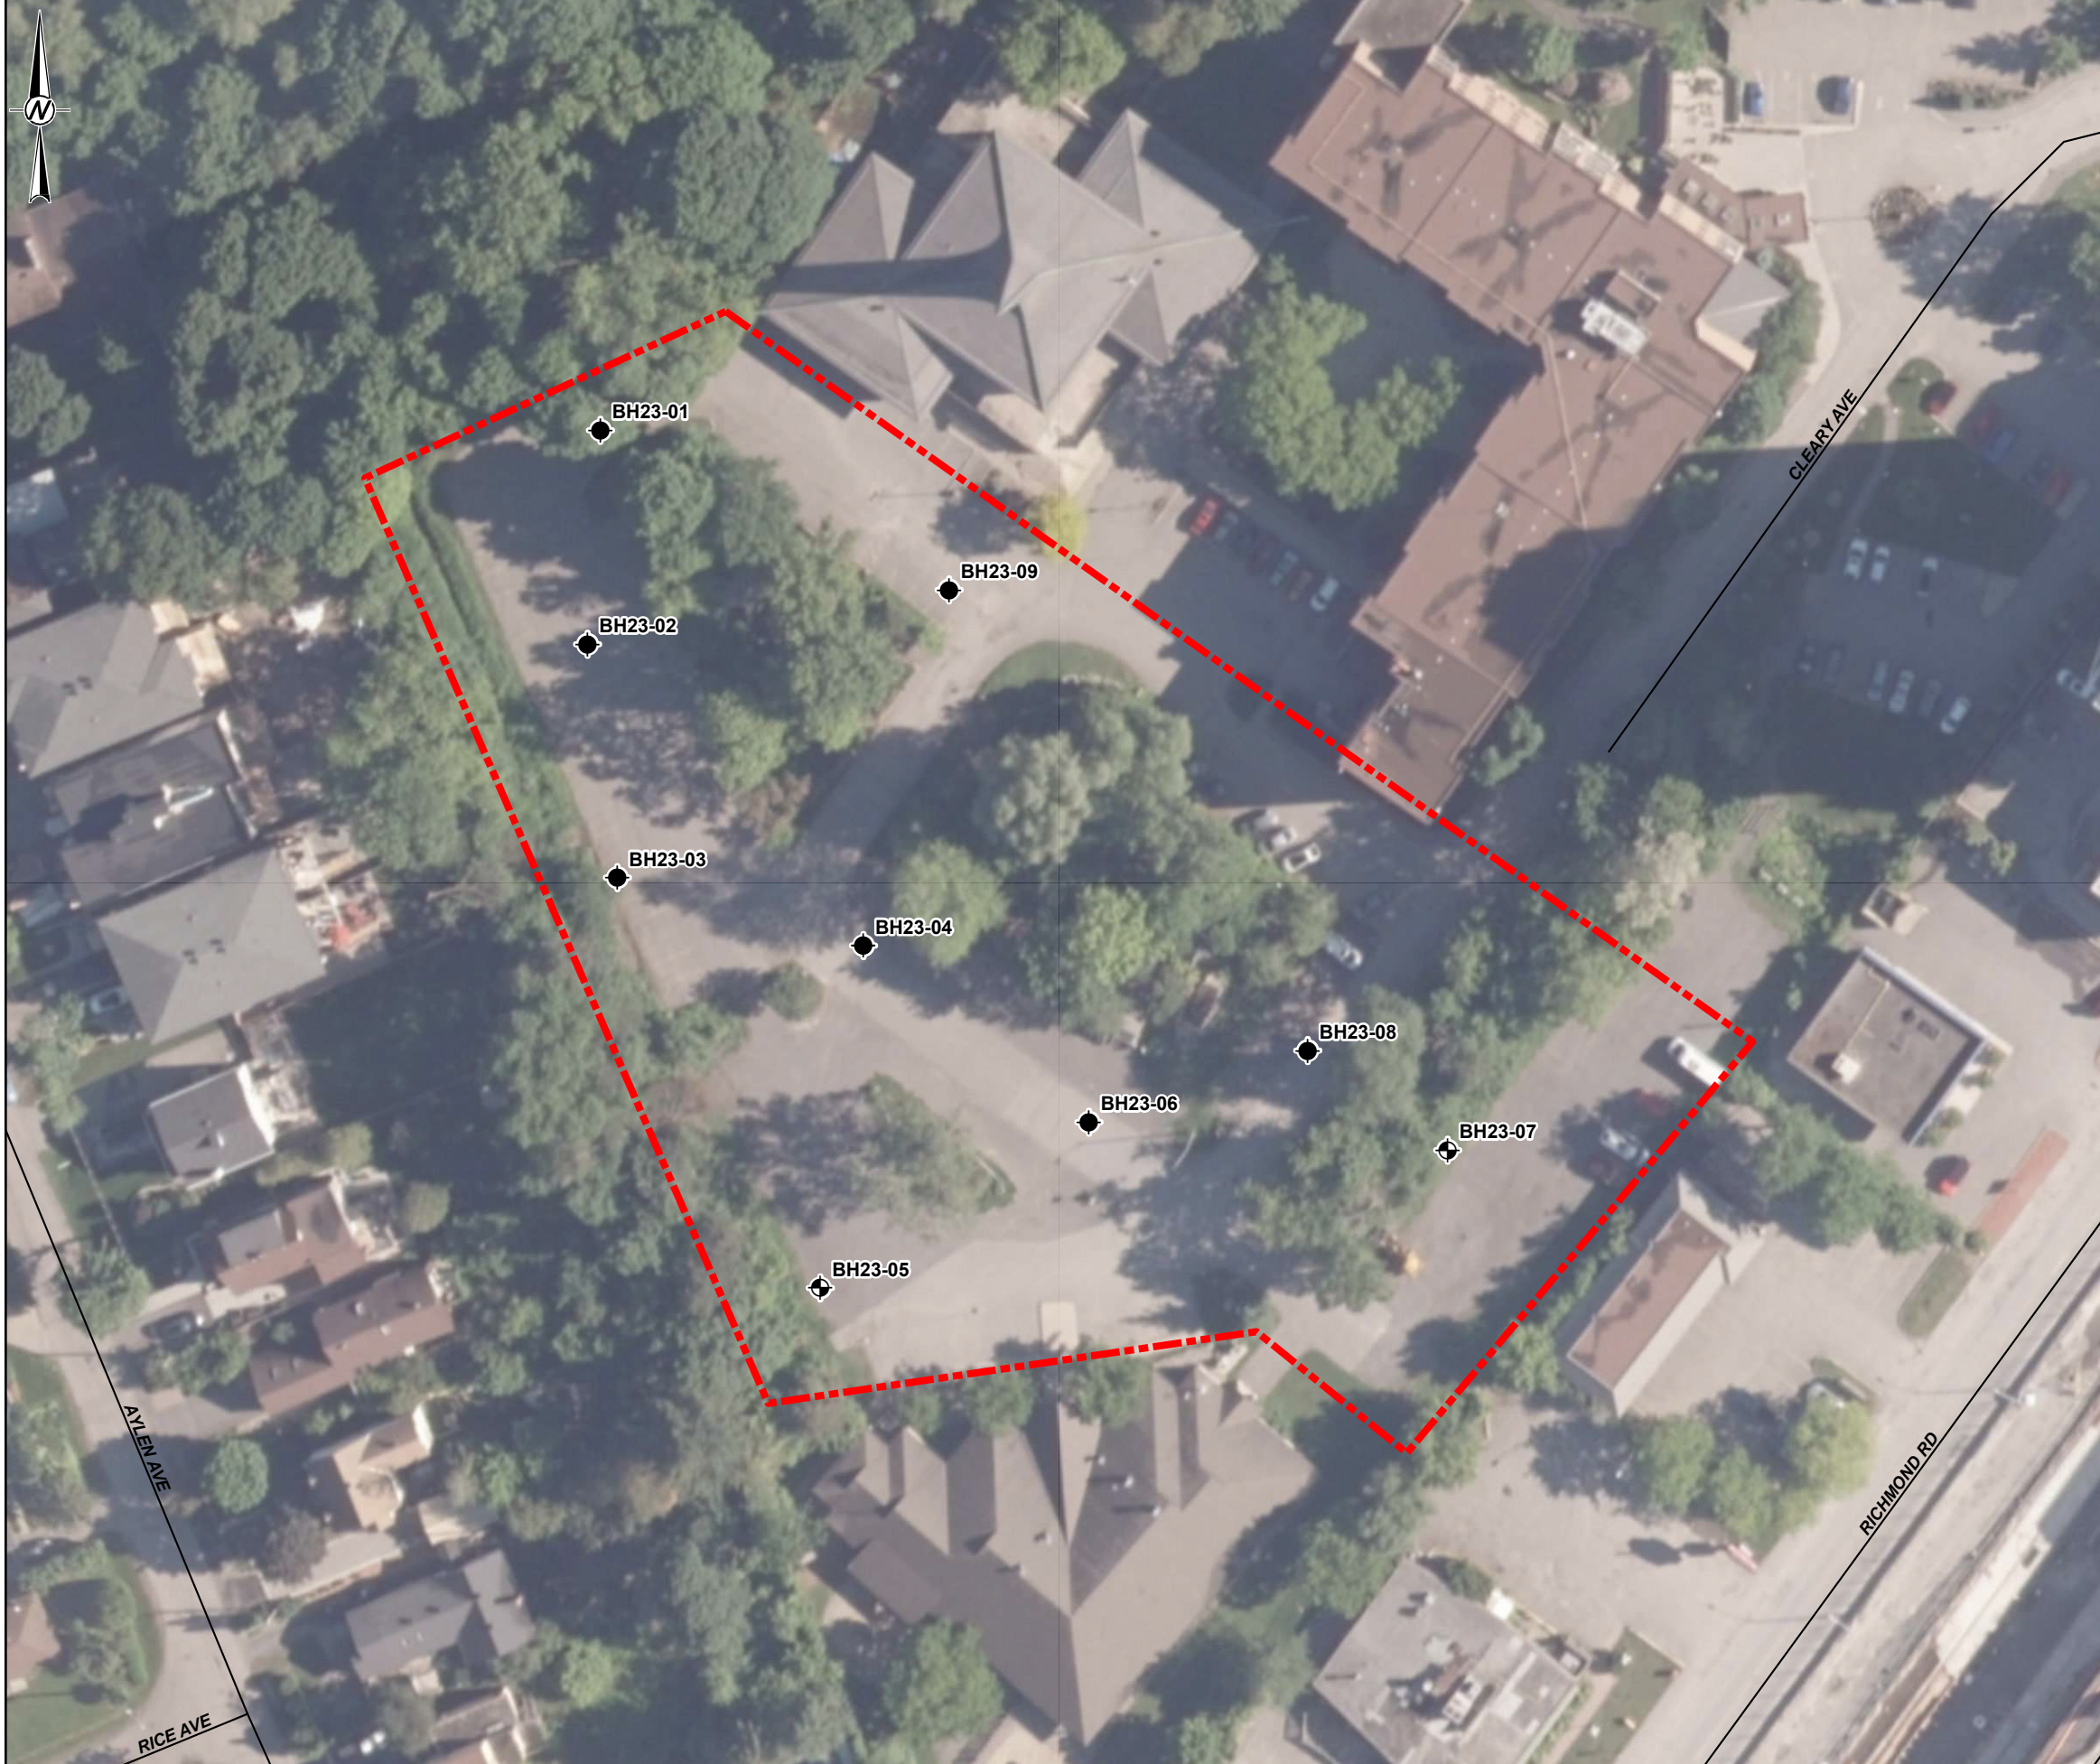
- BOREHOLE LOCATION
- BOREHOLE/MONITORING WELL LOCATION
- ROADWAY
- PHASE TWO SITE
