# **Preliminary Geotechnical Investigation Report, Rev. 1**

**Future Commercial Development  
2095 Dilworth Road  
Kars, ON**

**January 6, 2024  
Englobe Ref No: 02101208.000**

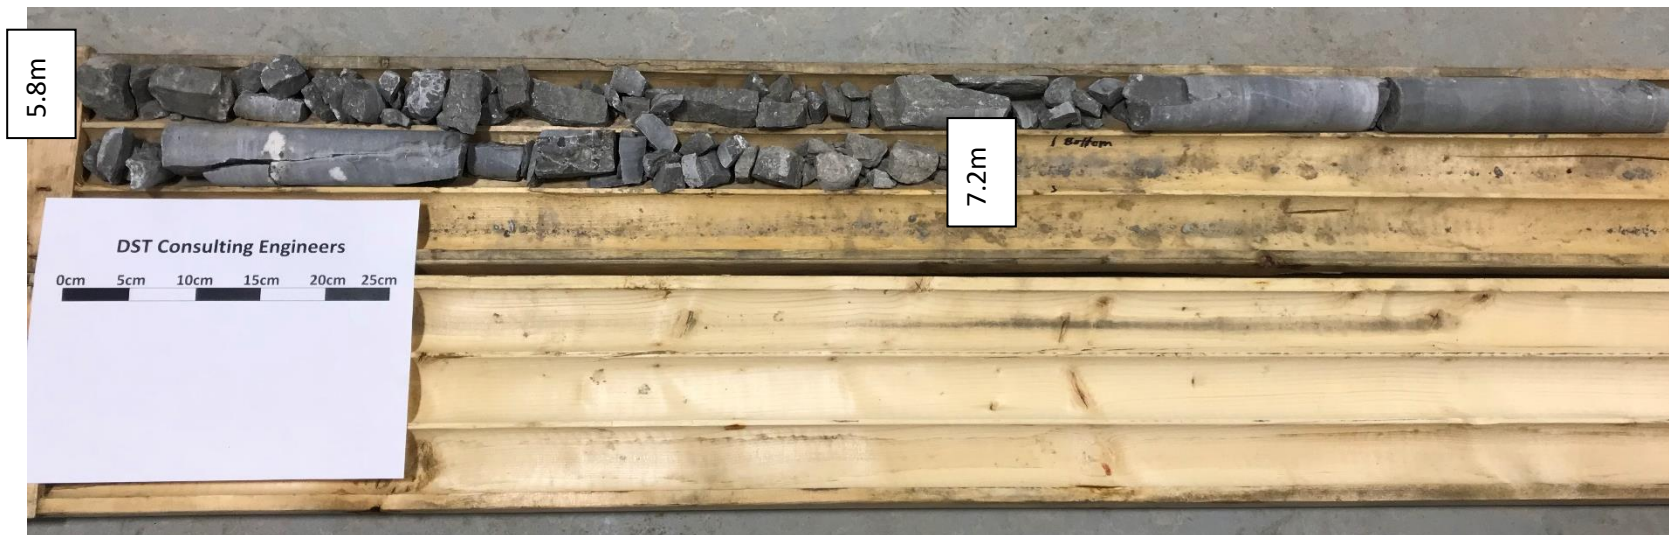
Rock Core Photo No.: 1

Rockcore Photograph  
2095 Dilworth Road, Kars, ON

Borehole: BH 21-05
