Phase One Environmental Site Assessment

1412 Stittsville Main Street
Ottawa, Ontario

Prepared for:

Elite Living Developments
10 Brad's Court
Stittsville (Ottawa), Ontario
K2S 1V2

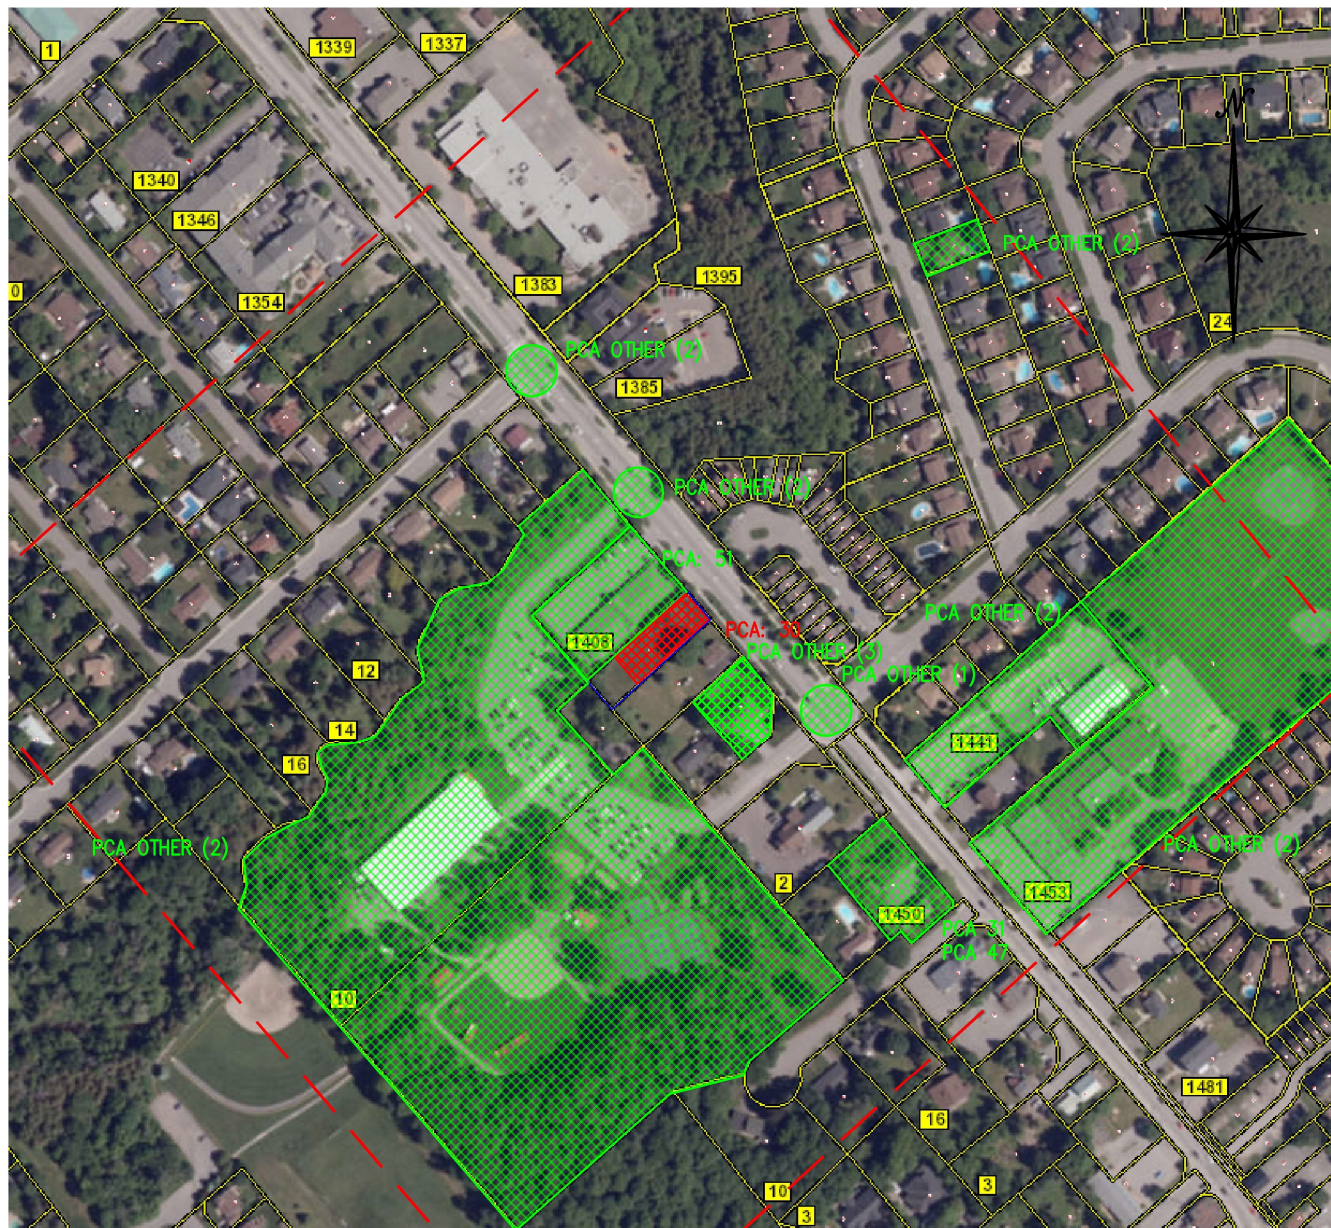
FIGURE 3

Based on the results of the Phase One Environmental Site Assessment, the following areas of potential environmental concern were identified and are presented in **Figure 3**:

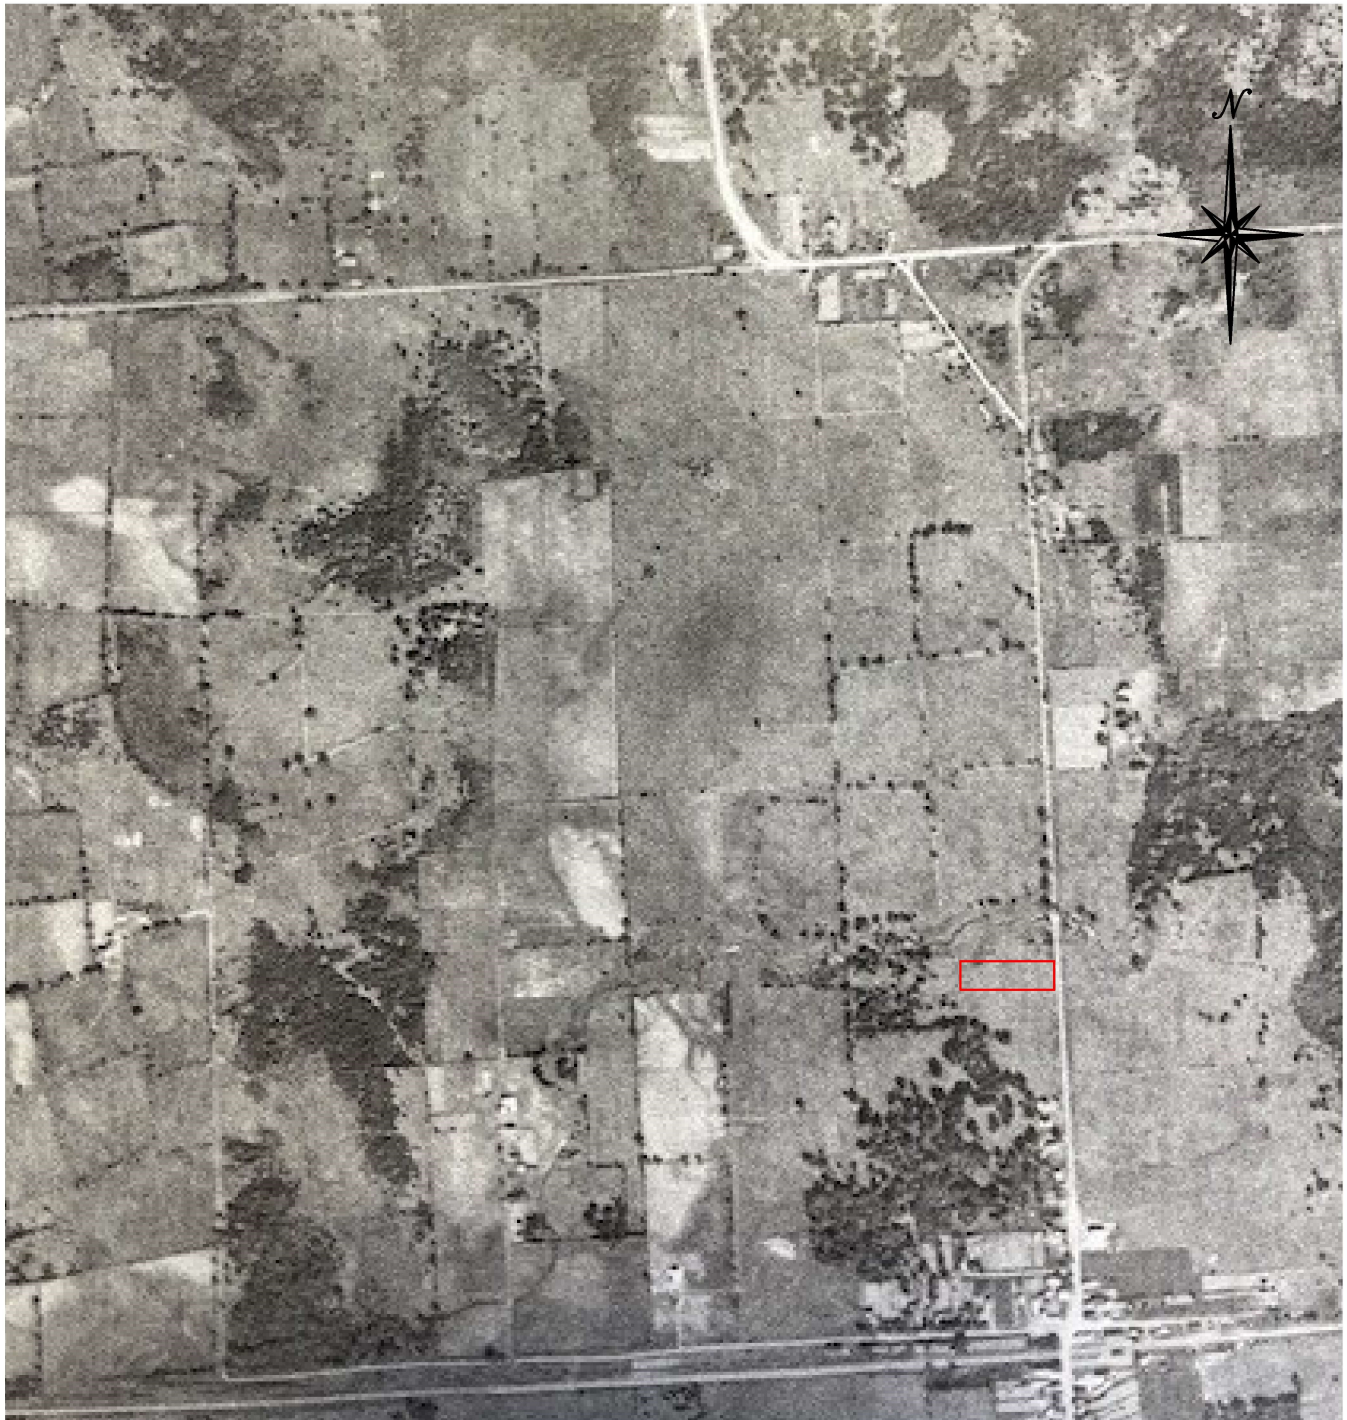
AP1

Year	Phase One Property (Site)	Phase One Study Area (Surrounding Area)
1932 (AP1)	The aerial photograph number is A4432-35. The Site appears to be agricultural land.	Stittsville Main Street is present to the east of the Site. The surrounding lands to the north, south, east and west appear to include agricultural lands, with areas of tree cover. Development is observed further south of the Site along Stittsville Main Street.
1945 (AP2)	The aerial photograph number is A9610-112. The Site appears to be developed. Although the scale of the image makes it difficult for detailed observations, there does appear to be two (2) small structures, and an access road from Stittsville Main Street, at the eastern portion of the Site. The remainder of the Site appears to be agricultural land.	The properties to the north, east, south and west appear to include agricultural land, with areas of tree cover. The adjacent property to the south of the Site is developed.

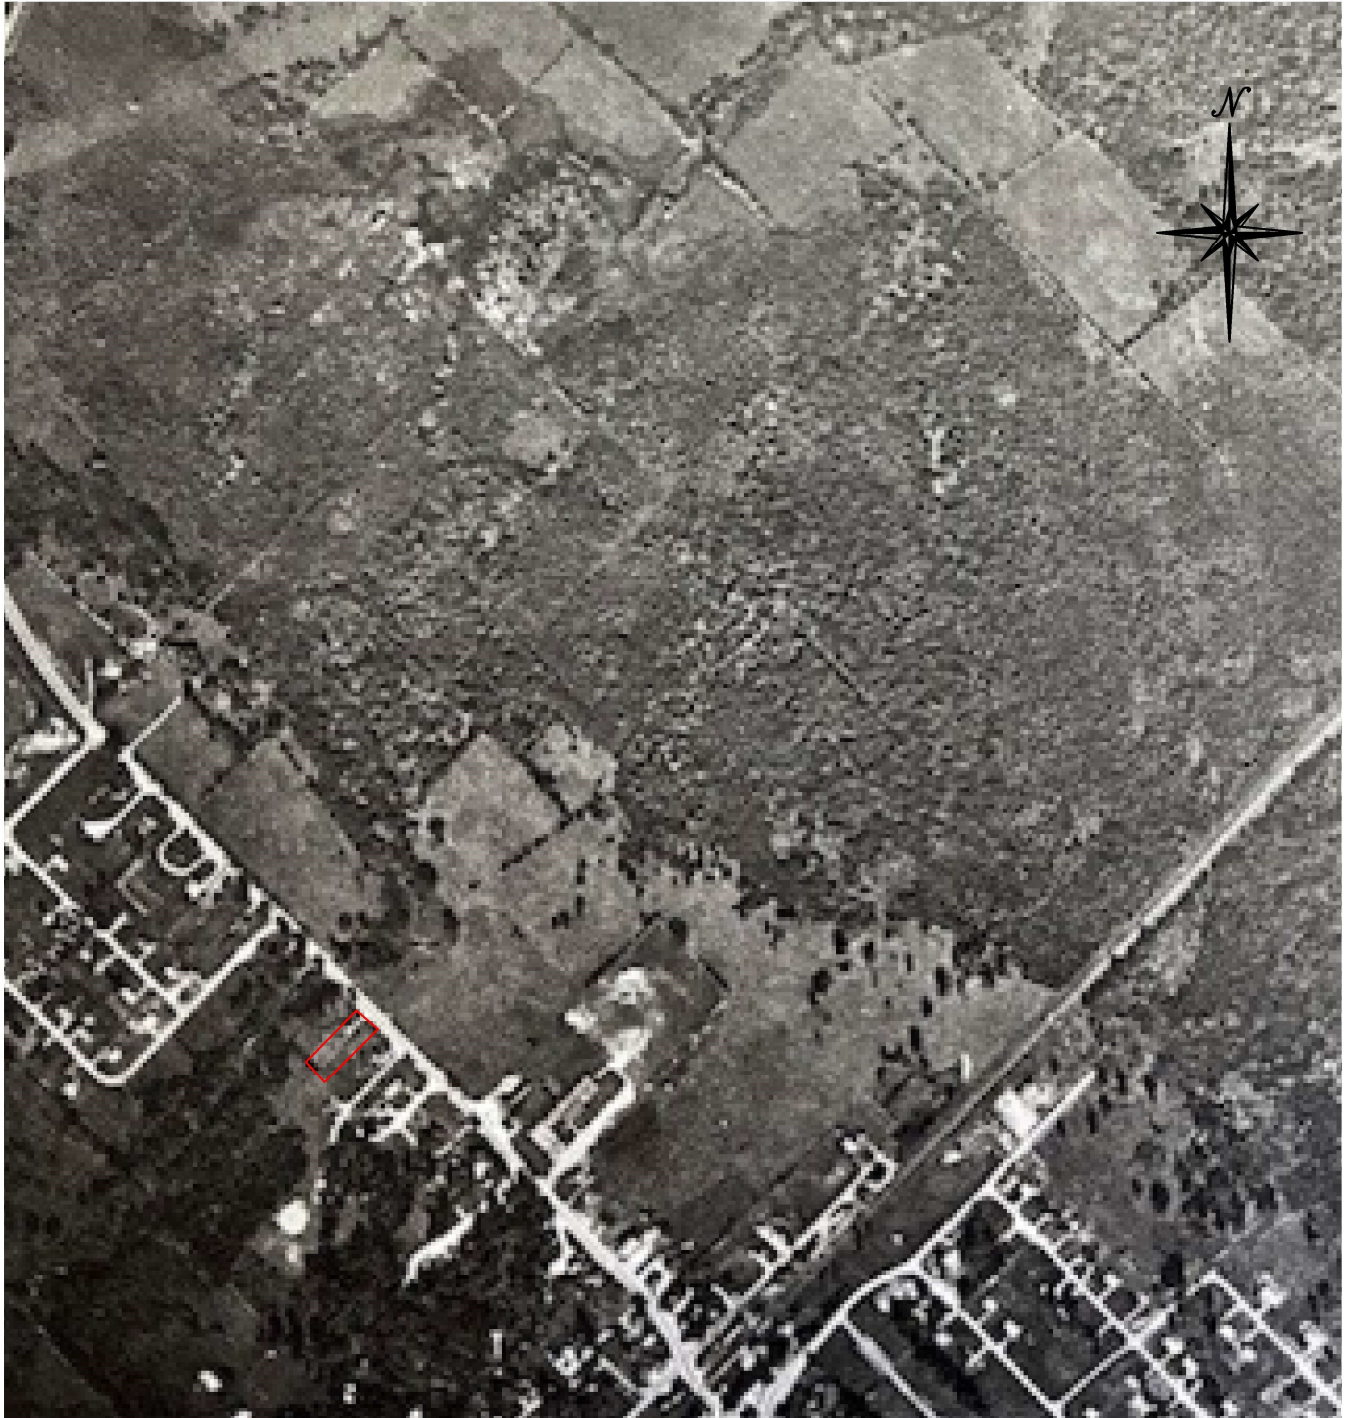
AP3

1963 (AP3)	The aerial photograph number is A18155-74. The previous development on the Site appears to have been replaced with a larger structure which is visible across the majority of the Site and extending on to the adjacent property to the north. There appears to be an access lane from Stittsville Main Street, extending west towards the structure.	The adjacent property to the north is forested followed by a residential development. The property to the west appears vacant, and possible occupied with agricultural fields. West of the Site is forested, and a baseball diamond is visible to the southwest. South and southeast of the Site is developed with residential, and the current school structure is visible.
1976 (AP4)	The Site appeared undeveloped. The previously identified structure is no longer visible.	Warner Colpitts Lane is present to the north of the Site. Other than additional development in the general area, no significant changes were observed in the general area of the Site.

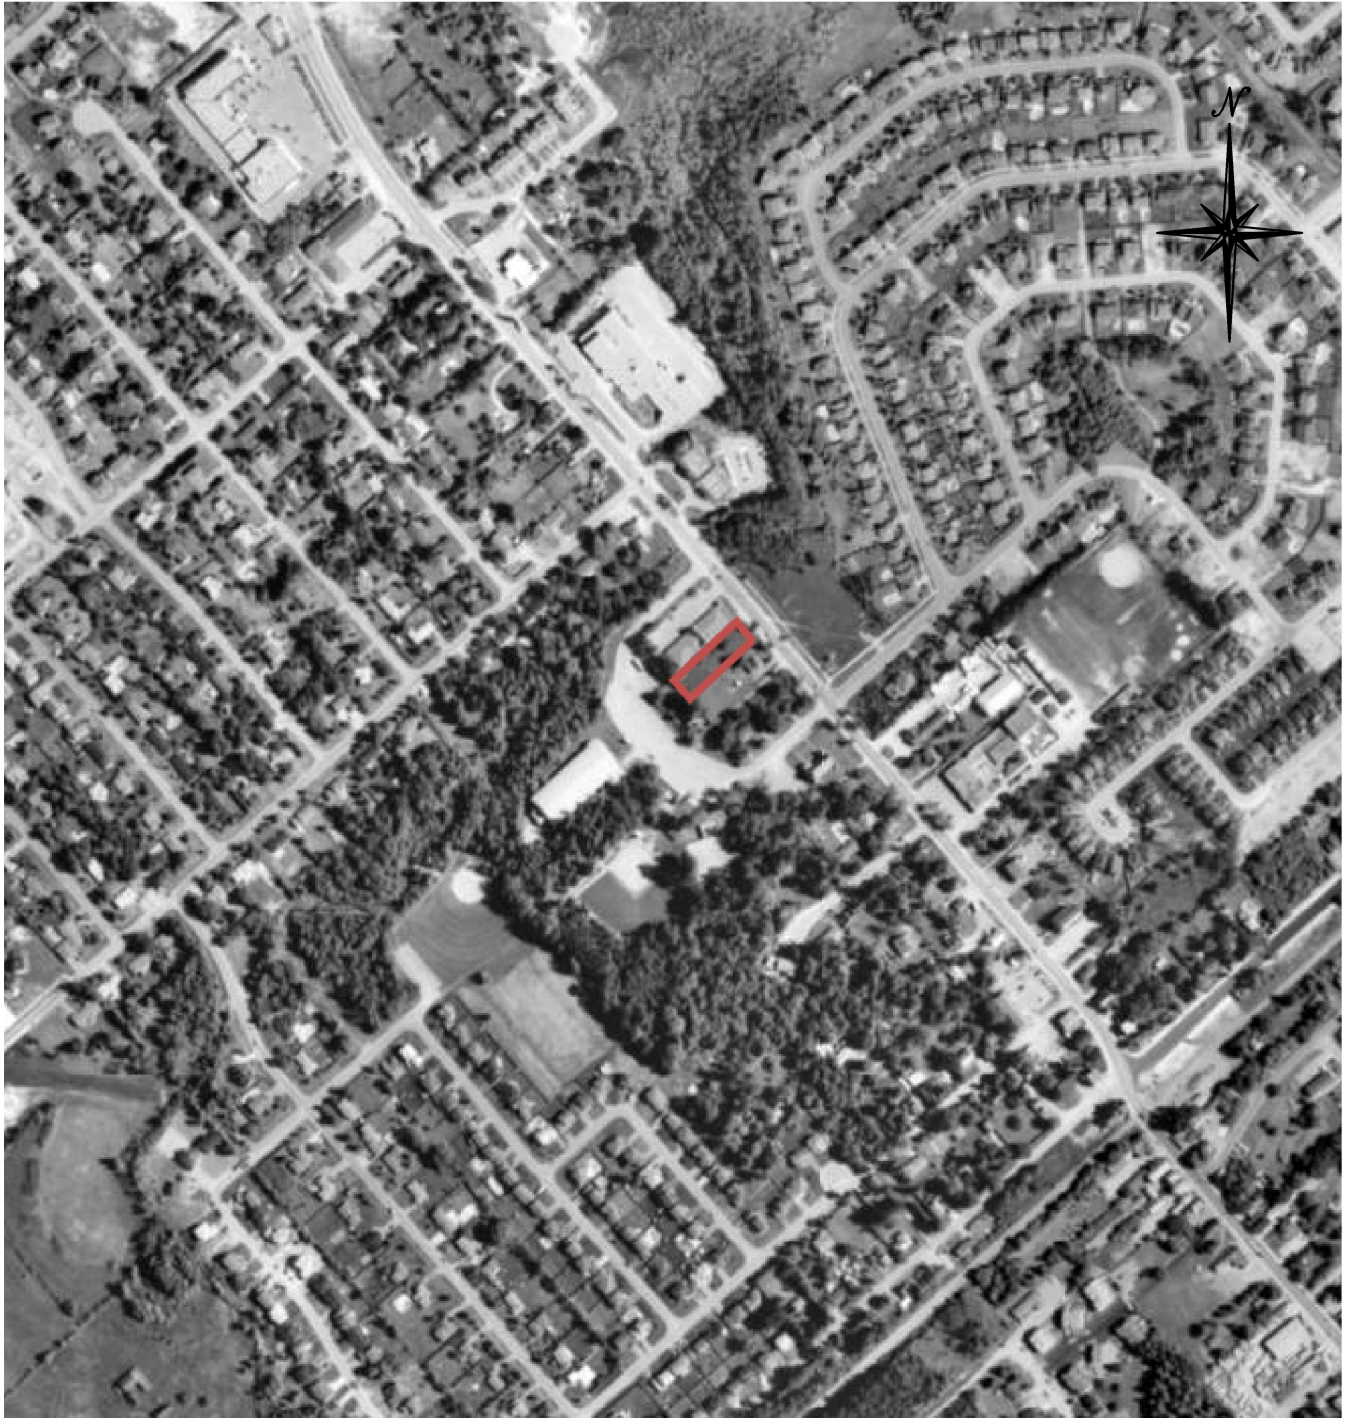
AP5

1999 (AP5)	The Site appeared similar to 1976.	No significant changes were observed to the Phase One study area with the exception of additional residential developments in the general area of the Site.
2002 (AP6)	The Site appeared similar to 1999.	No significant changes were observed to the Phase One study area from the observations made in 1999.
2011 (AP7)	The Site appeared similar to 2002.	No significant changes were observed to the Phase One study area from the observation made in 2002.
2022 (AP8)	The Site appeared similar to 2011.	No significant changes were observed to the Phase One study area from the observation made in 2011.

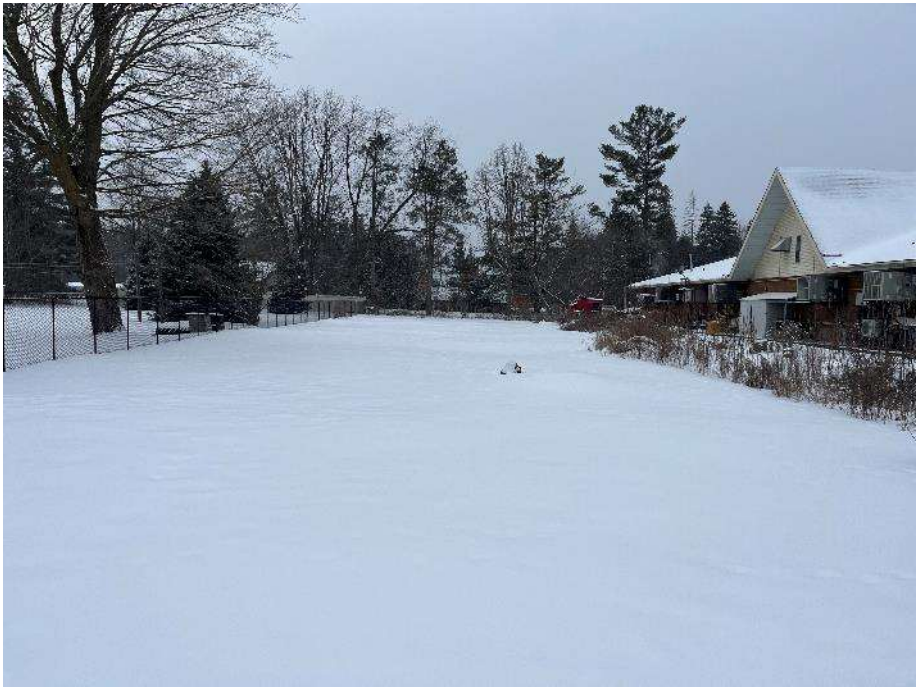
Photograph No. 1

Date: 1/27/2025	
Description From east facing west across entirety of the Site.	
Photograph No. 2

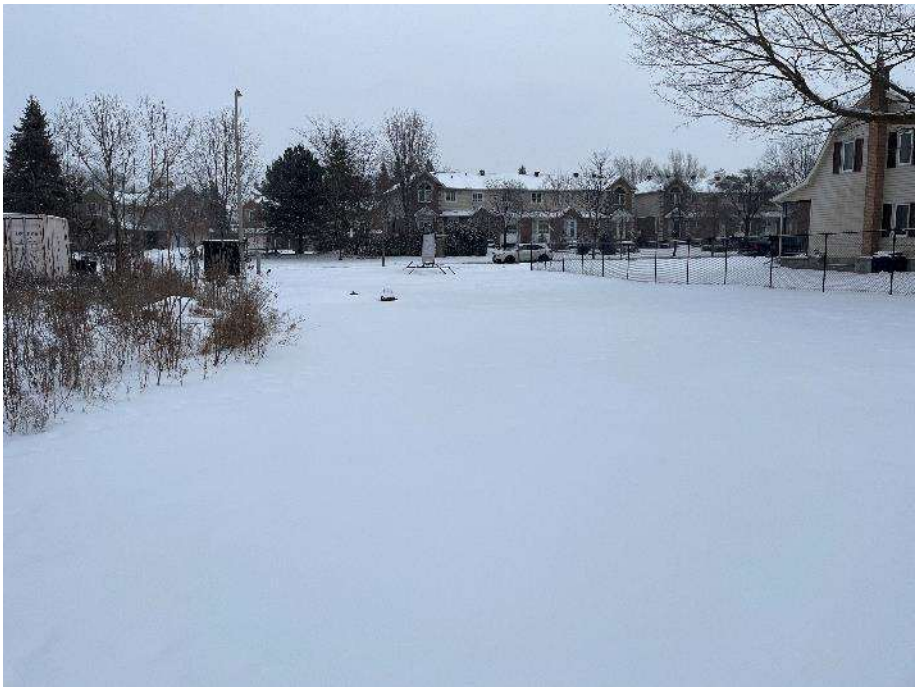
Date: 1/27/2025	
Description From west facing east across entirety of the Site.

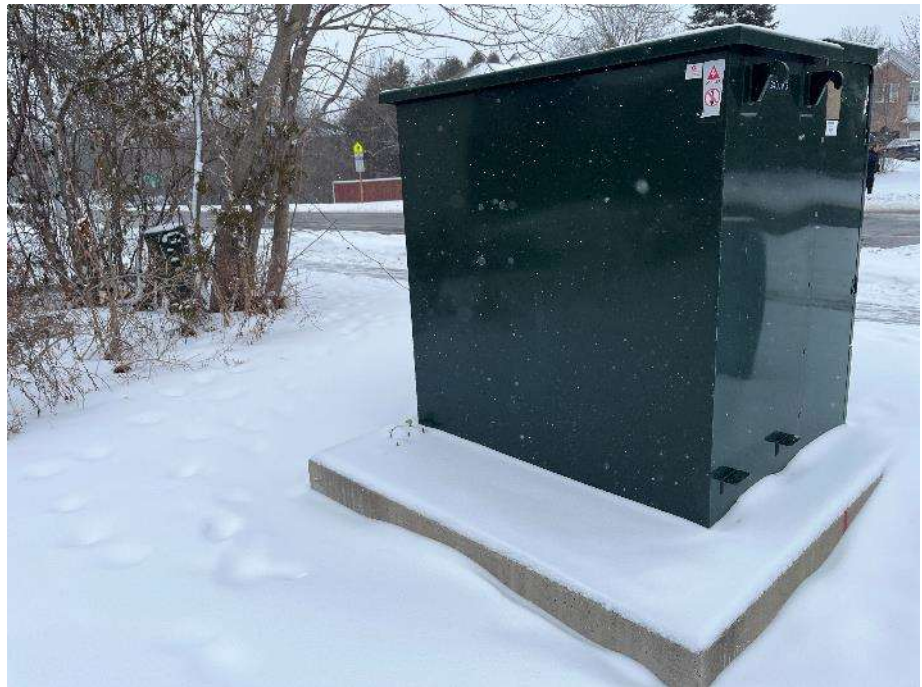
Photograph No. 4

Pad mounted generator – dated 2015.

Utilities	<p>A pad mounted transformer was observed along northeastern extent of the Site. The manufacturing date of the transformer, based on the corresponding manufacturer plate, is found to be June 2015.</p> <p>A Bell Canada service utility pedestal is present along the northeast of the Site, north of the transformer. It is unclear if the buried trench with</p>

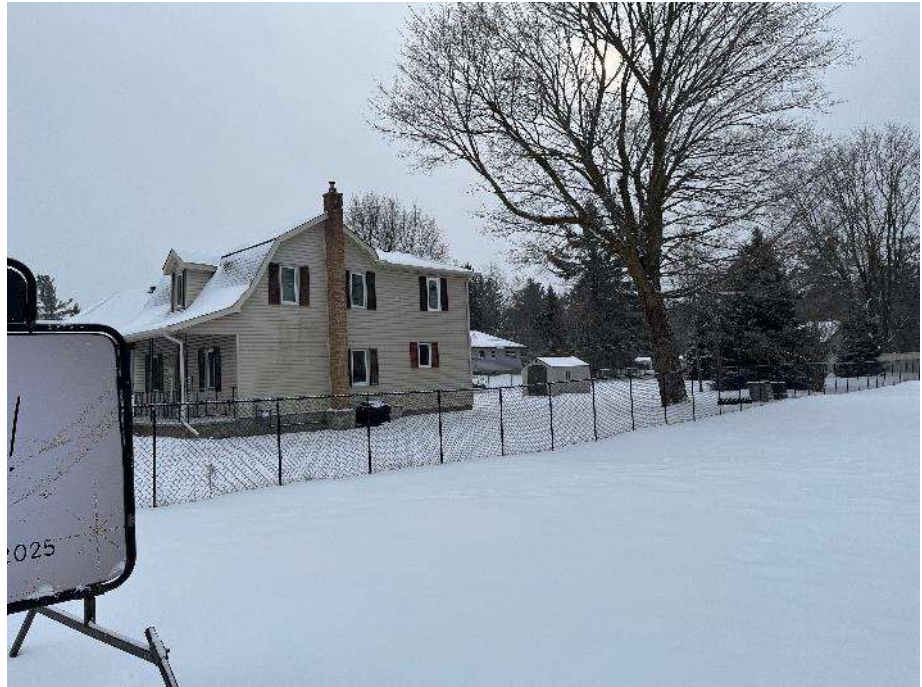
Photograph No. 5

Facing south towards the adjacent Residential development immediately south of the Site.

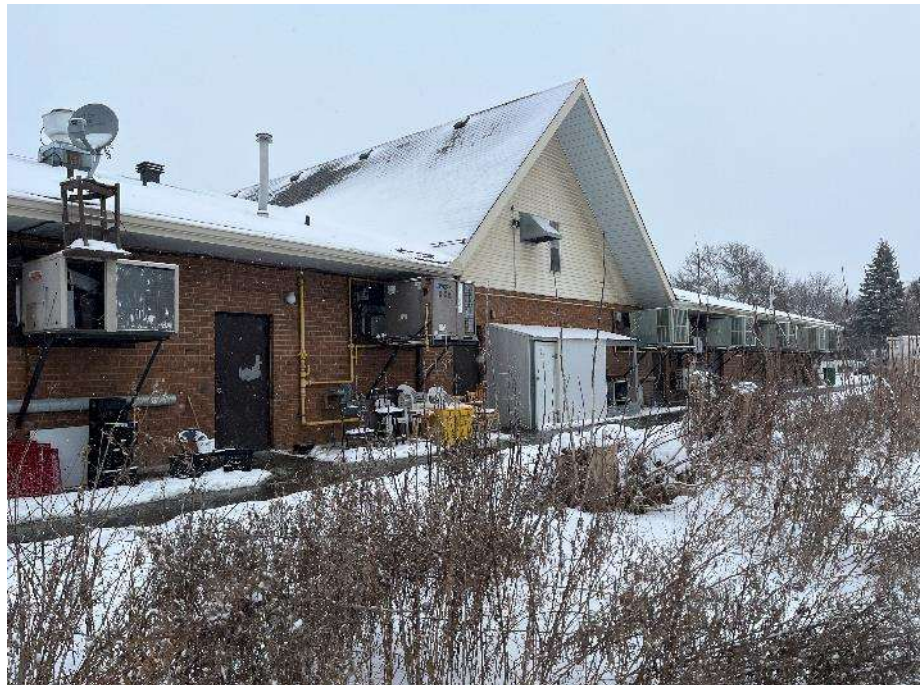
Photograph No. 6

From west facing east along the northern extent of the Site. Adjacent property Commercial development visible in photograph.

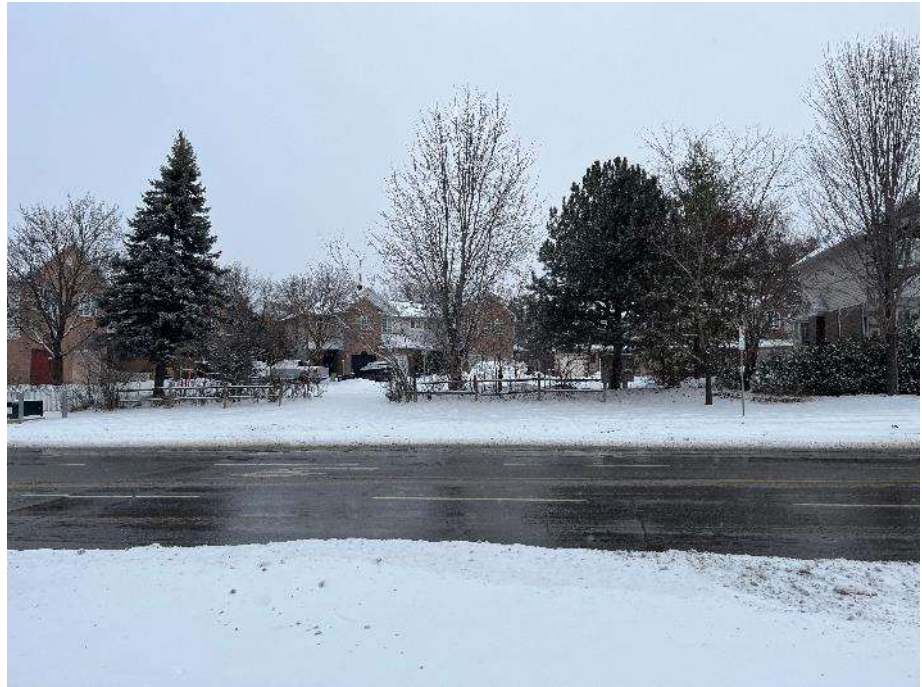
Photograph No. 7

Facing east of the Site. Stittsville Main Street followed by Residential development.

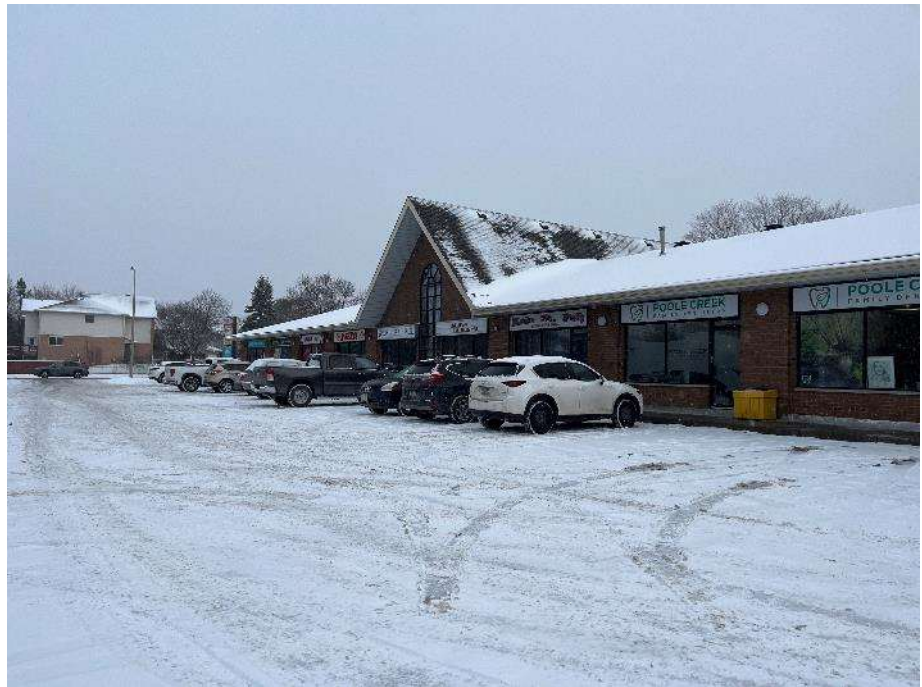
Photograph No. 8

From northwest to east along the northern extent of the adjacent Commercial development to the north of the Site.

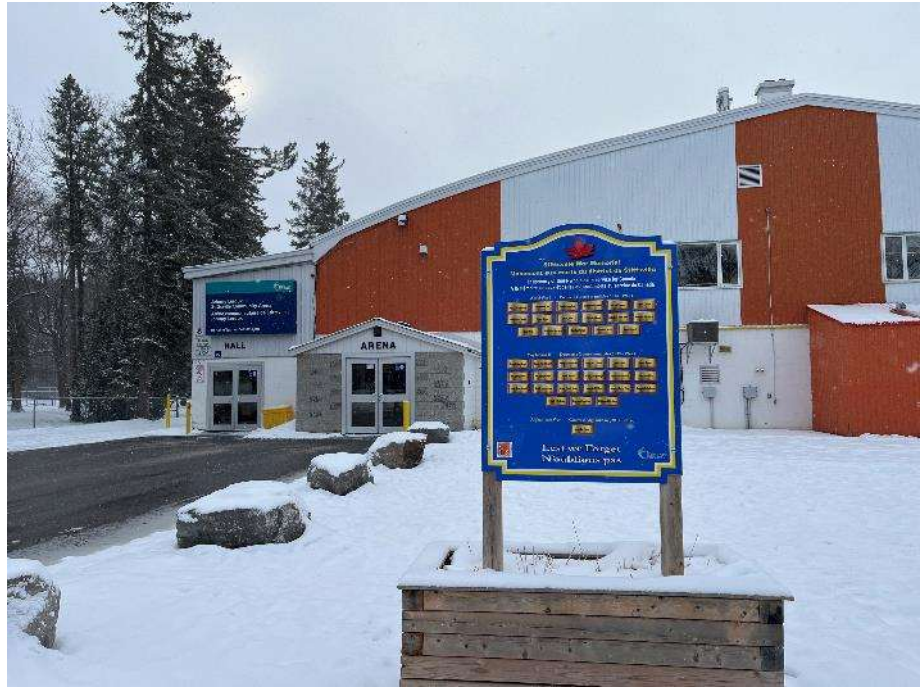
Photograph No. 9

Community centre and arena to the west of the Site – registered waste generator.

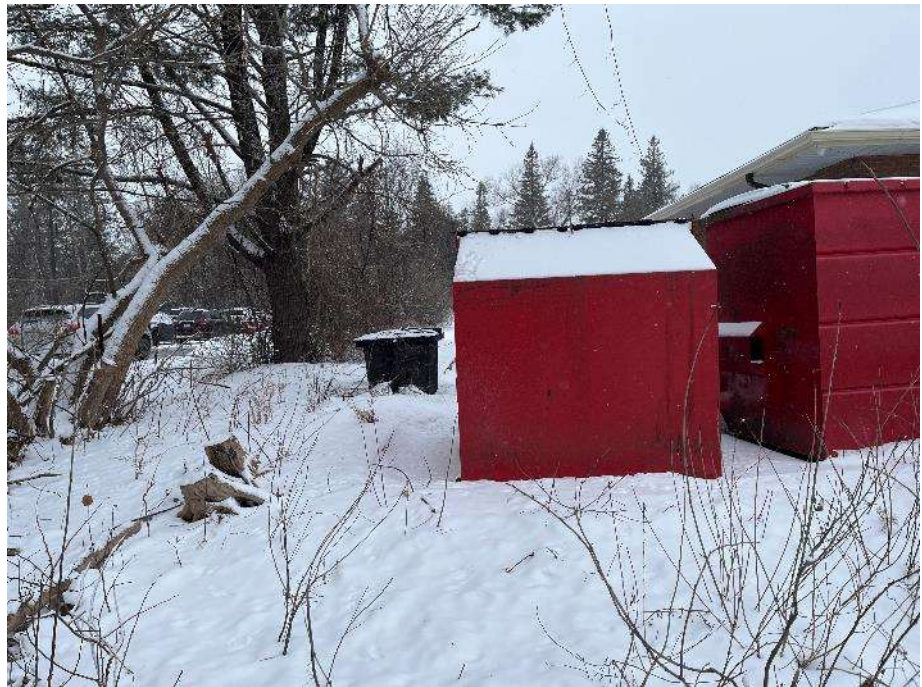
Photograph No. 10

Waste collection dumpsters and used cooking oil collection container observed on the adjacent property to the north.

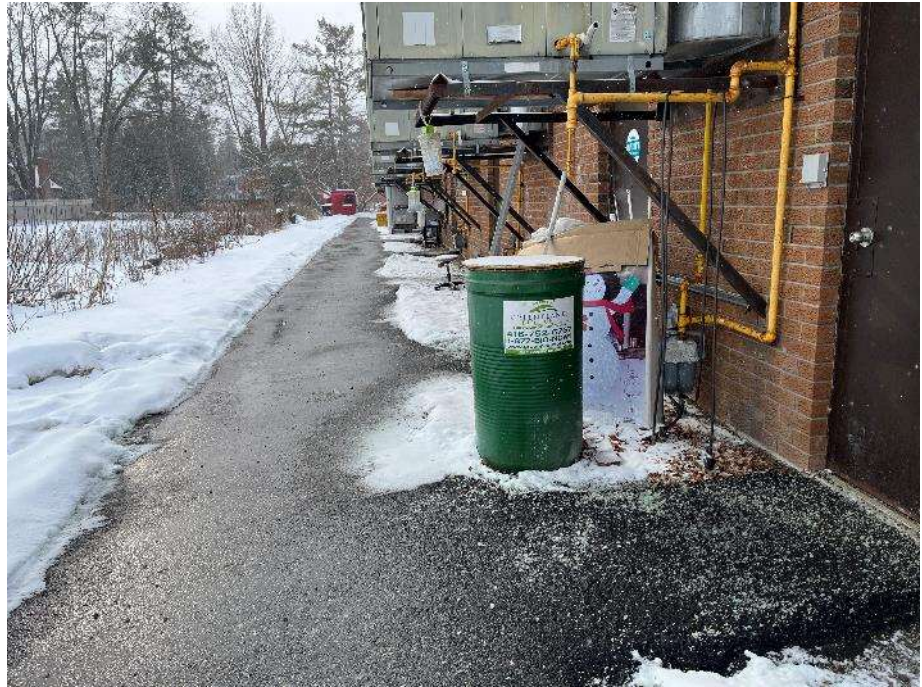
Photograph No. 11

From east facing west along the southern extent of the adjacent property to the north. Food cooking oil drum present in the photograph.

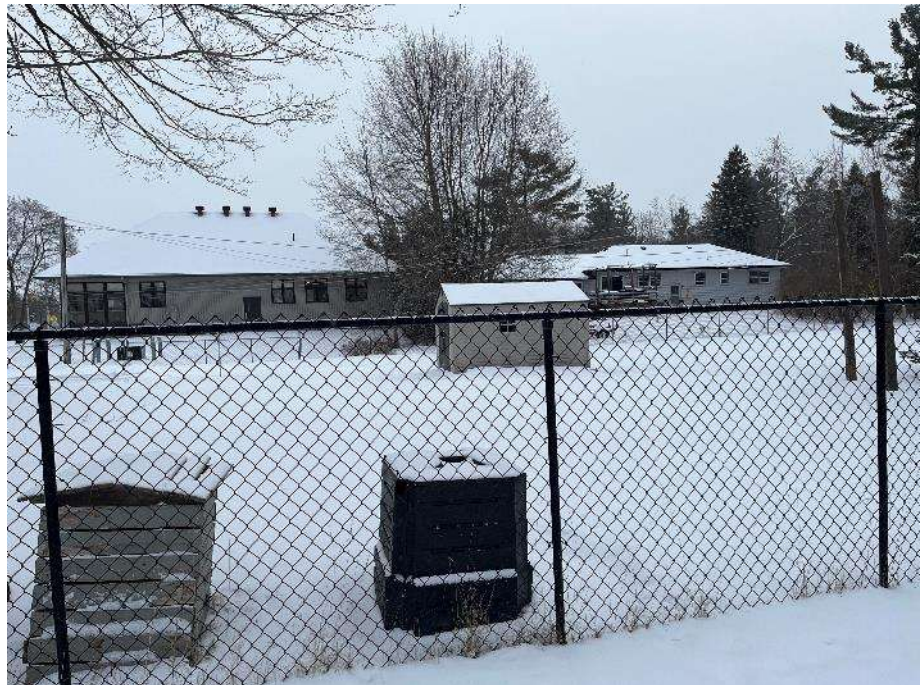
Photograph No. 12

Facing south from the approximate south-central limit of the Site. Commercial – Densit Office and Residential developments are present in the background.
