SUBSURFACE INVESTIGATION REPORT

73, 79 AND 83 STE CECILE ST., OTTAWA, ON, K4A 3N6

Report number: 59-HII-R2¹
March 31, 2025

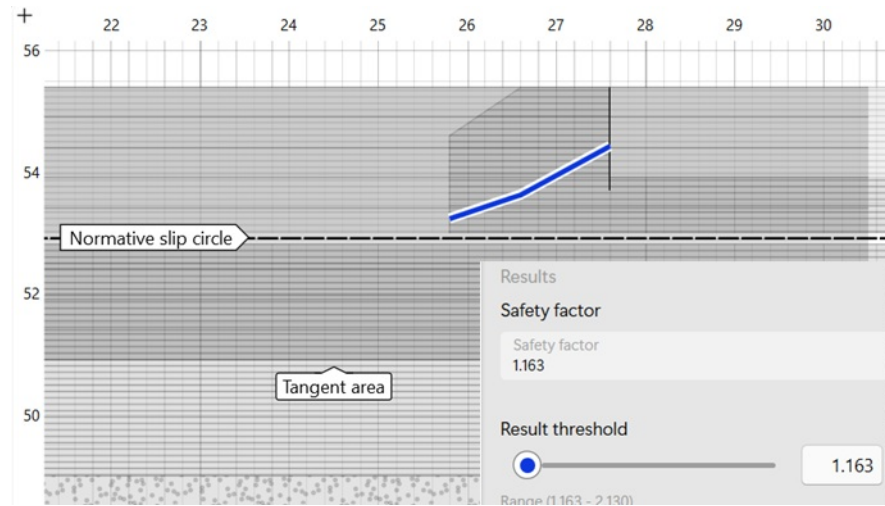
Figure 2: Factor of safety of proposed open cut

Shoring is required for any excavation deeper than 2.5 m depth.

- A material properties table has been added to the subsurface materials section. We added an analysis to this section to assess the need of shoring for 2.5 m maximum excavation depths given the materials and the geometry of cuts along the nearest property line.

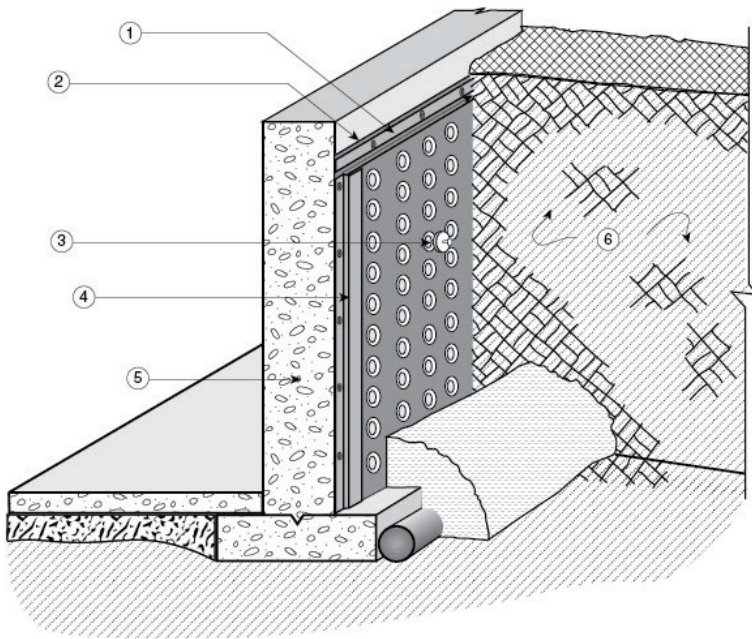
Figure 1. “Cosella-Dörken DELTA[®]-MS and DELTA[®]-MS CLEAR Dampproofing Membranes” – face in contact with the soil

1. termination bar
2. caulking (behind membrane)
3. fastener
4. mould strip
5. concrete foundation
6. backfill

For foundation elevations above the water table, Appendix C.1 presents page 2 of NRC Construction Evaluation Reports CCMC 12658-R showing dampproofing and foundation wall drainage system details satisfying the provisions under OBC 2012 and suitable for the conditions found at this site. Other available similar systems having the components shown in CCMC 12658-R may be used. Foundation drainage must be provided to daylight or a positive outlet, or sump.

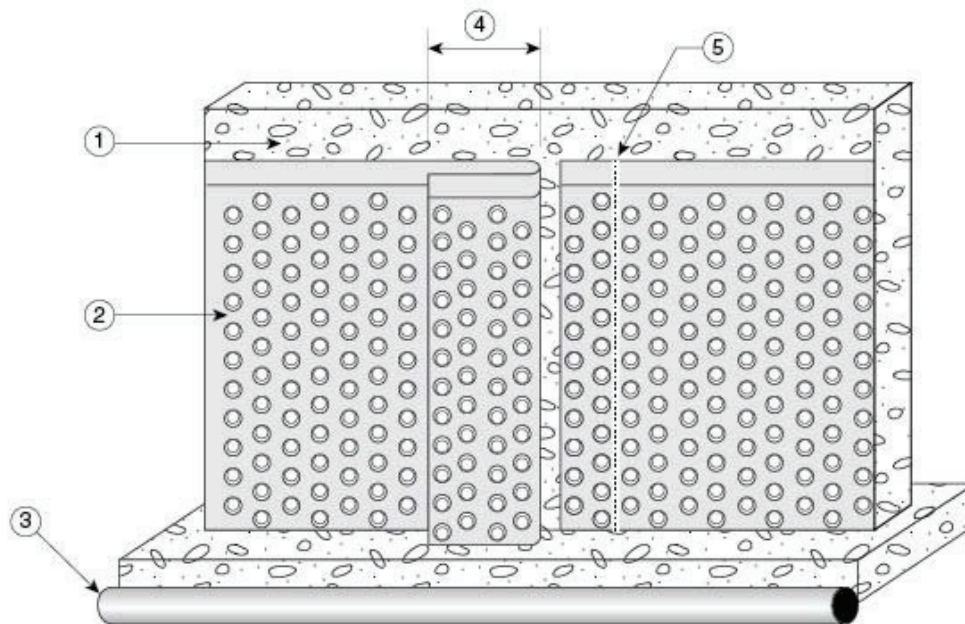
Figure 2. “Cosella-Dörken DELTA[®]-MS and DELTA[®]-MS CLEAR Dampproofing Membranes” – face in contact with the wall

1. concrete foundation
2. membrane
3. drainage tile
4. minimum 6" overlap
5. caulking
