**HENRY INVESTMENTS  
14072375 Canada Inc.**

**Phase II Environmental Site Assessment  
73-79, 83 Ste-Cecile,  
Vanier, Ontario**

**CM3 Project SDC1009**

**December 20, 2022**

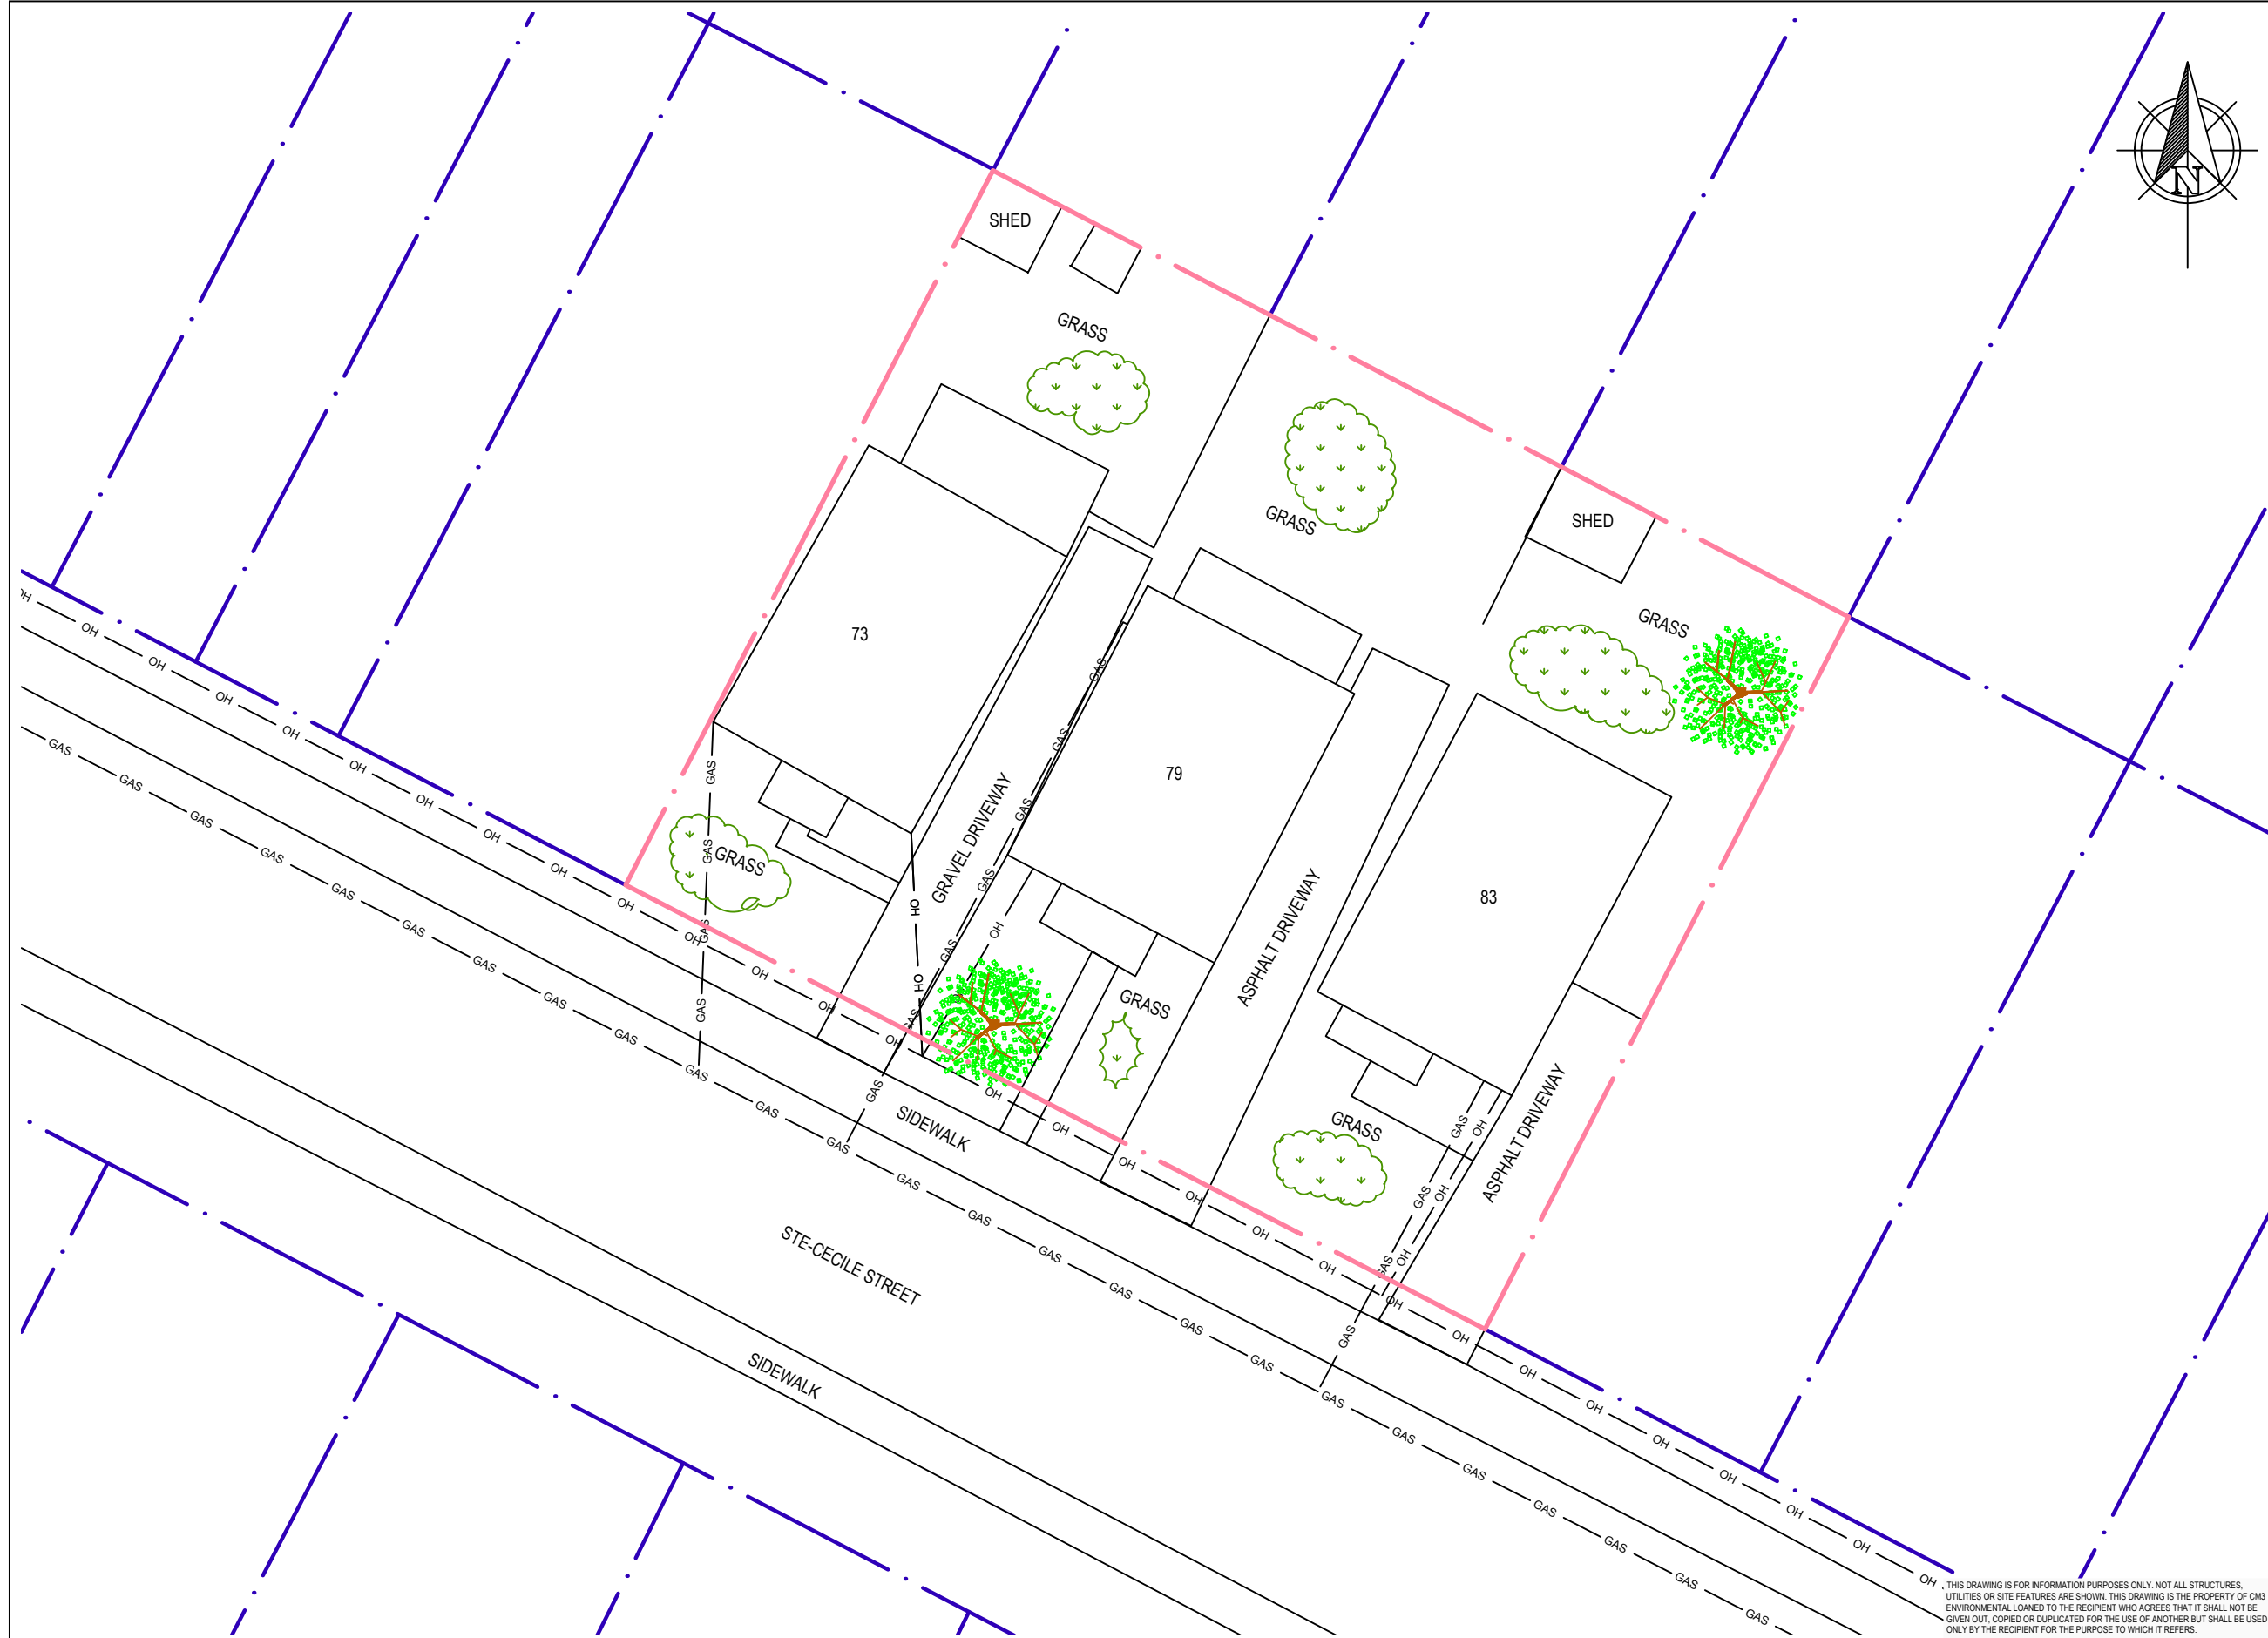
SITE PLAN

The subject properties comprised the three civic addresses 73, 79 and 83 Ste-Cecile Street, Ottawa, Ontario. The subject properties are rectangular in shape and bounded by the Ste-Cecile Street to the south, residential properties on Marquette Avenue to the north, and residential properties to the east and west. The total area of the subject properties is approximately 1,112 square metres (0.1 hectares). Buildings at the properties included a south-facing residential building on each lot. 73 and 83 Ste-Cecile were bungalow style single residence buildings. 79 Ste-Cecile was a two-storey multi unit-residential building. There were small sheds in the back yards of 73 and 83 Ste-Cecile.

The area between Ste-Cecile and the residential building was a concrete sidewalk with grass up to the buildings. Some landscaping and flower gardens were present next to the south wall of the building. A gravel laneway was present on the east side of 73 Ste-Cecile. An asphalt laneway was present on the east of both 79 Ste-Cecile and 83 Ste-Cecile. The 73 property was enclosed by a chain link fence to the north, west and shared the fence with the 79 property to the east. The 79 property was fenced into the north and shared a vinyl fence with the 83 property to the east. Most of the yards to the north were grass covered. All other ground coverings on the remainder of the properties consisted of grass or various types of vegetation.

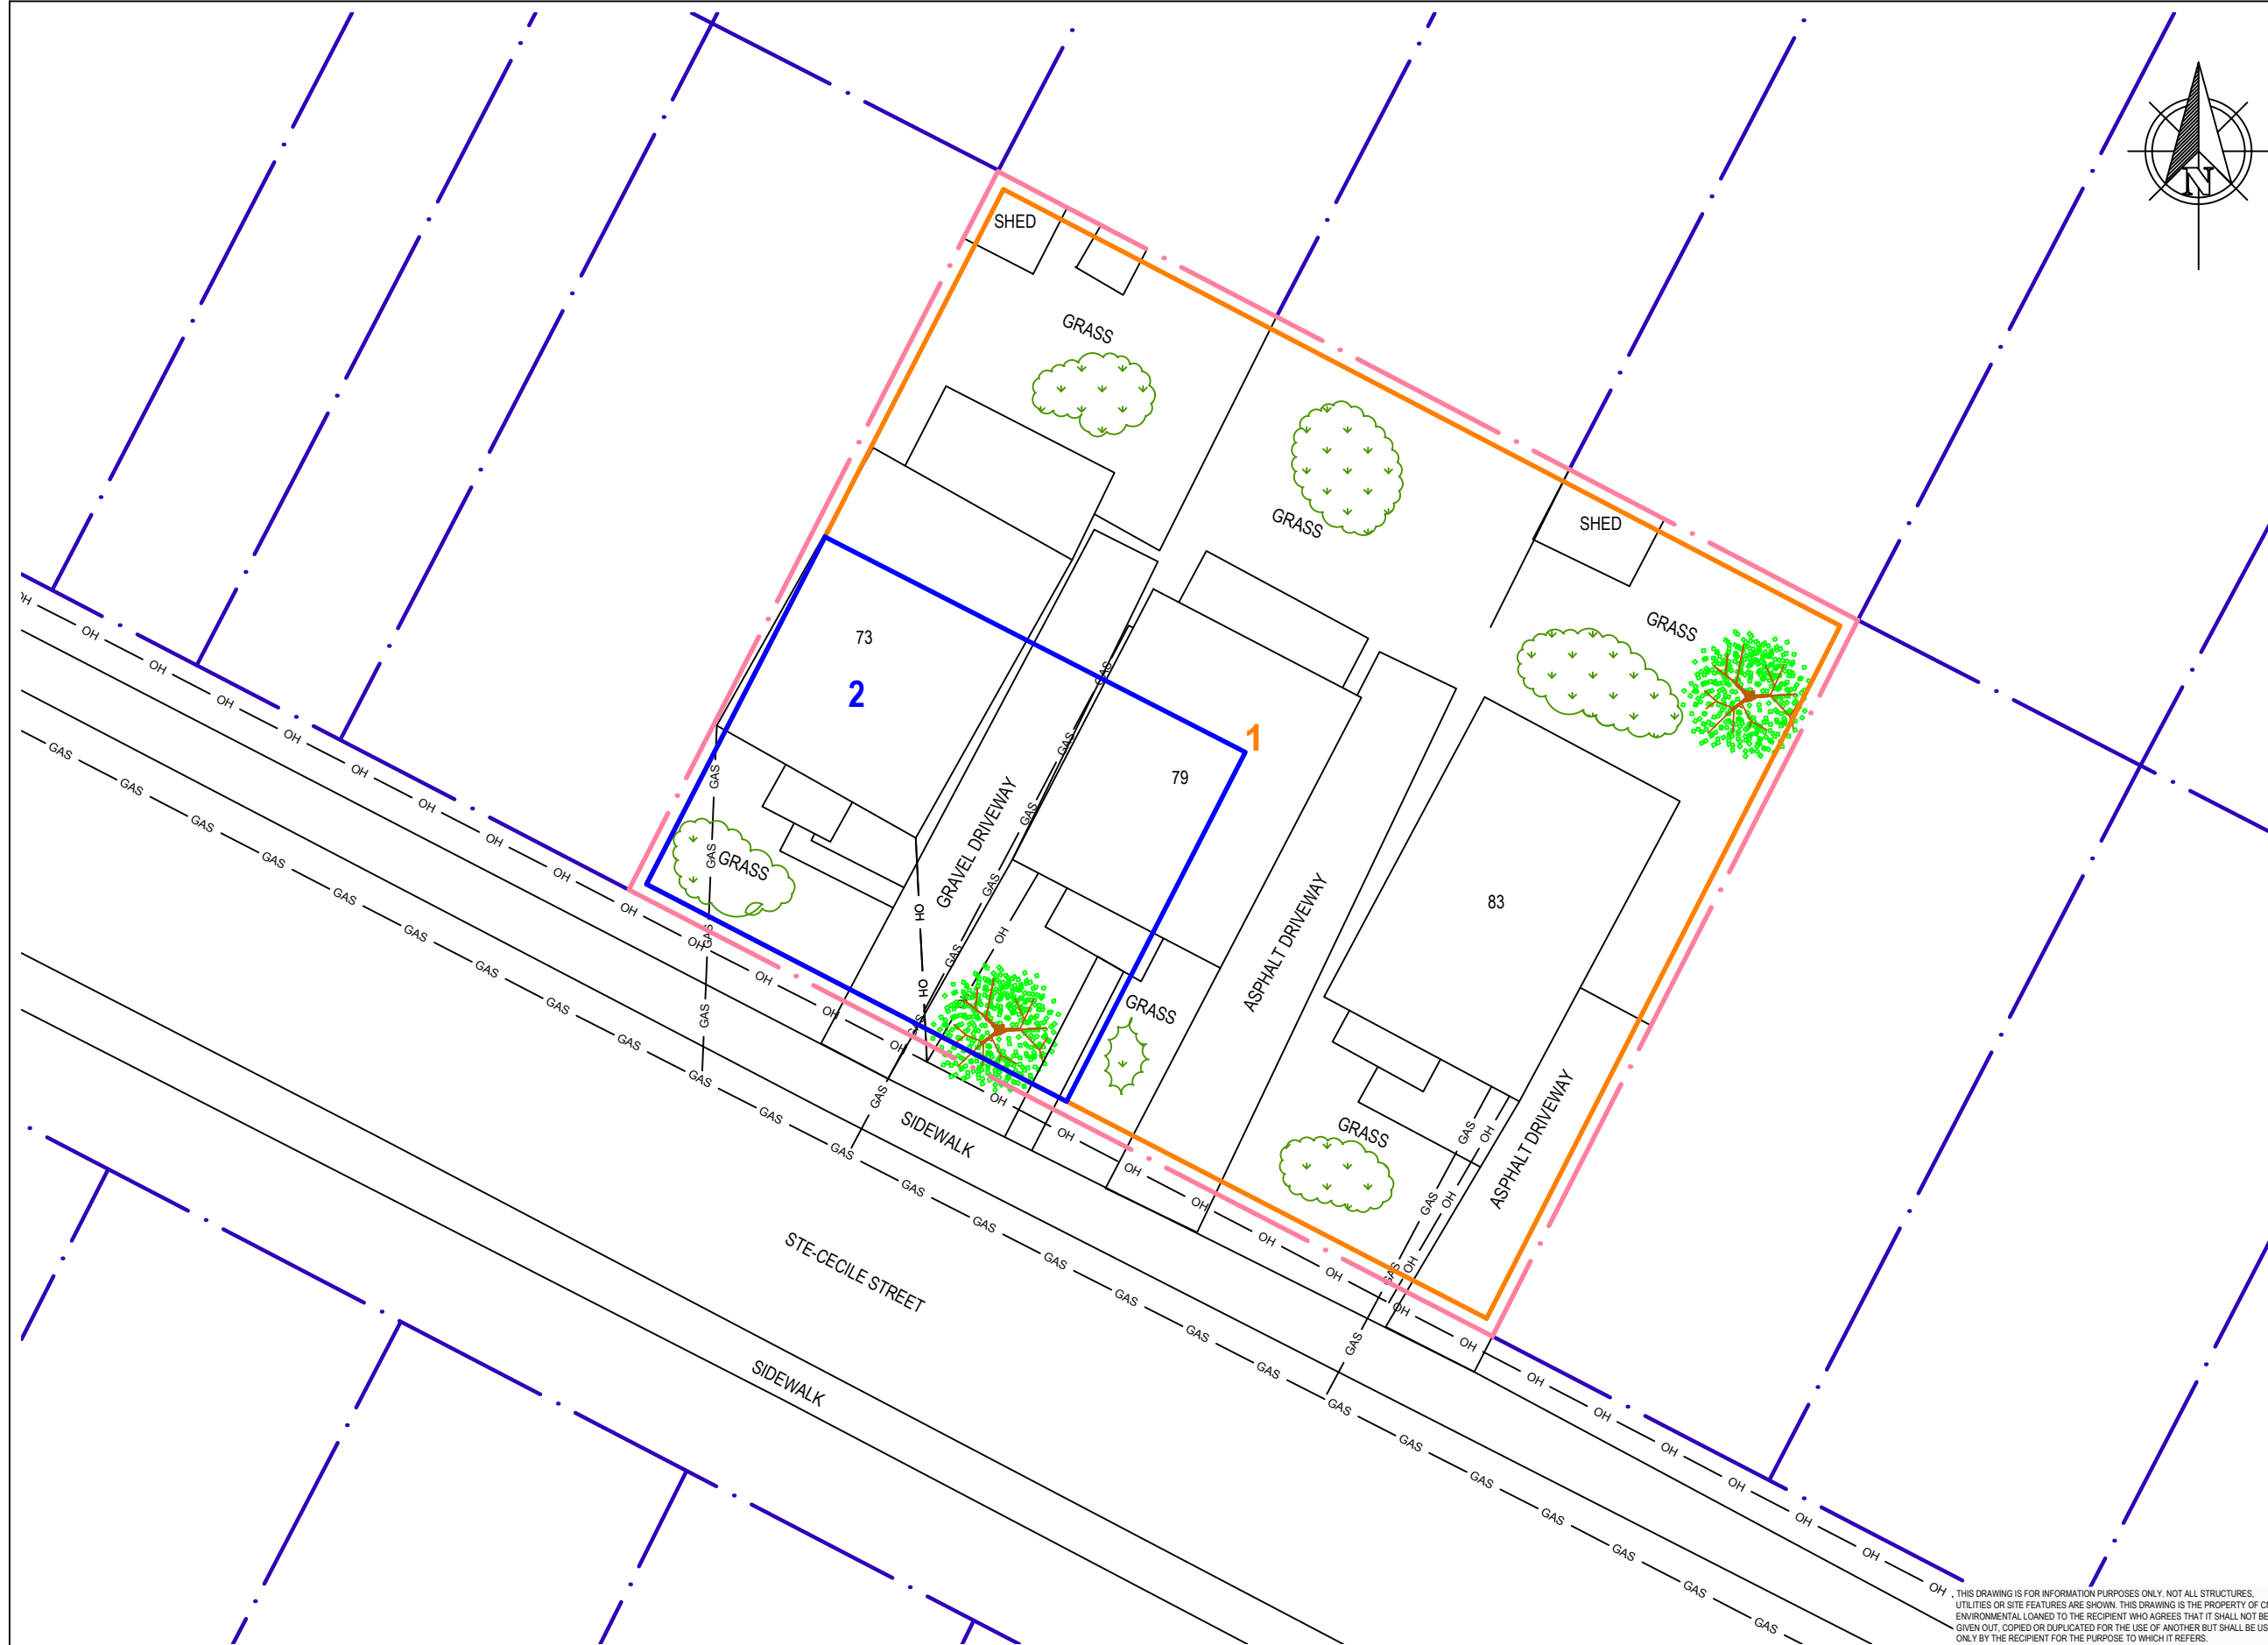
AREAS OF POTENTIAL ENVIRONMENTAL CONCERN

| Areas of Potential Environmental Concern | | | |
|---|---|---|---|
| 1 | Subject property. | PCA 1 – Importation of fill material of unknown quality. | VOCs, PHCs F1-F4 fractions, metals, PAHs |
| 2 | South-west of the subject site at 72 Ste-Cecile St. | PCA 2 – Former metal fabrication. | VOCs, metals |

The findings of the Phase I ESA identified two areas of potential environmental concern on the subject properties due to historic and current land use at the site. APECs are shown on **Figure 3**. The contaminants of concern were identified as VOCs, PHCs F1-F4 fractions, PAHs and metals, and potentially contaminated media included soil and groundwater. CM3 concluded that the PCAs and APECs could result in adverse environmental conditions at the subject property and a Phase II ESA was required to characterize soil and groundwater conditions and assess the presence of contamination at the APECs.

Soil samples from all borehole and all groundwater samples at all locations were used to evaluate the fill quality at the site. The results identified the presence of metals, PHCs and PAHs in at concentrations that were not detectable or well below the Table 5 SCS. VOCs were not detected in soil or groundwater. In general, the concentrations in subsurface soil samples met the MECP Table 5 SCS, suggesting that the fill material is not contaminated or contaminating groundwater.

Borehole soil sample MW1 SA7 and groundwater sample MW1 were collected to identify any possible impacts due to the historic presence of a metal fabrication shop located across the street from the subject property. The results identified the presence of metals and PHCs in soil and metal impacts in groundwater that comply with the SCS. Groundwater flow analysis also confirmed that the former metal fabrication facility is downgradient of the subject sites, making the possibility of contamination unlikely.

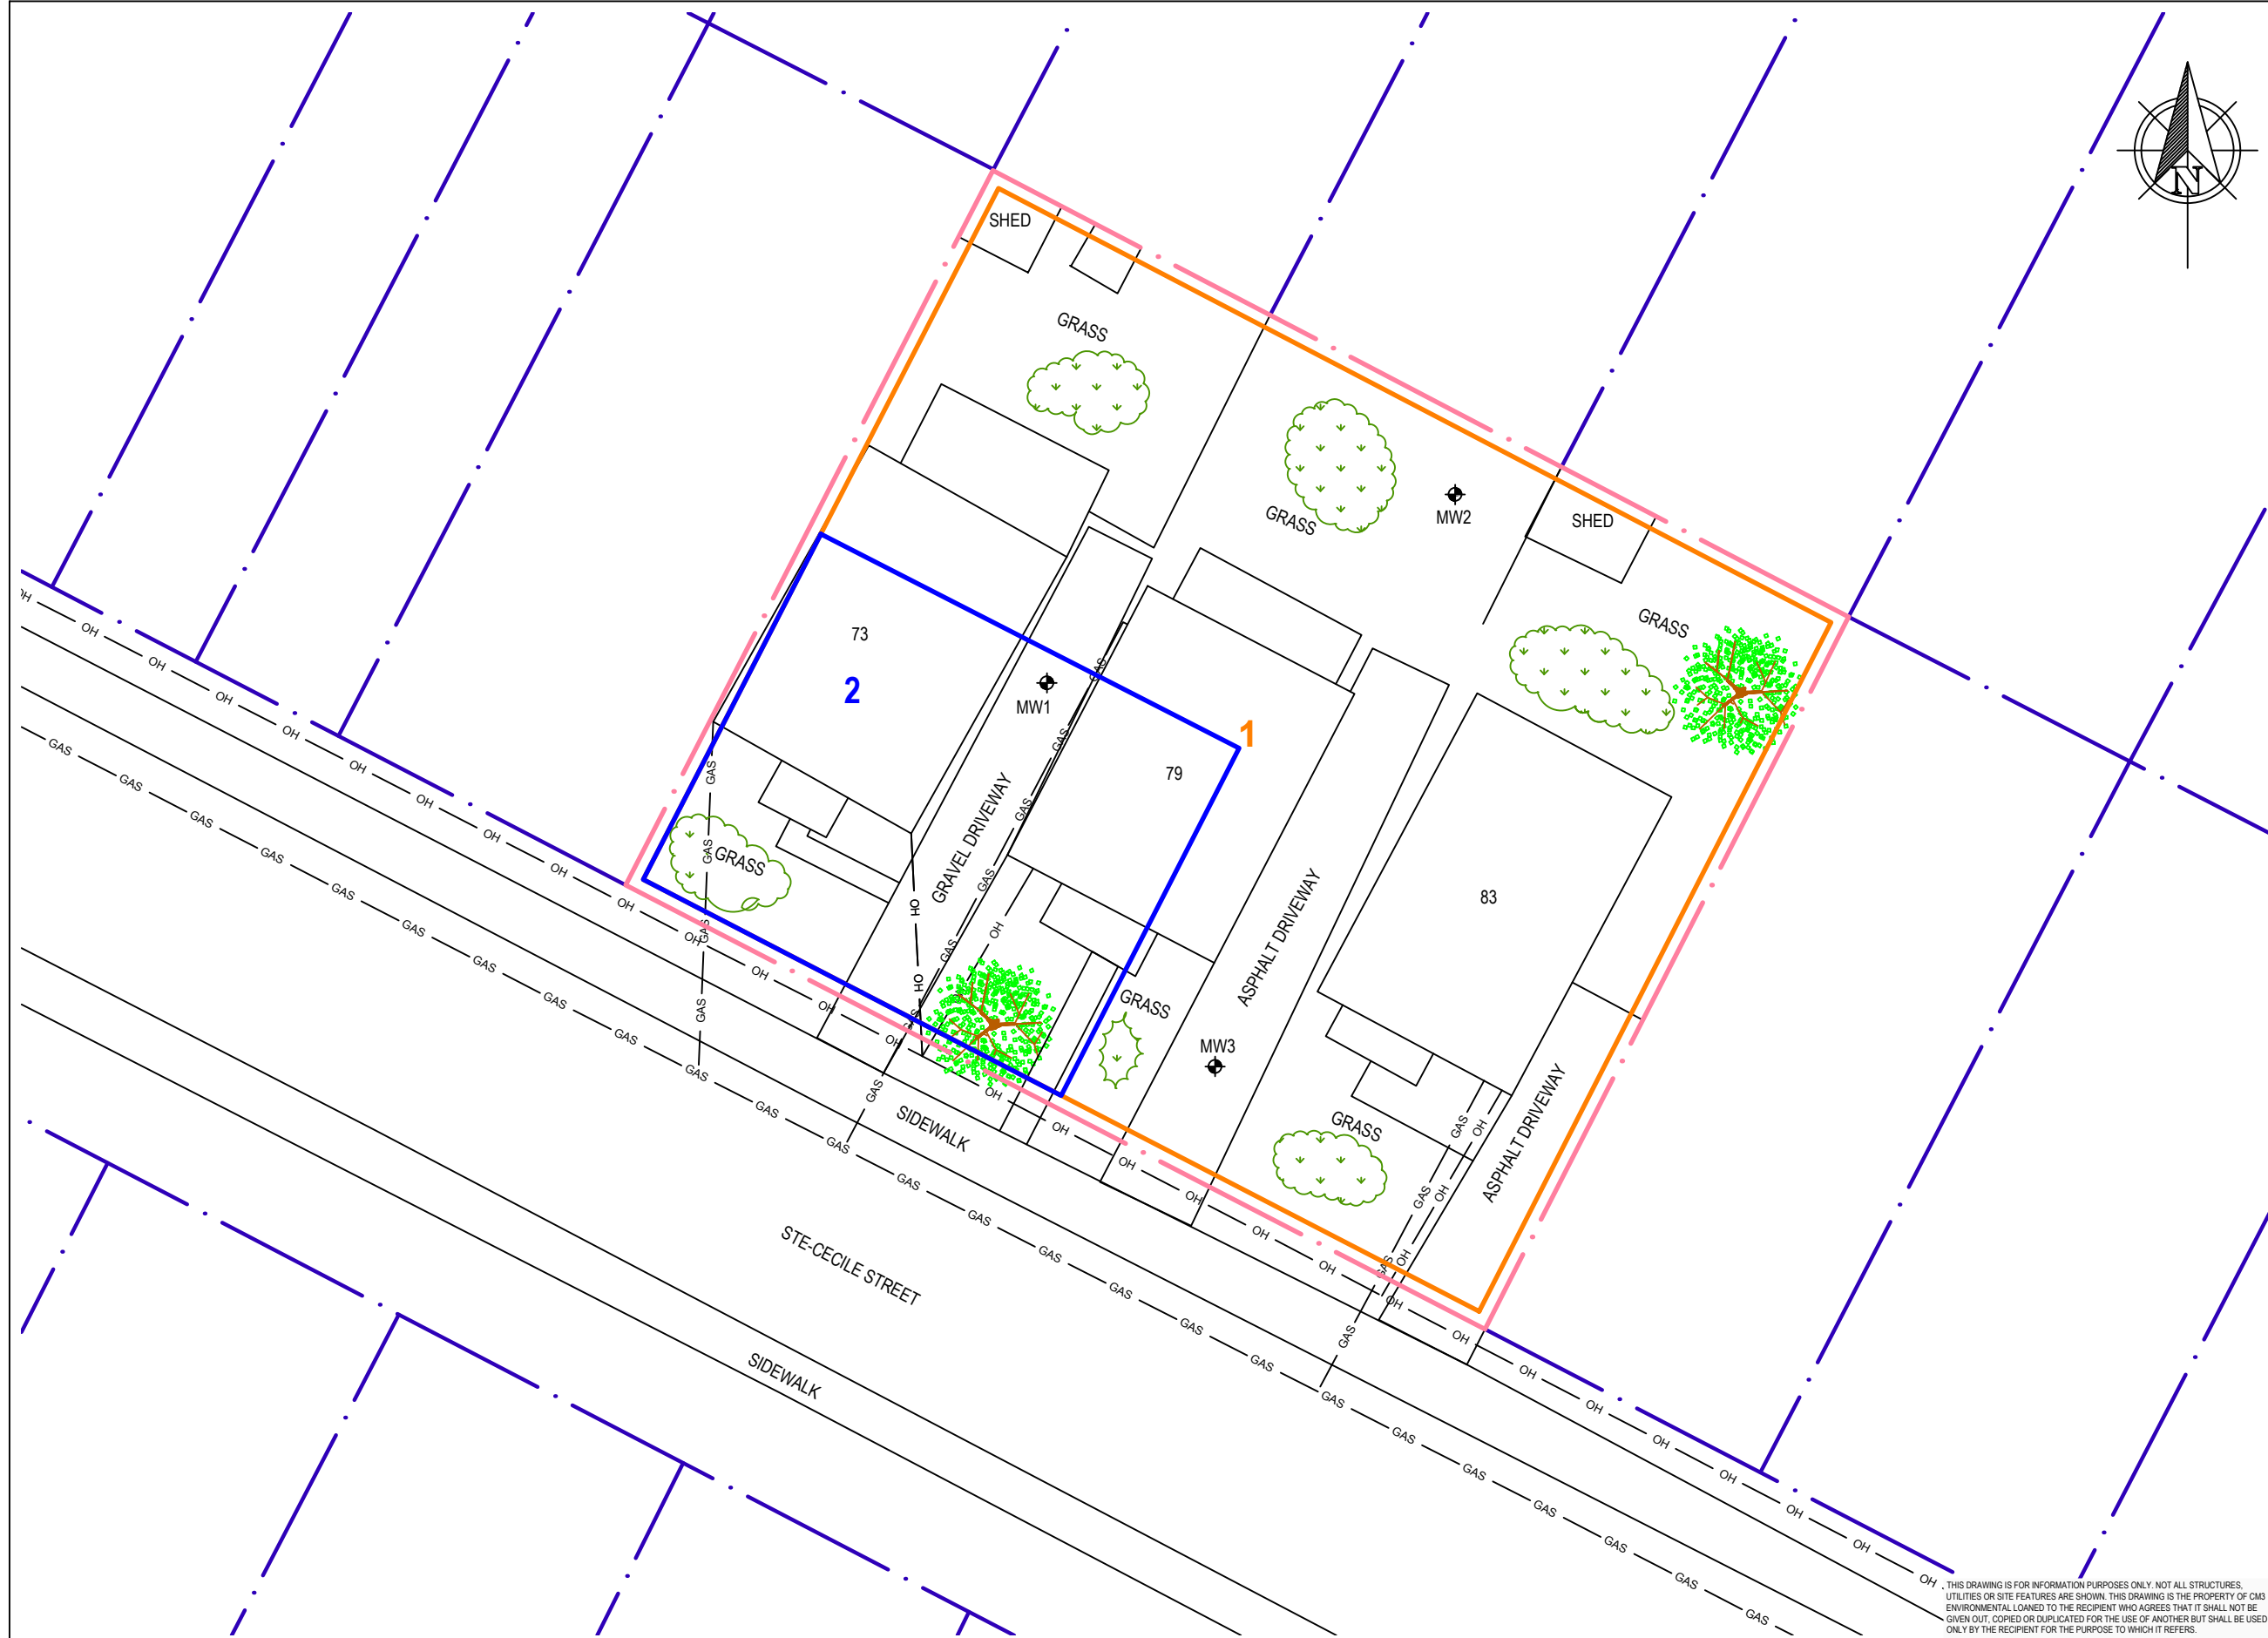
| Scale: | 1:250 | Figure: | 4 |

Boreholes MW1, MW2 and MW3 were completed as monitoring wells. Monitoring well construction consisted of 32 mm or 50 mm outside diameter, flush-threaded schedule 40 PVC well screens and risers. At each borehole, a 10-slot well screen was placed to intercept the water table to allow for the detection of LPH. A silica sand pack was placed around the outside of the well screen in the annular space of the borehole, to a minimum of 0.3 m above the screened interval. A bentonite seal was placed above the sand pack to approximately 0.3 m bg. All monitoring wells were capped with lockable j-plugs and finished at below grade in flush-mounted manhole protective casings set in gravel, asphalt or grass.

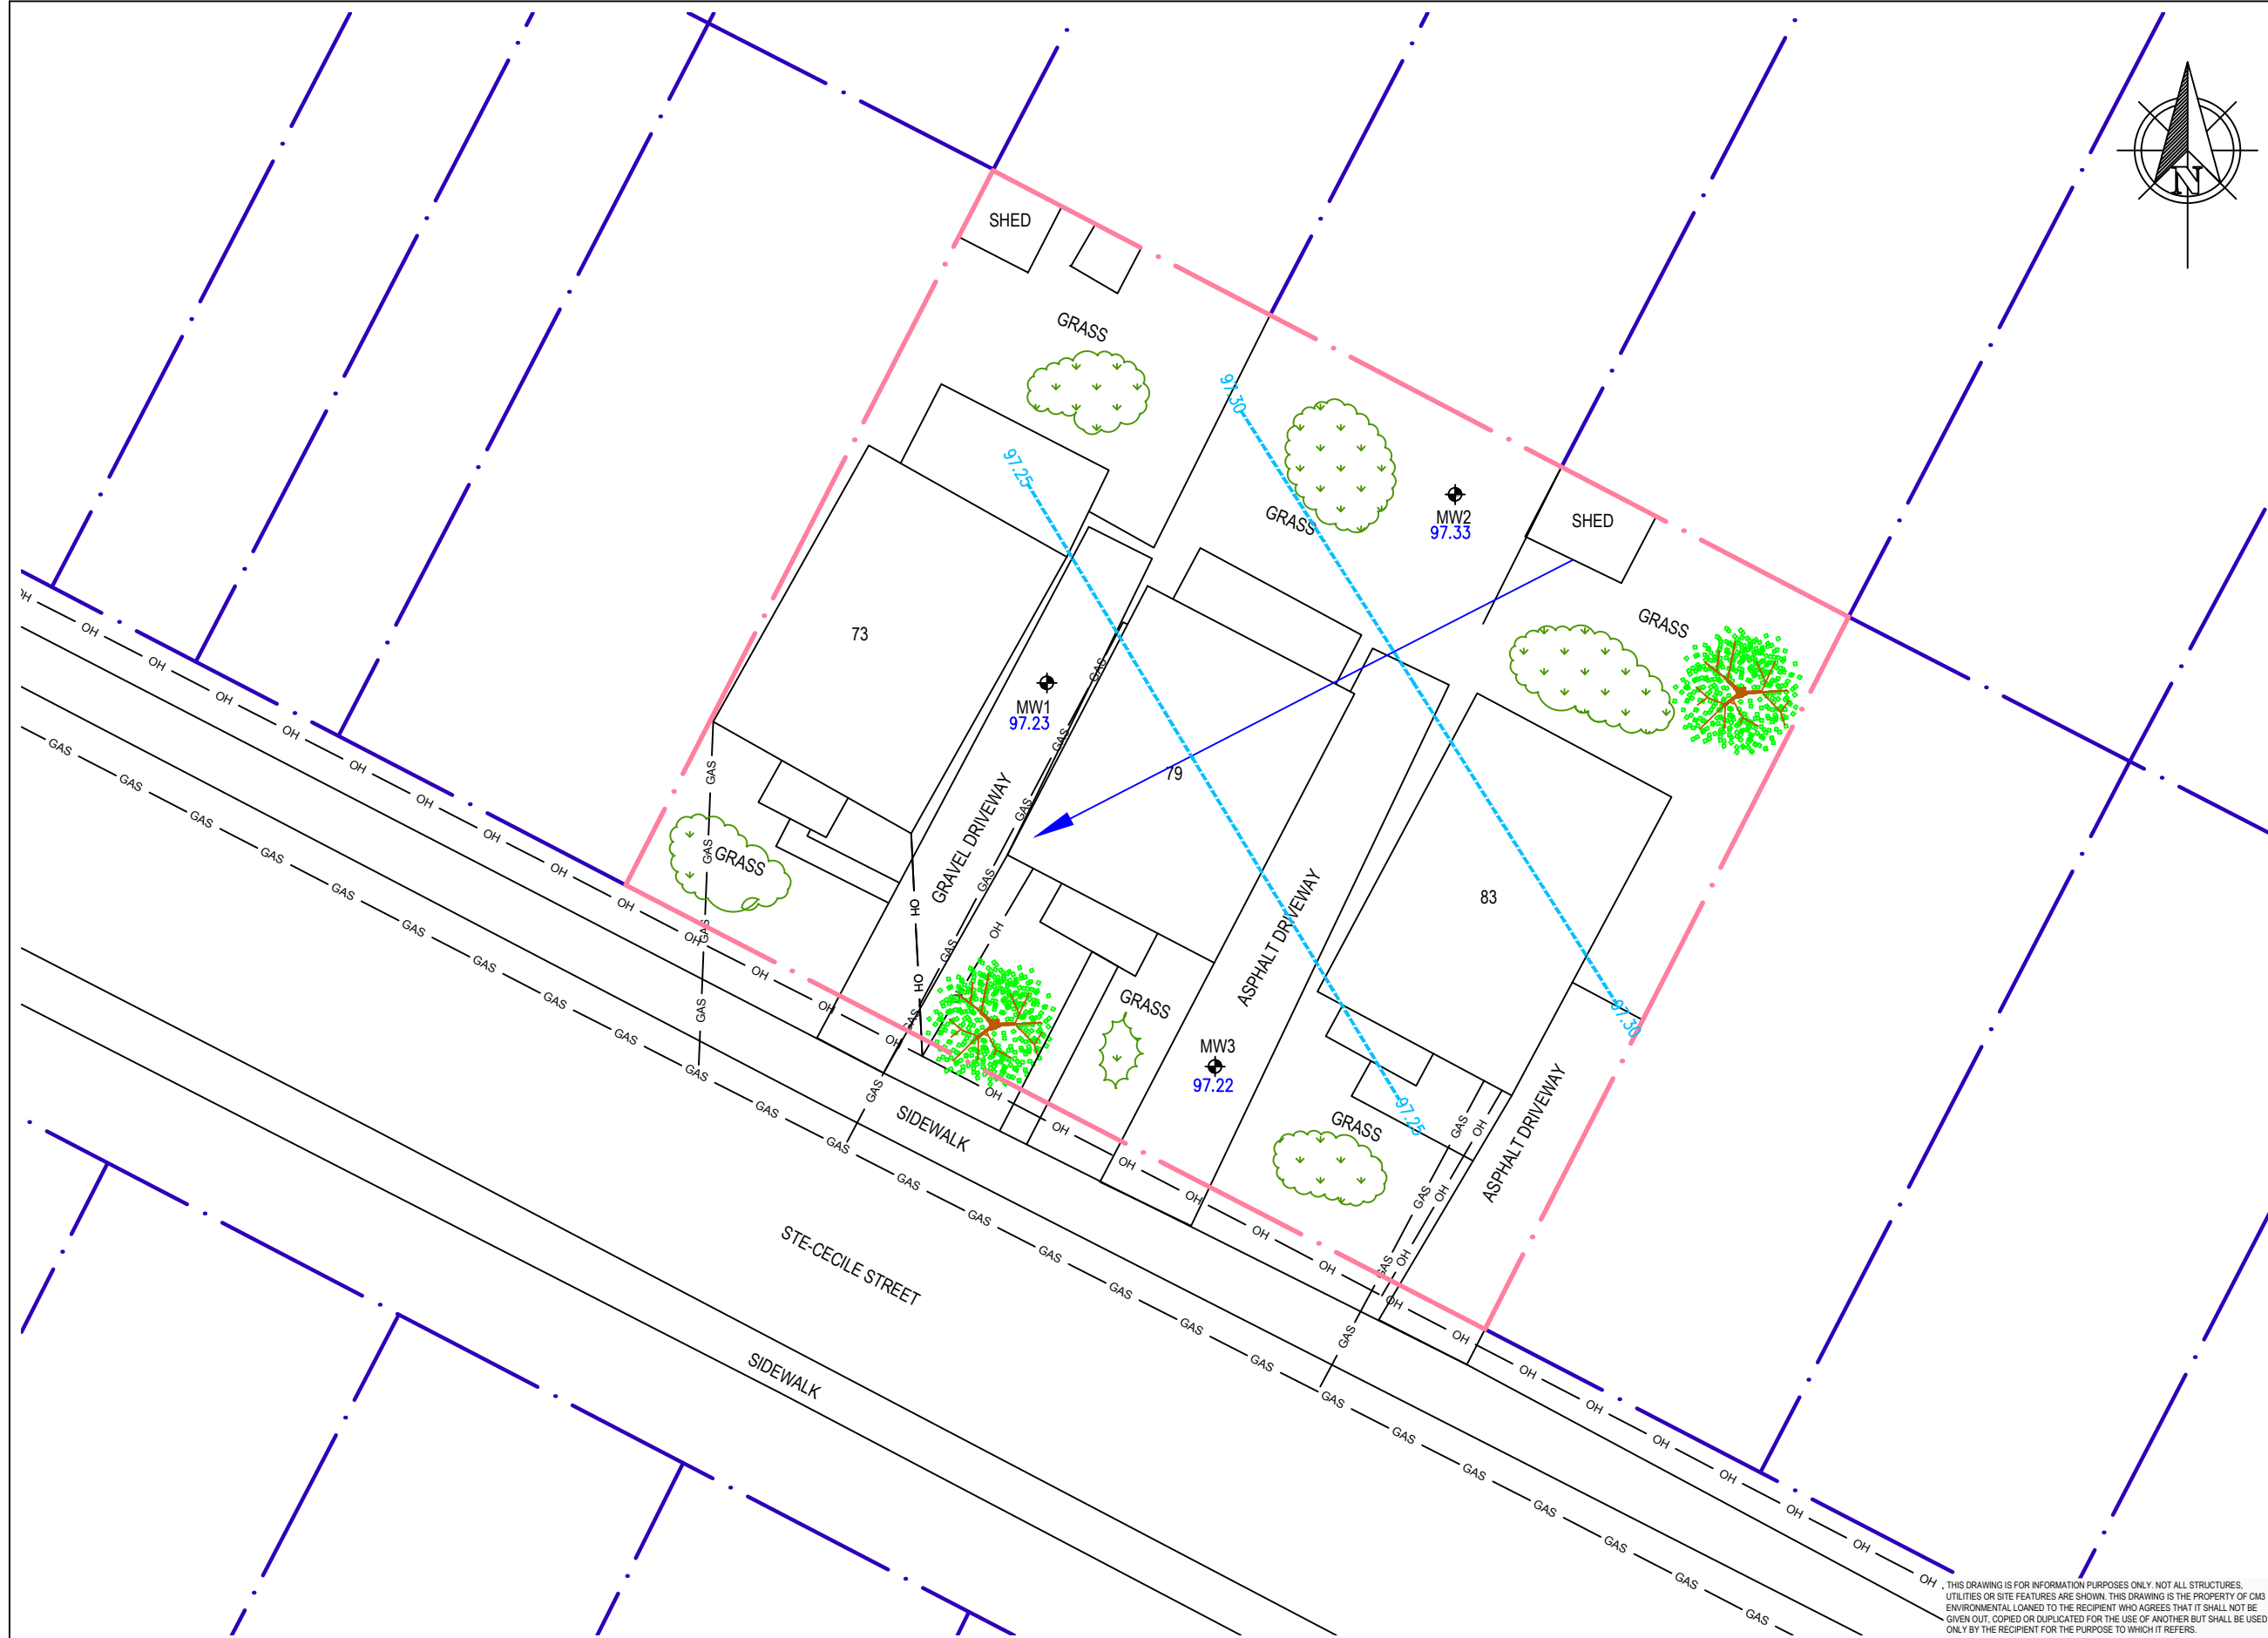
| Scale: | 1:250 | Figure: | 5 |

The depth to LPH (if present) and groundwater was measured in all monitoring wells on December 5, 2022. The December 5, 2022 water levels were at a relative elevation of 97.22 m arl to 97.33 m arl, and the average groundwater elevation was 97.26 m arl (2.74 m bg). The depth to LPH and water level measurements are provided in **Table 1**.

The groundwater flow direction was determined to be south-west based on the groundwater data. The groundwater elevations, contours and flow direction are provided on **Figure 5**.

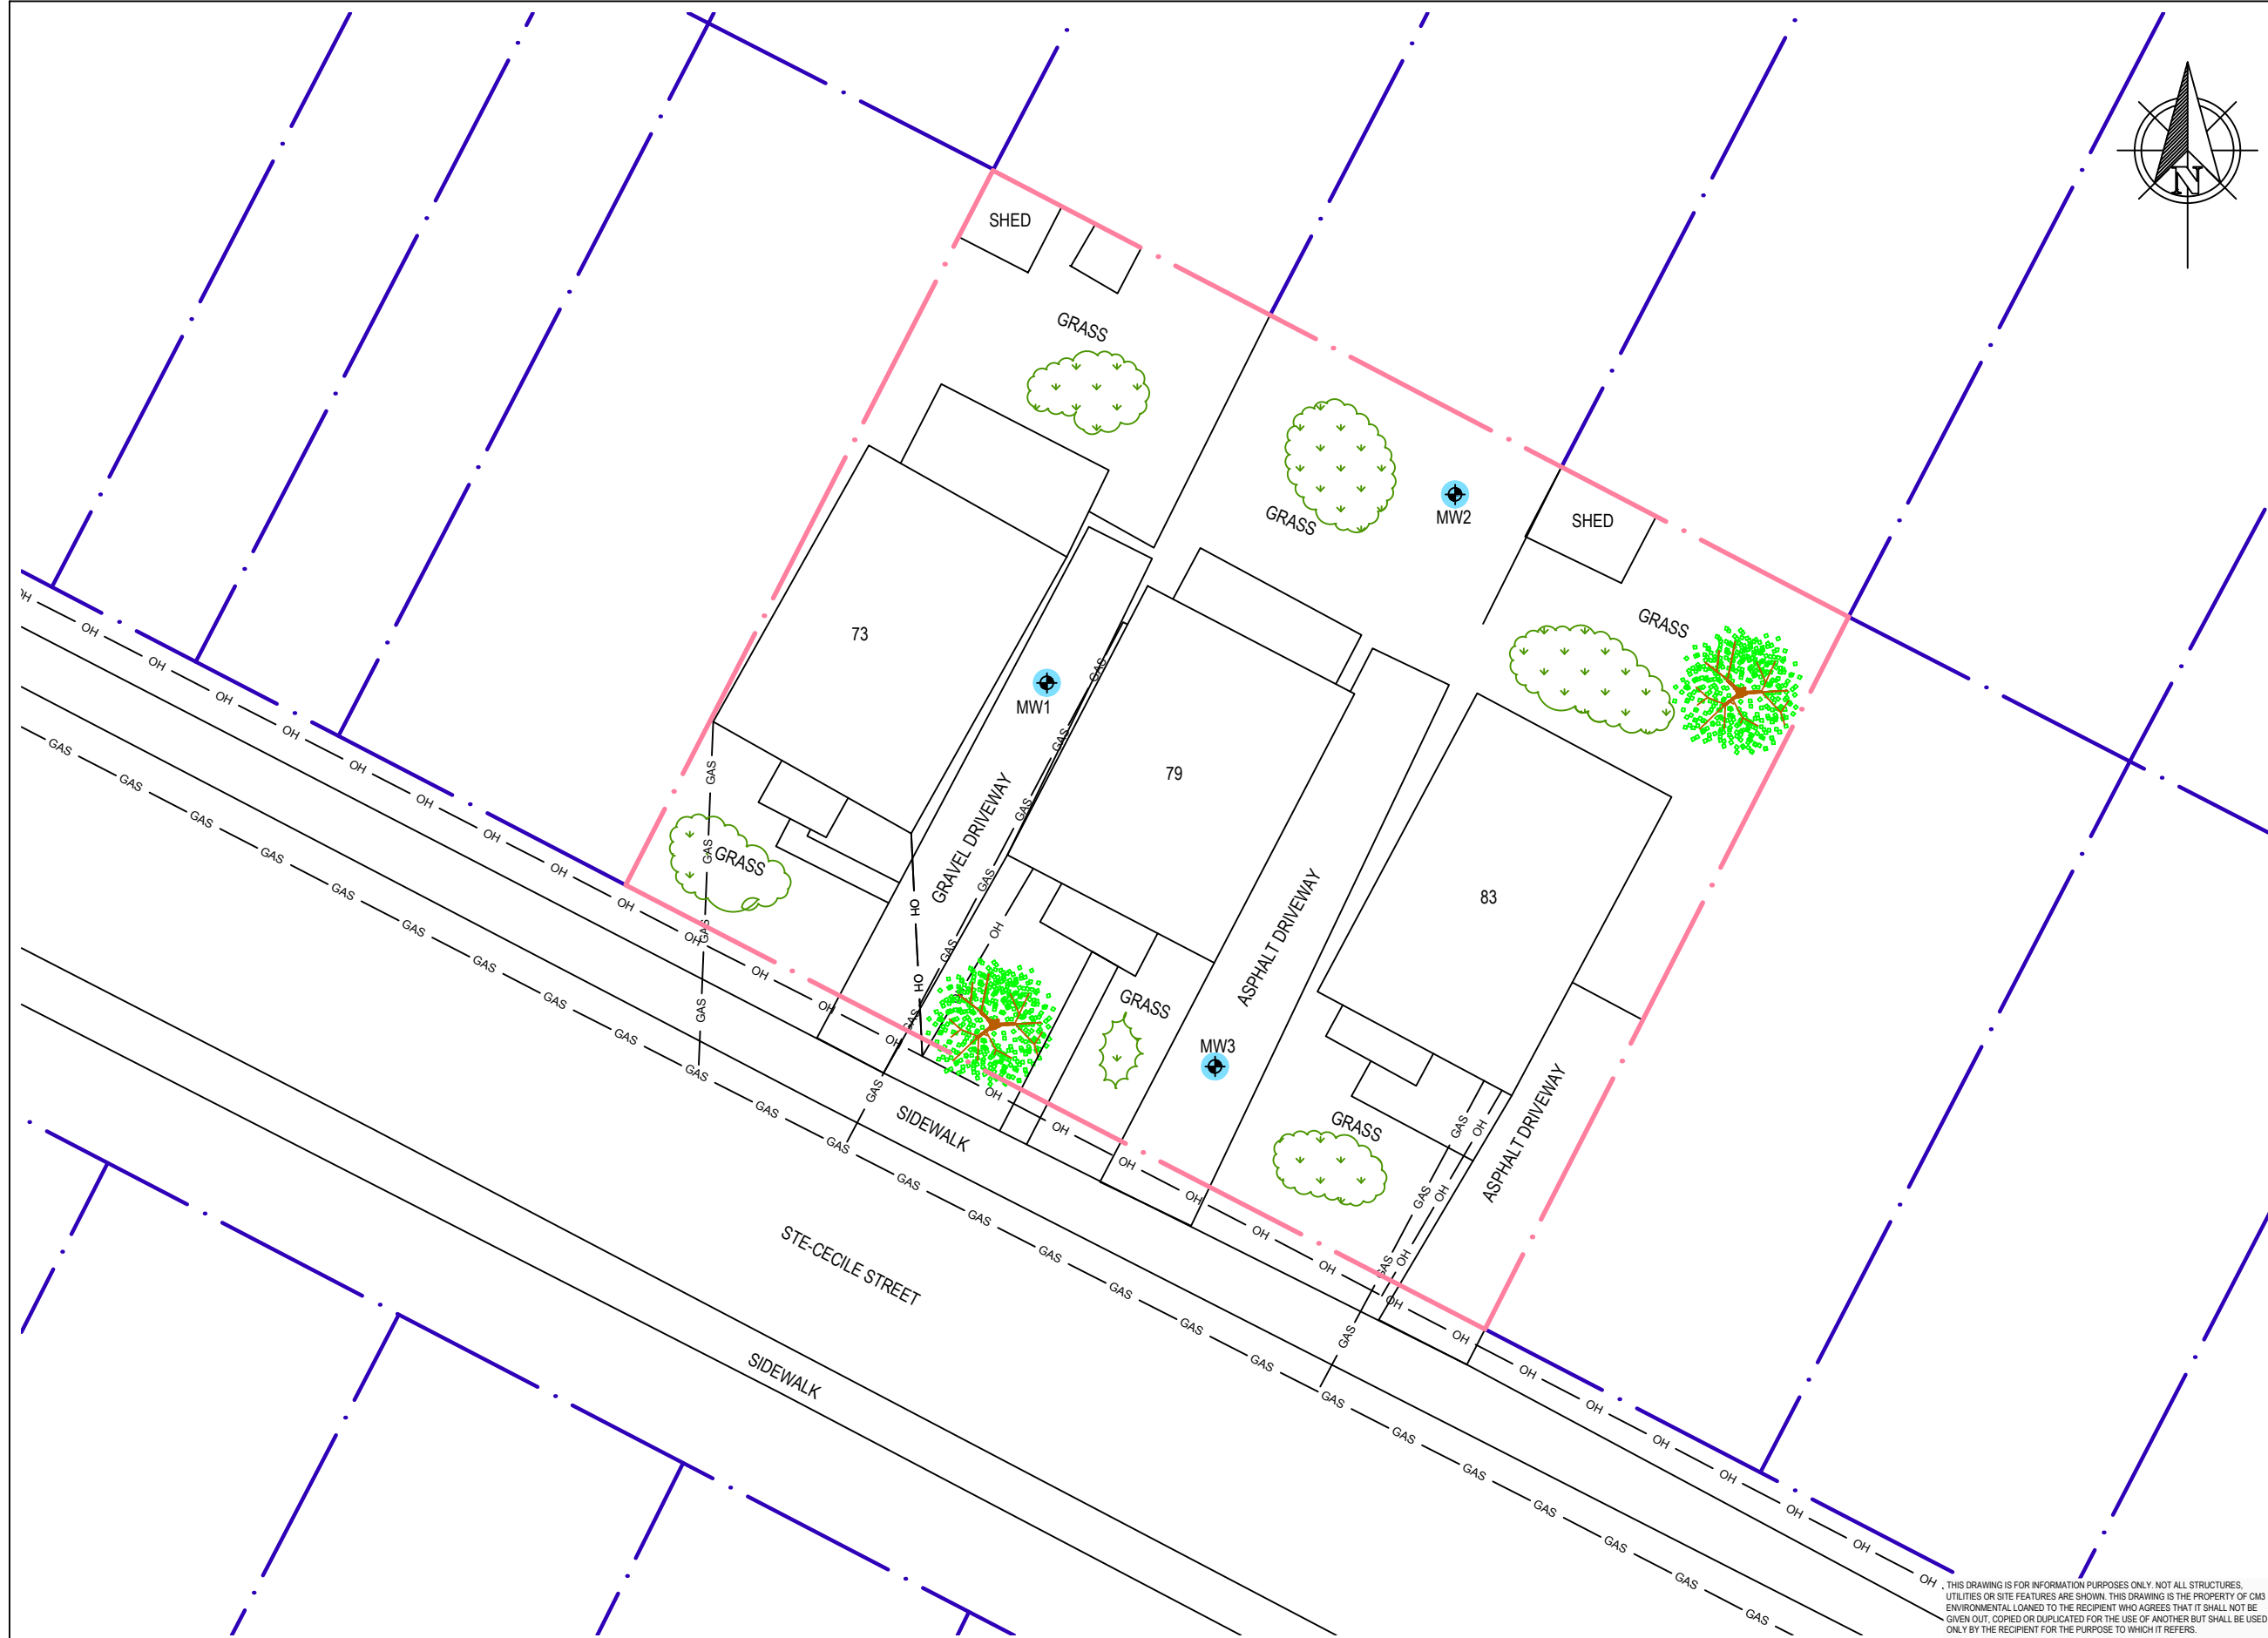
| Scale: | 1:250 | Figure: | 6 |

A total of 18 soil samples were collected from boreholes MW1, MW2 and MW3 for field screening and combustible vapour analysis. The vapour concentrations in borehole MW1 varied at depth and were between 40 ppm to 100 ppm. Vapour concentrations in borehole MW2 were between 35 to 110 ppm and vapour concentrations in MW3 were between 30 to 60 ppm. The borehole locations are provided on **Figure 4** and the vapour concentrations and field observations are included on the borehole logs, **Appendix A**.

Borehole samples MW1 SA7, MW2 SA4, and MW3 SA2 were analysed for VOCs, PAHs, PHCs F1-F4 fractions and metals.

The analytical results showed the presence of one or more PHCs F1-F4 fraction in MW1 SA7 and MW3 SA2. PHCs F1-F4 fractions were not detected in sample MW2 SA4. The concentration of

PHCs F1-F4 fractions detected in samples MW1 SA7 and MW3 SA2 met the Table 5 SCS. VOCs were not detected in any of the analysed samples, meeting the Table 5 SCS.

The PAHs fluoranthene, phenanthrene, and pyrene were detected in the soil sample MW2 SA4 at concentrations that comply with the Table 5 SCS. PAHs were not detected in any of the other analysed samples, meeting the MECP Table 5 SCS.

Metals were detected in all three borehole soil samples MW1 SA7, MW2 SA4 and MW3 SA2 at concentrations that comply with the Table 5 SCS.
