**HENRY INVESTMENTS  
14072375 Canada Inc.**

**Phase II Environmental Site Assessment  
73-79, 83 Ste-Cecile,  
Vanier, Ontario**

**CM3 Project SDC1009**

**December 20, 2022**

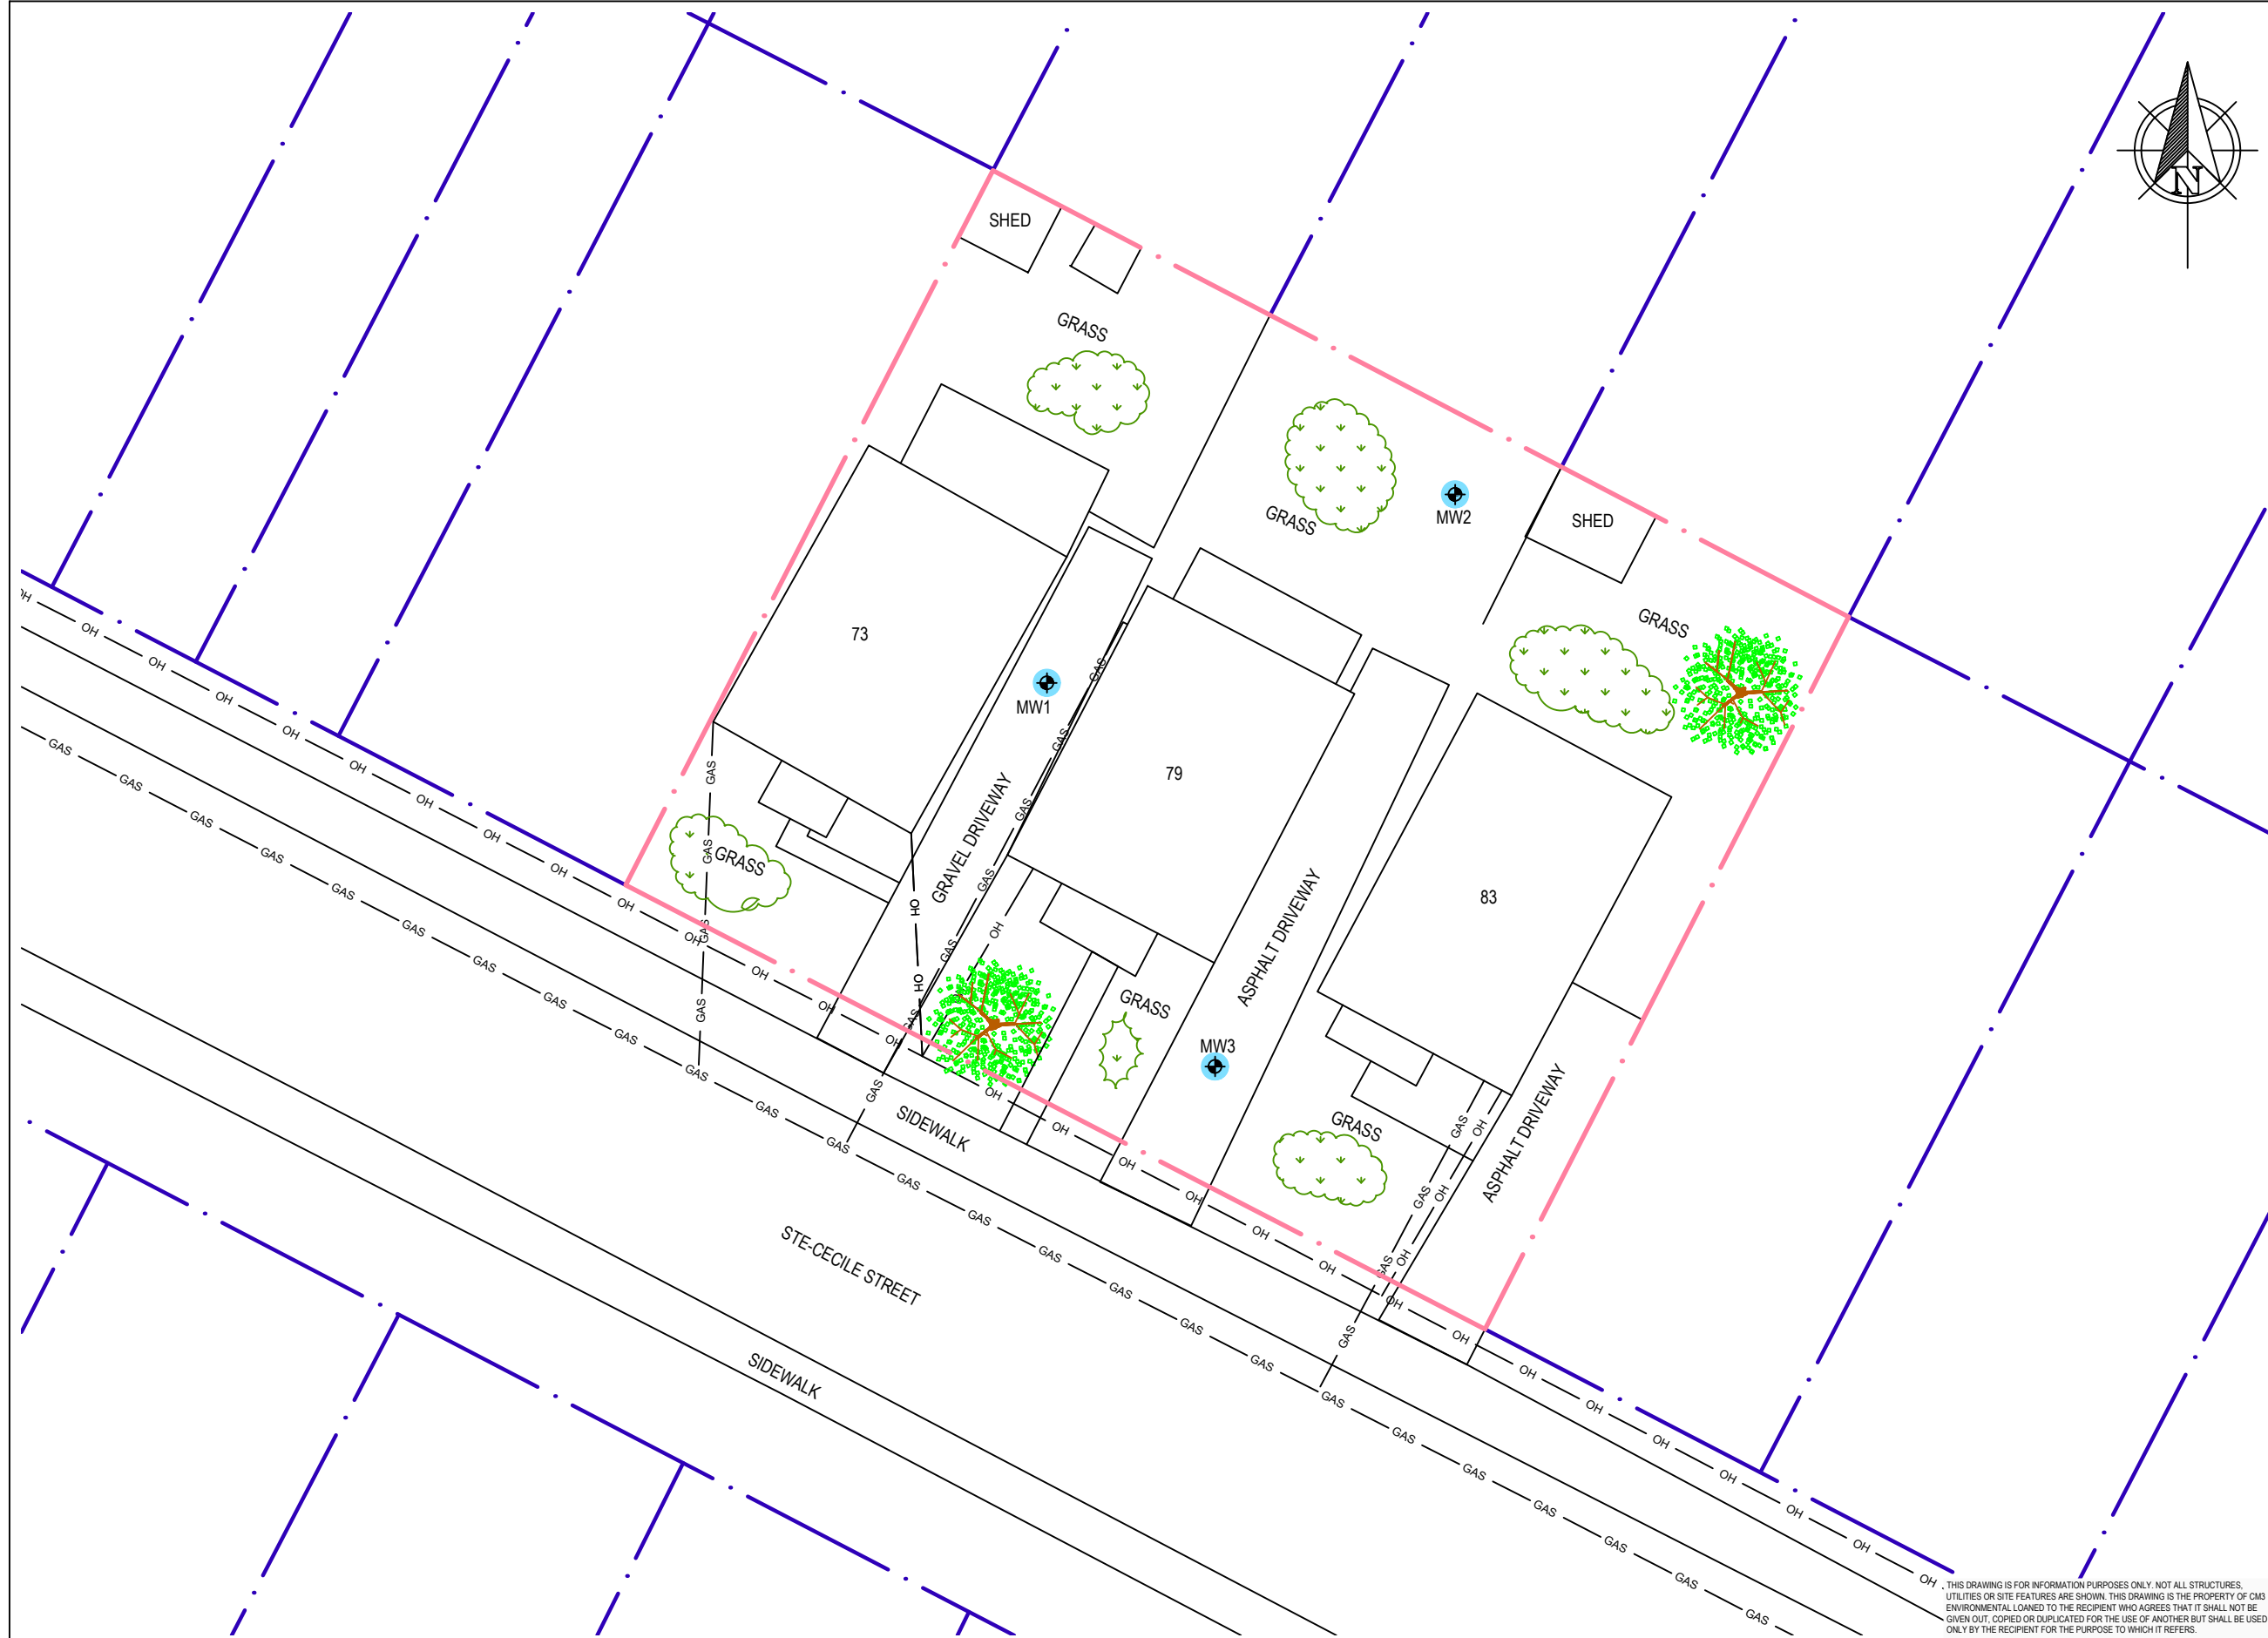
Groundwater samples MW1, MW2 and MW3 were analysed for VOCs, PHCs F1-F4 fractions, PAHs and metals. The groundwater sample analytical results are summarized in **Table 3**. The monitoring well locations and groundwater quality are provided on **Figure 7**. The groundwater sample laboratory reports are provided in **Appendix B**.

VOCs and PHCs F1-F4 fractions were not detected in any of the groundwater samples, meeting the MECP Table 5 SCS.

PAHs were not detected in samples MW1 and MW3, meeting the MECP Table 5 SCS. Several PAHs were detected in sample MW2 at concentrations that met the MECP Table 5 SCS.

Several metals were detected in all three samples, at concentrations below the MECP Table 5 SCS.

The results of the Phase II ESA did not identify impacts at any of the investigated APECs. No further environmental assessment is recommended, and the existing groundwater monitoring wells should be decommissioned prior to site development, as per Ontario regulation 903.
