**Phase Two Environmental Site Assessment  
Proposed Residential Development  
1174 Carp Road  
Ottawa, Ontario**

GEMTEC Project: 101785.004

January 7, 2025  
GEMTEC Project: 101785.004

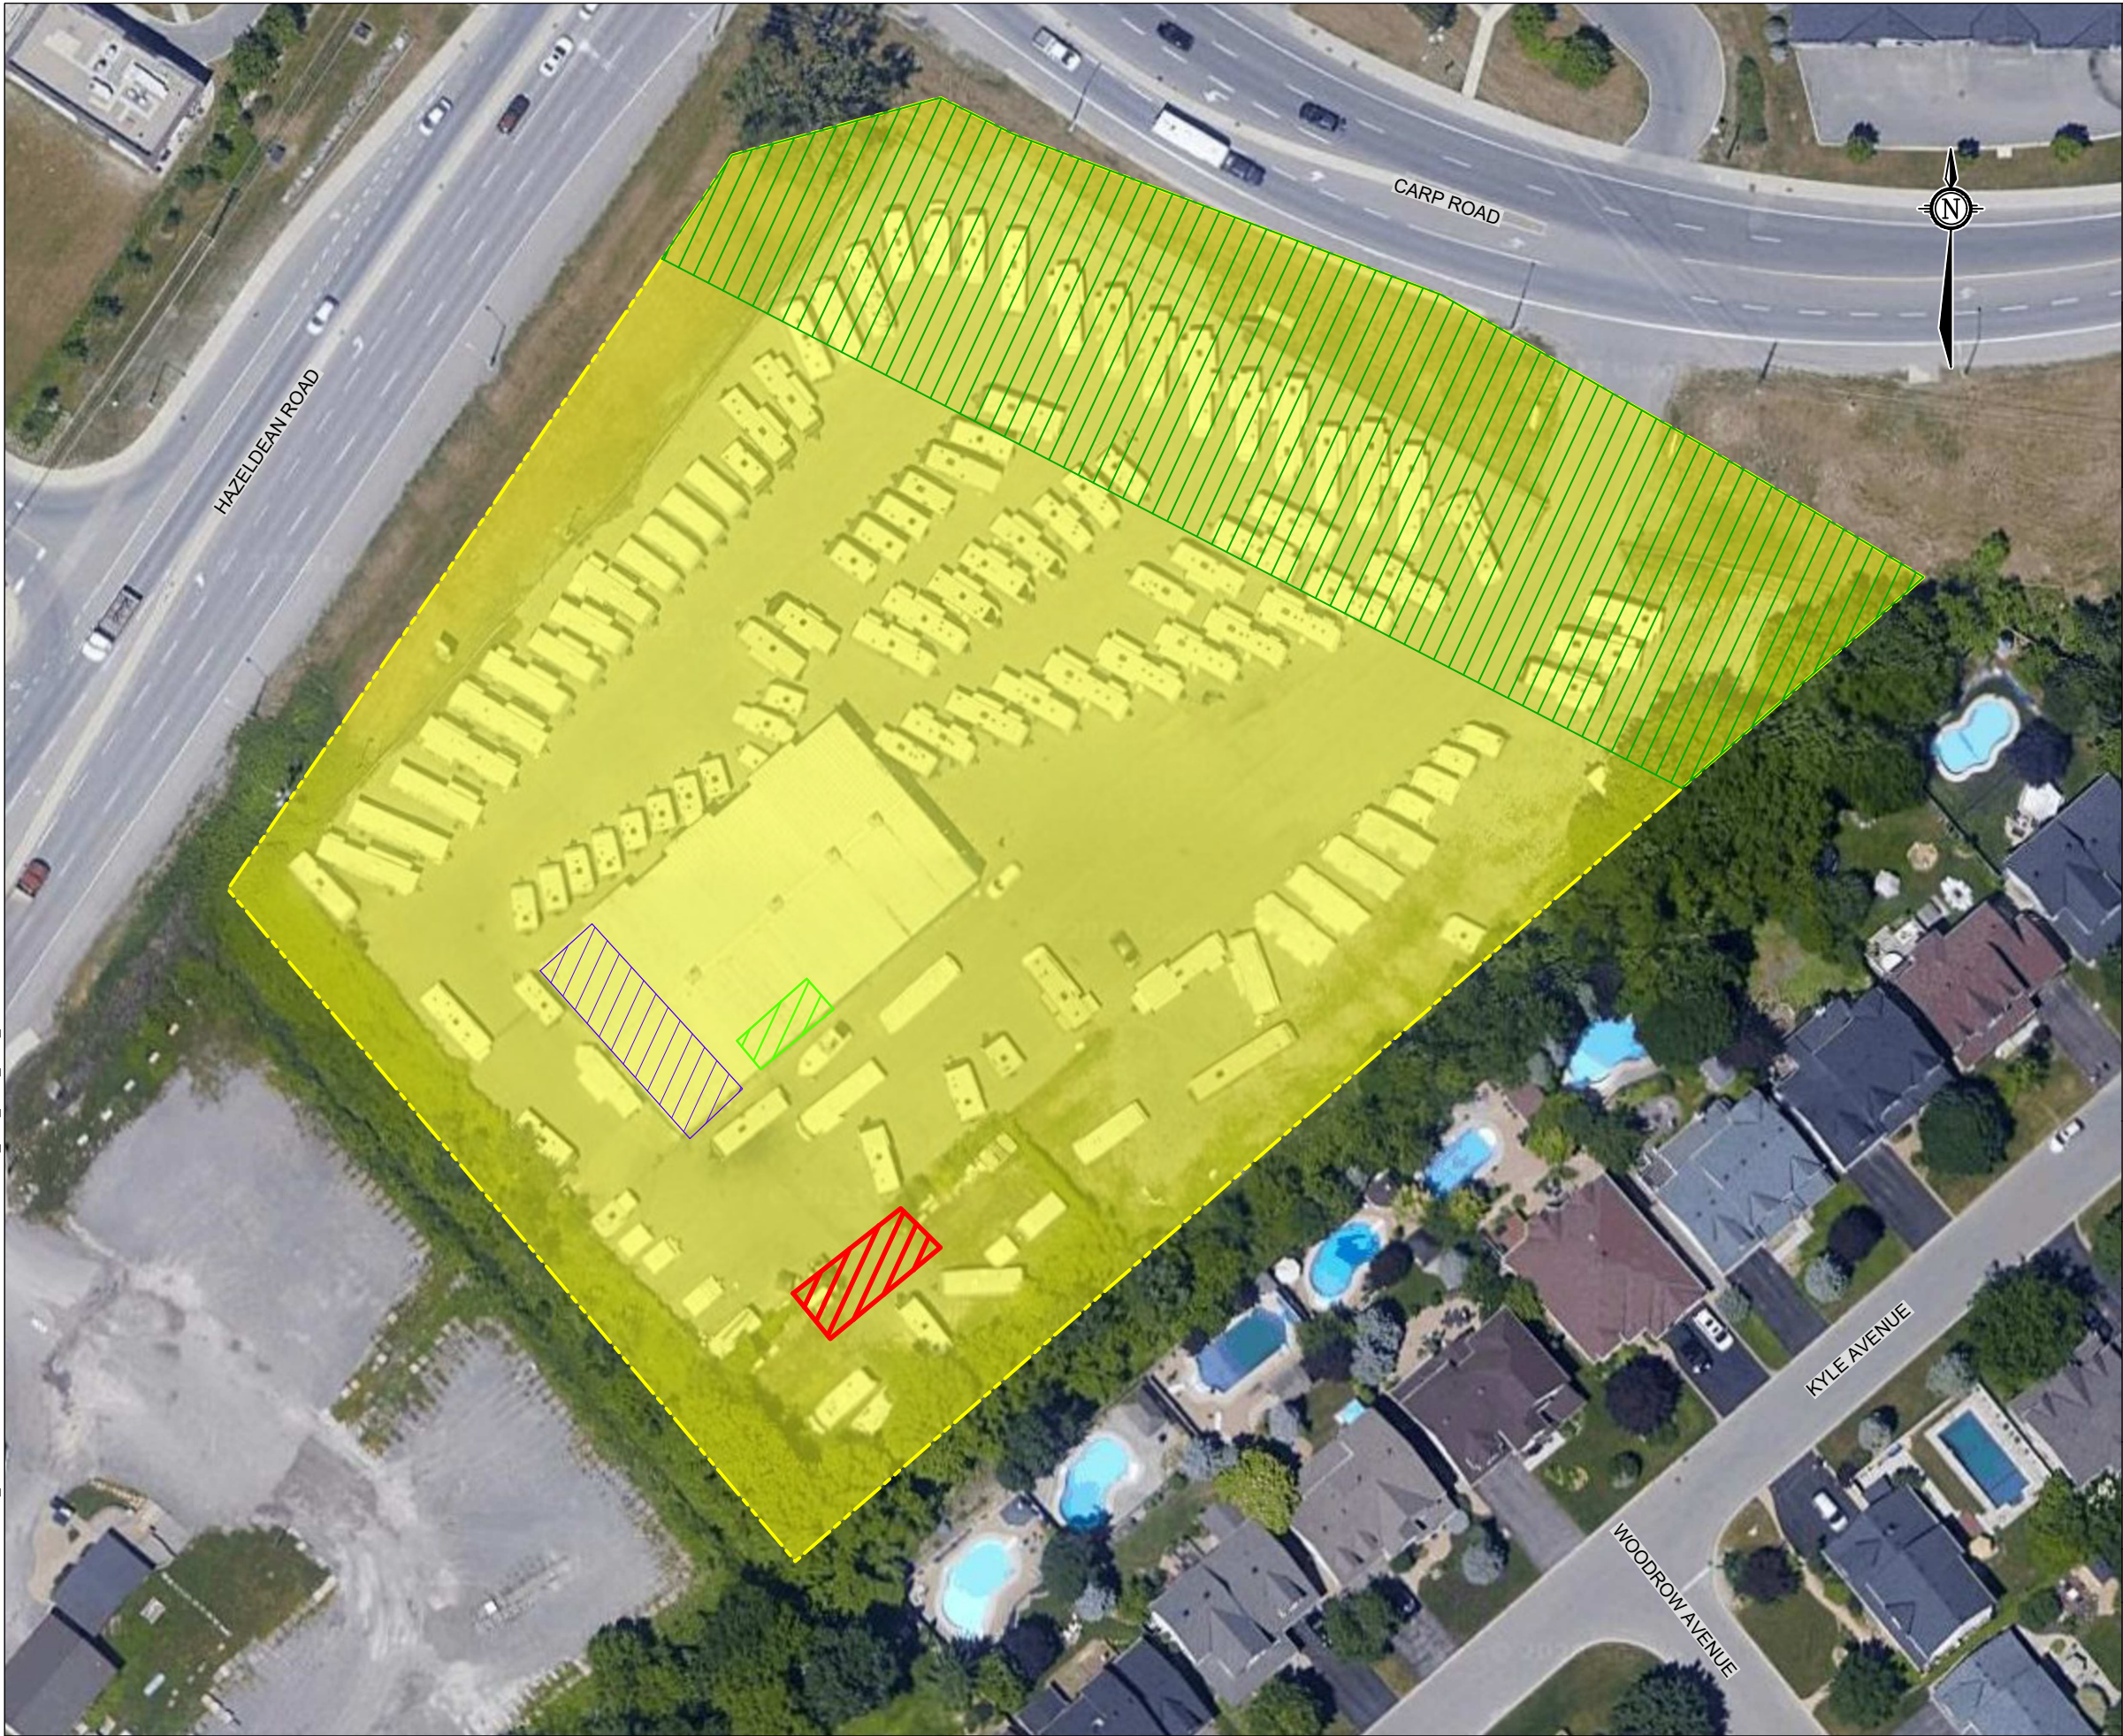
- APEC 1 – Presence of Fill Material at the Site
    - Through the review of aerial photographs, the Site has been developed since at least 1976 considering the presence of a structure on the Site. However, ground disturbance related to a cleared area and a structure was first noted in the eastern portion of the Site in the aerial photograph from 1932. The fill material is expected to be present across the Site. The COPCs were PHC F1-F4, VOCs, PAHs, and M&Is in soil.

- APEC 2 – Presence of historical ASTs at the Site
    - Through the review of aerial photographs, two ASTs were noted at the Site in the southwestern portion of the Site between 2005 and 2022. Considering the observations made during the review of aerial photographs

- APEC 3 – Presence of an automotive repair garage on-Site
  - Through the review of insurance reports, historical reports (Phase I ESA prepared by GEMTEC in 2023), and Site reconnaissance, the Site has historically had an auto repair garage/automotive repair facility located in the western portion of the on-Site structure. The COPCs are PHC F1-F4, Metals, PAHs, and VOCs in soil and groundwater.

- APEC 4 – Potential presence of a former oil water separator
  - During the Site reconnaissance, GEMTEC noted a concrete filled pit, potentially related to an oil/water separator. The COPCs are PHC F1-F4, and VOCs in soil and groundwater.
