**Geotechnical Investigation Report  
Proposed Development  
5872, 5880, and 5884 Hazeldean  
Road and 7 Savage Drive  
Ottawa, Ontario**

GEMTEC Project: 104054.001

Hazeldean Heights Inc.  
5872, 5880, and 5884 Hazeldean Road and 7 Savage Drive  
Stittsville, Ontario  
K2S1Z2

October 2, 2025  
GEMTEC Project: 104054.001

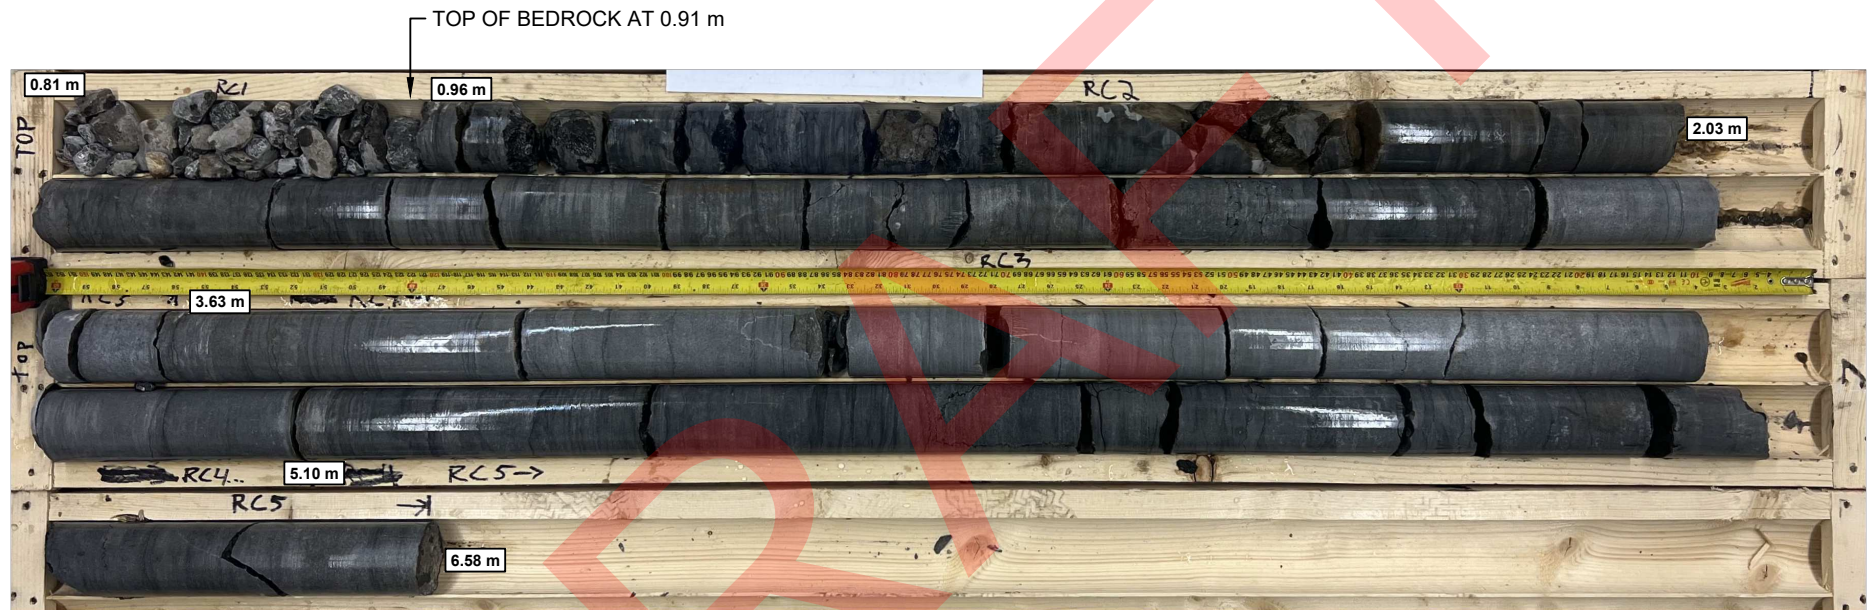
**FIGURE C2**

**BOREHOLE: 25-01**  
**BORING DATE: APRIL 30, 2025**  
**DEPTH: 0.81 TO 6.58 METRES BELOW GROUND SURFACE**

NOTE: MATERIAL IN CORE BOX FROM 0.81 TO 0.91 METRES BELOW GROUND SURFACE IS GRAVEL WITHIN FILL MATERIAL

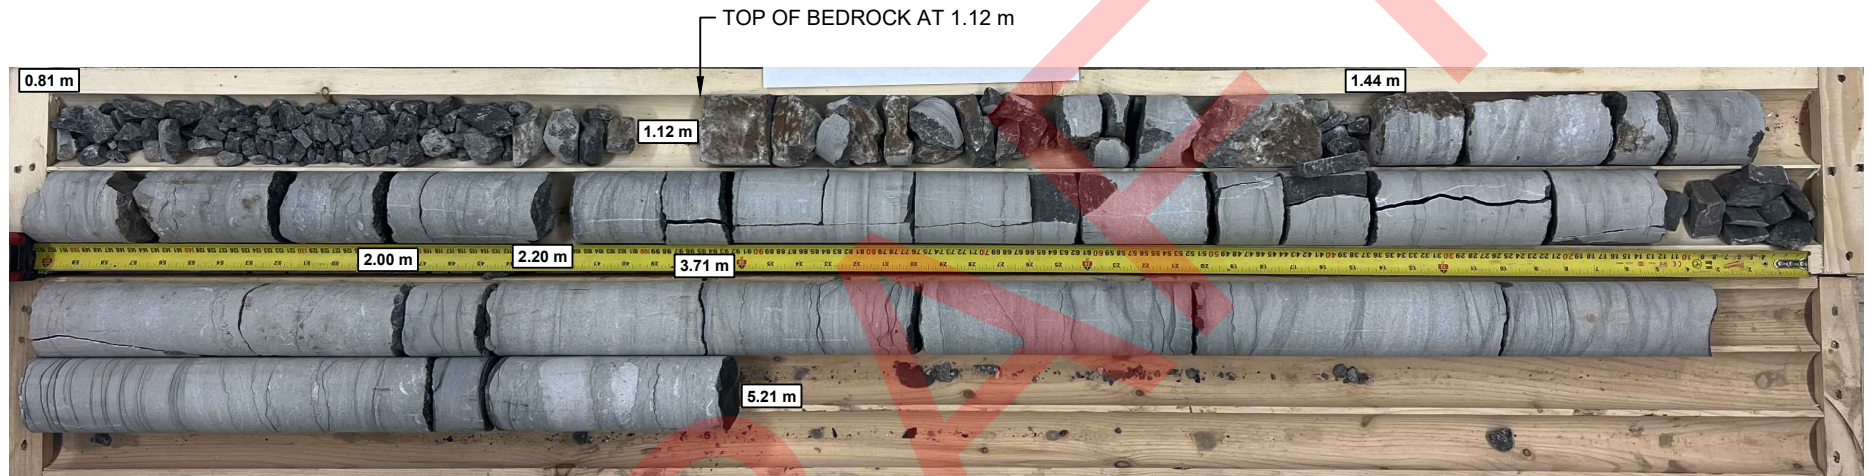
**FIGURE C3**

**BOREHOLE: 25-02**  
**BORING DATE: APRIL 30, 2025**  
**DEPTH: 0.81 TO 5.21 METRES BELOW GROUND SURFACE**

NOTE: MATERIAL IN CORE BOX FROM 0.81 TO 1.12 METRES BELOW GROUND SURFACE IS GRAVEL WITHIN FILL MATERIAL

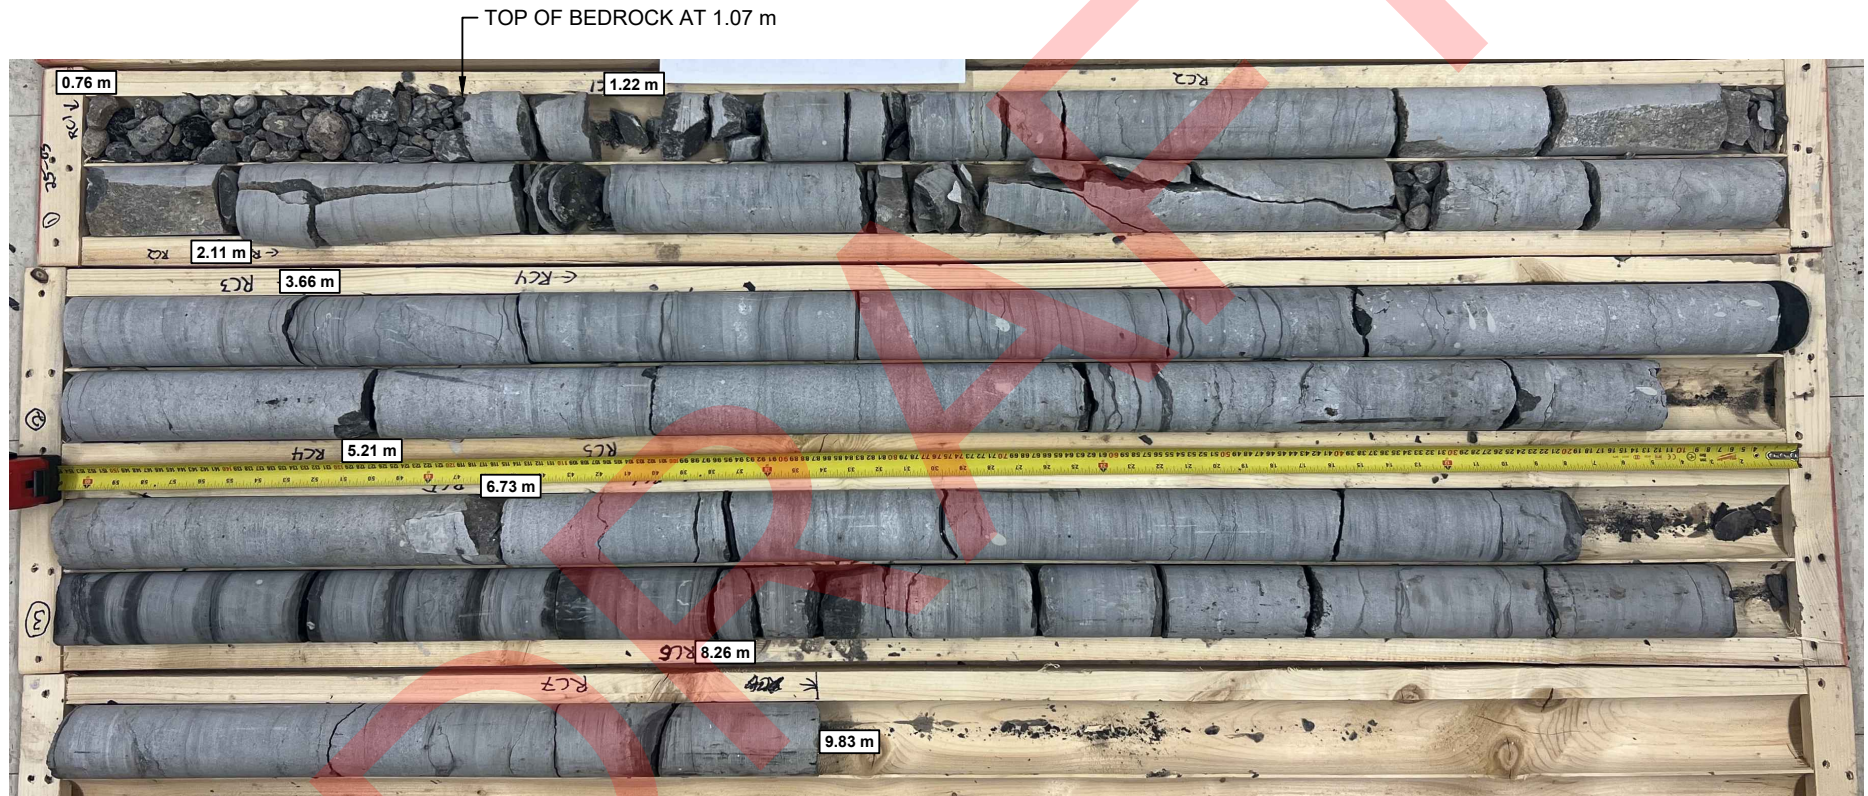
**FIGURE C5**

**BOREHOLE: 25-03**  
**BORING DATE: MAY 1, 2025**  
**DEPTH: 0.76 TO 9.83 METRES BELOW GROUND SURFACE**

NOTE: MATERIAL IN CORE BOX FROM 0.76 TO 1.07 METRES BELOW GROUND SURFACE IS GRAVEL WITHIN FILL MATERIAL

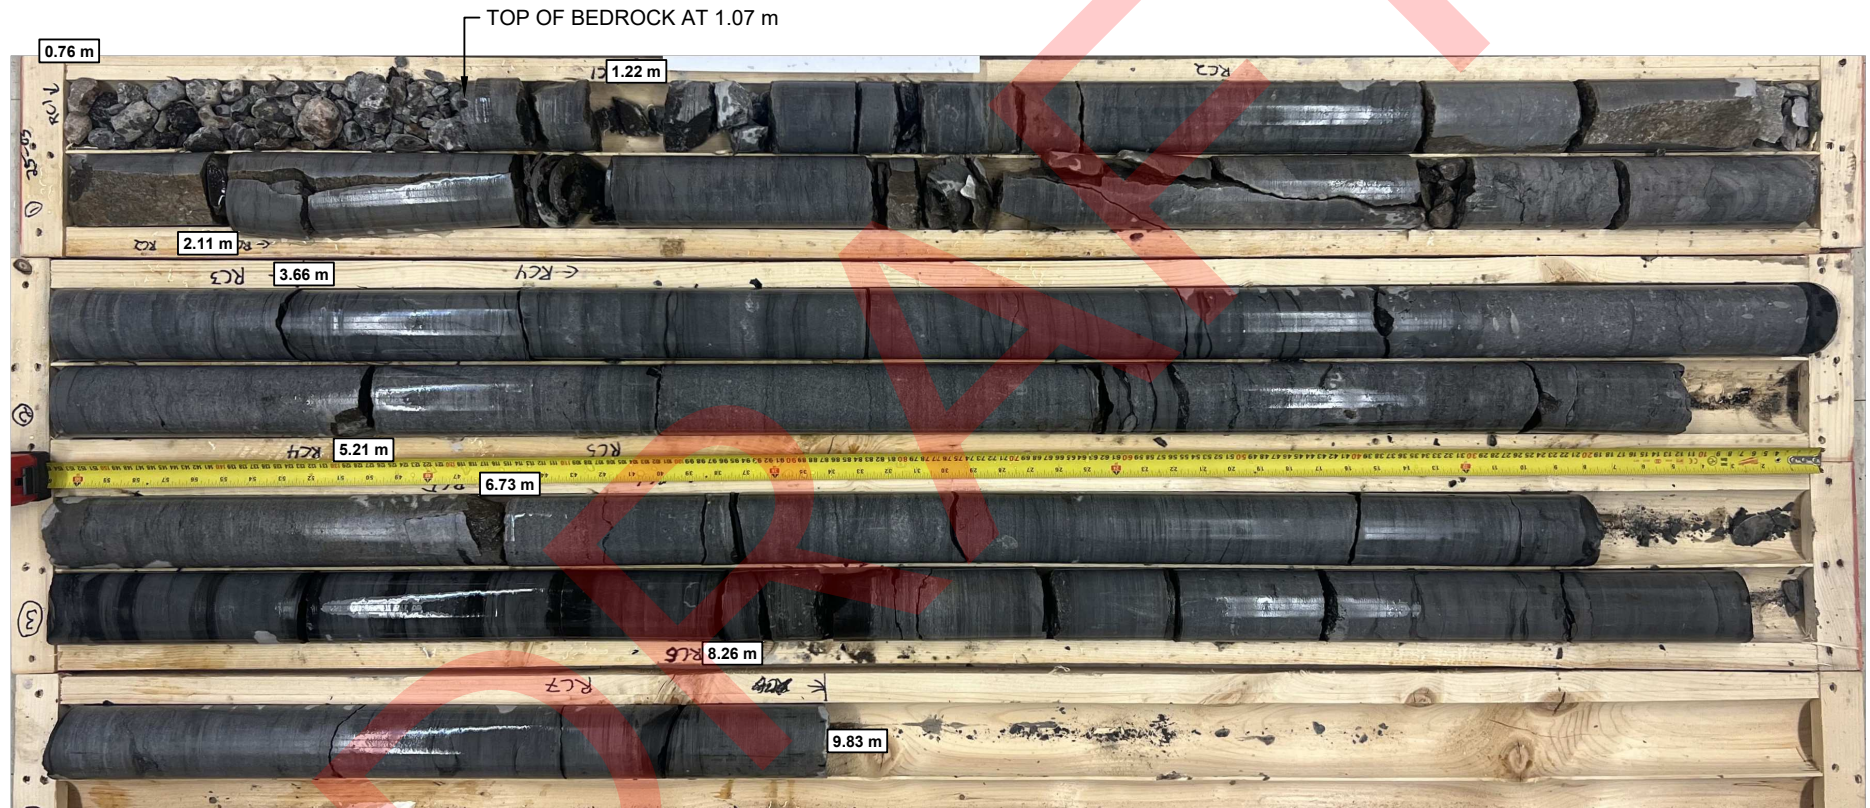
**BOREHOLE: 25-03**  
**BORING DATE: MAY 1, 2025**  
**DEPTH: 0.76 TO 9.83 METRES BELOW GROUND SURFACE**

NOTE: MATERIAL IN CORE BOX FROM 0.76 TO 1.07 METRES BELOW GROUND SURFACE IS GRAVEL WITHIN FILL MATERIAL
