**GEOFIRMA ENGINEERING LTD.
PROPOSED WILD BIRD CARE CENTRE**

**8520 McArton Road
Ottawa, Ontario**

DRAFT REPORT

January 10, 2020

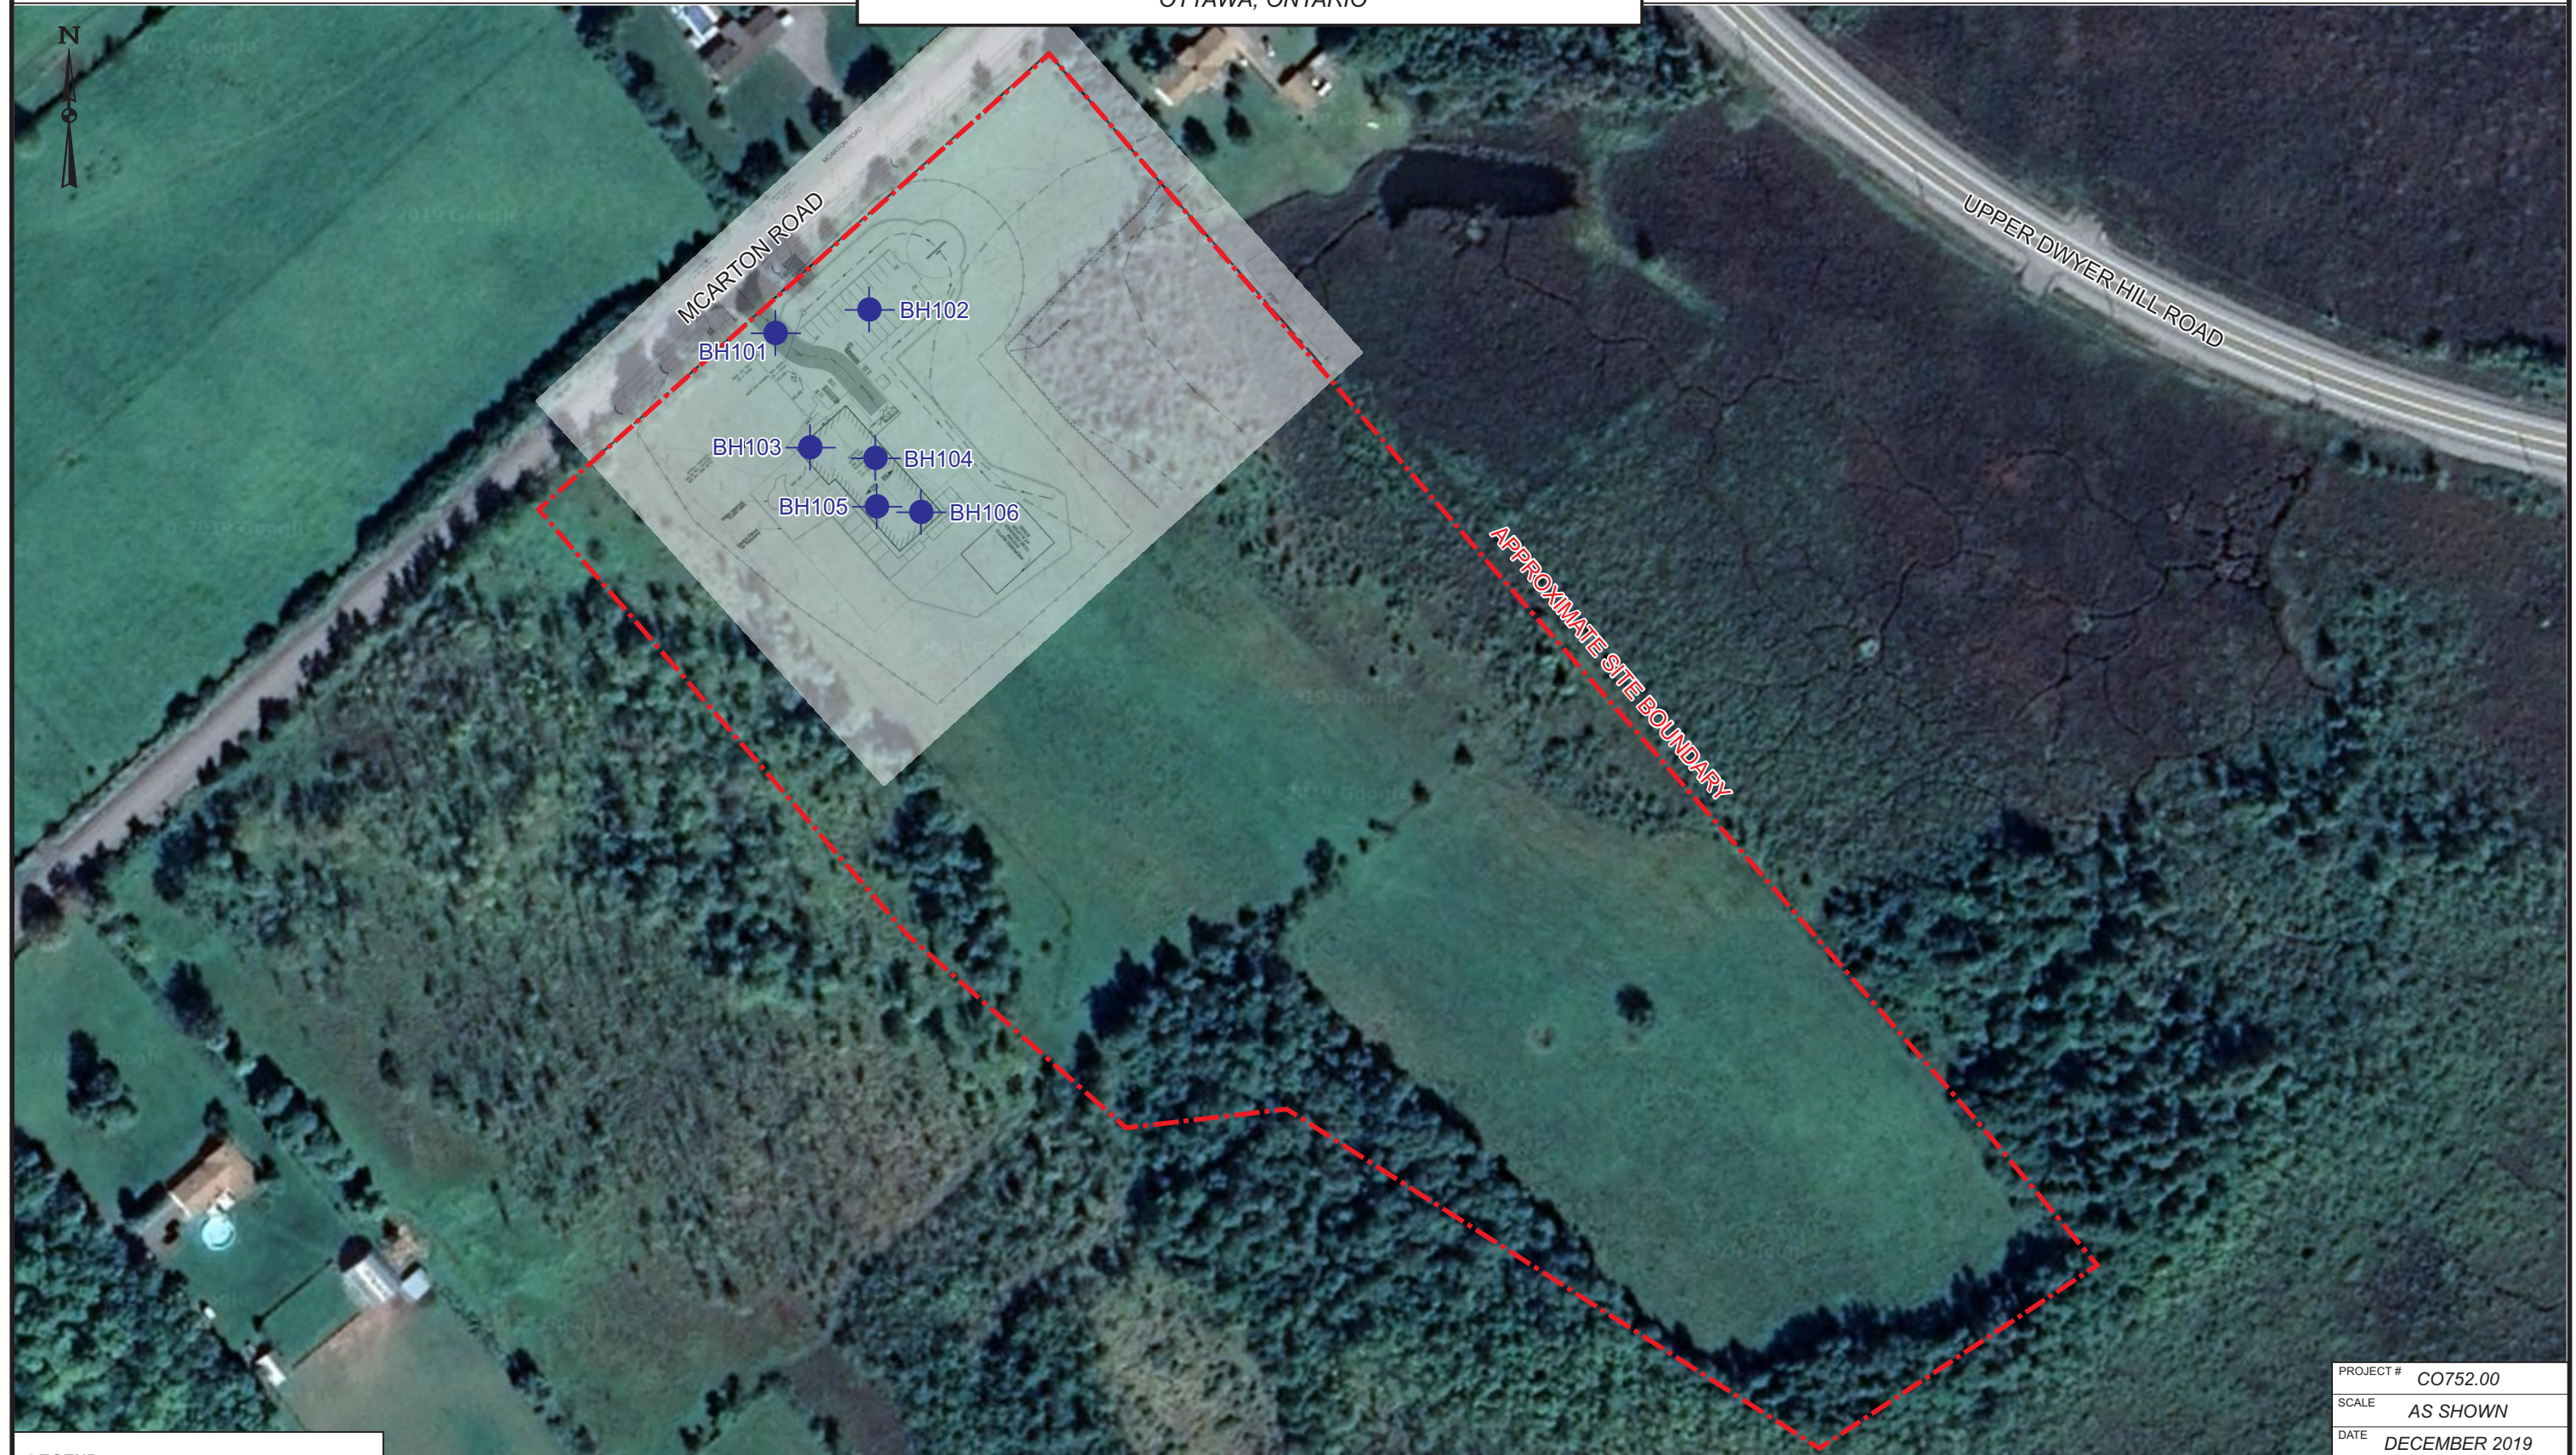
FIGURE 1
BOREHOLE LOCATION PLAN

The location of the proposed development is shown on Figure 1: Borehole Location Plan attached to this report. The base drawing was provided for our use by Geofirma Engineering Ltd.; attached in Appendix V.

The fieldwork for this investigation was carried out on December 16 and 17, 2019. It consisted of six (6) boreholes, advanced by a drilling contractor commissioned by **Terrapex**. The locations of the boreholes were chosen by **Terrapex** to provide general coverage of the Site; shown on Figure1: Borehole Location Plan attached to this report.

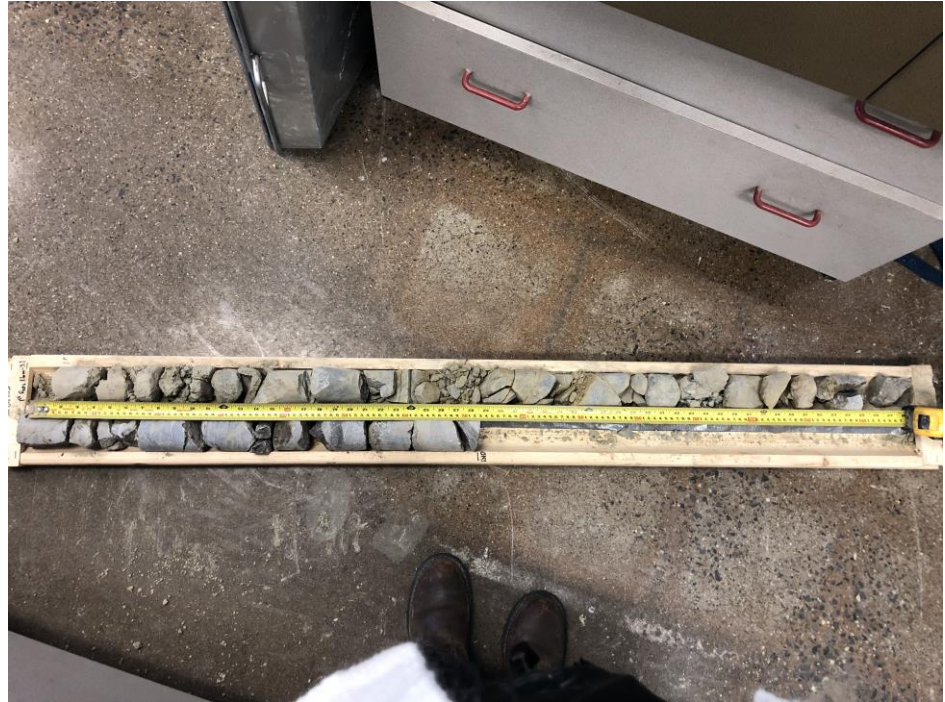
The rock core at borehole BH103 is intensely fractured with an average of six (6) fractures per foot, with core recovered mostly in lengths of 0.03 to 0.1 m. The rock is considered to be moderately weathered with discoloration throughout. Total Core Recovery (TCR) ranged between 92% and 95%. The Rock Quality Designation (RQD) value ranged from 0% to 9%; very poor condition.

Client: Geofirma Engineering Ltd.**Site Location:** 8520 McArton Road, Ottawa, ON**Project No:** CO752.00**Photo No:** 1**Date:** December 16, 2019**Viewing Direction:**
Read core log from left to right**Description:**
BH103 Rock Core.

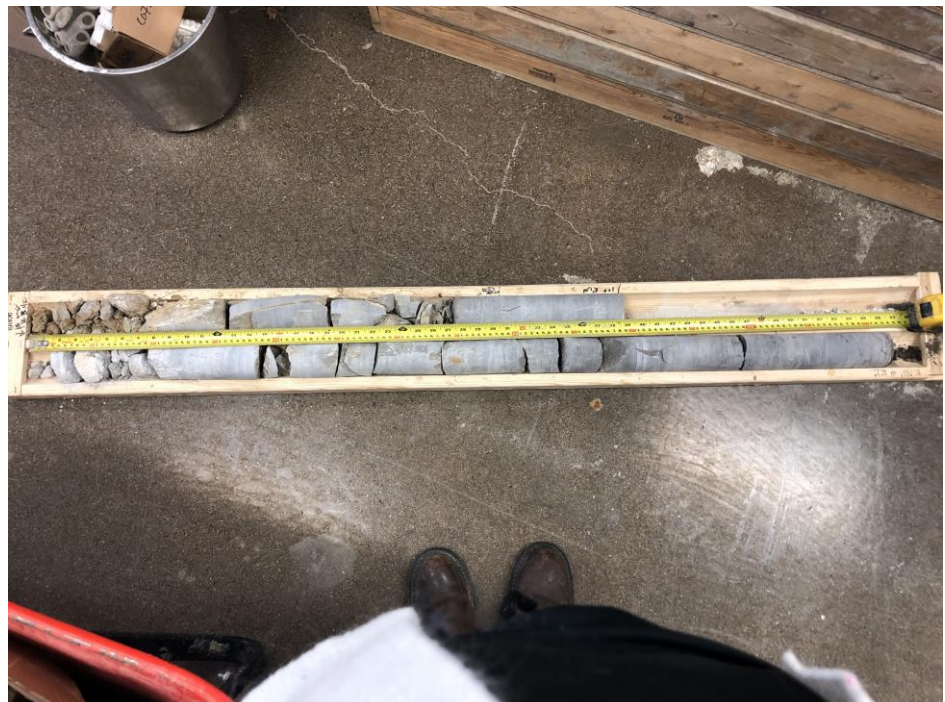
The rock core at borehole BH106 is moderately fractured with an average of four (4) fractures per foot, with core recovered mostly in lengths of 0.1 to 0.3 m, with most lengths greater than 0.2 m. The rock is considered to be moderately weathered within the top 0.5 m to slightly weathered with depth. Total Core Recovery (TCR) ranged between 96% and 98%. The Rock Quality Designation (RQD) value ranged from 0% to 78%; which indicates a very poor to good condition.

**Photo No:** 2**Date:** December 16, 2019**Viewing Direction:**
Read core log from left to right**Description:**
BH106 Rock Core.
