## **Geotechnical Investigation**

Proposed 10 Unit Residential Development 1164-1166 Highcroft Drive Manotick, Ontario Revision 2

LRL File No.: 180783 February, 2019, Revised March 2021

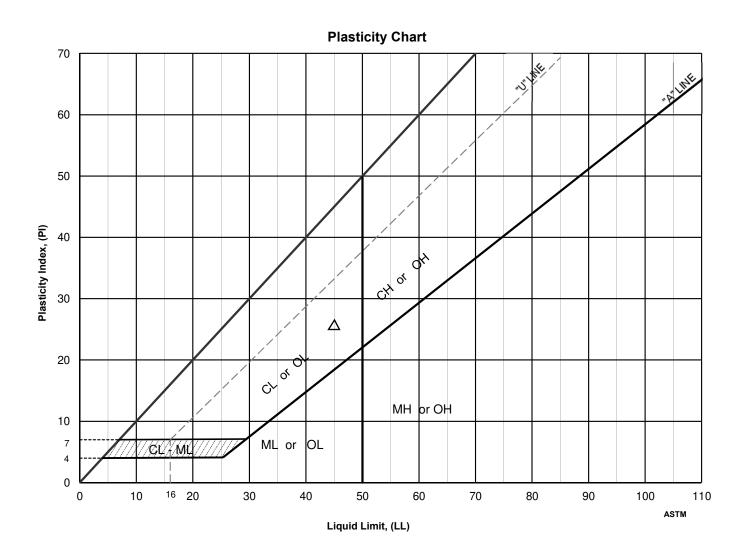
Location	Sample	Depth, m	Moisture Content, %	Liquid Limit	Plastic Limit	Plasticity Index	Liquidity Index	Activity Number	uscs
$\triangle$	BH 5	SS-3	1.52 - 2.13	42	45	19	26	0.88	n/d	CL

Atterberg limits and moisture contents were conducted on the spoon soil sample collected between depths 1.52 and 2.13 m in BH5 (SS5-3). Based on the test result, the sample yielded a plastic limit of 19% and corresponding liquid limit of 45%. These values indicate that the subsoil contains inorganic clays of low plasticity. A summary of these values are provided below in **Table 2**.

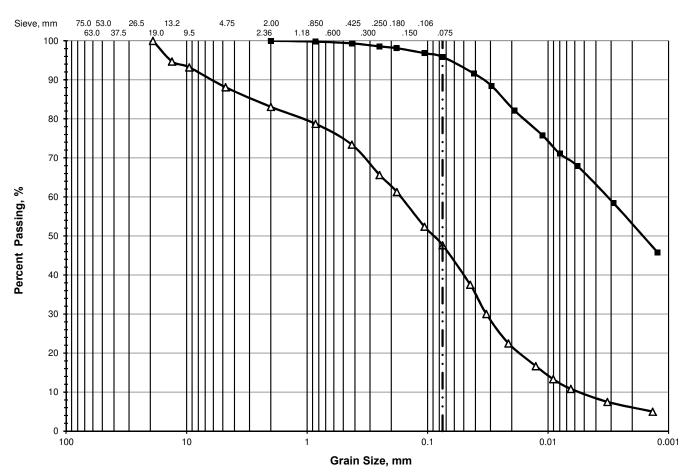
> <b>75</b> mm	% GRAVEL			% SAN	D	% FINES		
	7311111	Coarse	Fine	Coarse	Medium	Fine	Silt	Clay	
$\triangle$	0.0	0.0	11.9	5.0	9.7	25.8	41.8	5.9	
•	0.0	0.0	0.0	0.0	0.7	3.5	44.1	51.7	
					_

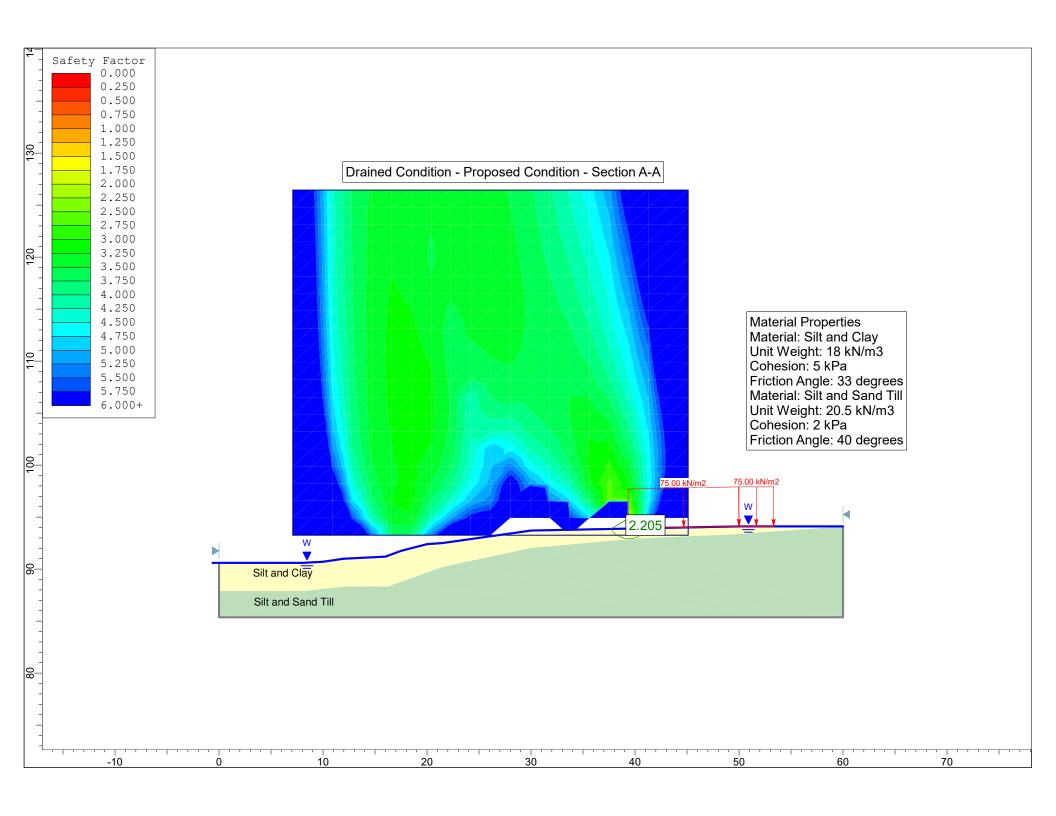
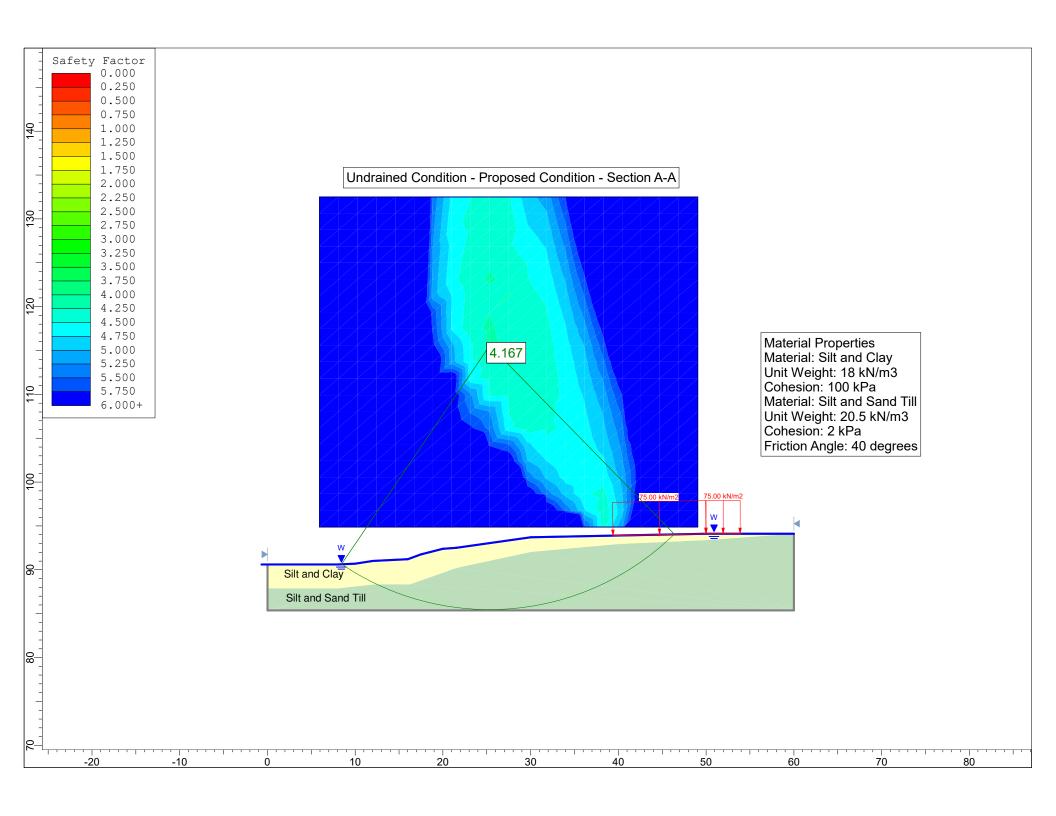
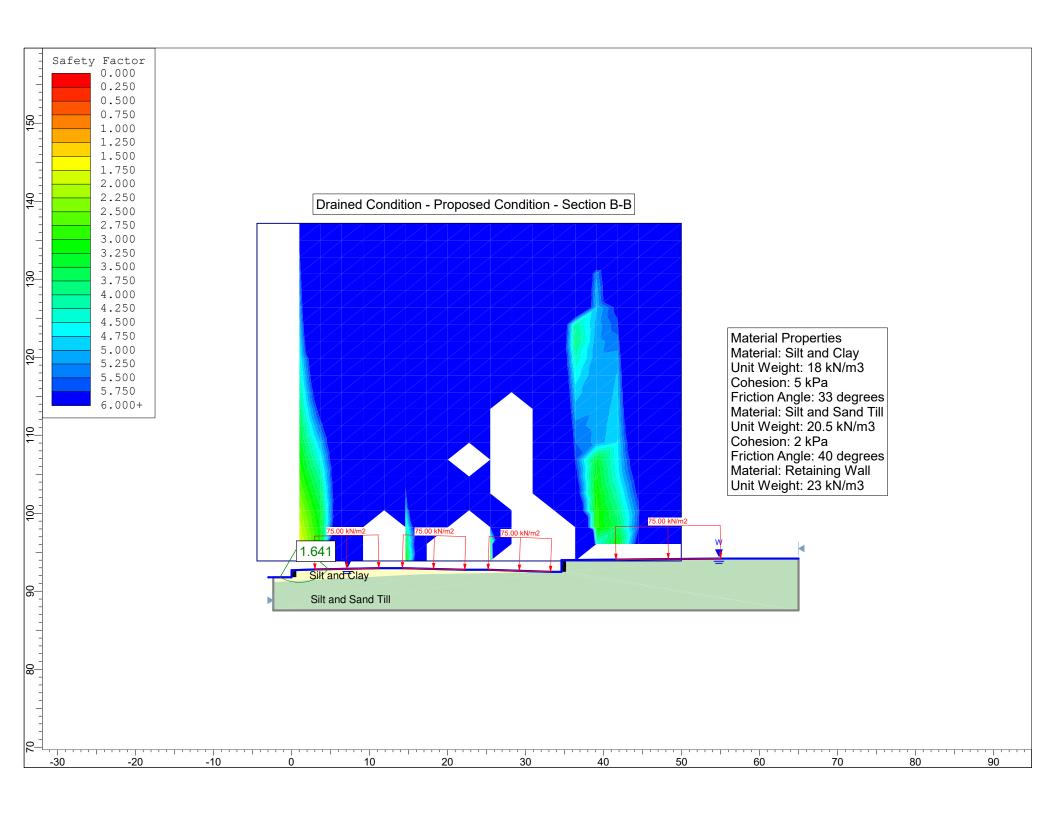
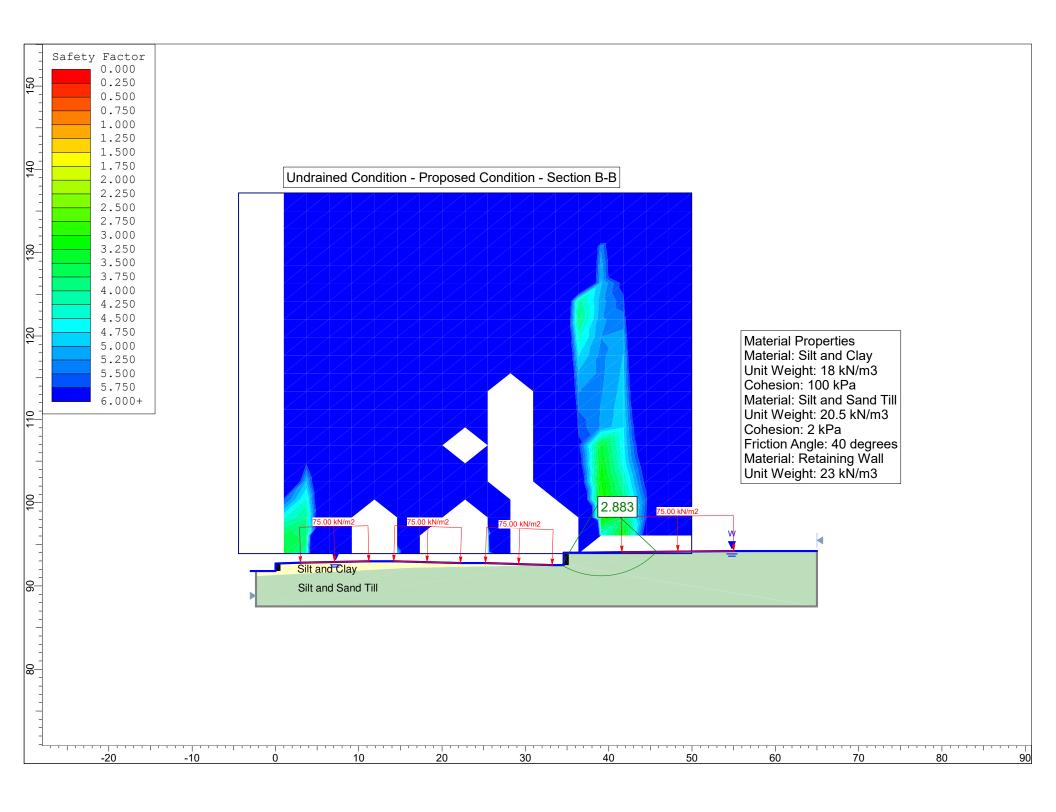
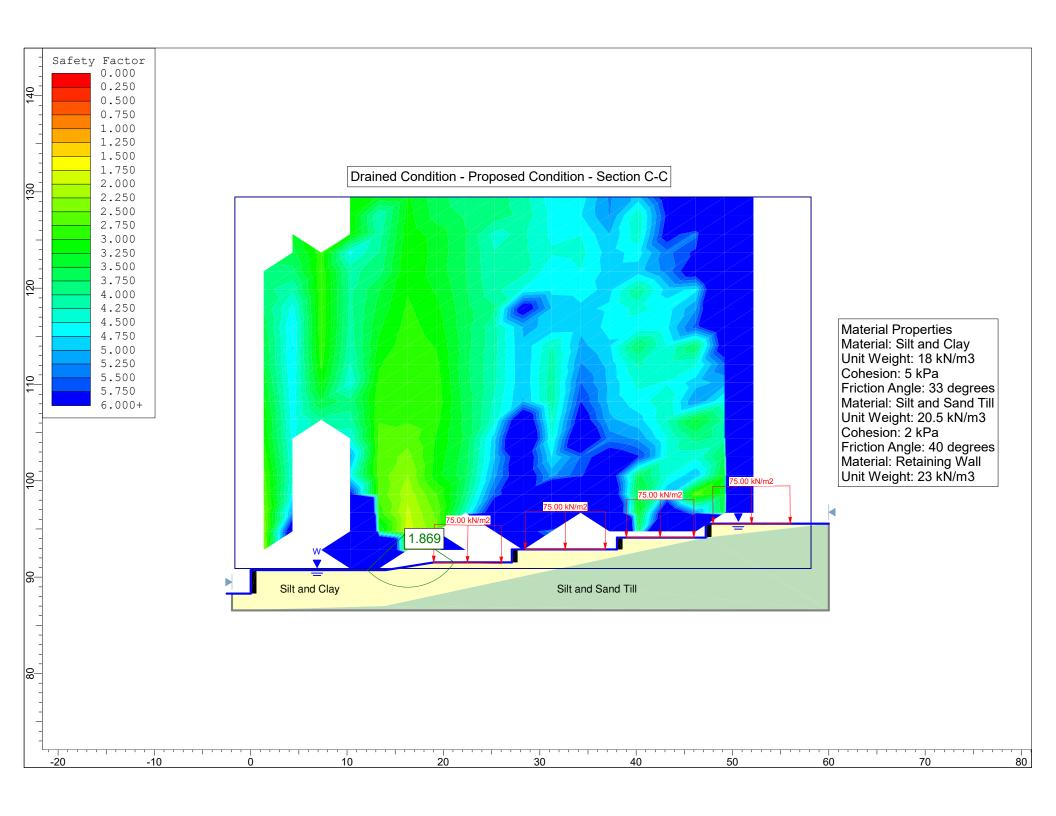
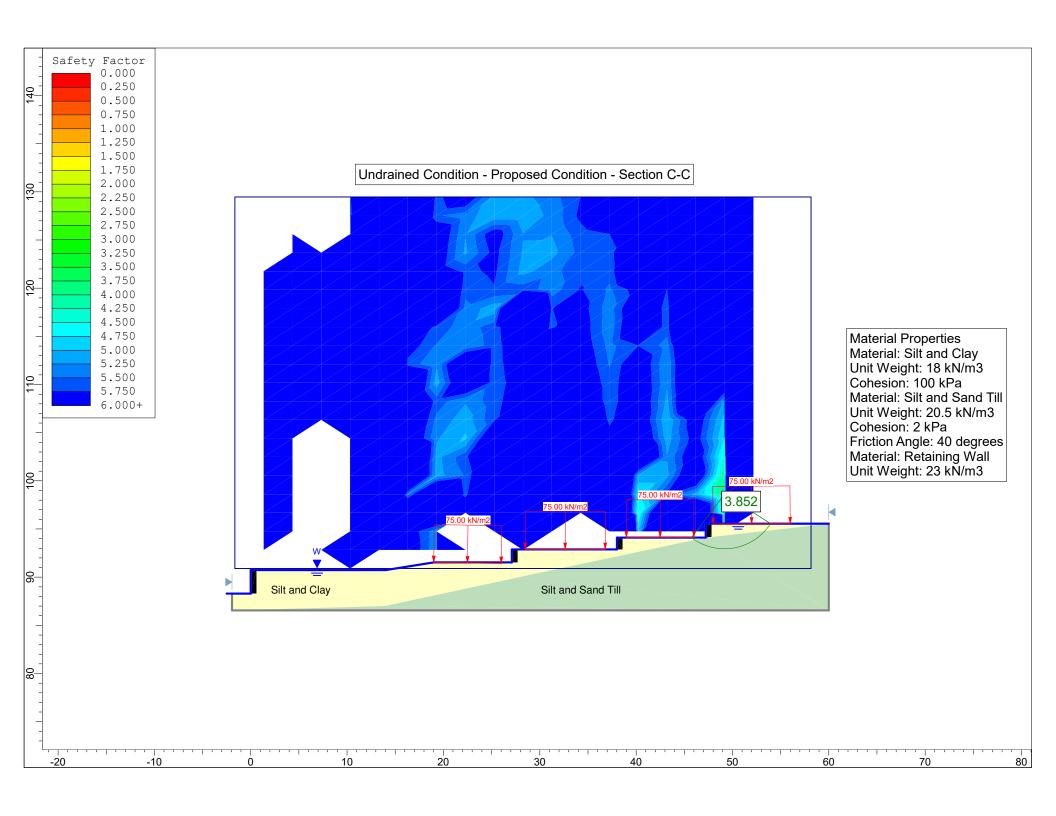
The factor of safety (FoS) against slope failure was run with the additional loading for the residential units for the undrained and drained condition. The FoS values were found ranging between 1.64 and 4.17. A FoS of 1.5 or greater is considered to be safe with regards to slope stability. The designed load was not provided (design bearing pressure at serviceability limit state) while generating this report. However a typical value assumed to be 75 kPa for similar type of residential construction was included within the model.

The slope modelling program, Slide 5.0 (Rocscience), was used to implement the Bishop simplified method of slices. Three (3) slope profiles were selected for the proposed condition and modeled to check the conditions of the slope. The proposed loading for the residential units and retaining walls were included in the models. The slope was analyzed under both the undrained (short term failure) and drained (long term failure) conditions.
