**Geotechnical Investigation  
Proposed Commercial Building  
1243 Teron Road  
Ottawa, Ontario**

November 12, 2019  
Project: 64742.02

**Re: Geotechnical Investigation  
Proposed Commercial Building  
1243 Teron Road  
Ottawa, Ontario**

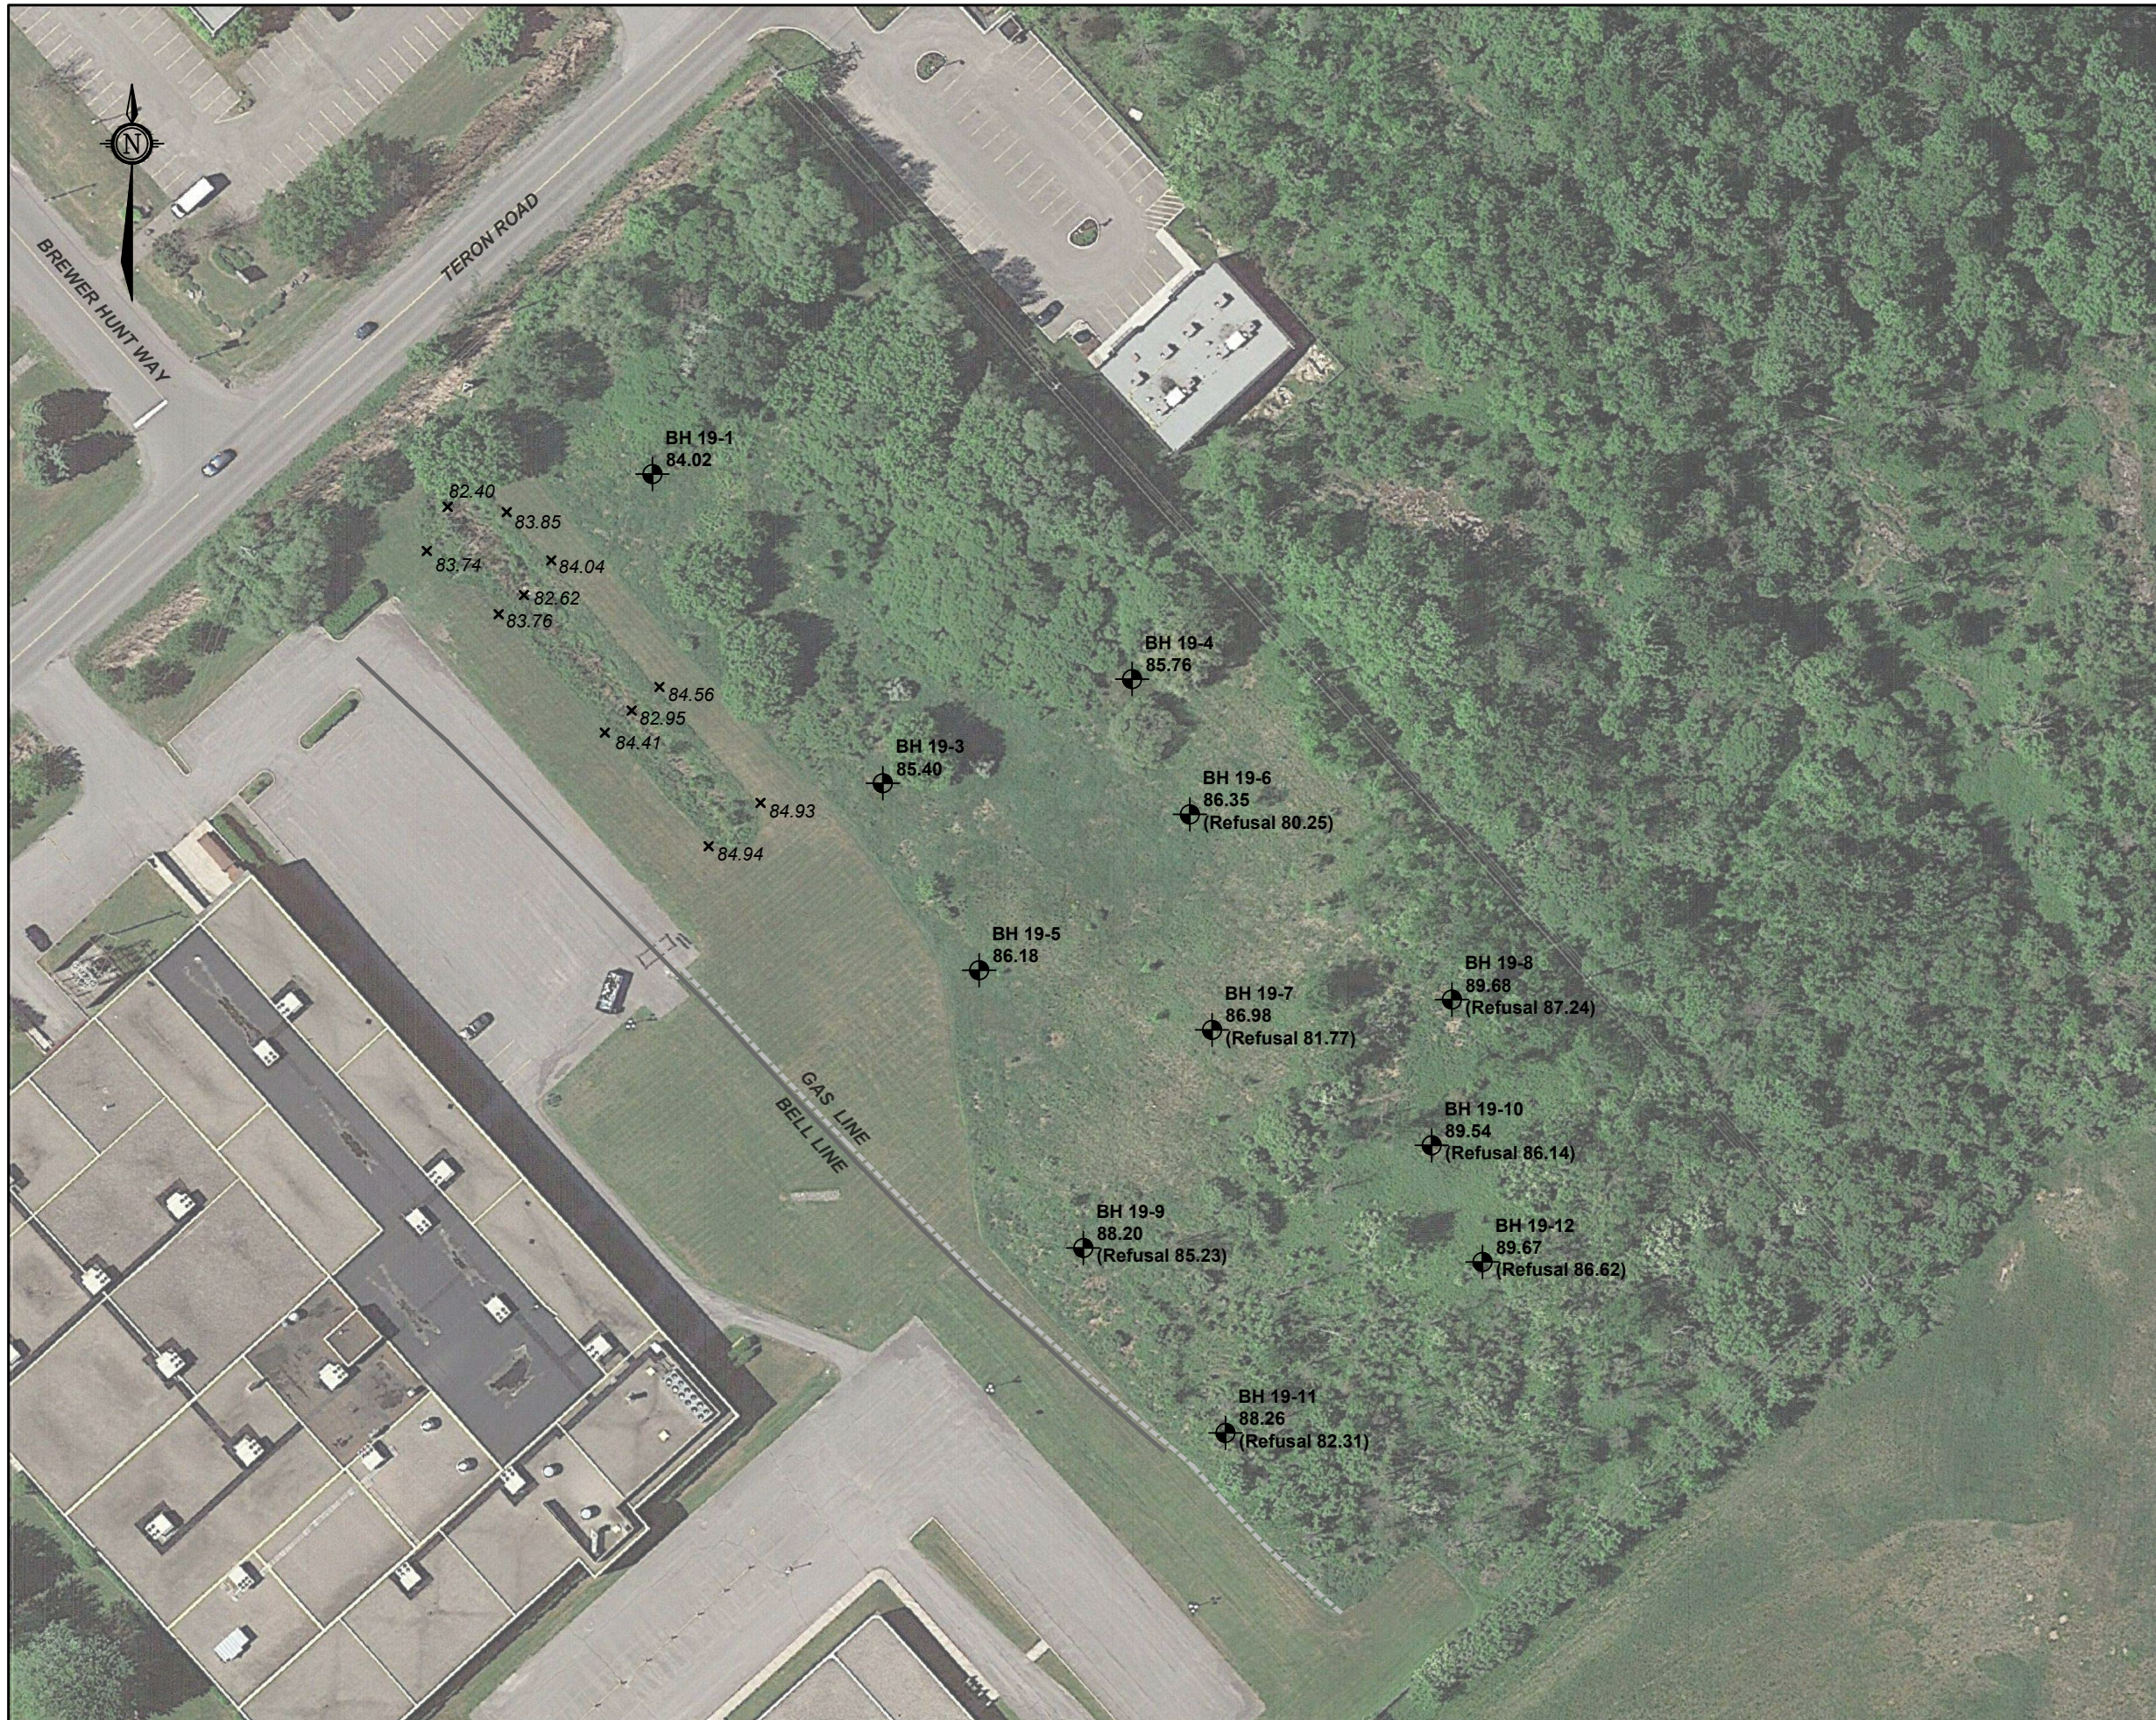
The results of the boreholes are provided on the Record of Borehole sheets in Appendix A. The approximate locations and ground surface elevations of the boreholes are shown on the Borehole Location Plan, Figure 1. The laboratory testing results are provided on the Soils Grading and Plasticity charts in Appendix B. The results of the chemical analysis of soil samples relating to corrosion of buried concrete and steel are provided in Appendix C.

This report presents the results of a geotechnical investigation carried out for the proposed commercial building located at 1243 Teron Road in Kanata (Ottawa), Ontario (see Key Plan, Figure 1). The purpose of the investigation was to identify the general subsurface conditions at the site by means of a limited number of boreholes and, based on the factual information obtained, to provide engineering guidelines on the geotechnical design aspects of the project, including construction considerations that could influence design decisions.

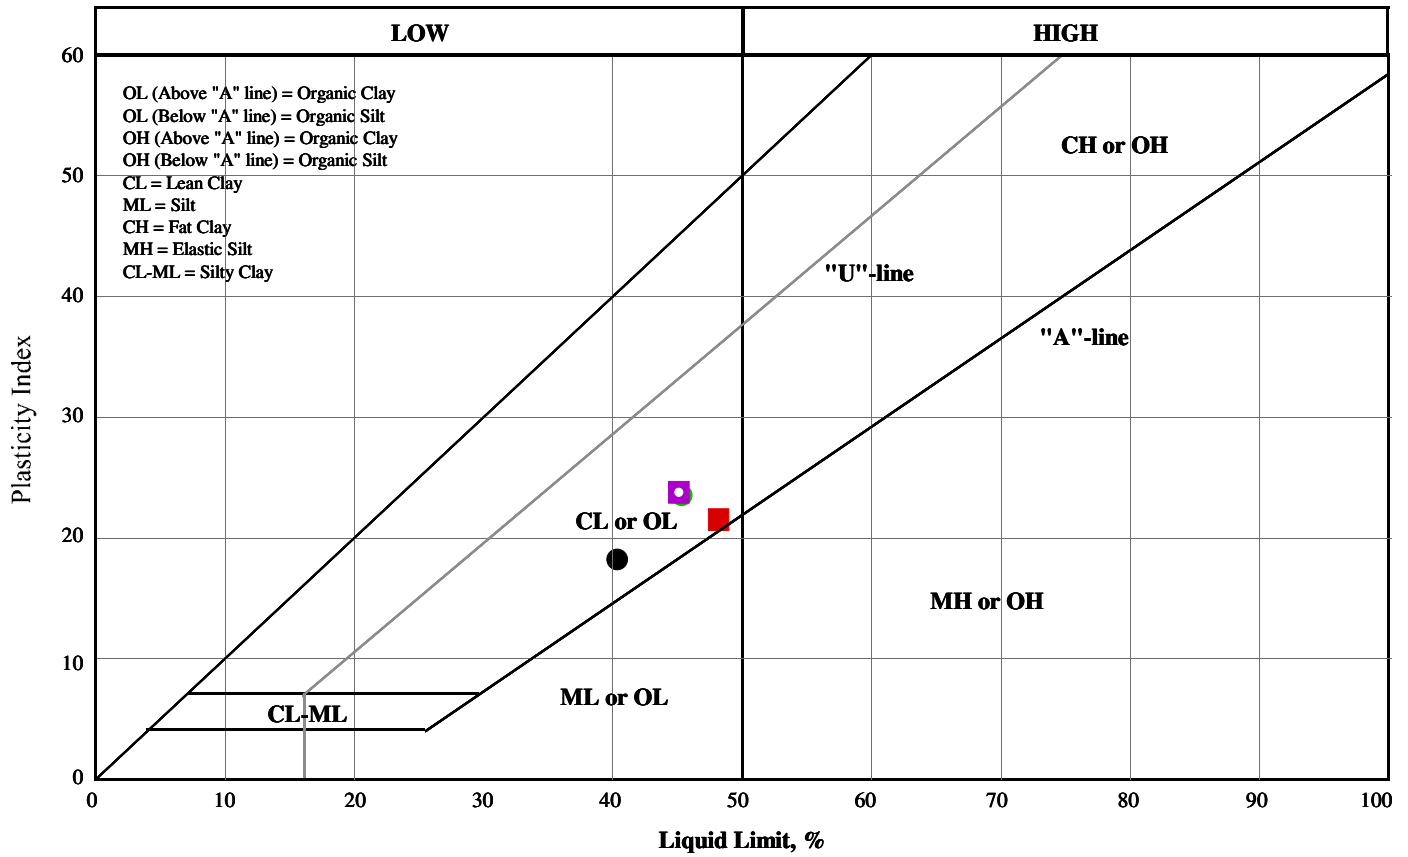
Symbol	Borehole /Test Pit	Sample Number	Depth	Liquid Limit	Plastic Limit	Plasticity Index	Non-Plastic	Moisture Content, %
●	19-1	04	2.29-2.90	40.3	22.1	18.2	<input type="checkbox"/>	31.19
■	19-6	03	1.52-2.13	48.2	26.7	21.5	<input type="checkbox"/>	35.62
○	19-11	02	0.76-1.37	45.3	21.8	23.5	<input type="checkbox"/>	34.22
◻	19-11	04	2.29-2.90	45.1	21.3	23.8	<input type="checkbox"/>	44.23
