FIELD REPORT

Our File #: 190361

PROJ. LOCATION: 1994 St. Joseph Boulevard
Ottawa

INSPECTION TYPE: Test Pits

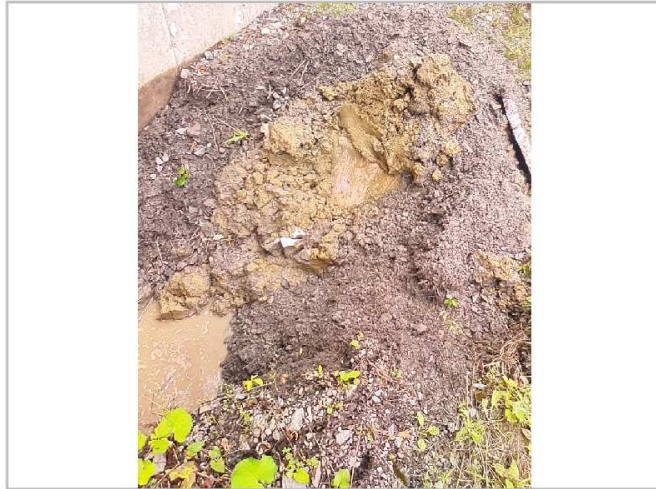
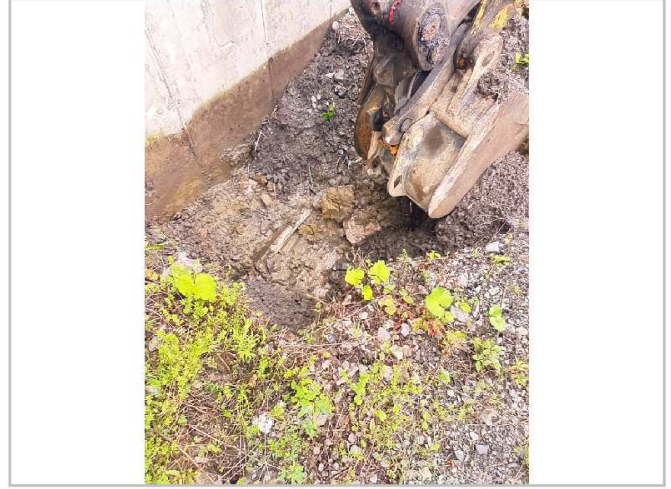
SITE PHOTOS

At the time of the site visit 2 test pits were completed at opposite ends of the existing retaining wall down to the footing level

The soil at the bottom of the existing wall consisted of a grey brown silty clay.

2' of backfill cover

16" of extending footing

4" footing height

2" of rigid insulation was underneath footing and extended approximately 0.9m

An allowable bearing pressure of 100 kPa SLS 150 kPa ULS may be used for design purposes.
