**PATERSON  
GROUP**

PH4593-LET.01

Subject: **Hydrogeological Risk Brief  
Proposed Multi-Story Building  
5497 Manotick Main Street, Ottawa, Ontario**

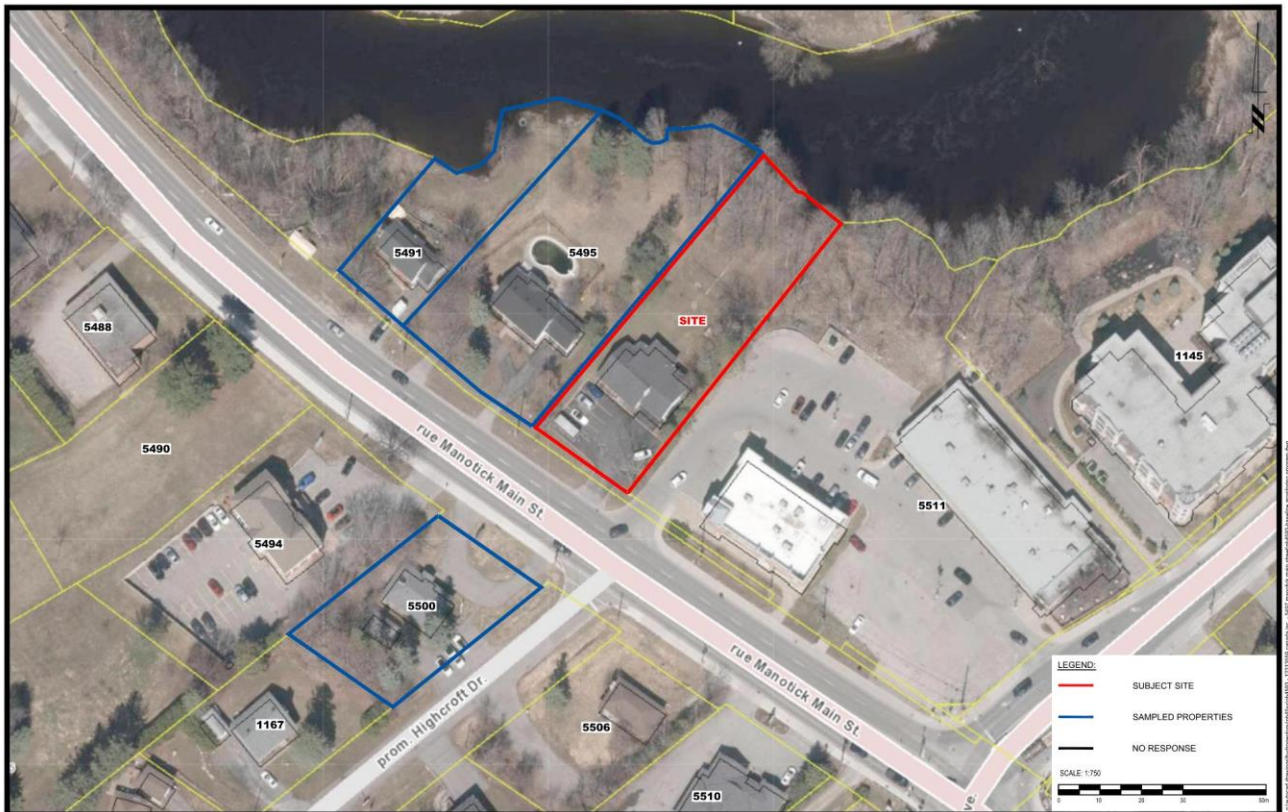
Figure 1 – Sample Location Plan

The municipal addresses selected, as shown in Figure 1 - Sampling Location Plan, are as follows:

- 5491 Manotick Main Street
- 5495 Manotick Main Street
- 5500 Manotick Main Street
