CULTURAL HERITAGE IMPACT STATEMENT PHASE II

145 Loretta Avenue & 951 Gladstone Avenue,
Ottawa, Ontario

PREPARED BY: COMMONWEALTH HISTORIC RESOURCE MANAGEMENT
Revision 2 April 2021

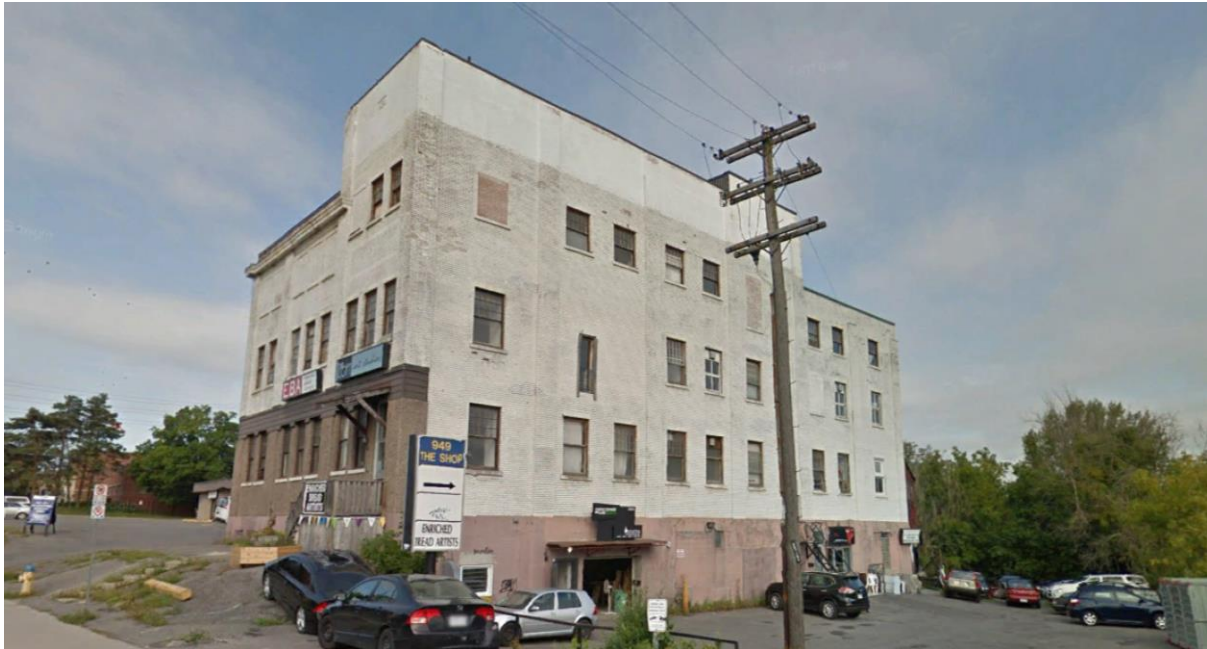
Figure 3: View looking west along Gladstone to the development site. Note the fenestration pattern on the east elevation (left) which characterizes its light industrial use with doors occurring on the second and third-floor levels and the location of an internal hoist to move material between floor levels. Source: Google Earth.

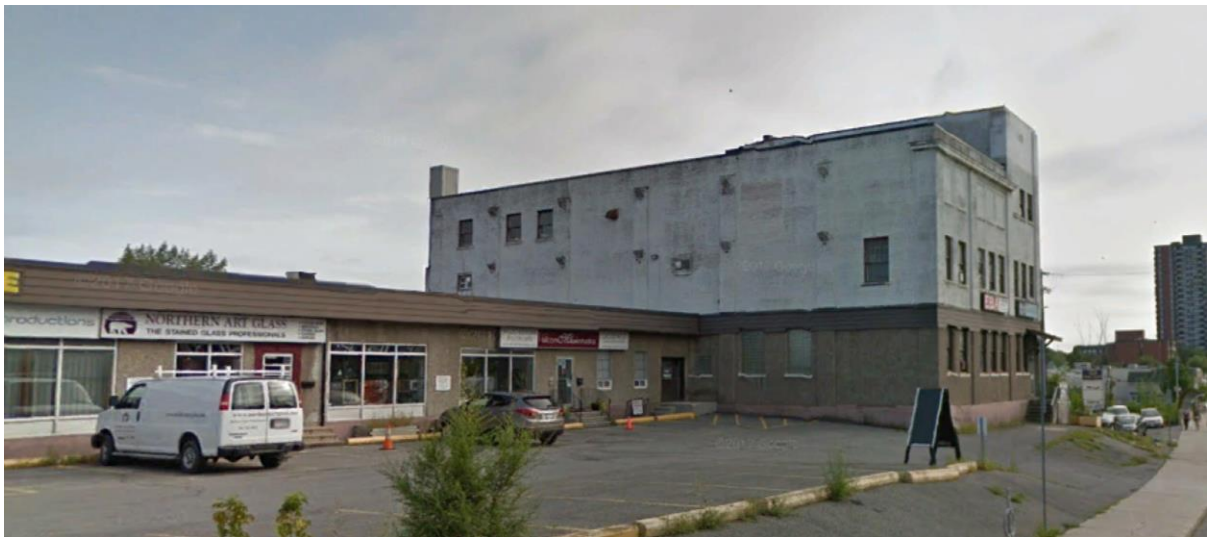
Figure 4: View of the west side of the former Standard Bread Company factory. Note the grade change between the first-floor level and the sidewalk along Gladstone. Source: Google Earth.

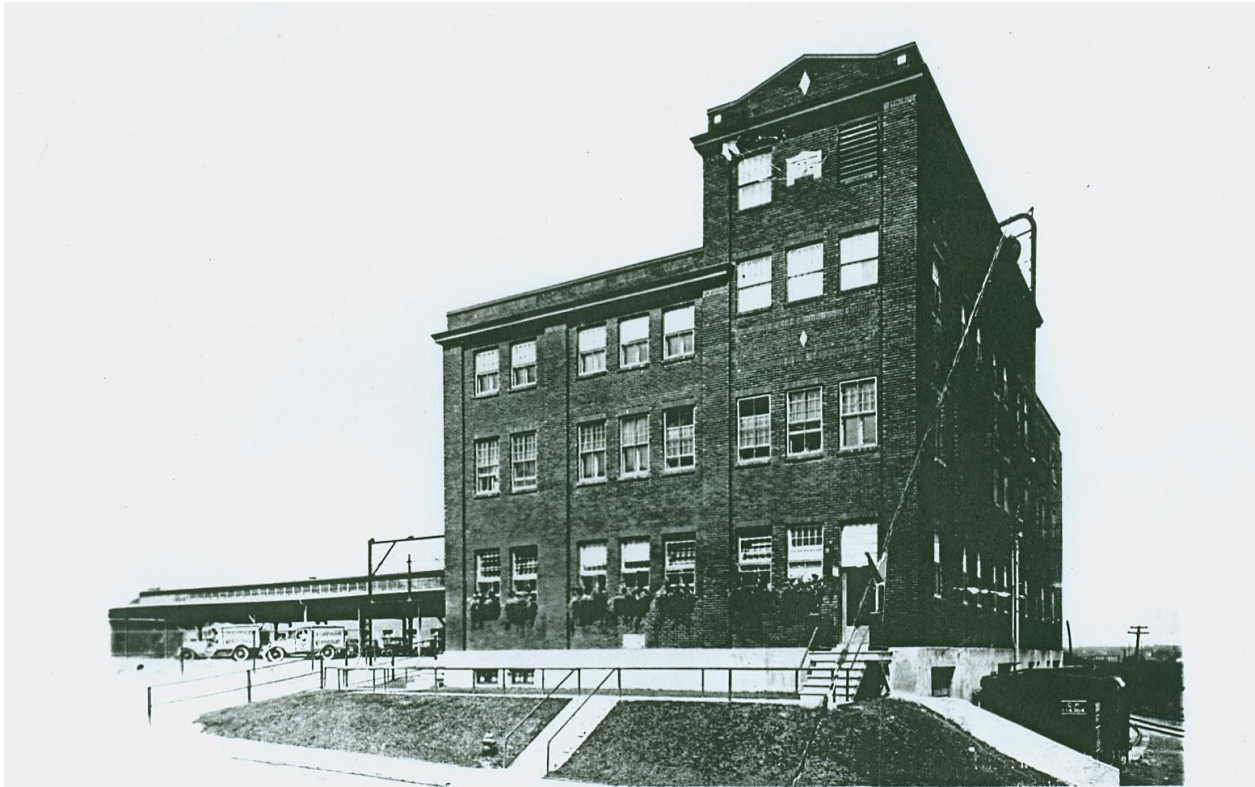
Figure 6: A photograph circa 1930 of the Standard Bread Building. Note the railway boxcar on a siding to the right of the photo. Source: City of Ottawa Archives

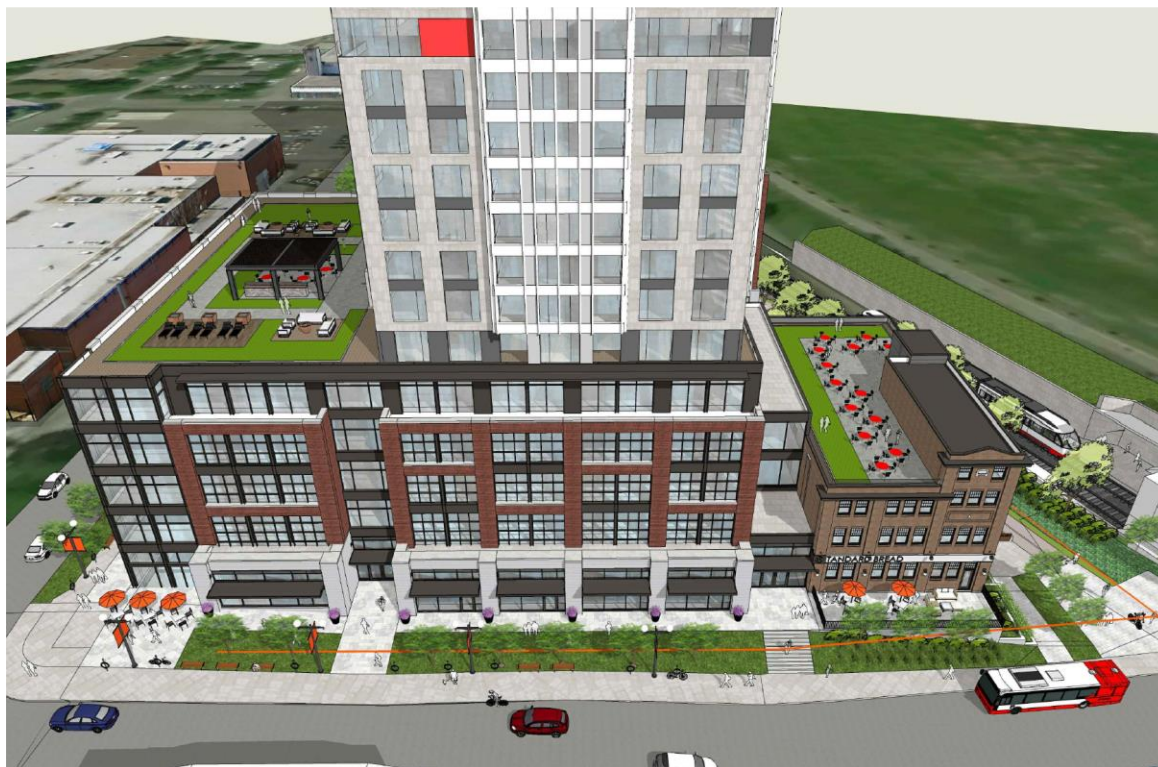
Figures 8: The birds eye view looking north along Gladstone illustrates the relationship of the new four storey podium and its relationship to the street and to the Standard Bread Building. Concern raised by heritage staff were the front entrance and the desire that the entrance remain operative and the signboard. As illustrated **the existing entrance will be maintained as a functional door. The sign board treatment needs further design development as there was no signboard on the building when completed in 1924.** The stairs from the sidewalk leading to the entrance were identified as a character defining feature. Repositioning them aligned with the link helps define the pedestrian flow. Source: Hobin Architecture.

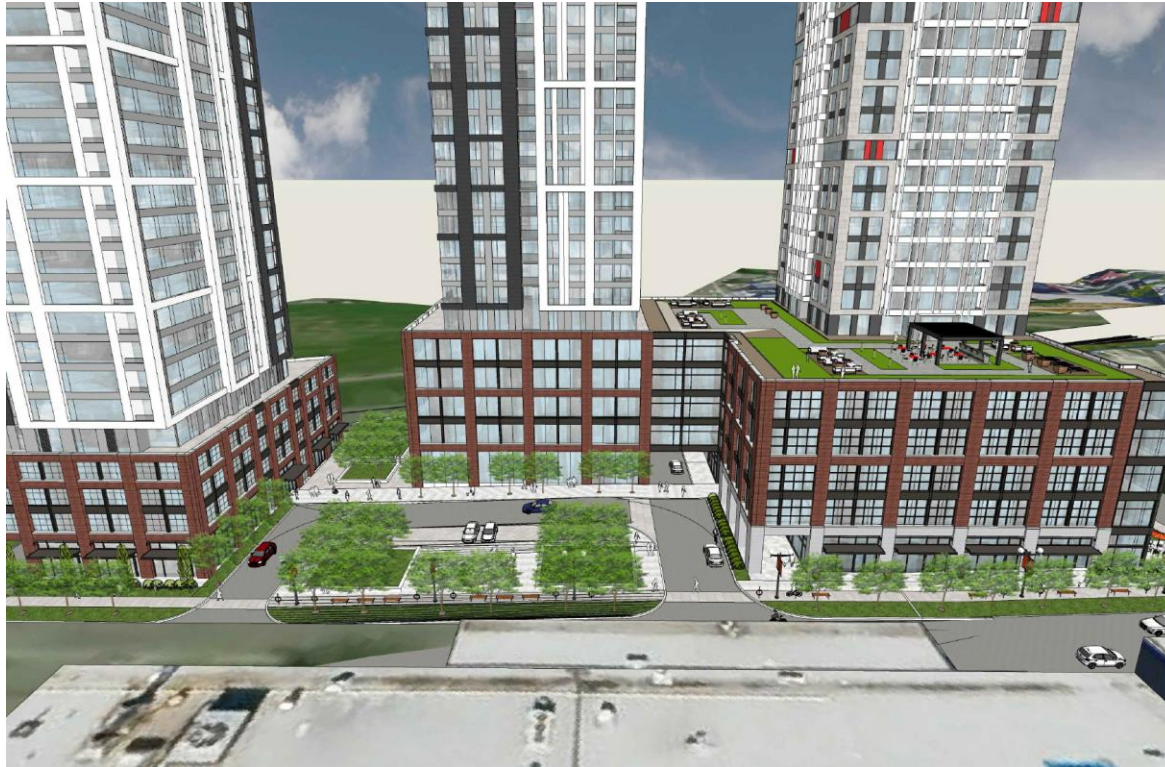
Figure 9: Birds eye view looking east along Loretta. The four-storey podium with the towers set back help to mitigate the scale with neighbouring buildings. Source: Hobin Architecture.

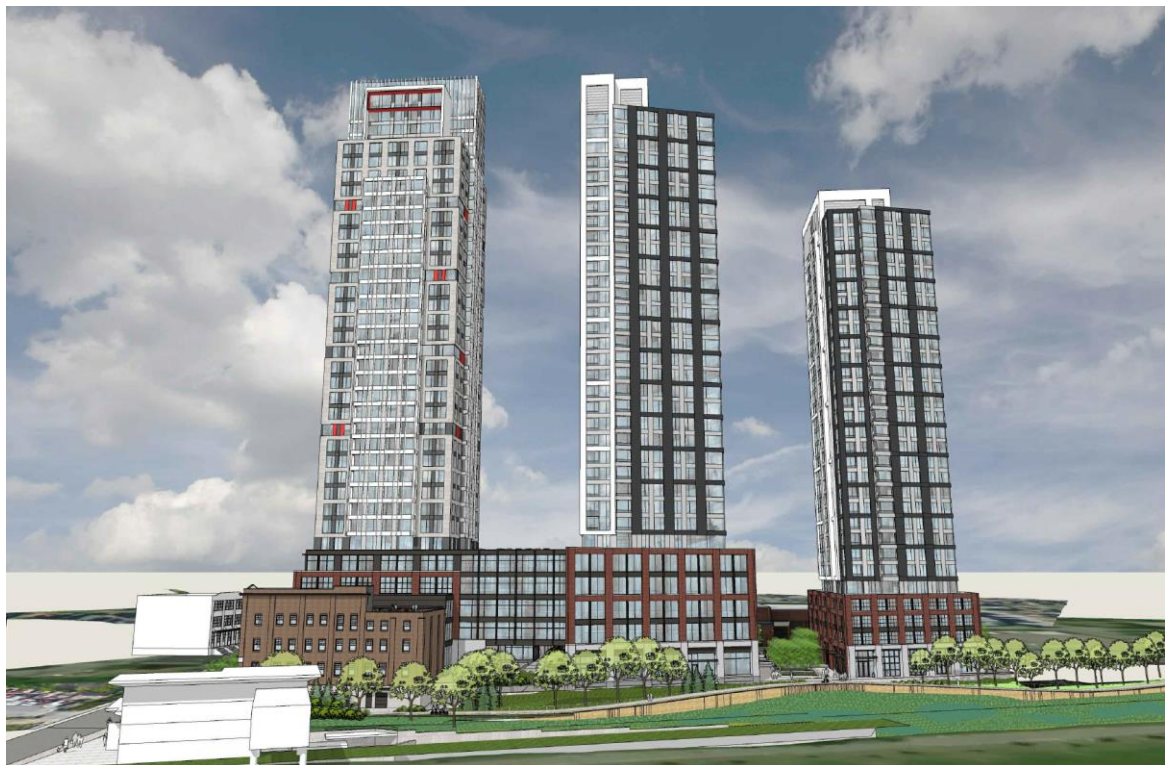
Figure 10: View looking west with the Standard Bread building in the foreground. Source Hobin Architecture.

The development proposal includes the rehabilitation of the heritage building, and the conservation of the exterior form and materials, except for the single storey wing extending to Loretta Avenue. The recently installed cement board with a decorative stone finish will be removed, and the original fenestration pattern restored with the removal of brick infill from the windows. The gabled brick and metal parapets will be re-instated to their original form and design. The intent is to repair the deteriorated exterior concrete and localized spalled brick as necessary and repaint the exterior a red similar to the original brick colour. Deteriorated concrete windowsills will be replaced and new insulated single hung windows installed with a light configuration like the original window patterns.

The fenestration pattern on the east elevation overlooking the O-Train corridor will be retained, including doors and existing bricked in openings removed. An existing basement level loading door will be repurposed to an access door to the basement of the building. The areas of spalling brick on the north elevation of the building that will be repaired, and the wall will be repainted. The west façade will be incorporated into the new development.

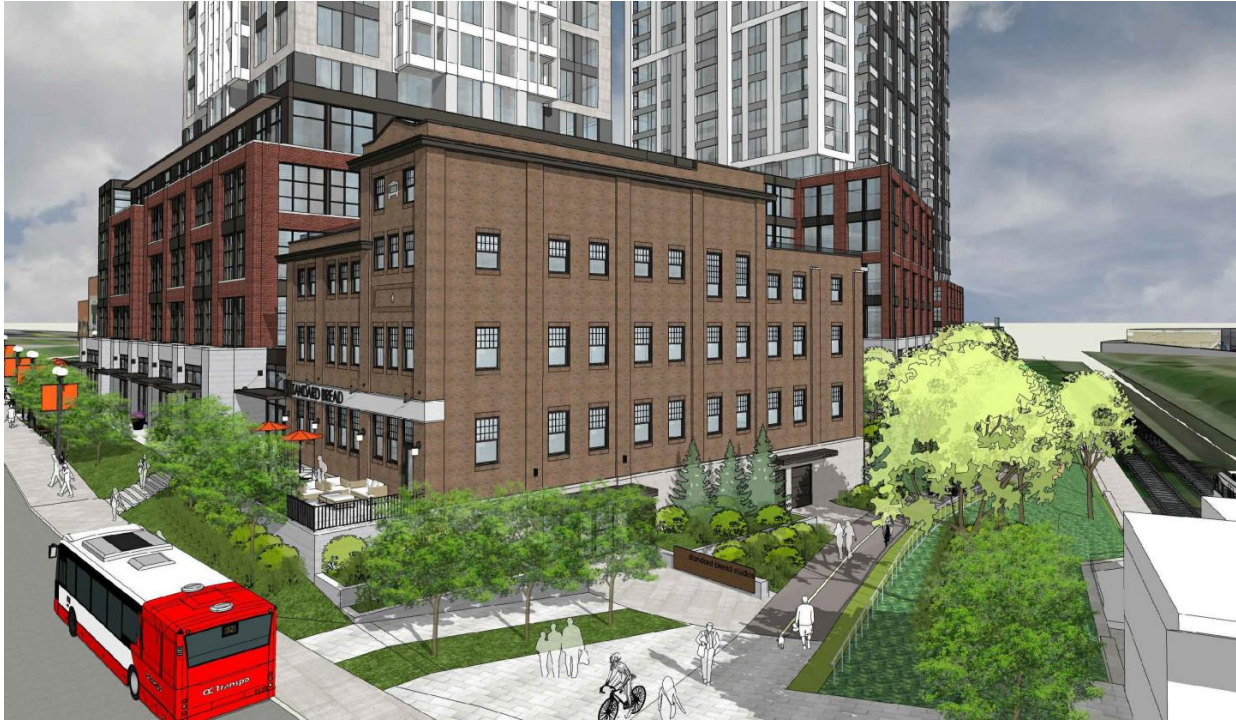
Figure 12: Rendered perspective view looking north-west to the Standard Bread Building. Hobin Architecture 2021

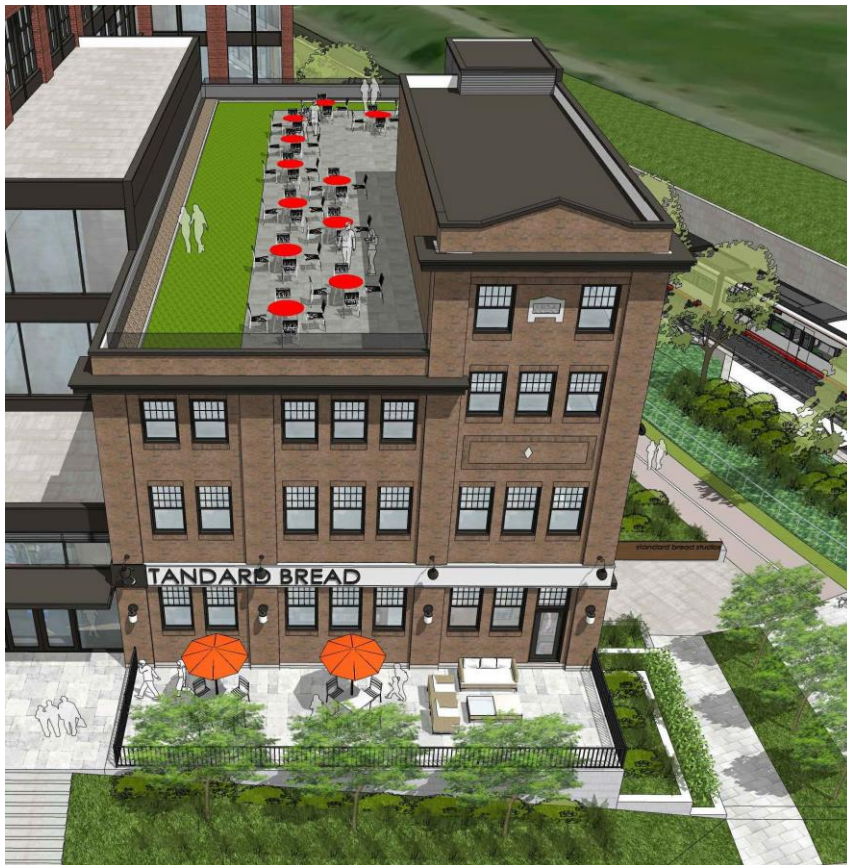
Figure 13: A Perspective view of the south elevation of the Standard Bread Building and a future multi-use pathway adjacent to the railway corridor that will be accessible from a terrace adjacent to the common lobby of towers 2 and 3. Source: Hobin Architecture 2021.

Heritage Staff identified the treatment of the west façade and how the glass link will be attached to the heritage building. Needs further design development. **The link between the podium and Standard Bread Building and the north elevation of the link has been setback further to provide a more three-dimensional view of the building when seen from the west. The height of the link is under review.**

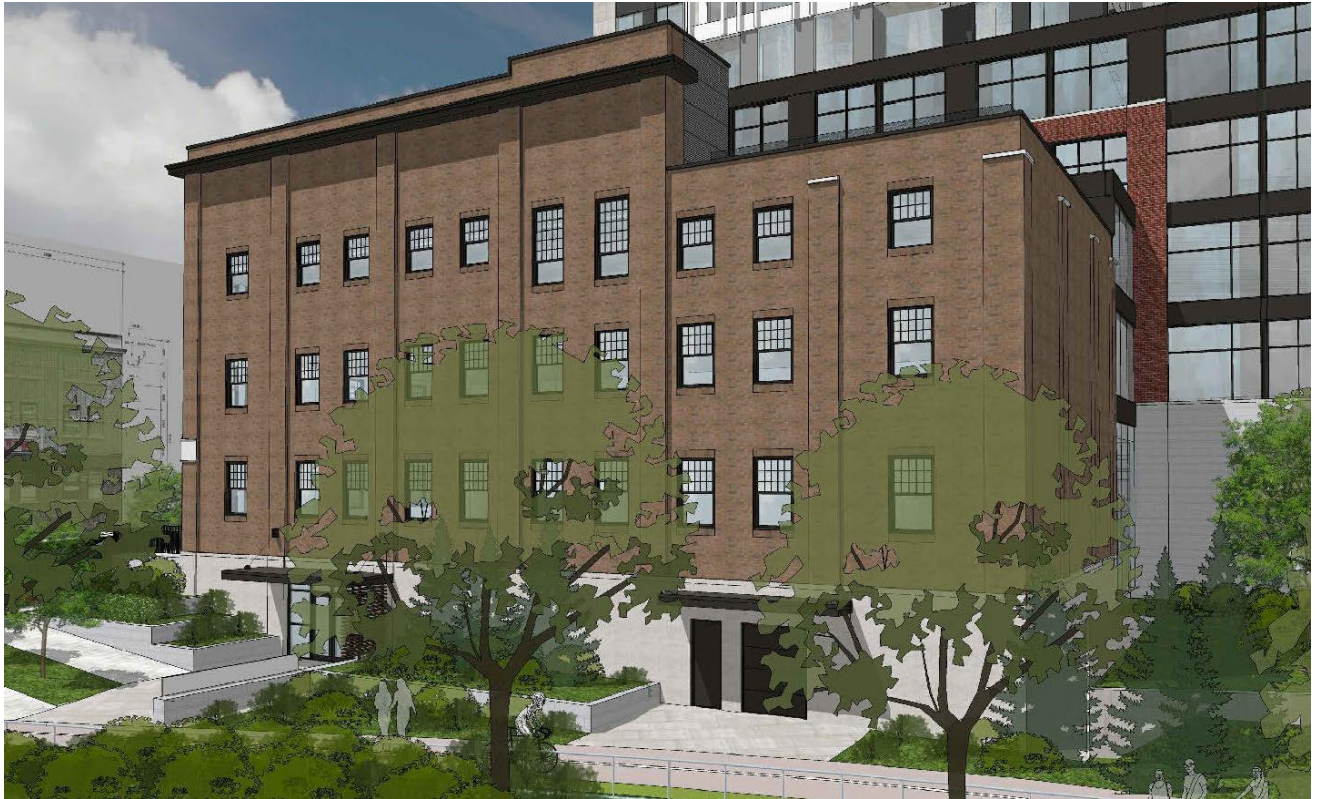
Figure 14: Rendered perspective view of the east elevation of the Standard Bread Building. The Standard Bread sign on the front of the building is being treated as a place holder and will require further study. Source: Hobin Architecture 2021.

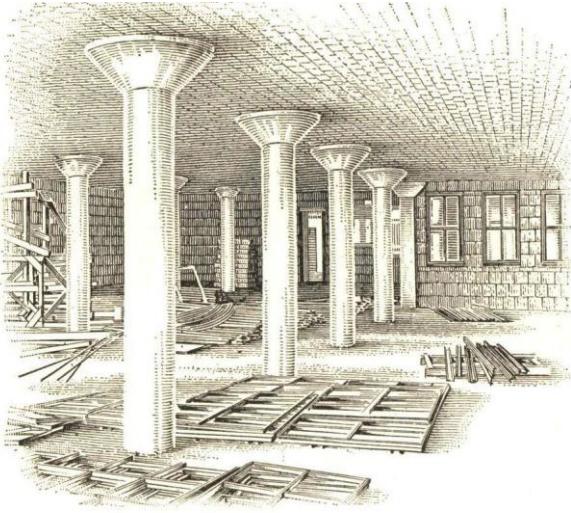
FIG. 63

Figure 15: Concrete Mushroom Columns are a character defining feature. Source: Fig. 63 illustration from *Plain and Reinforced Concrete Construction*.

The structural system consists of reinforced concrete columns and floor slabs with a terra cotta infill between columns to which the exterior brick is secured. (see figure 15)

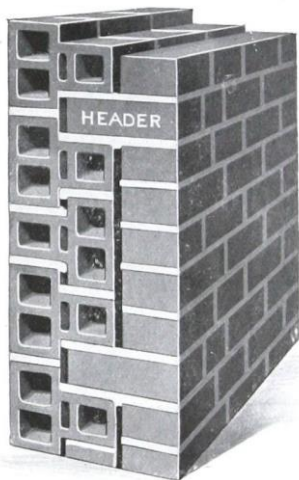
The bricks are a pressed brick with ground shale as the primary raw material, common for the period as clay deposits were being exhausted. The bricks are wire cut and have a textured surface that is painted. The removal of the paint from the interstices in the brick surfaces will be difficult if not impossible as the oil-based paint is well adhered to the surfaces. The brickwork is generally in good condition with localized spalled bricks. The brickwork in the areas that were inspected appeared to be well adhered to the terra-cotta backup walls when sounded with a hammer.

Figure 16: A mock-up sketch illustrating the Standard Bread wall composition tilted Wall of Denison Tile Face with Pressed or Common Brick. Source Sun Brick Co. Limited Manufactures of "Suntex" Products pg 73.

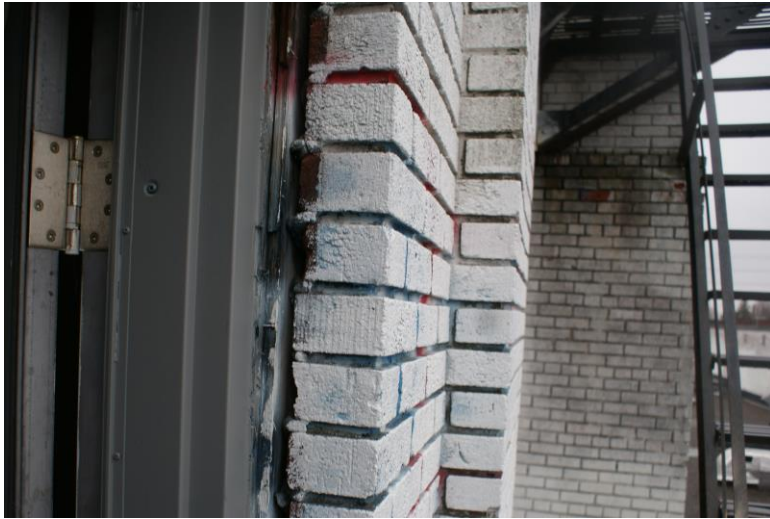
Pointing: The original pointing mortar mix would appear to be a 1-part Portland, 3 parts sand with an admixture of lime to improve workability and adhesion to the masonry units. The Portland cement mortar mix was in common use when the building was completed in 1924 and is noted in manufacturers specifications for brickwork and terra-cotta tile. The joint profile is a recessed joint with a depth equal to the distance between bricks. The original mortar included a black pigment which has faded over the years where exposed. The pointing is in good condition, except for localized areas.

Figure 17: View of the exterior brickwork from a second-floor fire escape. Note the highly textured brick surfaces and recessed joint profile. Source: Commonwealth 2020.

The removal of the paint finish from the exterior brick will be extremely difficult to remove. The wire cut bricks have a rough surface and the bond between the brick surface and the paint is stable. The brick has a surface texture that will retain residual paint in surface irregularities making it difficult to remove all the paint from the surface. The building may have been painted to protect a relatively porous brick that was deteriorating; alternatively, it may have been for aesthetic reasons. A test of various methods of paint removal and their relative success will be undertaken to determine the appropriate conservation approach. Based on the site inspection and the outcome of tests, painting the exterior brick in a tone similar to the colour of the original brickwork may be the less intrusive solution.

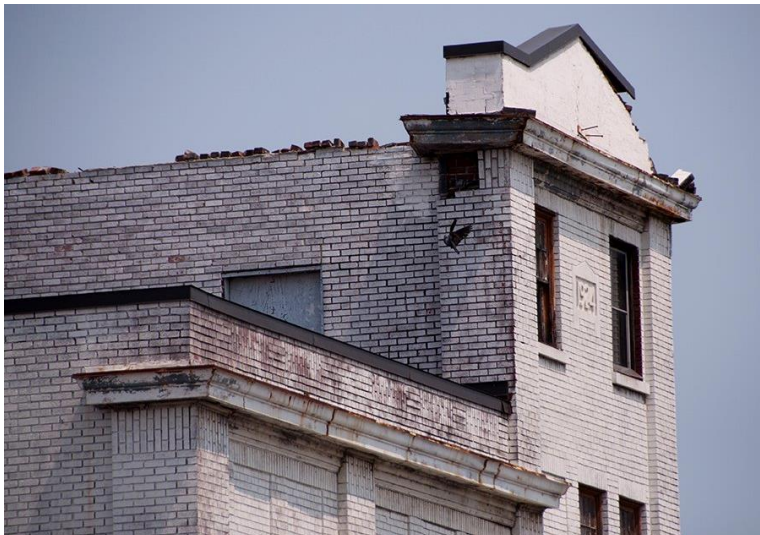
- The gabled brick and metal parapets will be re-instated to their original form and design.
- At the roof level on the west elevation, in the northern four bays, bulges in the brick veneer were observed. The method of anchoring the brick has not been investigated yet.

Figure 18: The gabled brick and metal parapets will be re-instated to their original form and design. The height of the parapet can be determined from period photos.

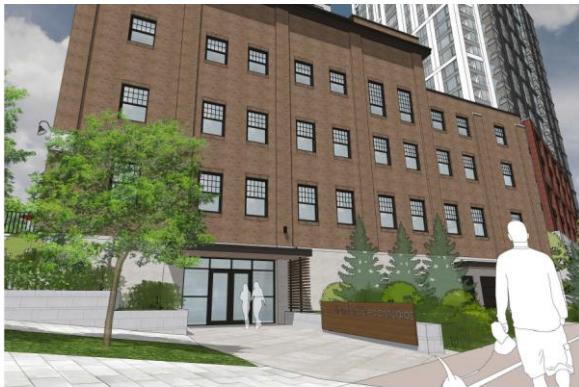
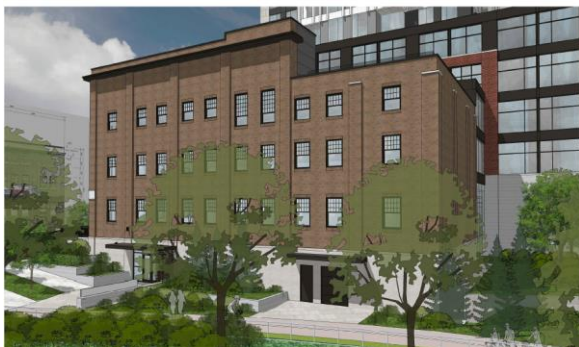
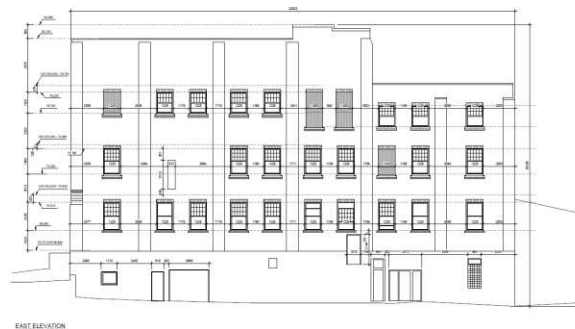
Figure 19 and 20: The fenestration along the east facade follows the profile of the original building as the as-found drawing below illustrates. The large industrial opens have been retained with the stucco treatment on the lower level and the red coloured finish of the brick. Source Hobin Architecture. 2021

The fenestration pattern on the east elevation overlooking the rail corridor is noted to be a character-defining feature reflecting its industrial use adjacent to a railway siding when constructed in 1924. The existing fenestration pattern will be retained including doors, and windows.

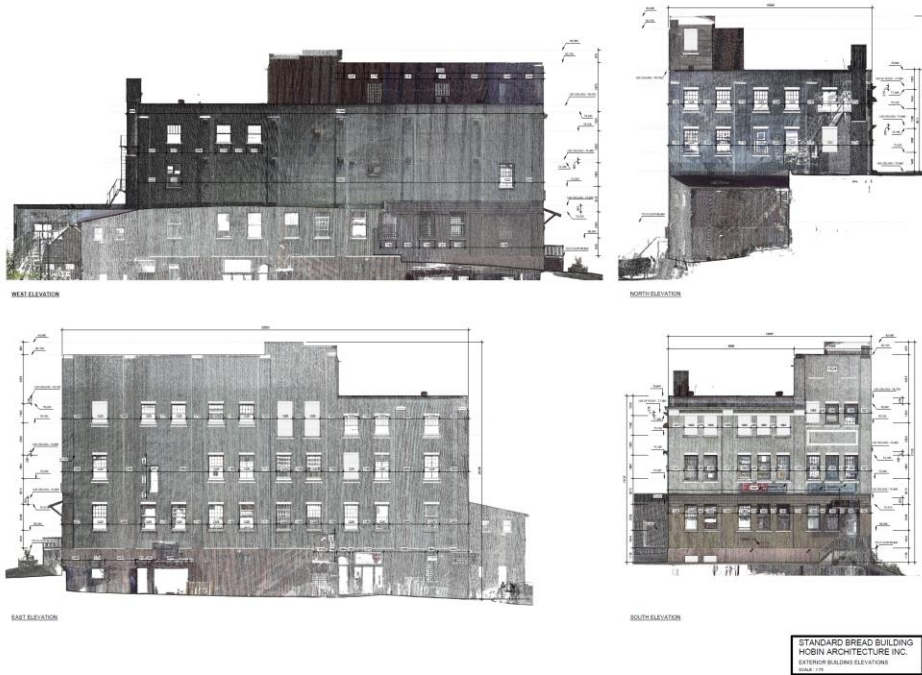
Figure 21: Photogrammetric recording of the Standard Bread Building. Source Hobin Architects

Photogrammetric As-Found drawings have been prepared documenting the condition of the four facades. These will supplement the rendered set of plans and elevations which also record the existing conditions.

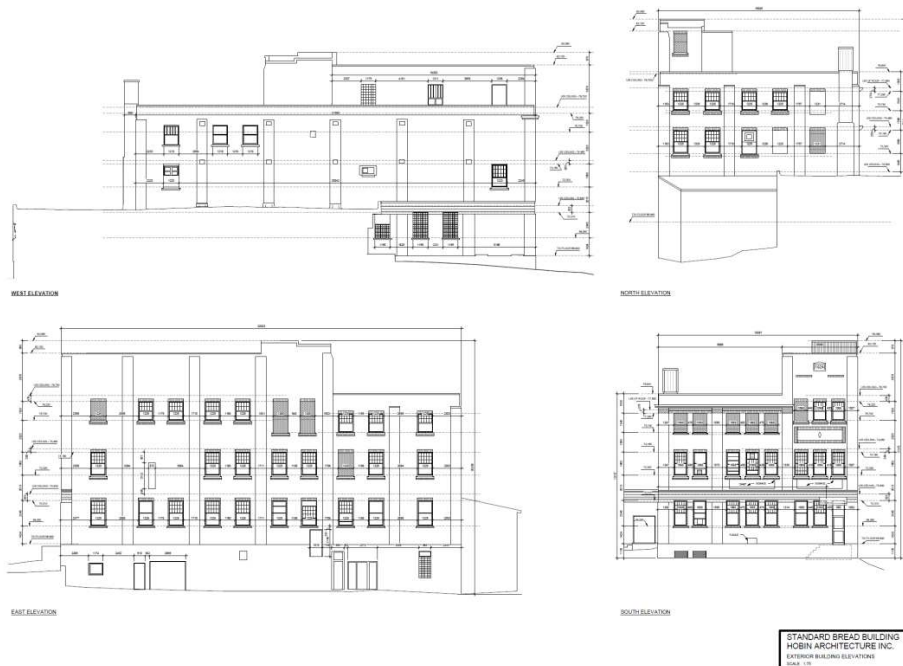
Figure 22: Dimensioned As-found record of elevation and floor plans of the Standard Bread Building. Source Hobin Architecture Inc.

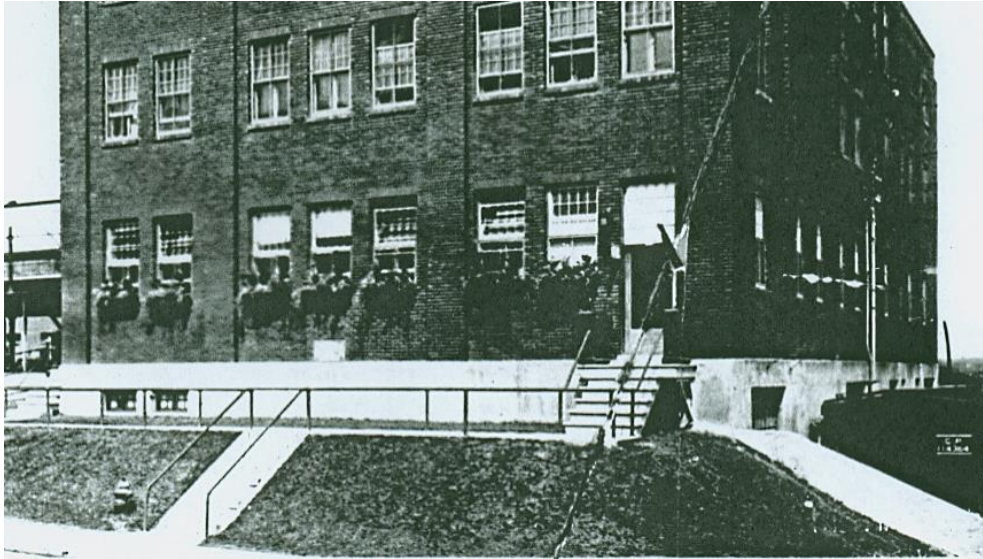
Figure 23: The 1930 view of the front entrance with a stairway leading from Gladstone and an entrance on the right-hand side of the building are defining features.

The design of the landscaping / streetscape in front of the Standard Bread building on Gladstone Street and its interface with the building needs further development. Historic photographs document the location of the main entrance to the building as a character-defining feature. If possible, the historic entrance should be interpreted from the street with stairs leading to the entrance from the public sidewalk.
