PROJECT NAME
CIRCLE K STORES INC.
R&R No. 52287

1545 WOODROFFE AVENUE
NEPEAN, ON, CANADA
K2G 1W2

SHEET TITLE
PROPOSED DEVELOPMENT CONSERVED VEGETATION PLAN

SHEET NUMBER
L1.1

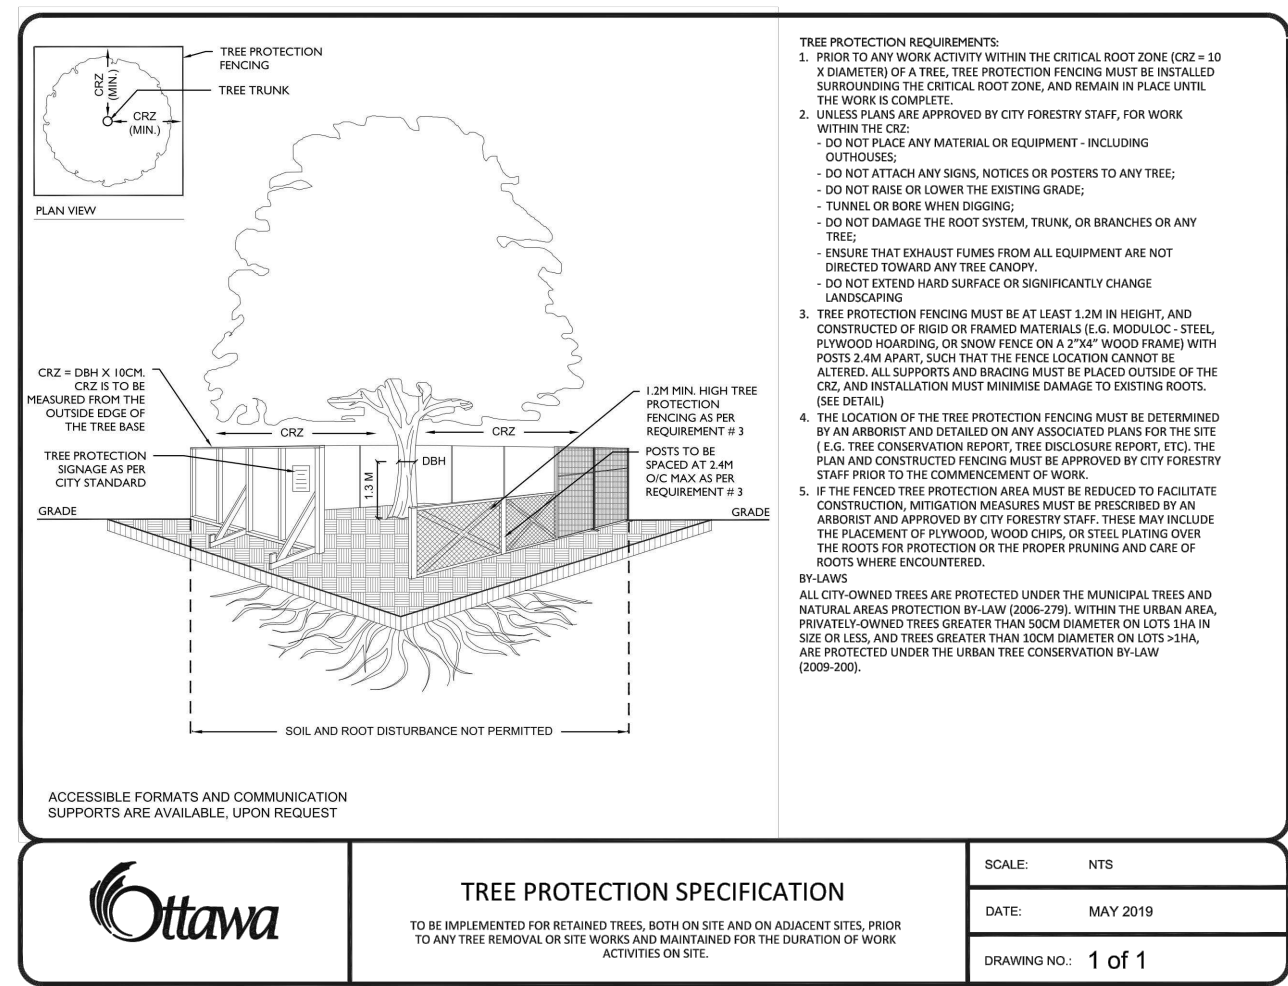
SPECIFICATIONS FOR THE PROTECTION AND PRESERVATION OF EXISTING TREES

- ALL EXISTING TREES WHICH ARE TO REMAIN SHALL BE FULLY PROTECTED WITH FENCING ERECTED AROUND THE ENTIRE PERIMETER OF THE TREE PROTECTION ZONE IN ACCORDANCE WITH TPZ MINIMUM DISTANCE REQUIREMENTS. GROUPS OF TREES AND OTHER EXISTING PLANTINGS TO BE PROTECTED, SHALL BE DONE IN A LIKE MANNER WITH FENCING AROUND THE ENTIRE CLUMP(S).

- AREAS WITHIN THE PROTECTIVE FENCING SHALL REMAIN UNDISTURBED AND SHALL NOT BE USED FOR THE STORAGE OF BUILDING MATERIALS OR EQUIPMENT.
- THIS WORK SHALL BE COMPLETED, TO THE SATISFACTION OF THE COMMISSIONER OF DEVELOPMENT SERVICES, PRIOR TO THE ISSUANCE OF BUILDING PERMITS FOR THE SITE DEVELOPMENT. THE DEVELOPER OR HIS/HER AGENT SHALL TAKE EVERY PRECAUTION NECESSARY TO PREVENT DAMAGE TO TREES OR SHRUBS TO BE RETAINED.

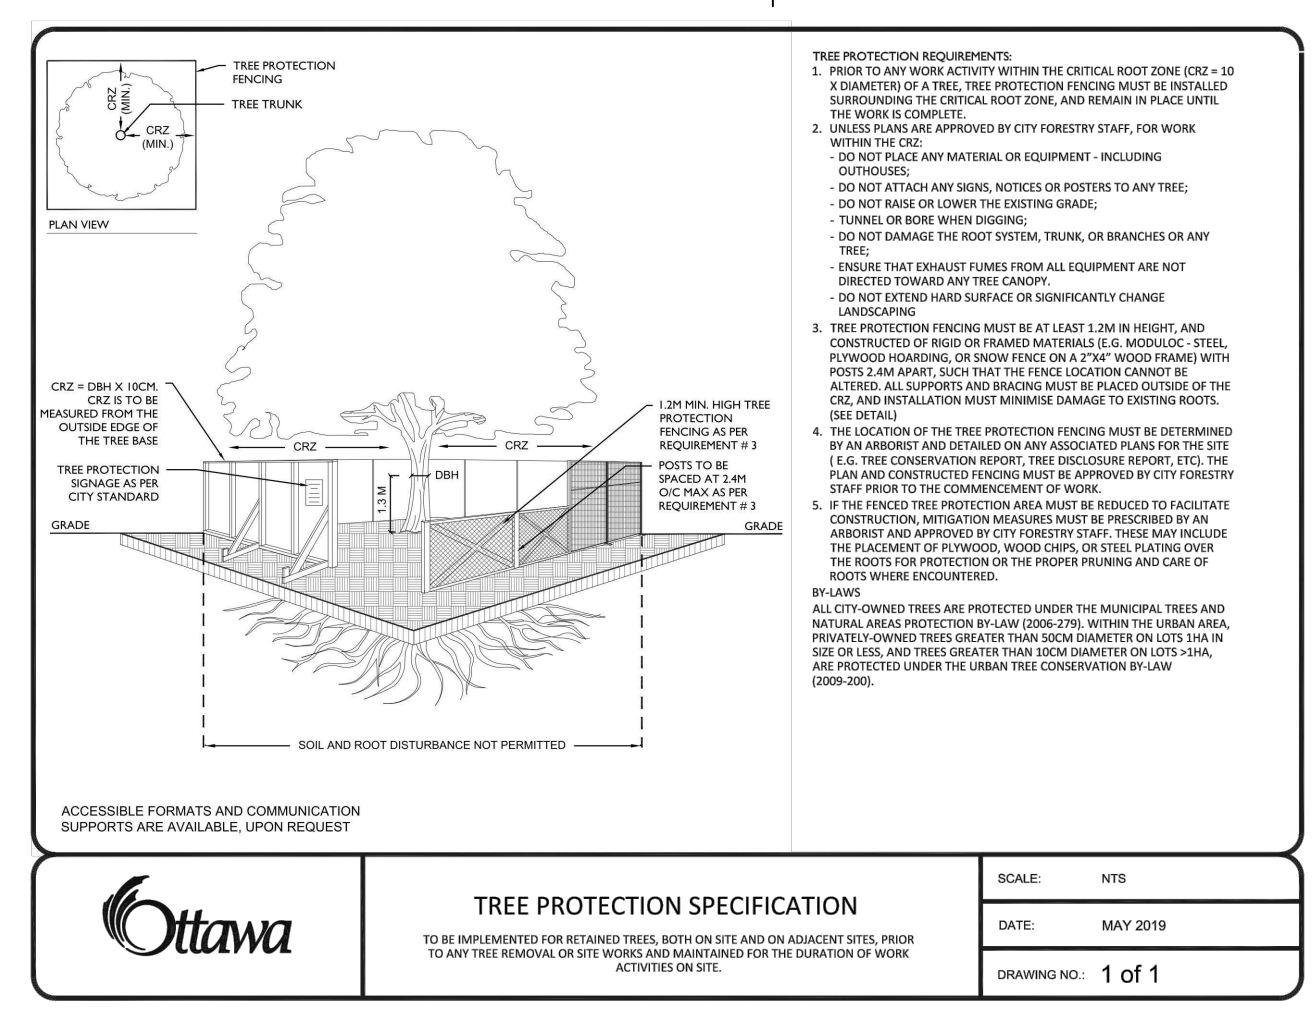
SPECIFICATIONS FOR THE PROTECTION AND PRESERVATION OF EXISTING TREES

- ALL EXISTING TREES WHICH ARE TO REMAIN SHALL BE FULLY PROTECTED WITH FENCING ERECTED AROUND THE ENTIRE PERIMETER OF THE TREE PROTECTION ZONE IN ACCORDANCE WITH TPZ MINIMUM DISTANCE REQUIREMENTS. GROUPS OF TREES AND OTHER EXISTING PLANTINGS TO BE PROTECTED, SHALL BE DONE IN A LIKE MANNER WITH FENCING AROUND THE ENTIRE CLUMP(S).

- AREAS WITHIN THE PROTECTIVE FENCING SHALL REMAIN UNDISTURBED AND SHALL NOT BE USED FOR THE STORAGE OF BUILDING MATERIALS OR EQUIPMENT.
- THIS WORK SHALL BE COMPLETED, TO THE SATISFACTION OF THE COMMISSIONER OF DEVELOPMENT SERVICES, PRIOR TO THE ISSUANCE OF BUILDING PERMITS FOR THE SITE DEVELOPMENT. THE DEVELOPER OR HIS/HER AGENT SHALL TAKE EVERY PRECAUTION NECESSARY TO PREVENT DAMAGE TO TREES OR SHRUBS TO BE RETAINED.
