**Servicing and Stormwater
Management Report – 2829
Dumaurier Avenue**

Stantec Project No. 160401596

March 20, 2023

Brigil Homes

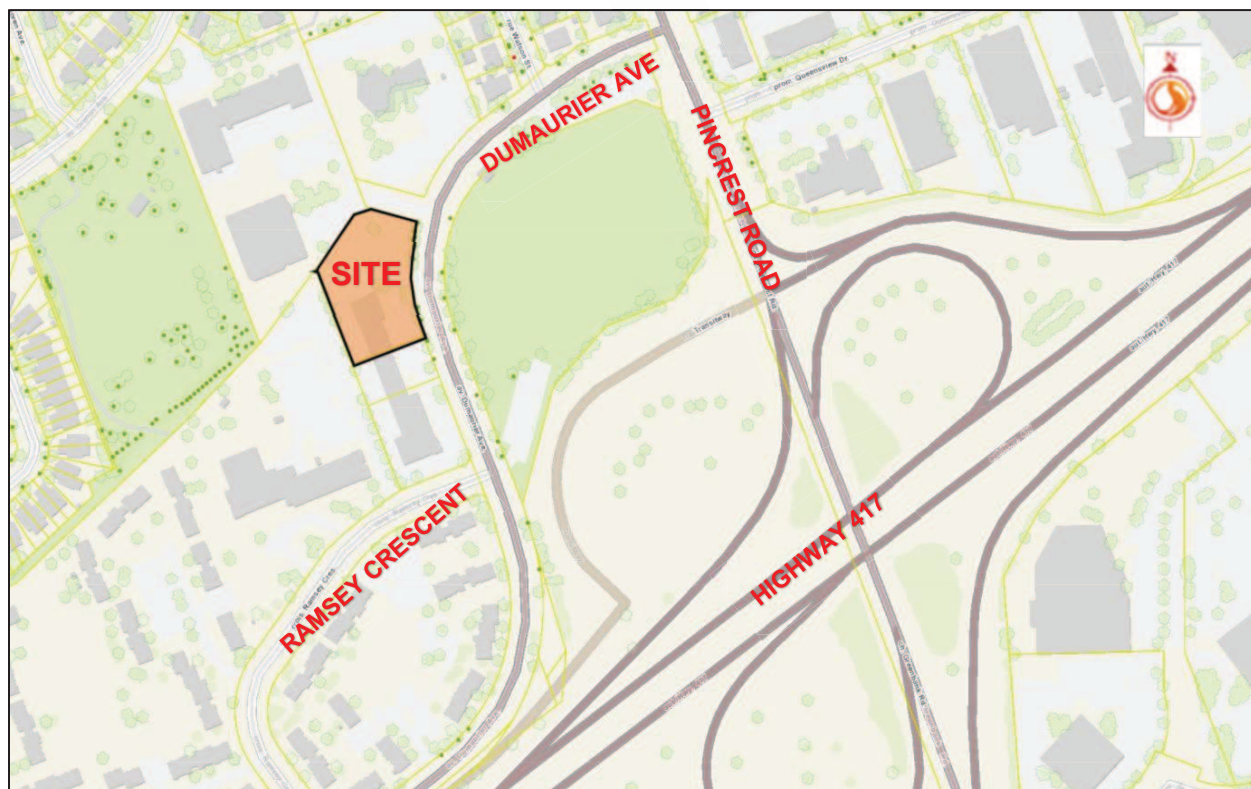
Figure 1: Key Plan (2829 Dumaური Ave. Site highlighted in Orange)
