**Servicing and Stormwater
Management Report – 2829
Dumaurier Avenue**

Stantec Project No. 160401596

July 5, 2024

Stantec Consulting Ltd.

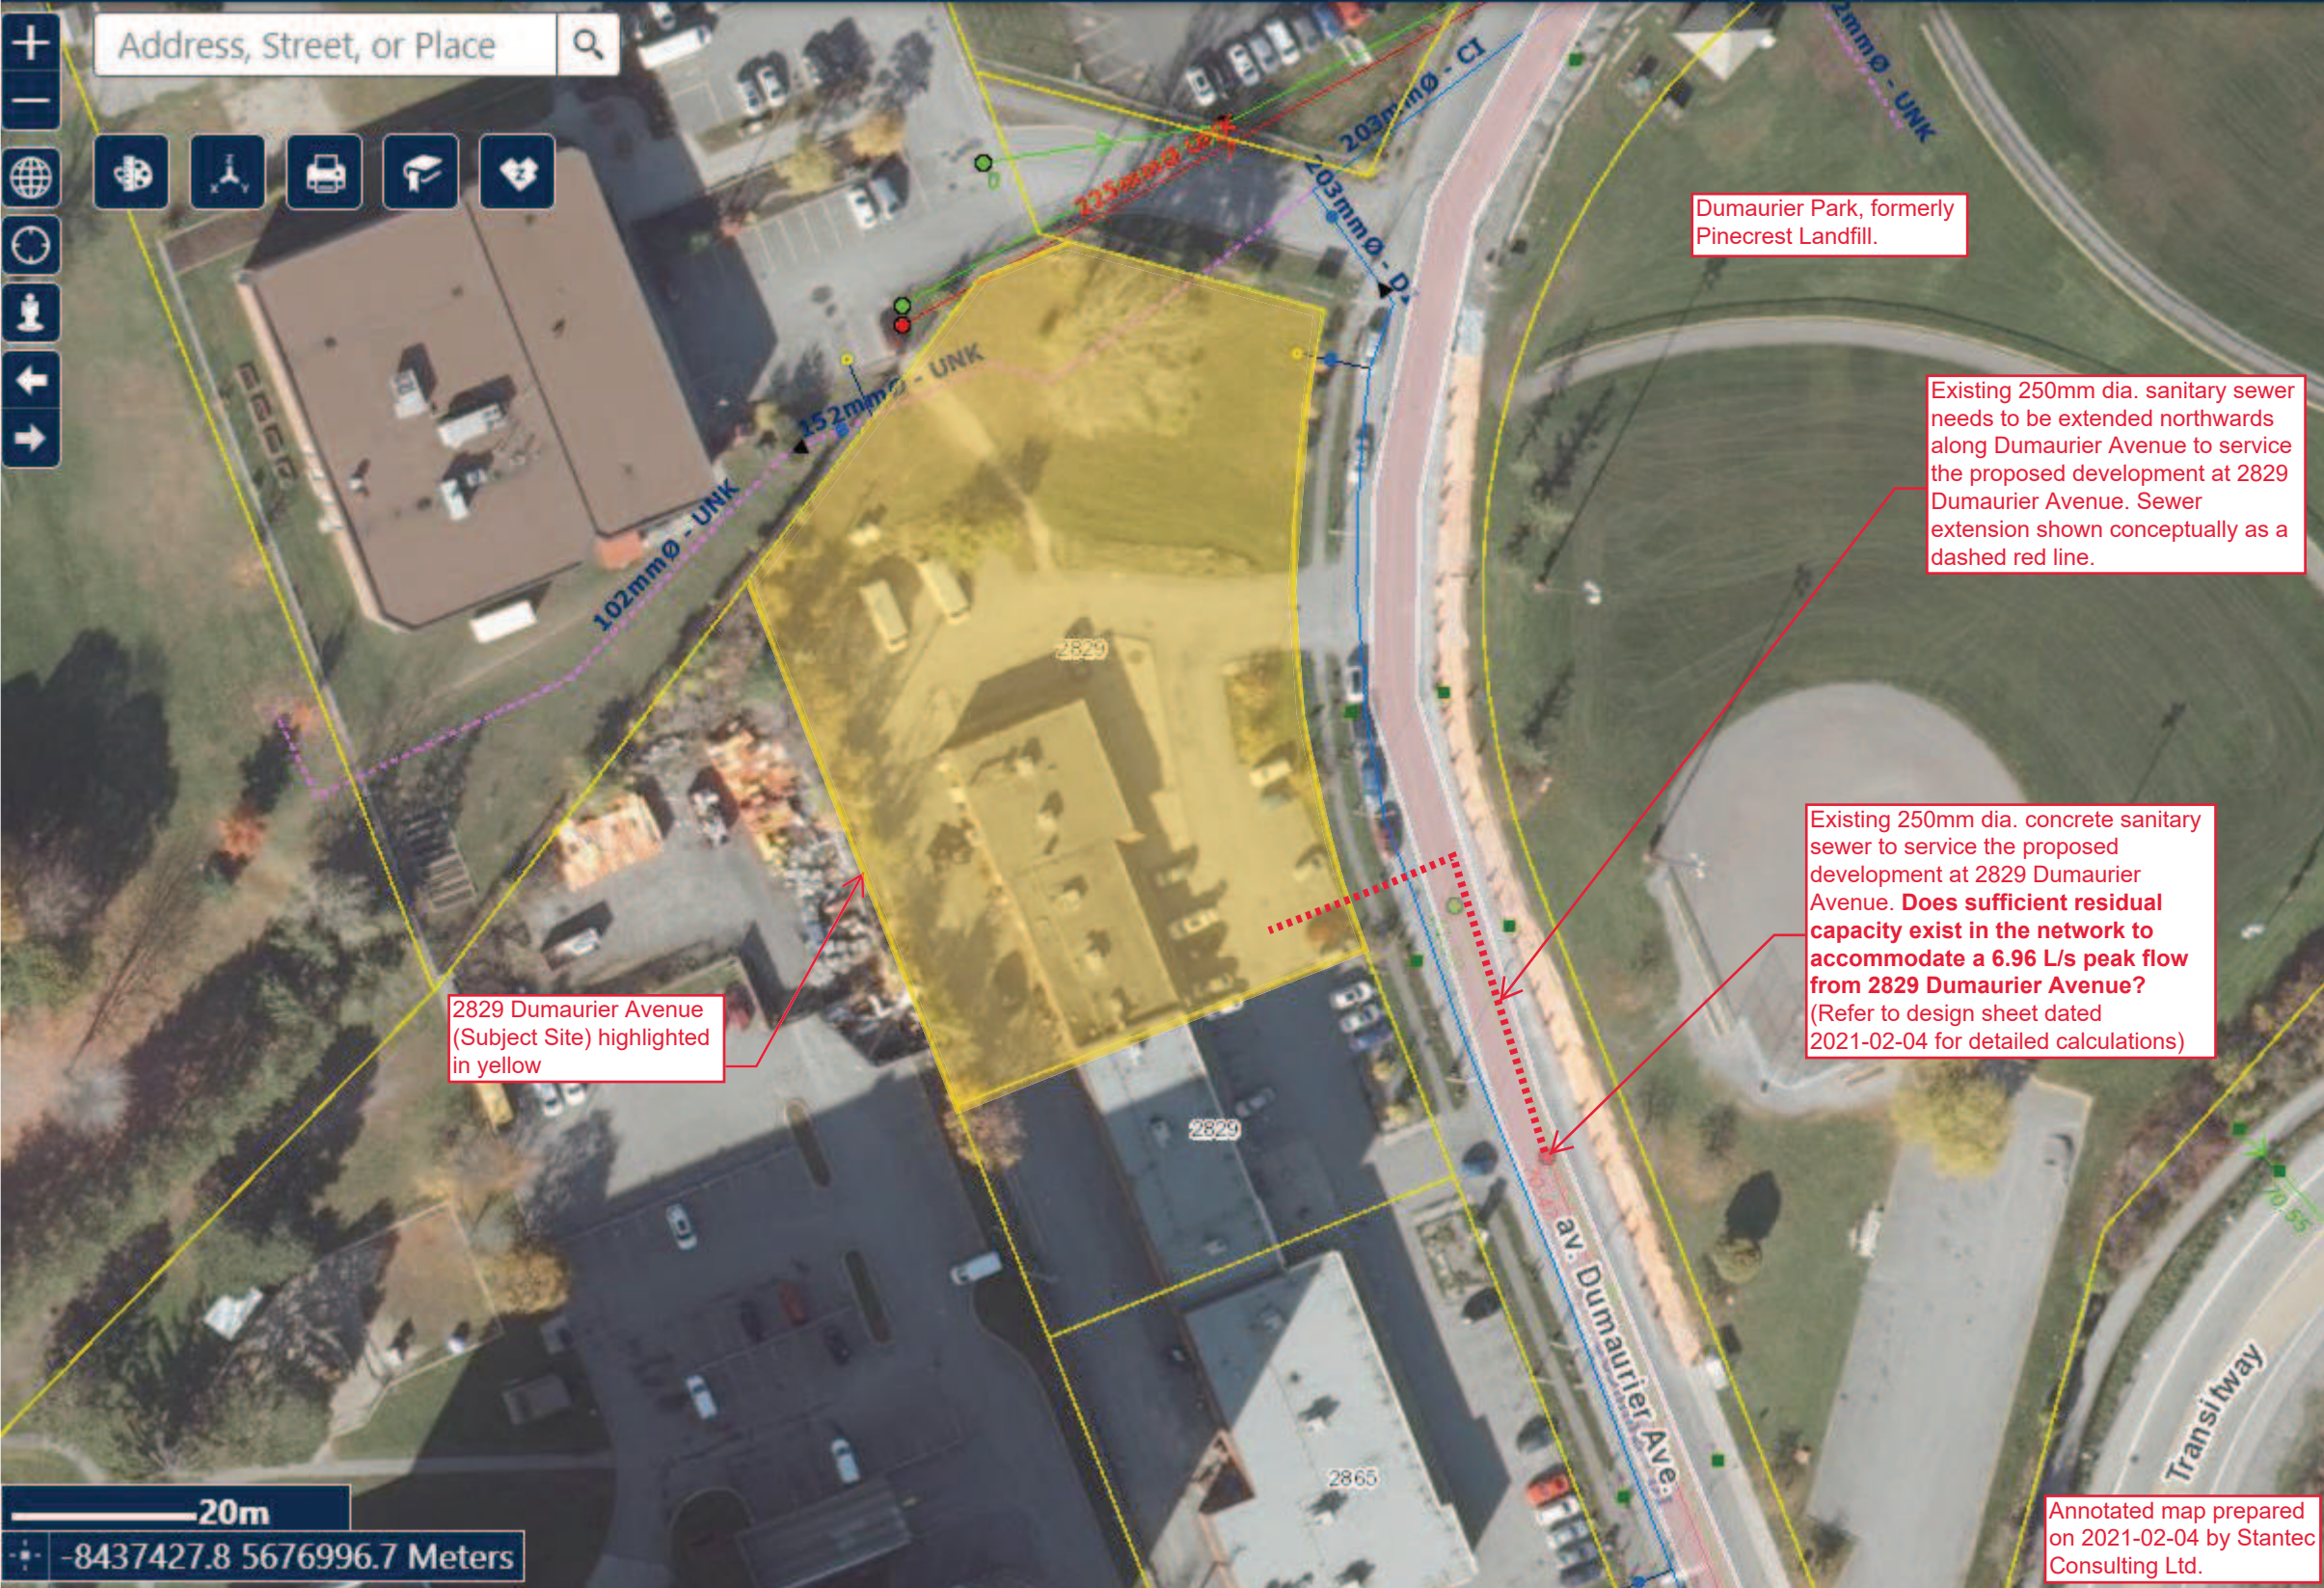
Dumaaurier Park, formerly Pinecrest Landfill.

Existing 250mm dia. sanitary sewer needs to be extended northwards along Dumaaurier Avenue to service the proposed development at 2829 Dumaaurier Avenue. Sewer extension shown conceptually as a dashed red line.

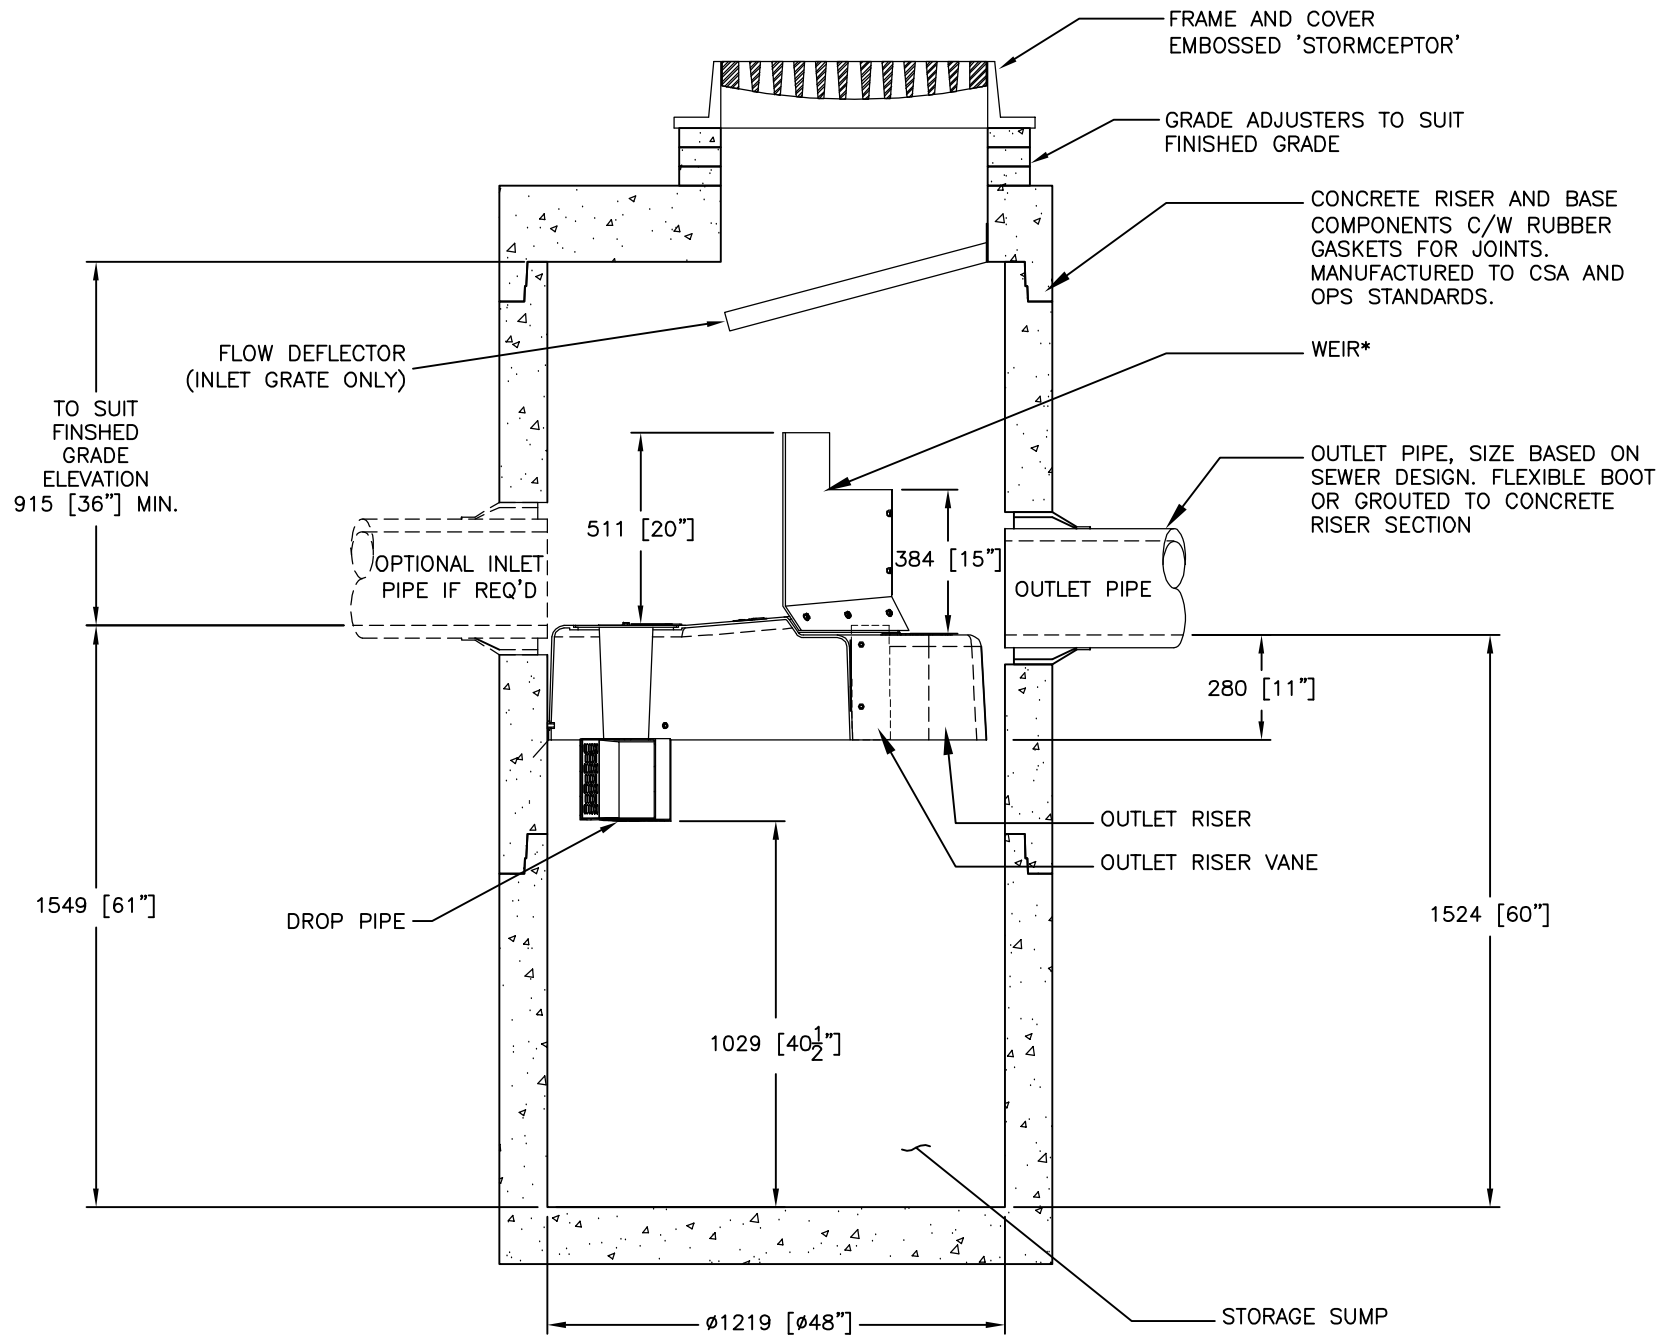
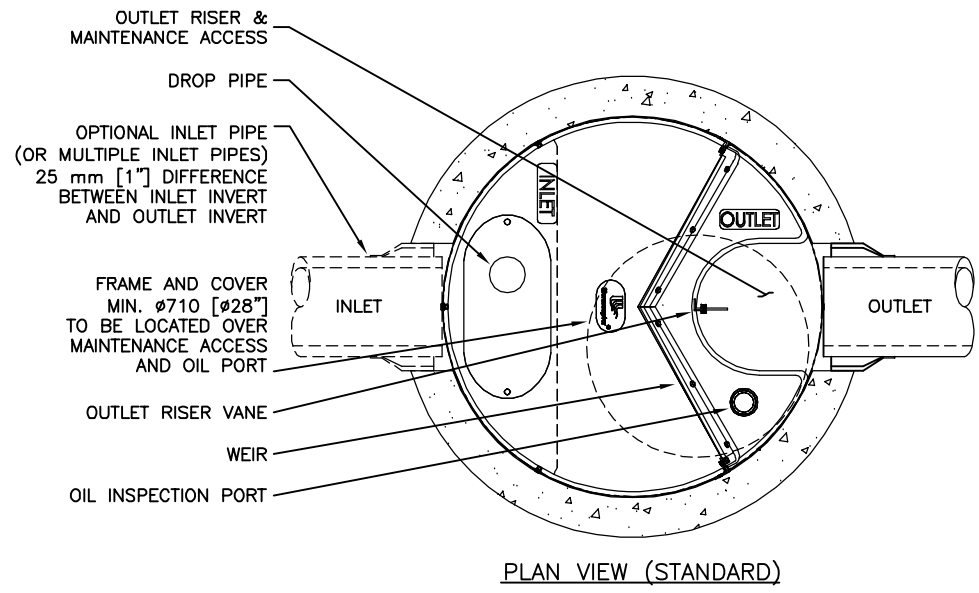
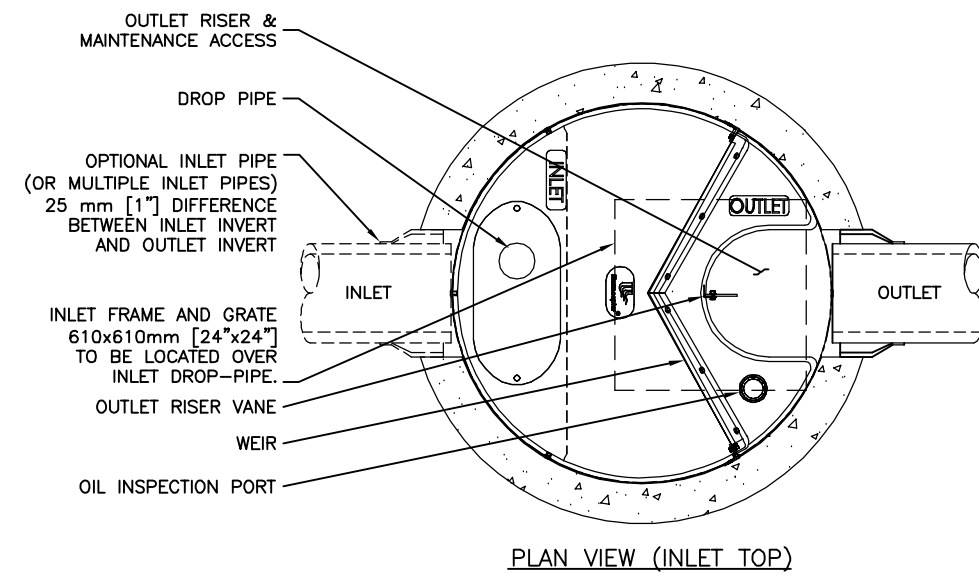
FOR SITE SPECIFIC DRAWINGS PLEASE CONTACT YOUR LOCAL STORMCEPTOR REPRESENTATIVE. SITE SPECIFIC DRAWINGS ARE BASED ON THE BEST AVAILABLE INFORMATION AT THE TIME. SOME FIELD REVISIONS TO THE SYSTEM LOCATION OR CONNECTION PIPING MAY BE NECESSARY BASED ON AVAILABLE SPACE OR SITE CONFIGURATION REVISIONS. ELEVATIONS SHOULD BE MAINTAINED EXCEPT WHERE NOTED ON BYPASS STRUCTURE (IF REQUIRED).

- GENERAL NOTES:**
- * MAXIMUM SURFACE LOADING RATE (SLR) INTO LOWER CHAMBER THROUGH DROP PIPE IS 1135 L/min/m² (27.9 gpm/ft²) FOR STORMCEPTOR EF4 AND 535 L/min/m² (13.1 gpm/ft²) FOR STORMCEPTOR EFO4 (OIL CAPTURE CONFIGURATION). WEIR HEIGHT IS 150 mm (6 INCH) FOR EF04.
