Final Geotechnical Reference Document

**Proposed Industrial Development -
Intersection of Rideau Street and Somme
Street
Ottawa, Ontario**

Consolidated FastFrate (Ottawa) Holdings Inc.

October 20, 2022

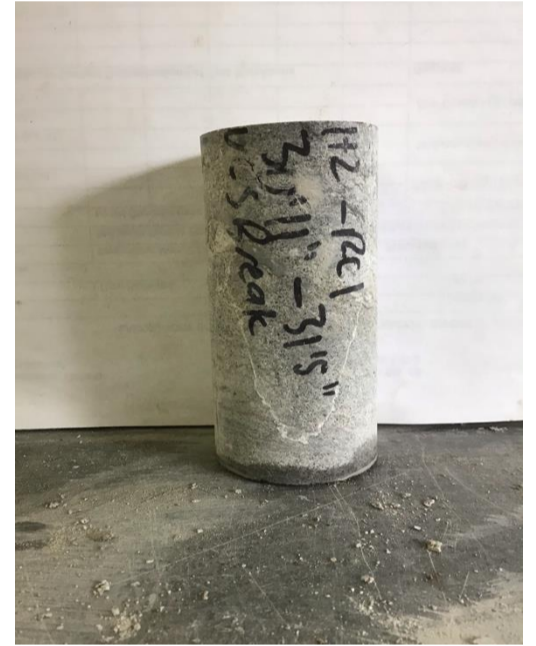
Before Test :

Maximum Applied Load, kN	241.3
Compressive Strength, MPa	139.1

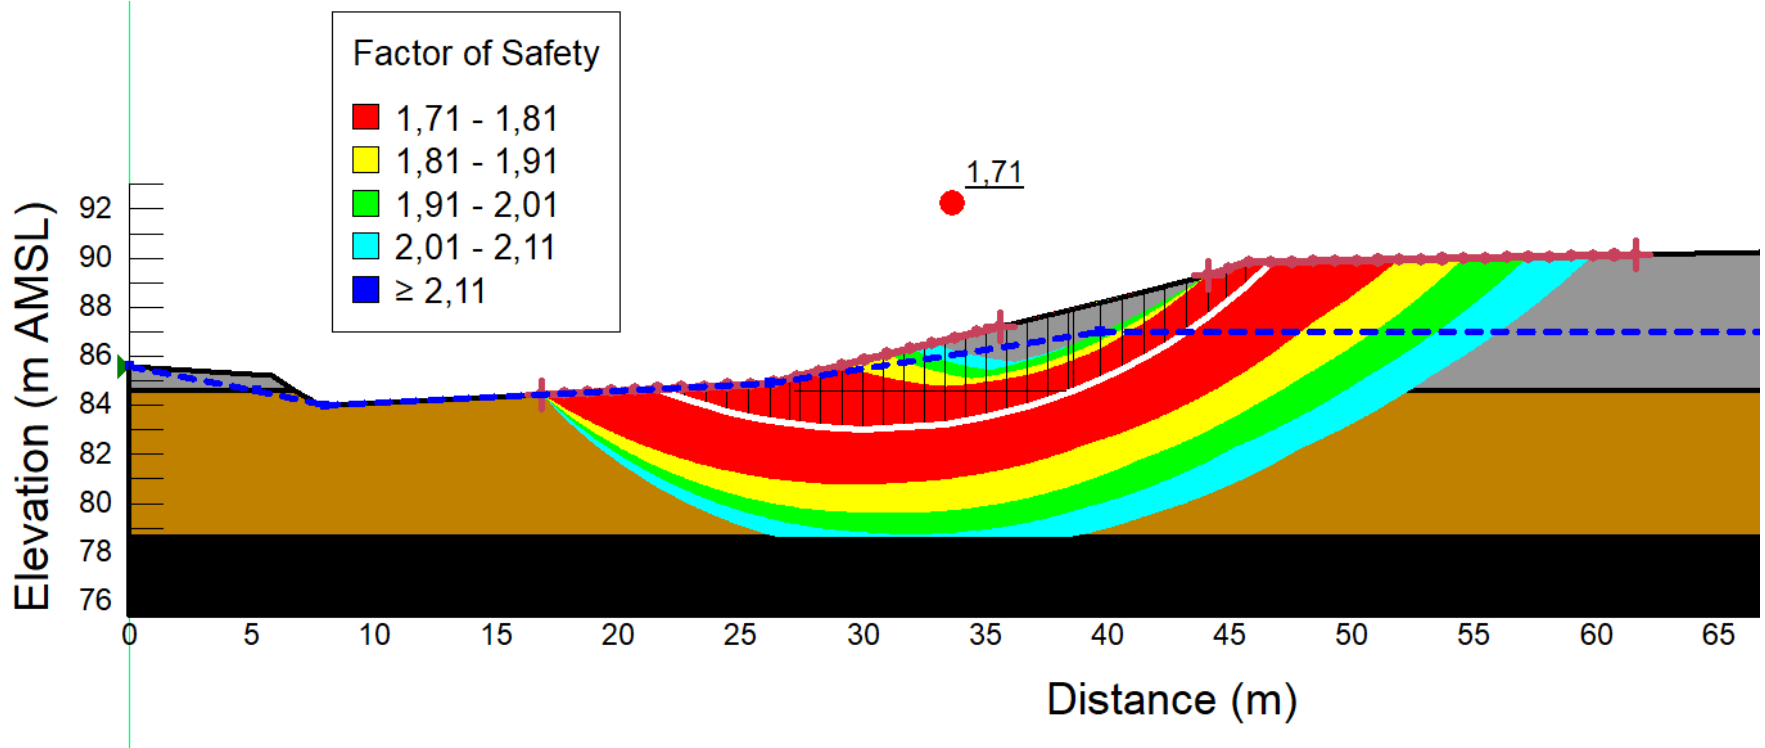
Client:	Consolidated FastFrate (Ottawa) Holdings Inc	Prepared by:	David Rizk, ing. (Qc)
Projet:	Proposed Industrial Development		
Reference:	12576381-RPT-1		
Location:	Intersection of Rideau Street and Somme Street, Ottawa, Ontario	Reviewed by:	Denis Roy, ing. (Qc), M.B.A.
Analysis:	Pseudo-Static ($K_h = 0.05g$)

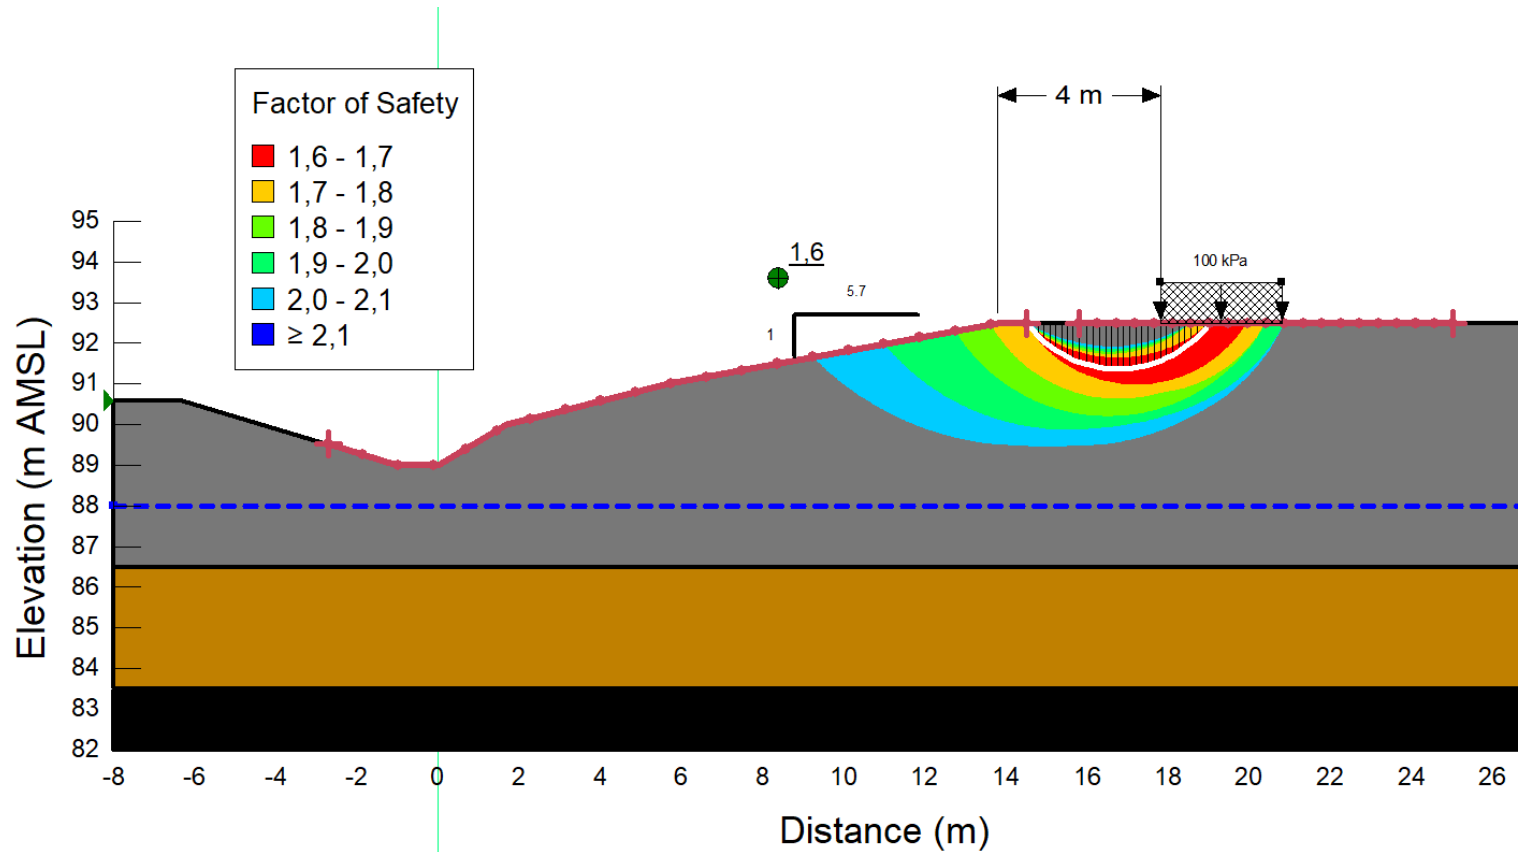
Client:	Consolidated FastFrate (Ottawa) Holdings Inc	Prepared by:	David Rizk, ing. (Qc)
Projet:	Proposed Industrial Development		
Reference:	12576381-RPT-1		
Location:	Intersection of Rideau Street and Somme Street, Ottawa, Ontario	Reviewed by:	Denis Roy, ing. (Qc), M.B.A.
Analysis:	Static

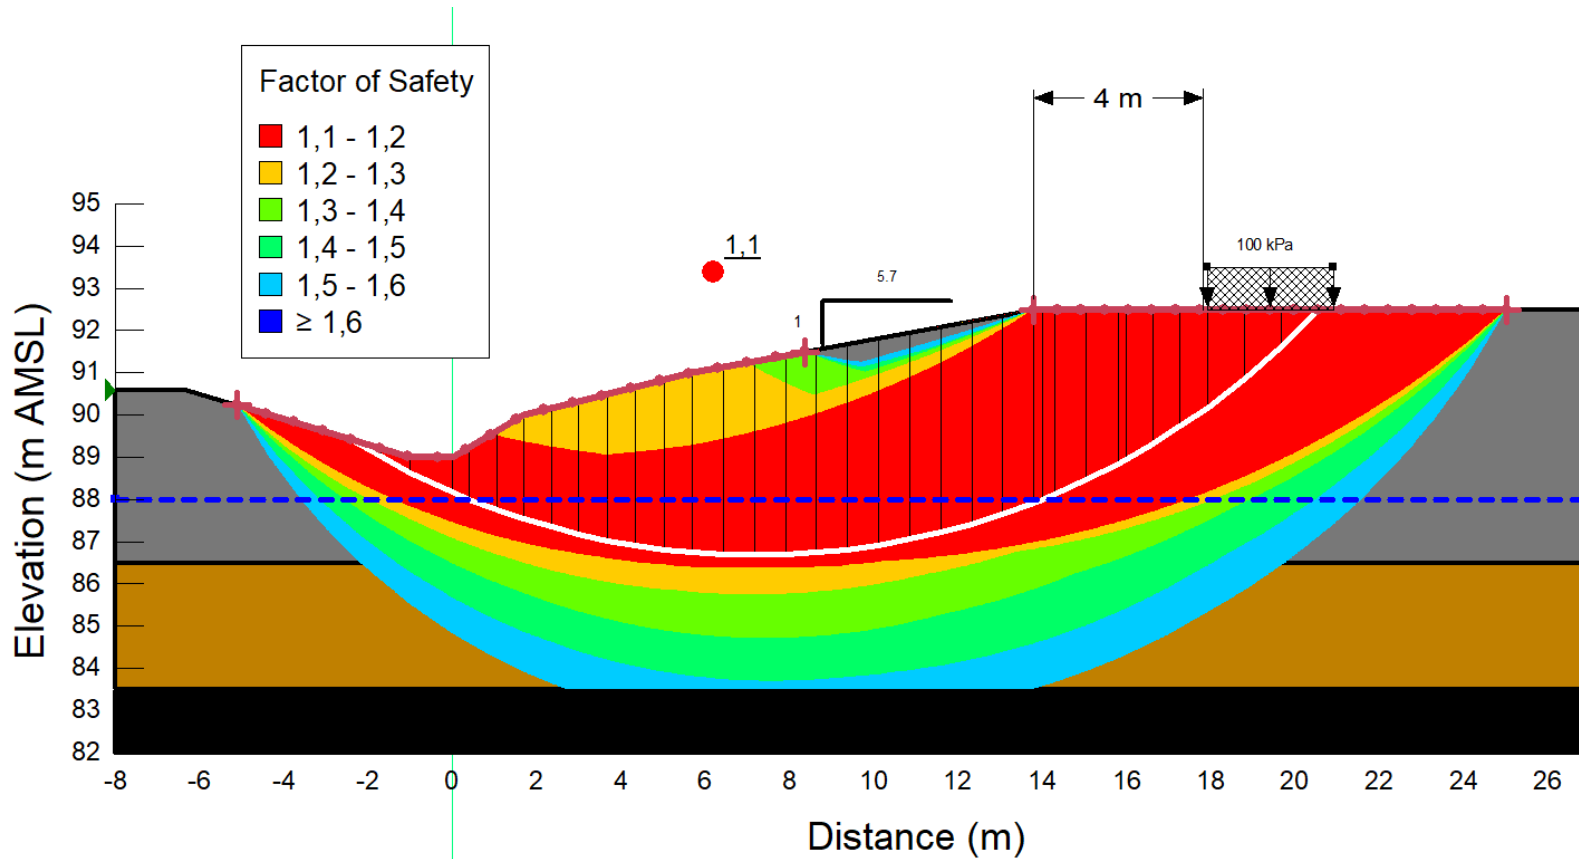
Client:	Consolidated FastFrate (Ottawa) Holdings Inc	Prepared by:	David Rizk, ing. (Qc)
Projet:	Proposed Industrial Development		
Reference:	12576381-RPT-1		
Location:	Intersection of Rideau Street and Somme Street, Ottawa, Ontario	Reviewed by:	Denis Roy, ing. (Qc), M.B.A.
Analysis:	Pseudo-Static (Kh = 0.35g)
