Revision 3 Geotechnical Investigation – Proposed Mixed-Use Development

150 Kanata Avenue & 1200 Canadian Shield Avenue, Kanata, Ontario

March 9, 2023

Pinchin File: 290435.001

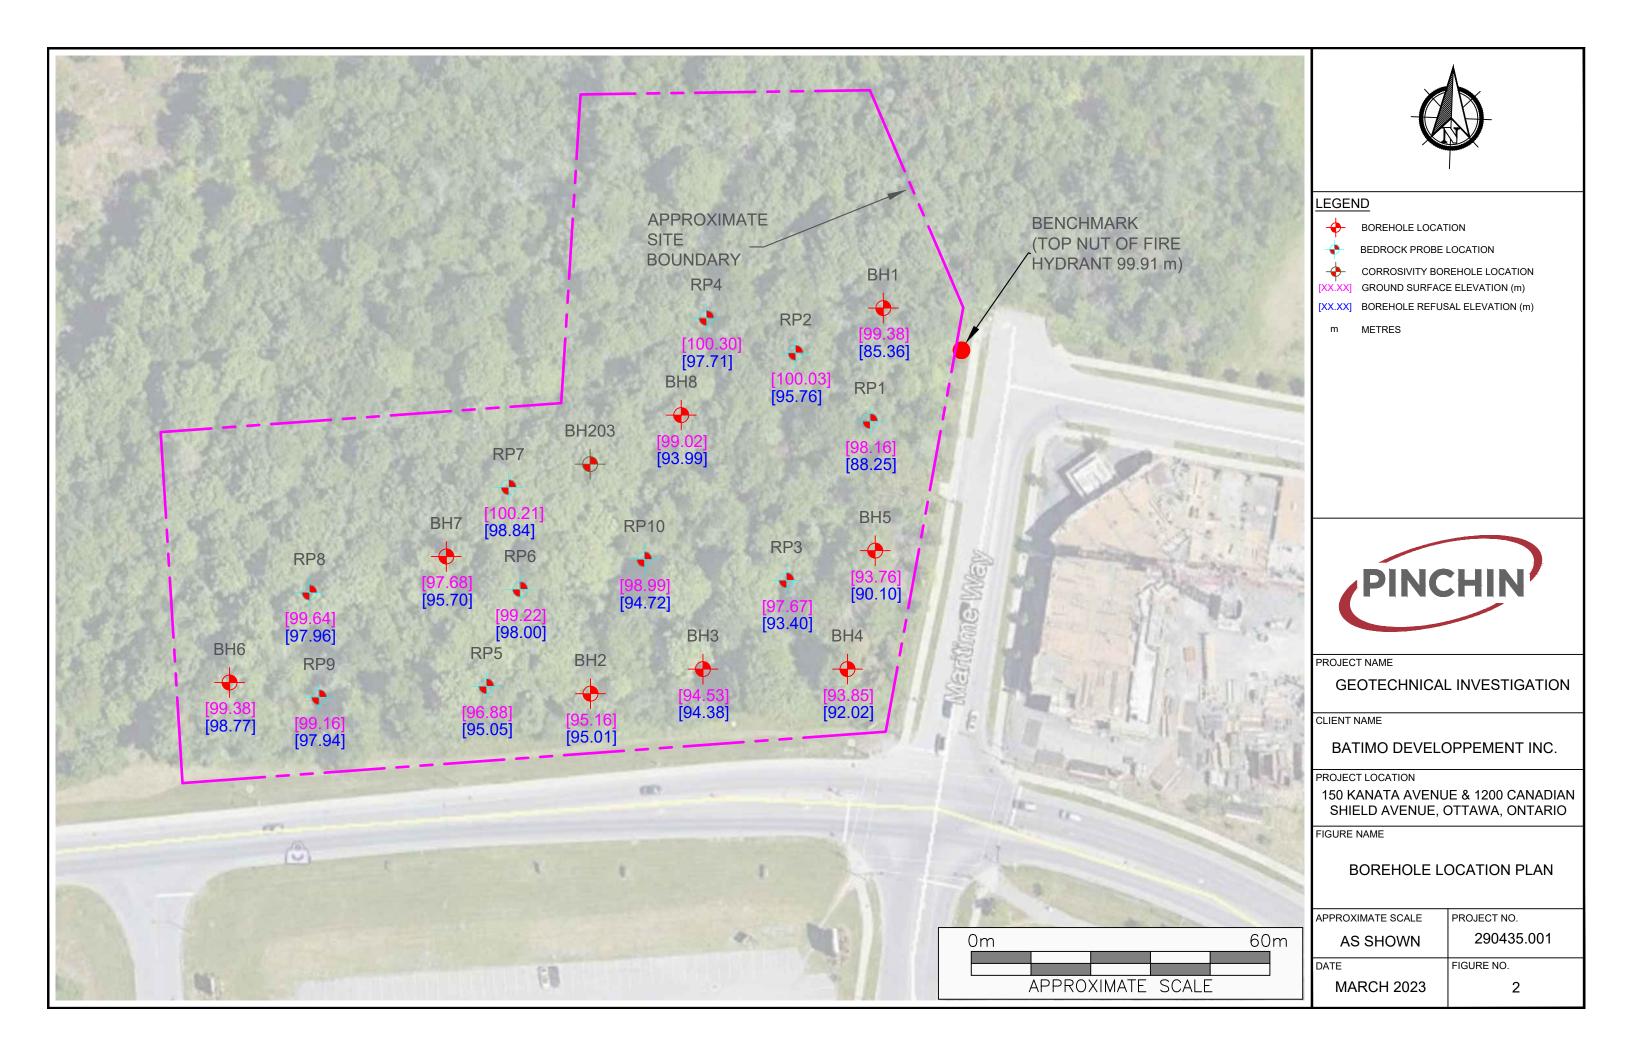
FIGURE 1	Кеу Мар
FIGURE 2	Borehole Location Plan

The purpose of the Geotechnical Investigation was to delineate the subsurface conditions and soil engineering characteristics by advancing a total of eight (8) sampled boreholes (Boreholes BH1 to BH8), at the Site. In addition, a supplemental field investigation was completed which consisted of advancing a total of ten (10) bedrock probes at the Site. The information gathered from the Geotechnical Investigation will allow Pinchin to provide geotechnical design recommendations for the proposed development.

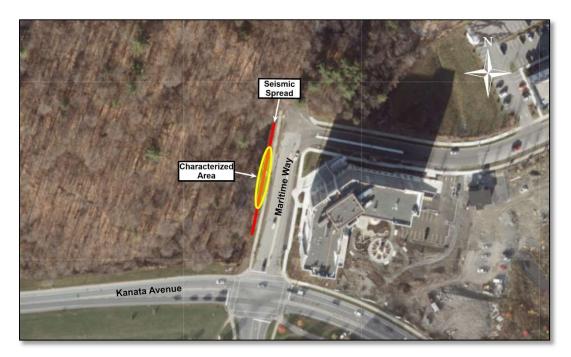
Figure 2: Location of the seismic spreads (source: geoOttawa)

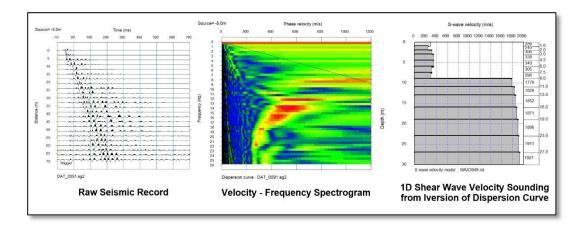
Figure 4: Example of a MASW/SPAC record, Phase Velocity - Frequency curve of the Rayleigh wave and resulting 1D Shear Wave Velocity Model

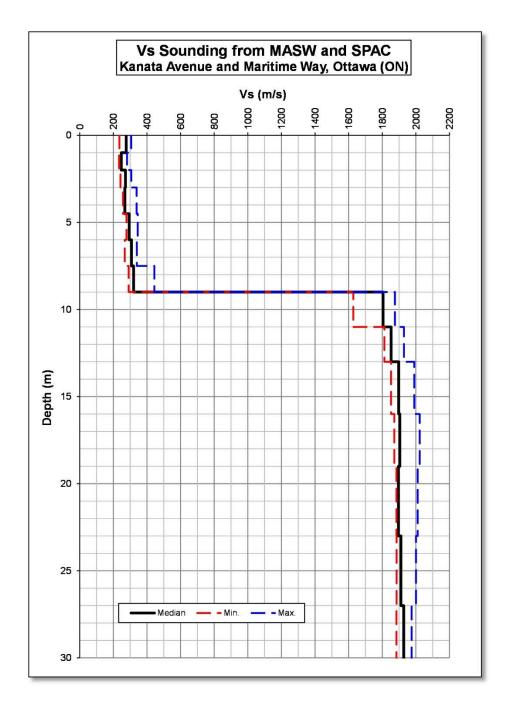
Figure 5: MASW Shear-Wave Velocity Sounding
