Geotechnical Investigation – Proposed Mixed-Use Development

150 Kanata Avenue & 1200 Canadian Shield Avenue,
Kanata, Ontario

May 26, 2022

Pinchin File: 290435.001

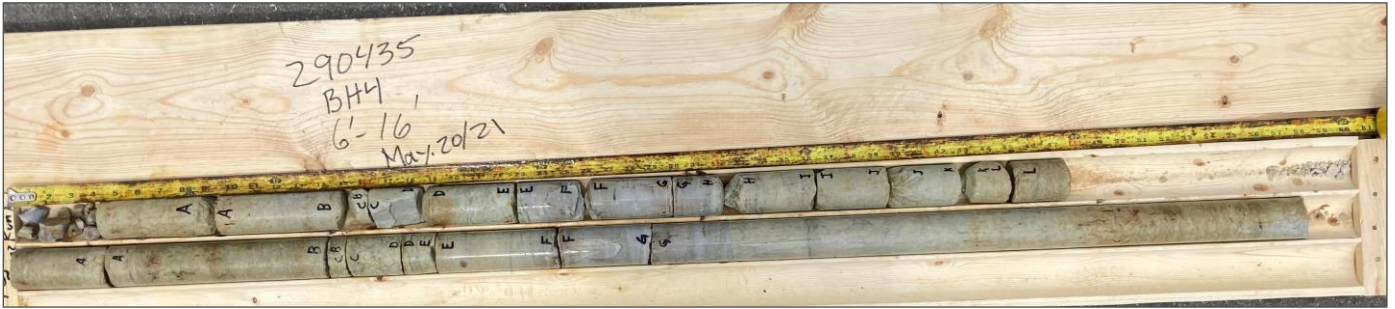
Photo 1 – Borehole BH4, Rock Core (Runs 1 and 2)

Refusal was encountered on bedrock within all boreholes and bedrock probes at depths ranging from approximately 0.2 to 14.0 mbgs (i.e., elevations 85.4 to 98.8 m). The bedrock cores recovered consisted of an upper layer of sandstone bedrock overlying granitic bedrock. The sandstone was noted to be moderately weathered, while the granite was noted to be faintly weathered. The bedrock was predominantly brownish grey with white and black banding, fine to medium grained, and contained some natural fractures with little oxidation. The bedrock at the fracture locations was mostly sharp and angular, which indicates minor water migration. Natural fractures were closely to moderately spaced and were generally found to occur in sets oriented at approximately 45 to 90° to the core axis. An approximate 70% wash return within the rock cores was observed. The wash return was milky white in colour. The rock core recovery ranged between 27 and 97%, with RQDs ranging from 0 to 88%, indicating a very poor to good rock quality. A photograph of the rock cores is provided in Appendix IV.

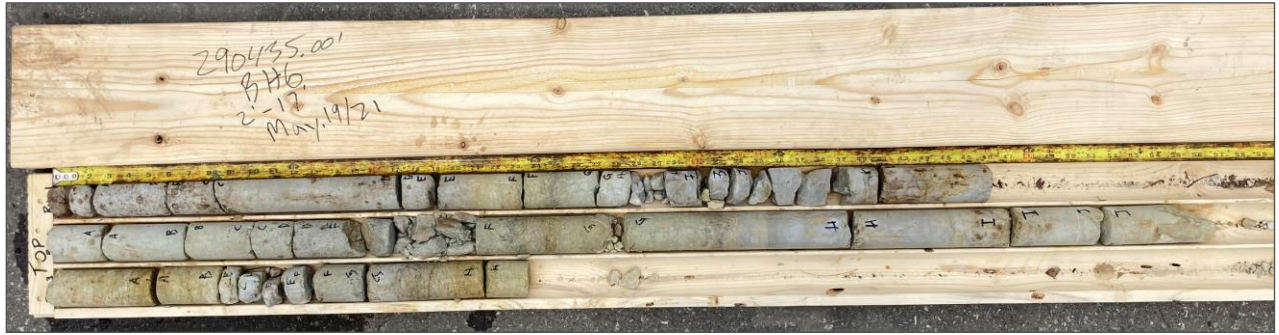
Photo 2 – Borehole BH6, Rock Core (Runs 1 to 3)

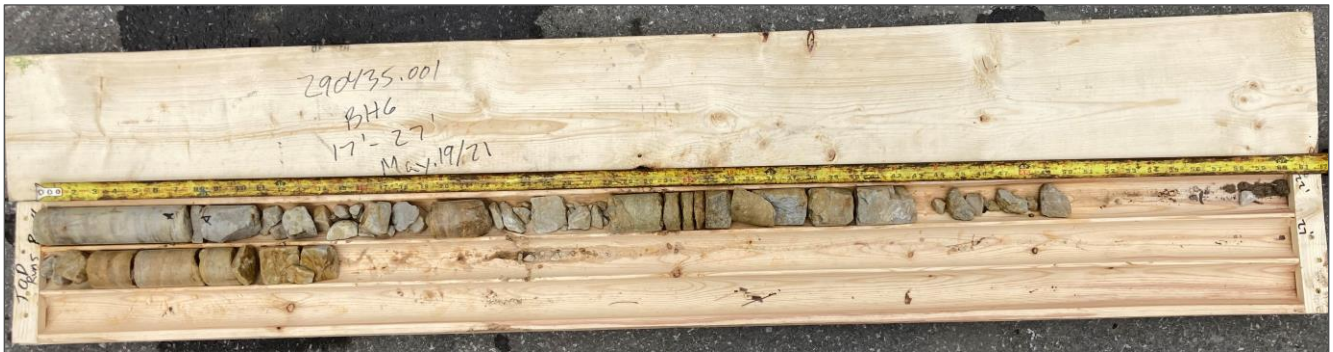
Photo 3 – Borehole BH6, Rock Core (Runs 4 and 5)

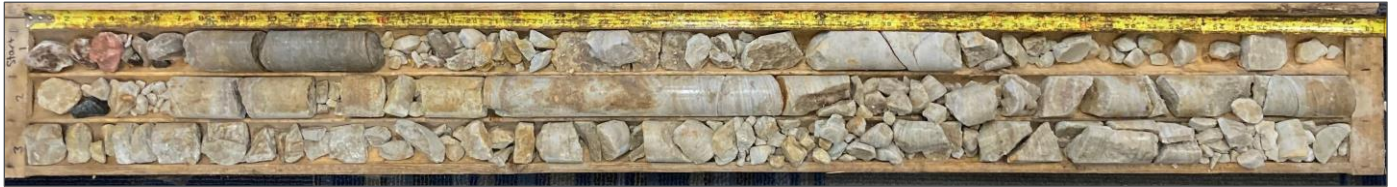
Photo 4 – Bedrock Probe RP4, Rock Core (Runs 1 to 3)

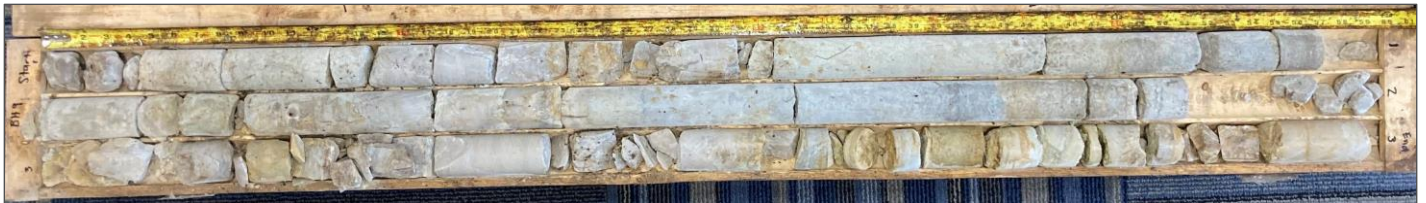
Photo 6 – Bedrock Probe RP9, Rock Core (Runs 1 to 3)
