Phase I Environmental Site Assessment

Northern Part of 1919 Riverside Drive
Ottawa, Ontario

October 15, 2021

Report: PE5409-1

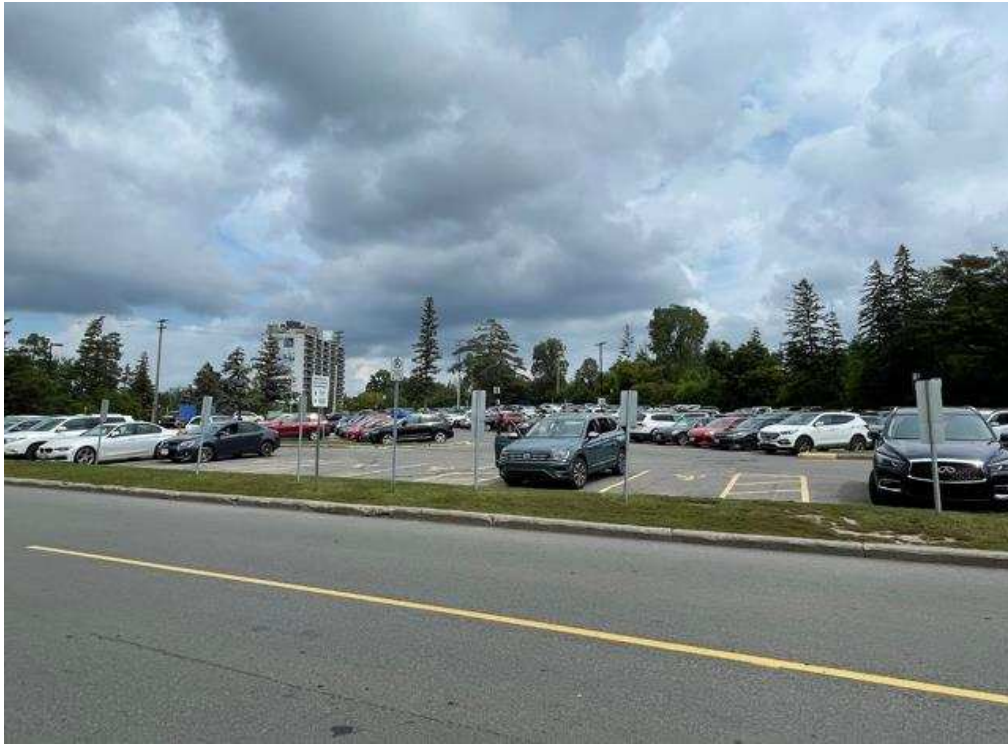
Photograph 1: View of the northern half of the Phase I ESA Property, looking northeast.

The site topography is above the grade of Smyth Road and slopes down towards the south. Site drainage consists primarily of infiltration with some sheet drainage to catch basins on-site and on the adjacent laneway.

No signs of an underground storage tank (UST) or above ground storage tank (AST) were noted at the time of the site visit. No areas of staining, unidentified substances or ponded water were observed on-site at this time.

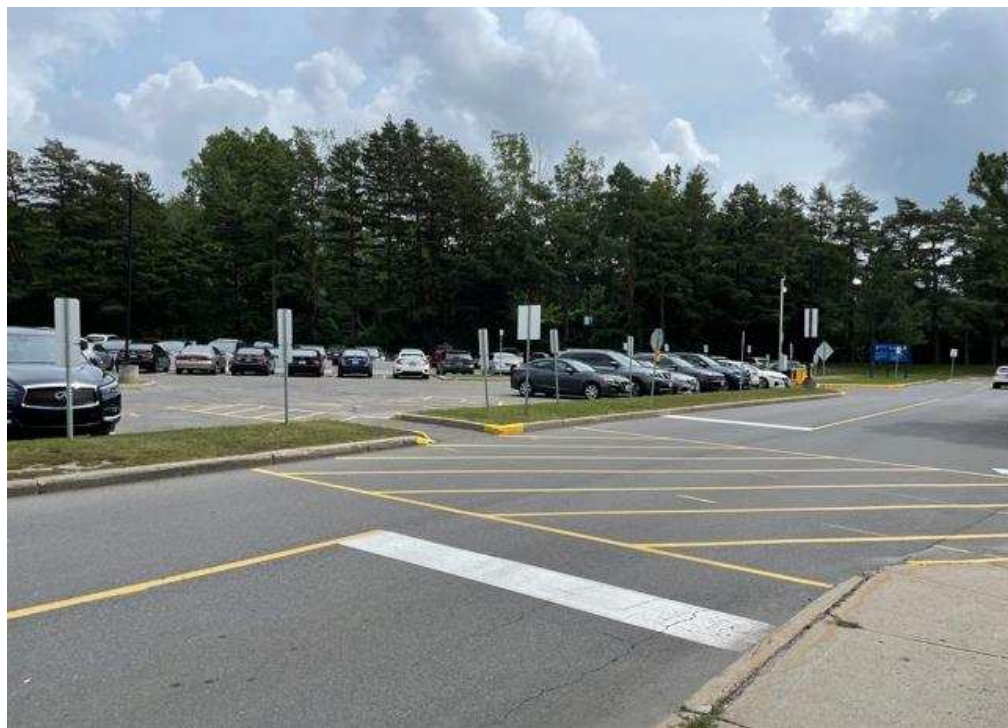
Photograph 2: View of the southern half of the Phase I ESA Property, looking southeast.
