**320 LEES AVENUE
 (2 ROBINSON)**

TREE CONSERVATION PLAN

TC-1

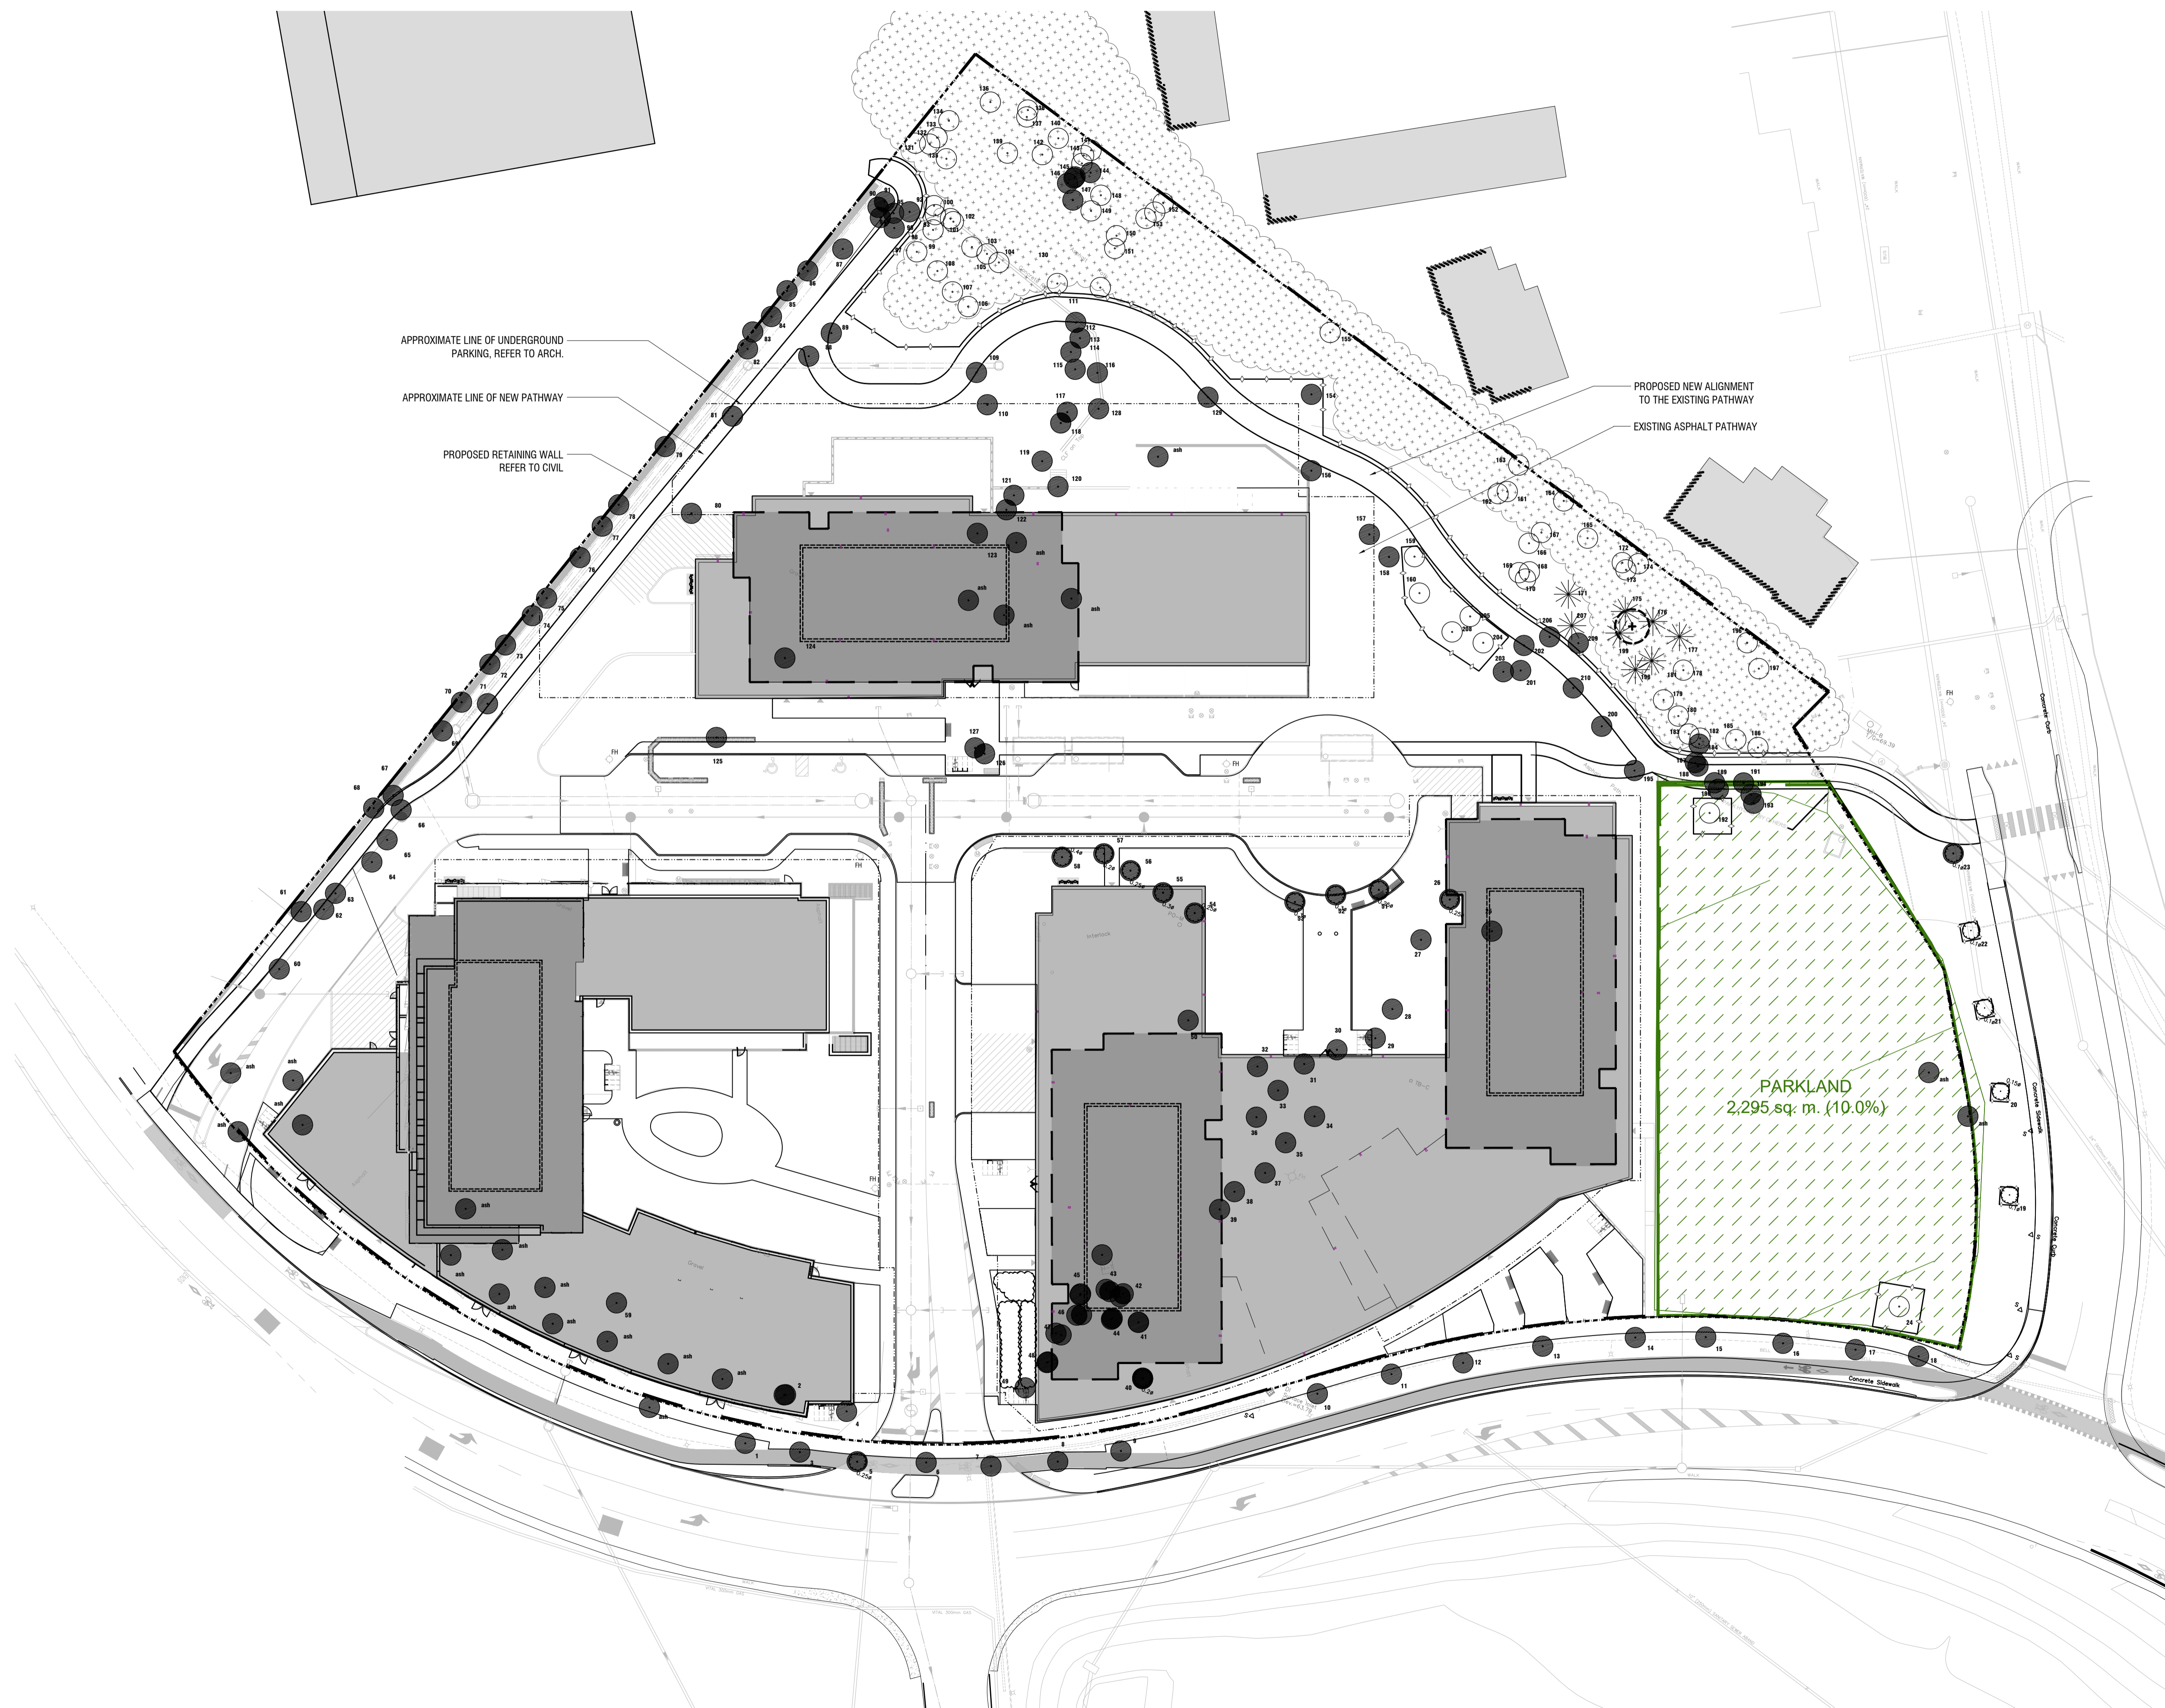
- EXISTING VEGETATION TO BE PRESERVED
- INDIVIDUAL TREE/STAND OF TREES TO BE PRESERVED AND KEY NO. - REFER TO TABLE # & REPORT FOR PRESERVATION TECHNIQUES DURING CONSTRUCTION
- INDIVIDUAL TREE/STAND OF TREES TO BE REMOVED AND KEY NO. - REFER TO TABLE #
- TREE PROTECTION FENCING
- AREA OF STUDY
