**PROJECT**  
1546 SCOTT STREET  
CITY OF OTTAWA

**SHEET TITLE**  
TREE PRESERVATION PLAN

**SHEET NUMBER** TPP-1  
**ISSUE** 1

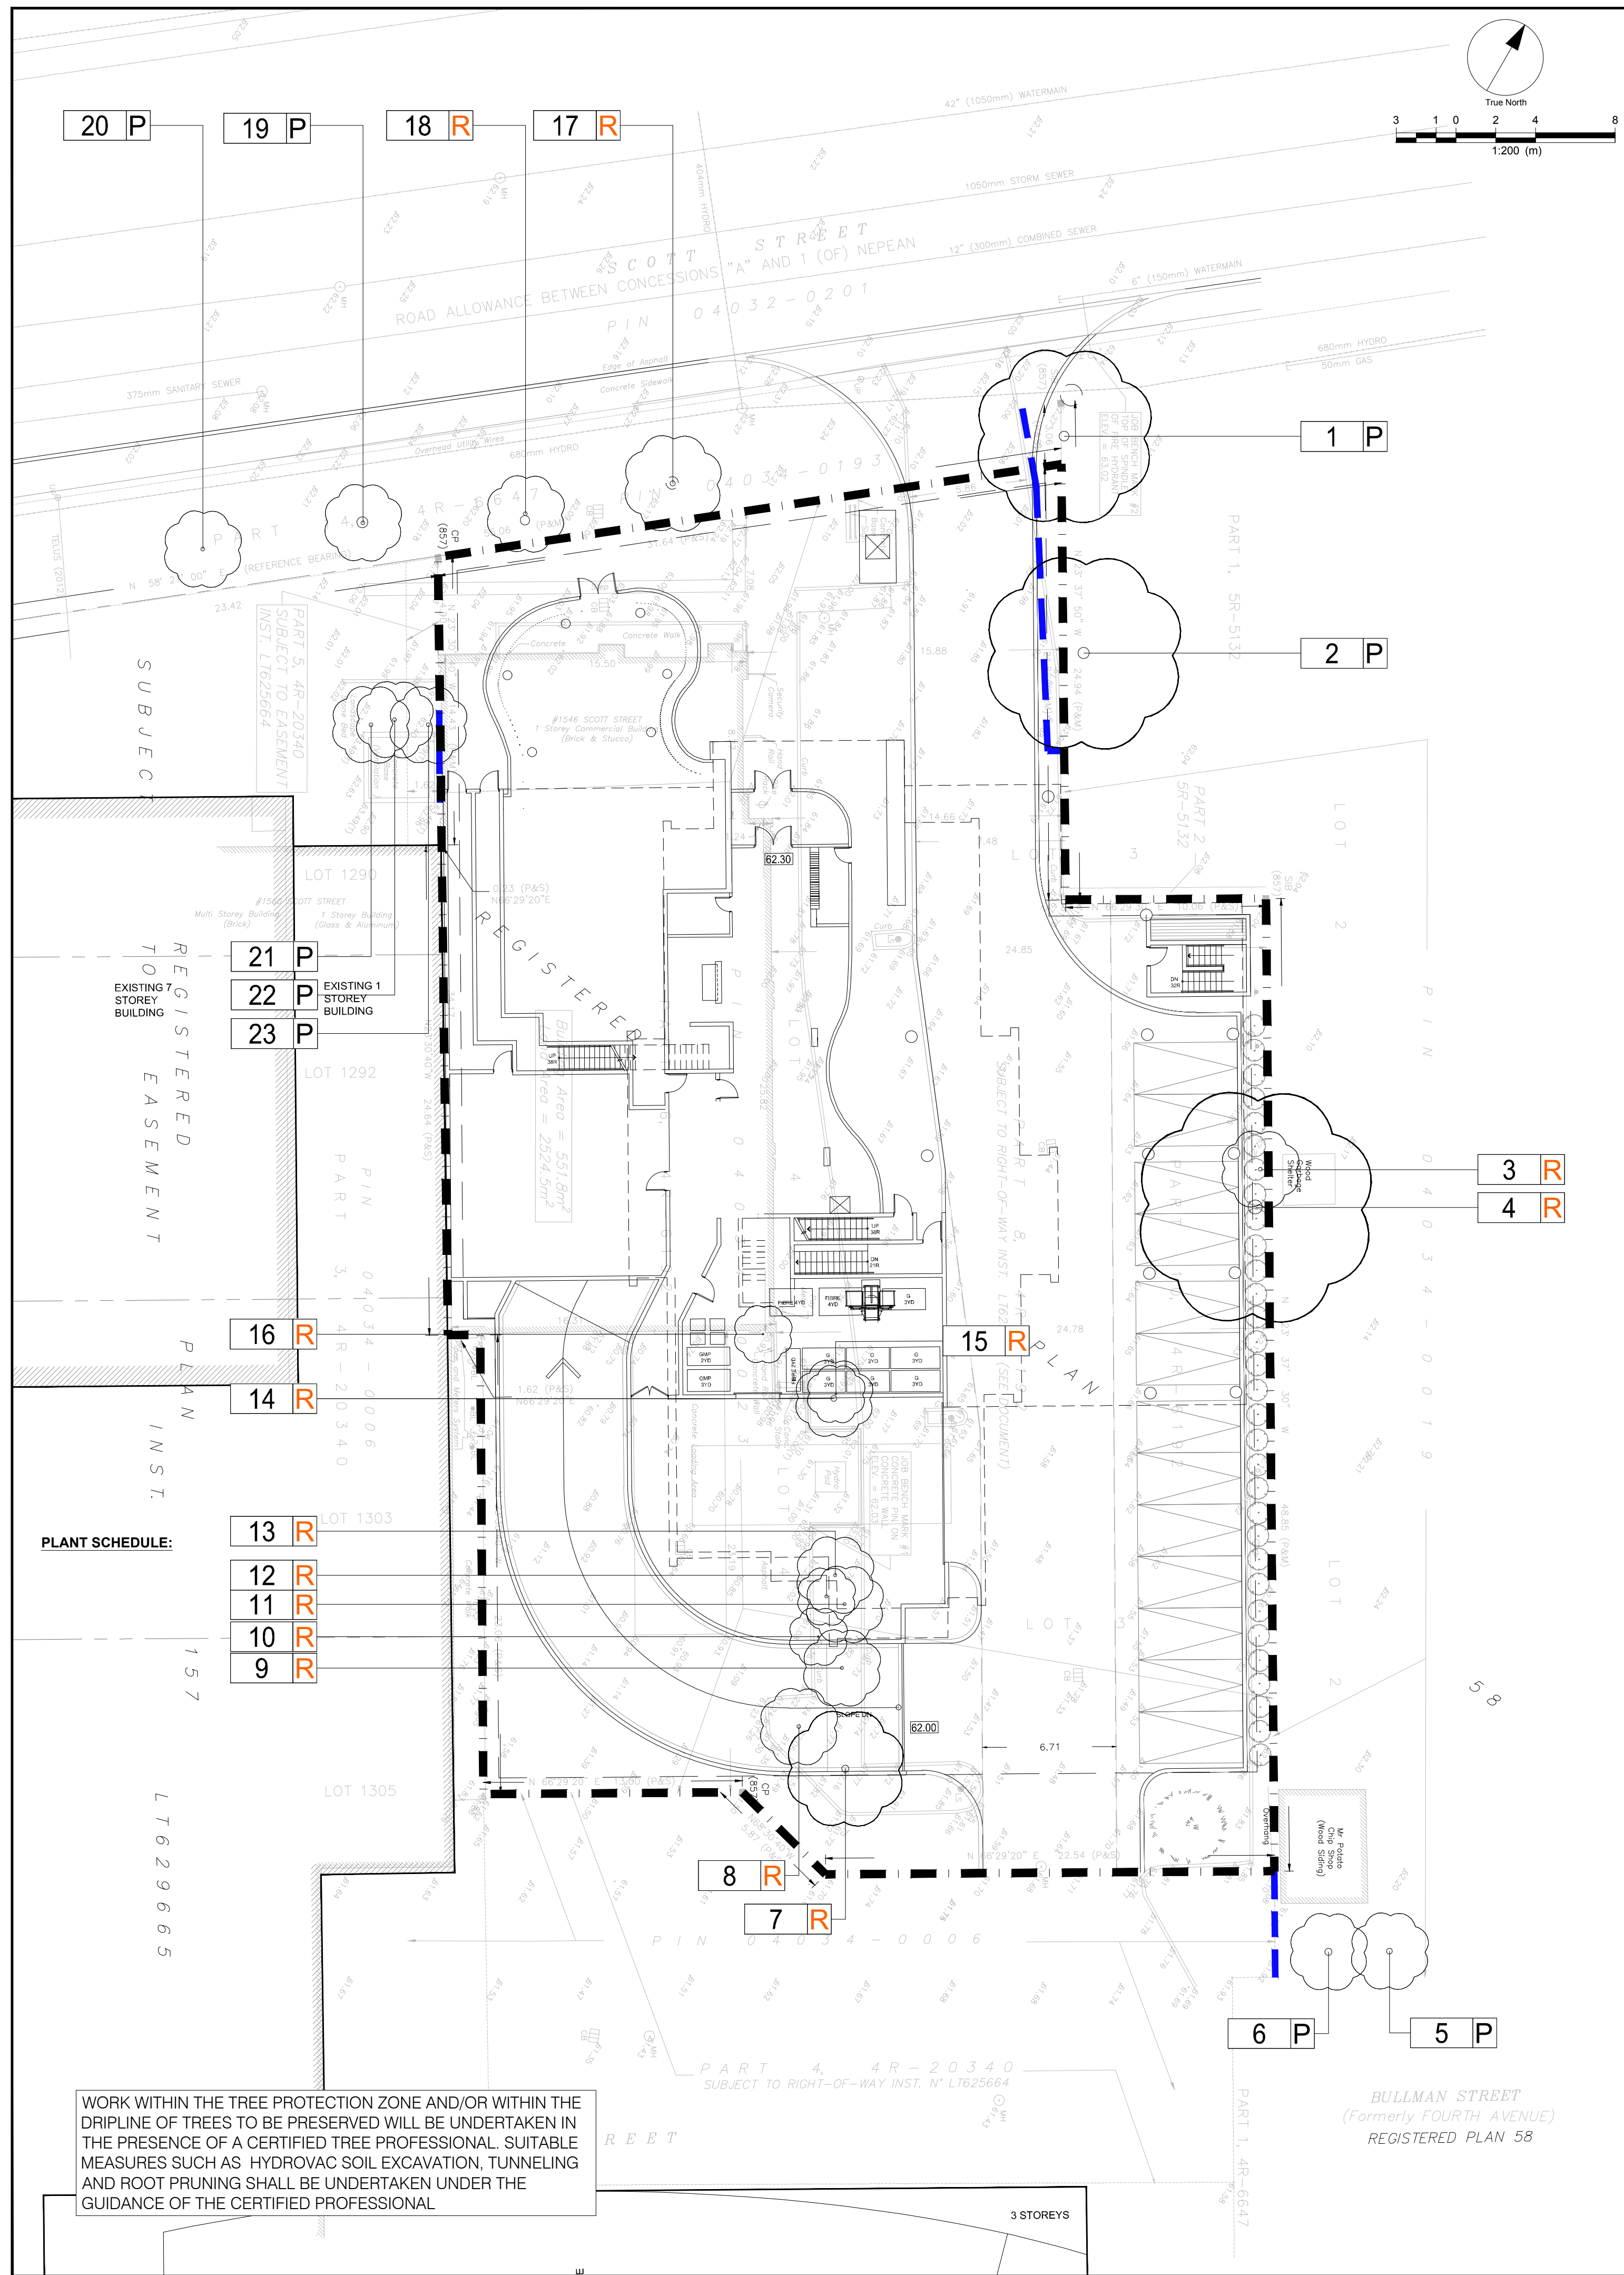
- EXISTING DECIDUOUS TREE
- TEMPORARY TREE PROTECTION FENCING
- PROJECT SITE BOUNDARY

- 000 P → TREE TO BE PRESERVED
- 000 R → TREE TO BE REMOVED
