PROJECT
1546 SCOTT STREET
CITY OF OTTAWA

SHEET TITLE
TREE PRESERVATION PLAN

SHEET NUMBER TPP-1
ISSUE 1

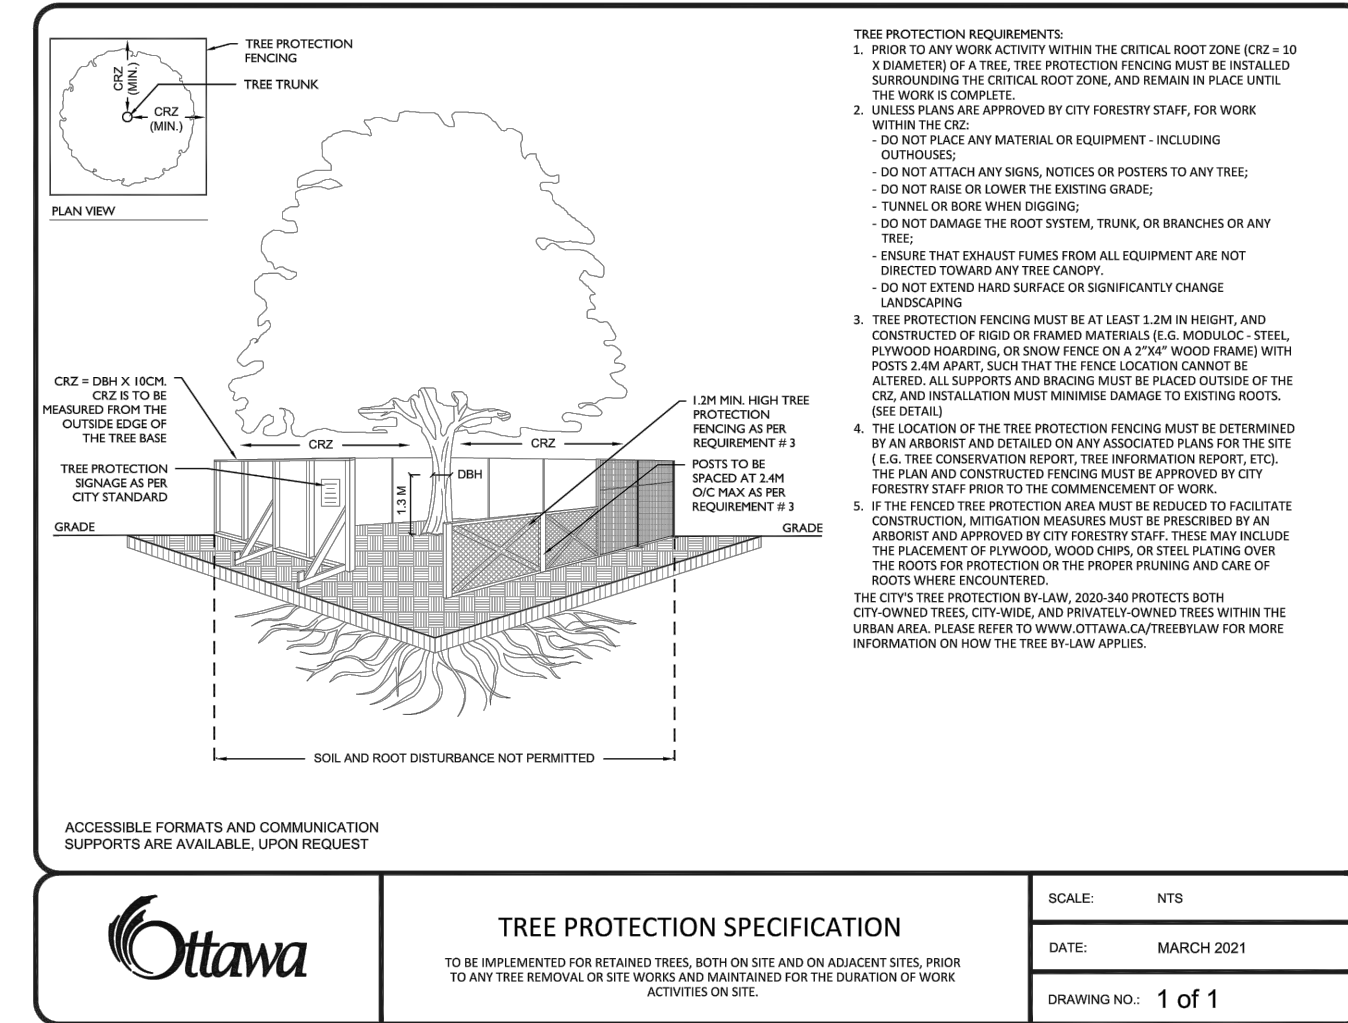
T1 TREE PROTECTION SPECIFICATION
TPP-1 N.T.S.
