PROJECT
1546 SCOTT STREET
CITY OF OTTAWA

SHEET TITLE
TREE PRESERVATION PLAN

SHEET NUMBER TPP-1 **ISSUE** 1

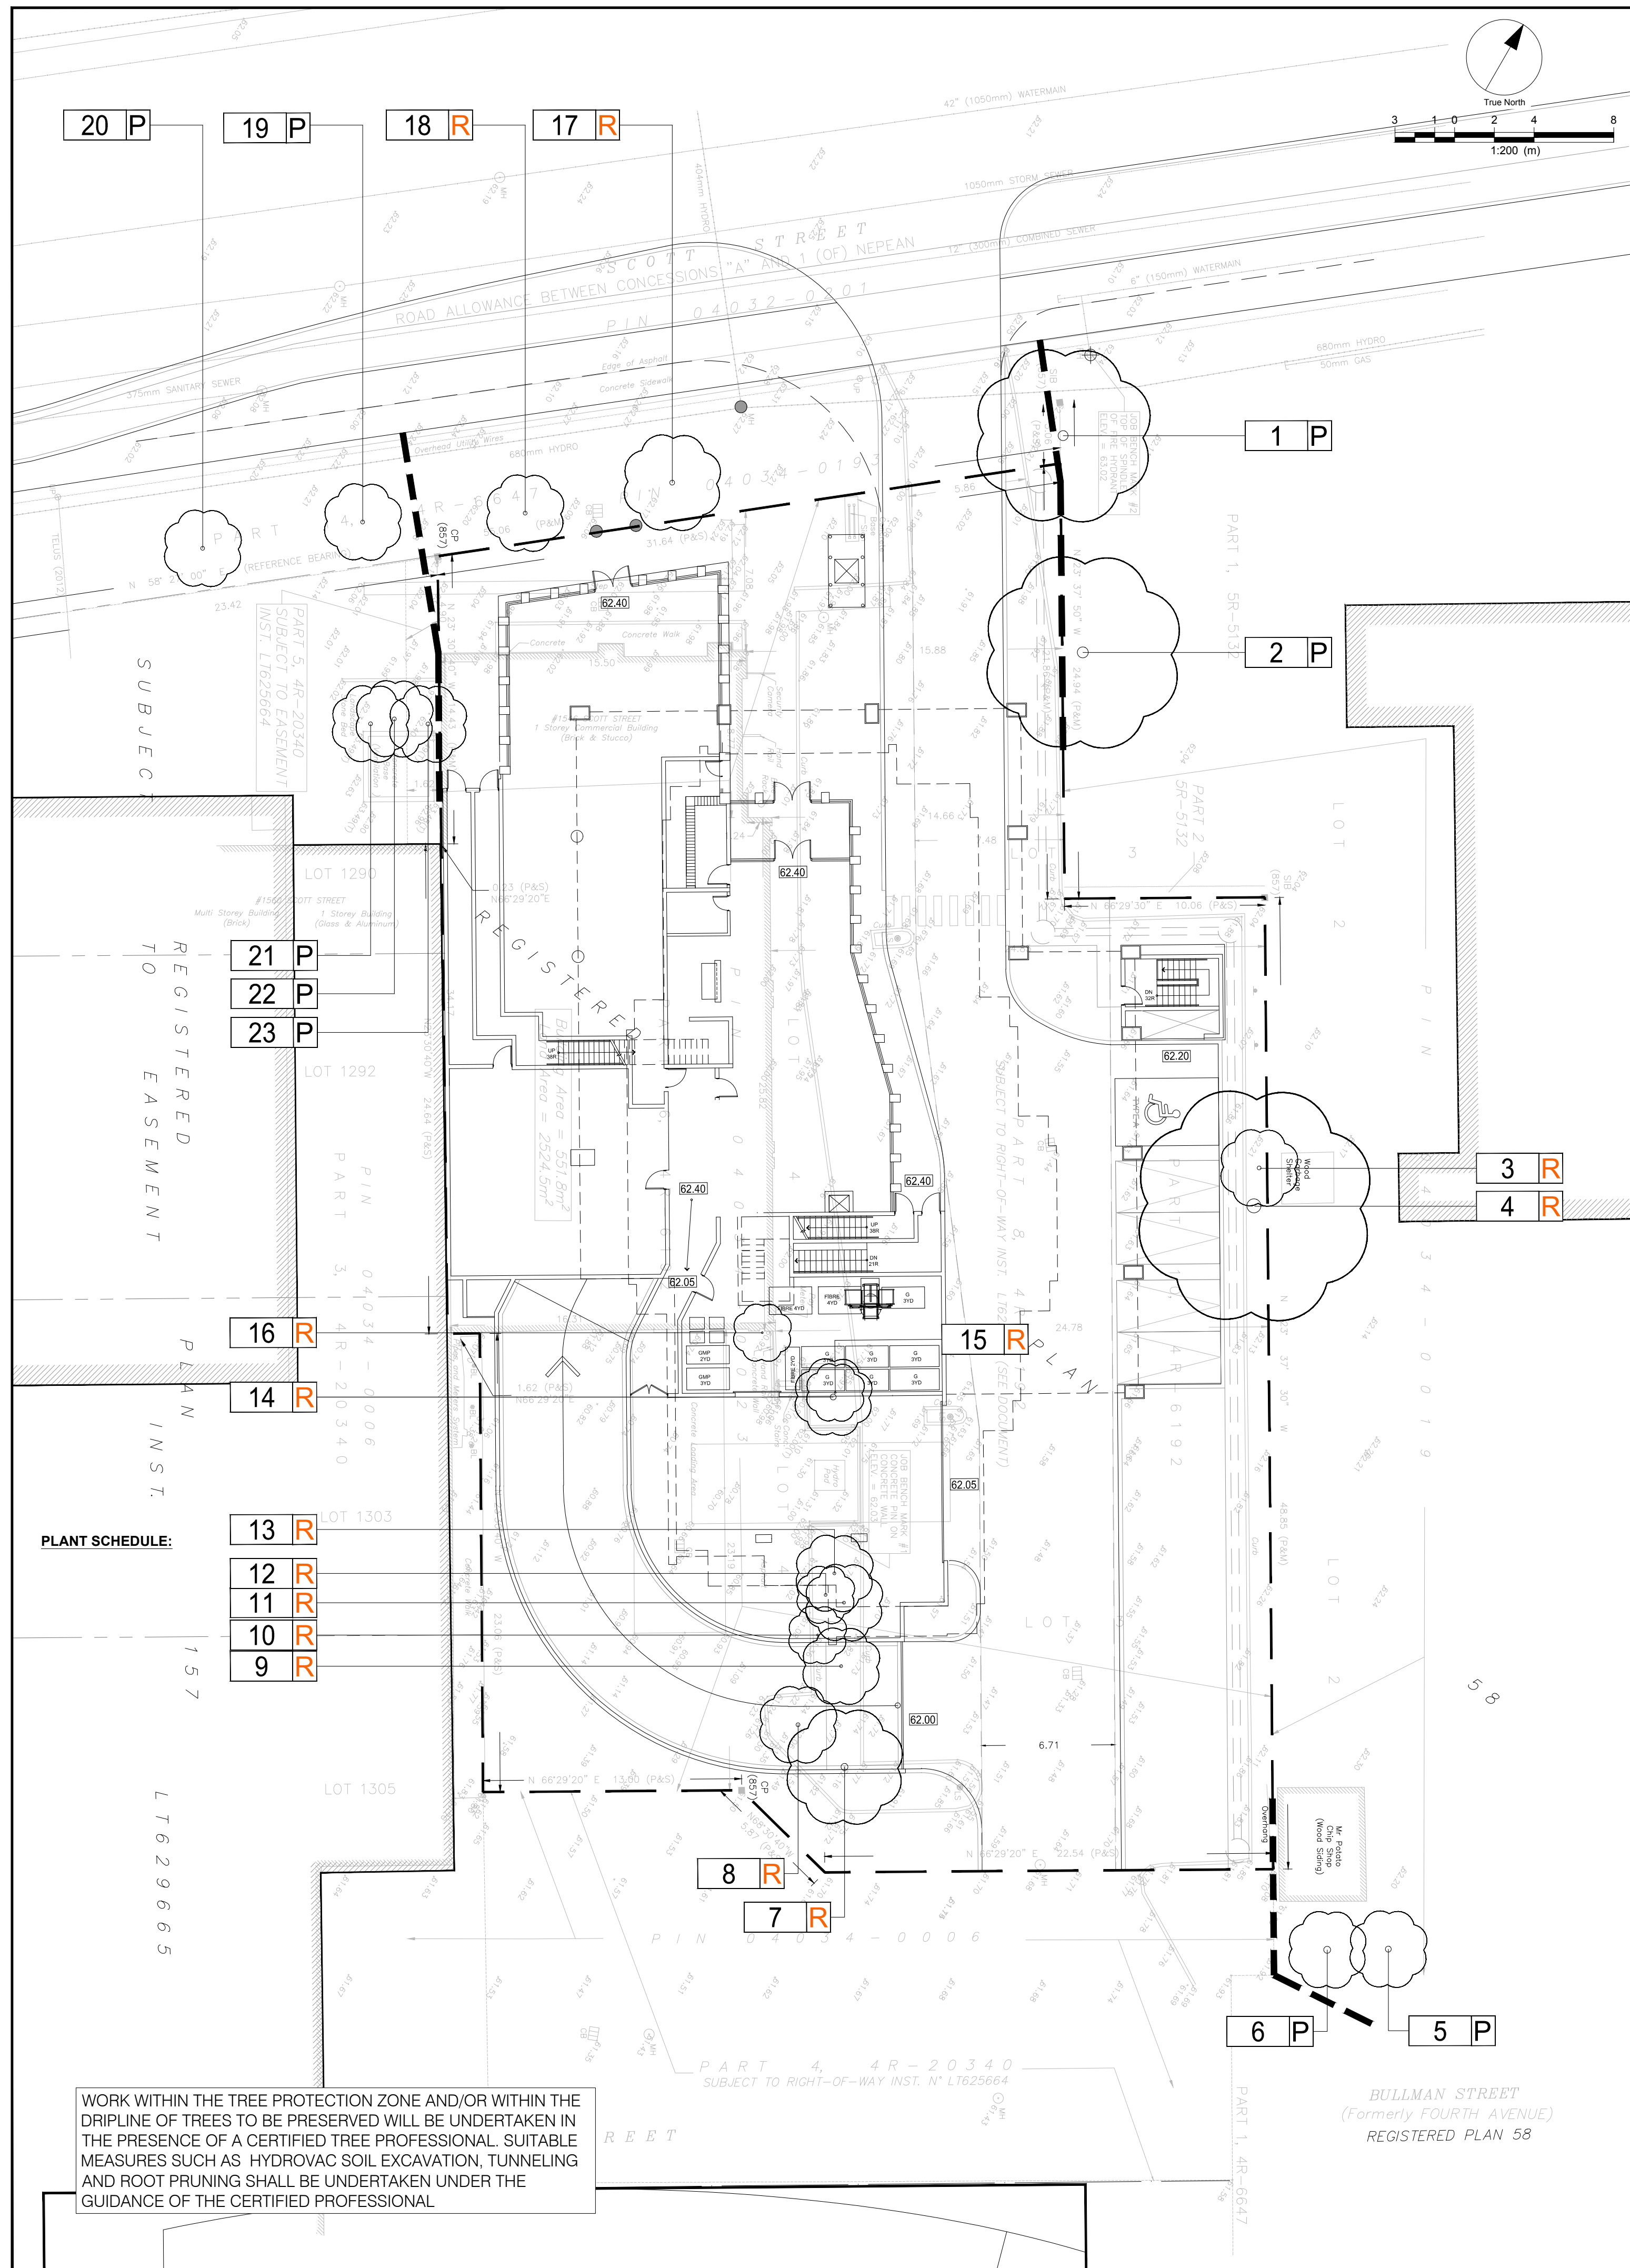
Table 1 - Tree Inventory Data
Data observed on July 29, 2021.

Tag #	Species	Common Name	Diameter at Breast Height (cm)	Drip Line Radius (m)	Condition			Overall Condition	Notes	Action
					Trunk	Canopy	Vigour			
1	<i>Acer negundo</i>	Manitoba maple	50	4.5	F	P-F	F	Poor-Fair	Co-dominant stems located 1m from ground. 1m from ground on the east side of trunk has wound and showing callused edges. Weak union woods at formal branch locations; dead woods in canopy; pruning and cabling should be considered. Tree located on City of Ottawa property.	Protection to be installed at property limits with reduced protection areas.
2	<i>Acer negundo</i>	Manitoba maple	55	5	G	G	G	Good	Overhangs adjacent commercial parking lot. Dead wood in the canopy. Tree located on adjacent property.	Protection to be installed at property limits with reduced protection areas.
3	<i>Acer negundo</i>	Manitoba maple	20,15,17,19,21	2	F	F	F	Fair	Multi-stem union located from ground; weak union woods with rot at formal branch locations; dead woods in canopy; pruning and cabling required. Vine present at lower canopy.	Remove

4	<i>Acer negundo</i>	Manitoba maple	70,45,17	6	P	F	G	Fair	Multi-stem union located less than 0.5m from ground. Dead wood present in canopy. Pruning and cabling required. Extensive vines in canopy.	Remove
5	<i>Acer platanooides</i>	Norway maple	21	2	G	G	G	Good	Good canopy; 2m from grade.	Preserve & Protect
6	<i>Acer platanooides</i>	Norway maple	20	2	G	G	G	Good	Good canopy; 2m from grade.	Preserve & Protect
7	<i>Ulmus pumila</i>	Siberian elm	35,28	3	P-F	F	F	Fair	Co-dominant stems located from ground. Insects damage present on trunk.	Remove
8	<i>Quercus rubra</i>	Red oak	23	2	G	G	G	Good	Overhangs adjacent commercial parking lot. Dead wood in the canopy. Insects damage present on trunk.	Remove
9	<i>Acer ginnala</i>	Amur maple	16,13,12	2	F	F	F	Fair	Multi-stem union located less than 0.5m from ground. Dead wood present in canopy. Pruning and cabling required. Extensive vines in canopy.	Remove
10	<i>Acer ginnala</i>	Amur maple	10,11	1.5	P	P	P	Poor-Fair	Multi-stem union located less than 0.5m from ground. Dead wood present in canopy. Barks are falling off, less than 10% tree canopy.	Remove

11	<i>Acer ginnala</i>	Amur maple	10,11,12,11	2	P-F	F	F	Fair	Multi-stem union located less than 0.5m from ground. Dead wood present in canopy. Pruning and cabling required. Extensive vines in canopy.	Remove
12	<i>Acer ginnala</i>	Amur maple	10	1.5	P	P	P	Poor	Multi-stem union located less than 0.5m from ground. Dead wood present in canopy. 45 degrees growing towards adjacent property. Cracked bark in the canopy.	Remove
13	<i>Acer ginnala</i>	Amur maple	15	2	P-F	F	F	Poor-Fair	Multi-stem union located less than 0.5m from ground. Dead wood present in canopy. Pruning and cabling required. Extensive vines in canopy.	Remove
14	<i>Acer ginnala</i>	Amur maple	28,24	2	P	P	P-F	Poor	Co-dominant stems located less than 0.5m from ground. Dead wood present in canopy. Growing with the Siberian elm closely.	Remove
15	<i>Ulmus pumila</i>	Siberian elm	10	1.5	P	P	P	Poor	Co-dominant stems located from ground. Insects damage present on trunk. Growing with the Amur maple closely.	Remove

16	<i>Ulmus pumila</i>	Siberian elm	10	1.5	P	P	P	Poor	Poor condition. Growing closely against wall.	Remove
17	<i>Gleditsia triacanthos</i>	Honey locust	28	2.5	G	G	G	Good	Great canopy;	Remove
18	<i>Gleditsia triacanthos</i>	Honey locust	19	2	F	F	G	Fair-Good	Trunk is in good shape; dead wood in canopy;	Remove
19	<i>Gleditsia triacanthos</i>	Honey locust	20	2	F	F	G	Fair-Good	Trunk is in good shape; dead wood in canopy; Off subject property.	Preserve & Protect
20	<i>Gleditsia triacanthos</i>	Honey locust	Less than 10		P	P	F	Poor-Fair	Multi-stem union located less than 0.5m from ground. Dead wood present in canopy; Off subject property.	Preserve & Protect
21	<i>Acer ginnala</i>	Amur maple	Less than 10		F	F	F	Fair	Multi-stem union located less than 0.5m from ground. Dead wood present in canopy. Off subject property.	Preserve & Protect
22	<i>Acer ginnala</i>	Amur maple	20,18,16	1.5	F	P-F	F	Fair	Multi-stem union located less than 0.5m from ground. Dead wood present in canopy. Leader has 60 degree jog. Epicormic growth in canopy. Off subject property.	Preserve & Protect

23	<i>Acer ginnala</i>	Amur maple	15,17,18	1.5	F	F	G	Fair-Good	Dead wood present in canopy. Multi-stem union located less than 0.5m from ground. Off subject property.	Preserve & Protect
