# **Geotechnical Investigation**

Proposed Dog Kennel 5969 Ottawa Street Richmond, Ontario Revision 1

LRL File No.: 210341 October, 2021; Revised August 2023

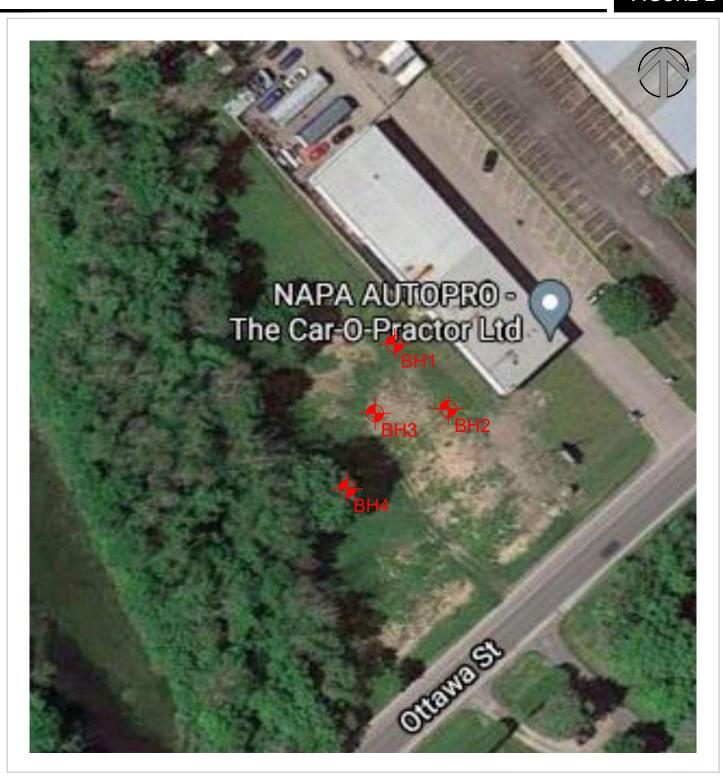
FIGURE 2

The fieldwork for this investigation was carried out on August 23, 2021. Prior to the fieldwork, the site was cleared for the presence of any underground services and utilities. A total of four (4) boreholes were drilled within the proposed building footprint, and near the top of the slope. The approximate locations of the boreholes are shown in Figure 2 included in **Appendix A**.
