Geotechnical Investigation

Proposed Dog Kennel
5969 Ottawa Street
Richmond, Ontario
Revision 2

LRL File No.: 210341

October, 2021; *Revised May, 2024*

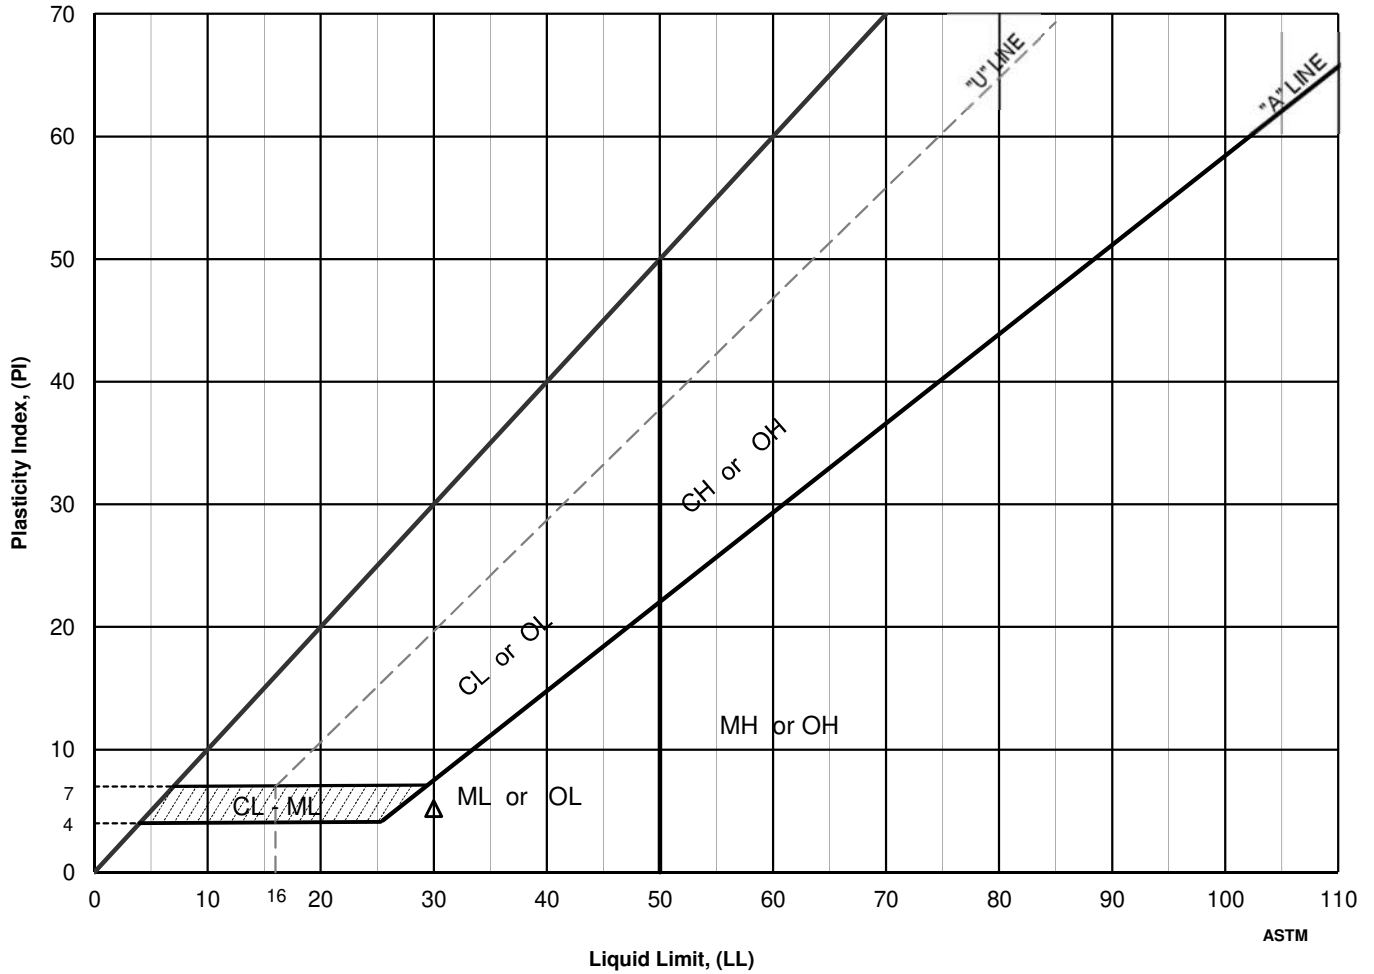
Plasticity Chart

Location	Sample	Depth, m	Moisture Content, %	Liquid Limit	Plastic Limit	Plasticity Index	Liquidity Index	Activity Number	USCS
△ BH 3	2	0.76 - 1.37	37	30	25	5	2.29	n/d	ML

Atterberg limits and moisture contents were conducted on the spoon soil sample collected between depths 0.76 and 1.37 m in BH3. A summary of these values are provided below in **Table 3**.

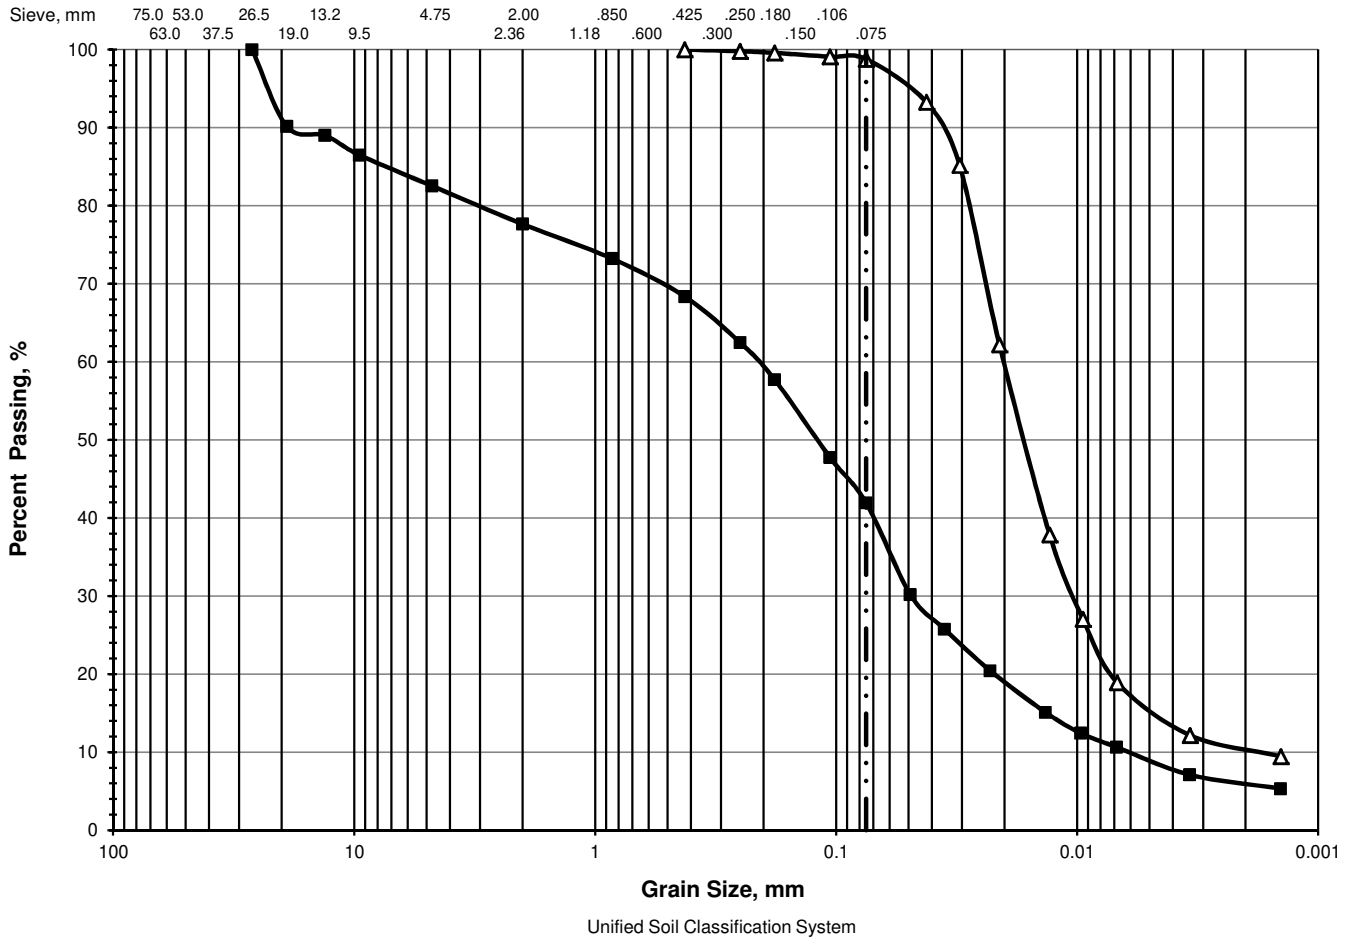
File No.: 210341
Report No.: 2
Date: August 23, 2021

> 75 mm	% GRAVEL		% SAND			% FINES	
	Coarse	Fine	Coarse	Medium	Fine	Silt	Clay
△	0.0	0.0	0.0	0.0	1.2	88.6	10.2
■	0.0	8.5	8.9	4.9	9.3	26.5	36.1

Location	Sample	Depth, m	D ₆₀	D ₅₀	D ₃₀	D ₁₅	D ₁₀	C _c	C _u
△	BH 1	2	0.76 - 1.37	0.0203	0.0170	0.0104	0.0048	0.0018	3.0
■	BH 2	3	1.52 - 2.13	0.2136	0.1226	0.0486	0.0134	0.0062	1.8

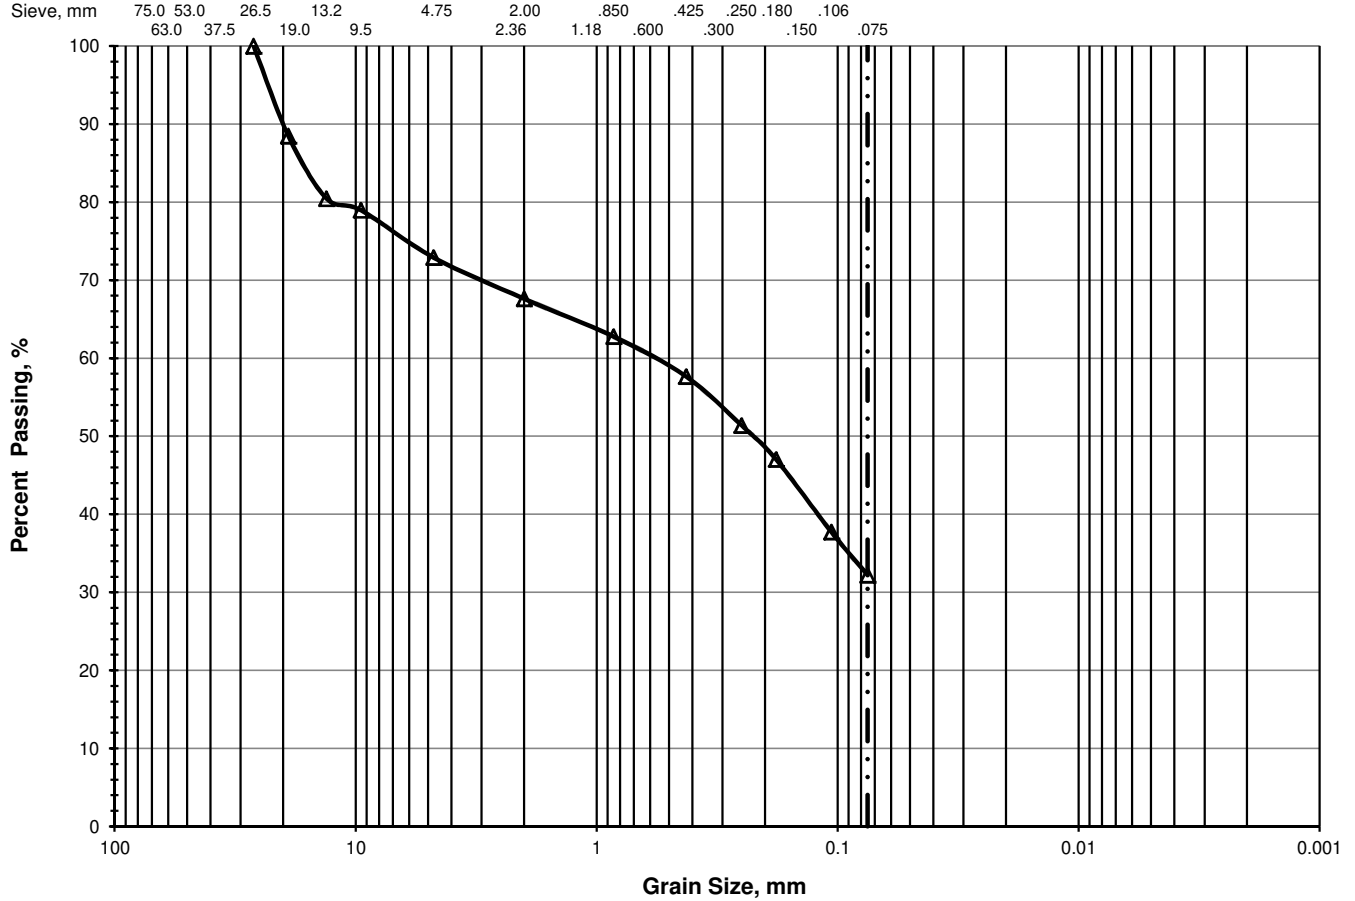
File No.: 210341
Report No.: 2a
Date: August 23, 2021

> 75 mm	% GRAVEL		% SAND			% FINES	
	Coarse	Fine	Coarse	Medium	Fine	Silt & Clay	
△	0.0	10.0	17.1	5.3	10.0	25.4	32.2

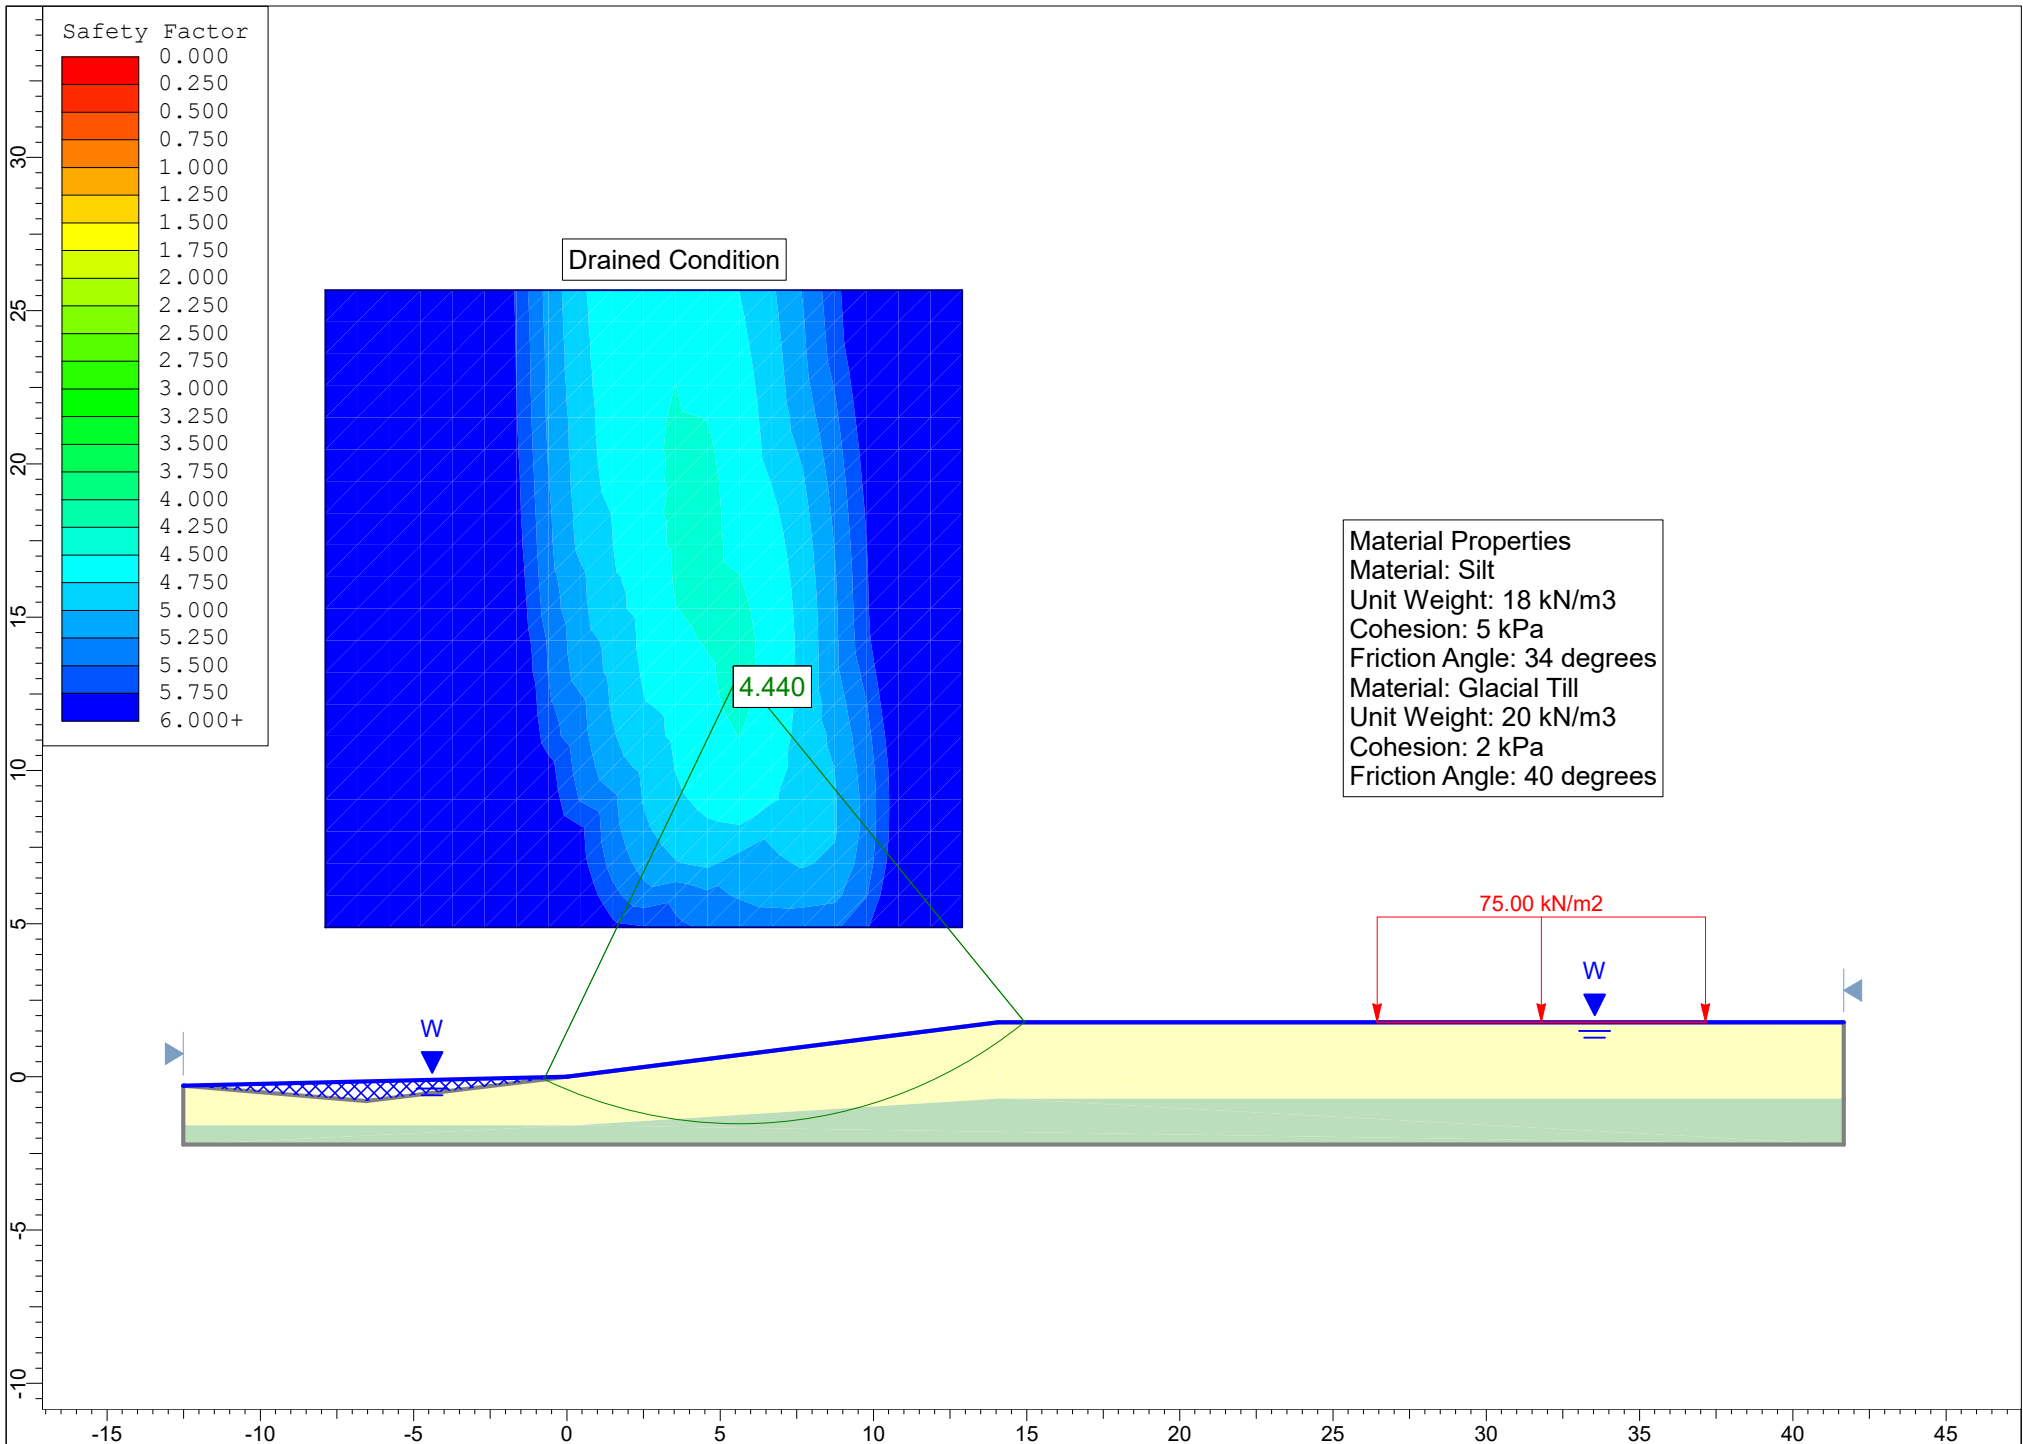
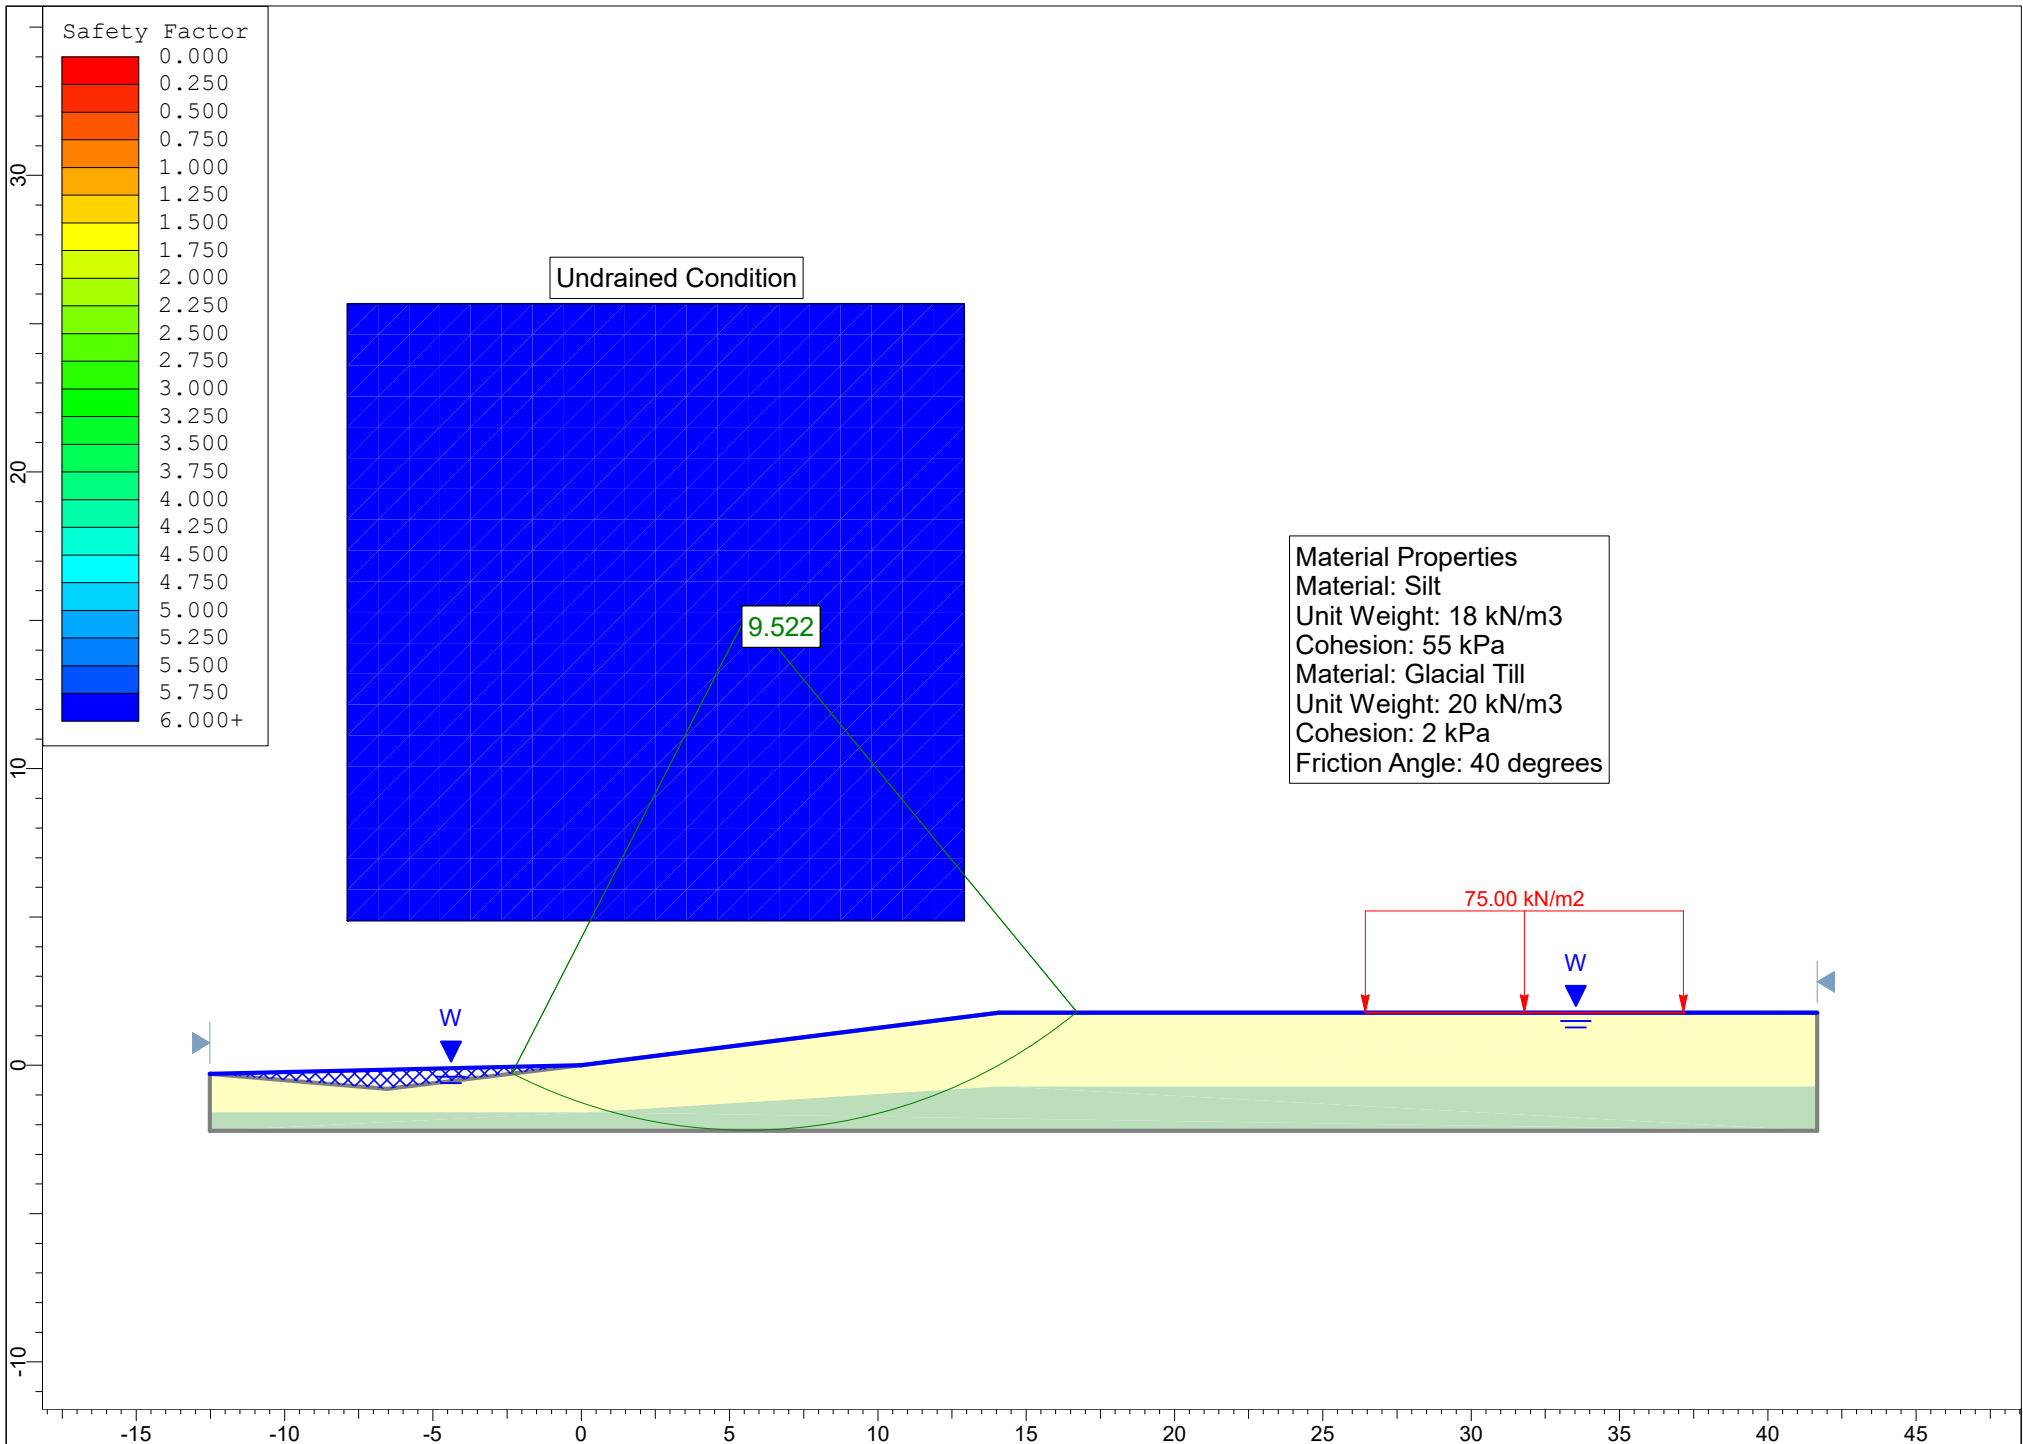
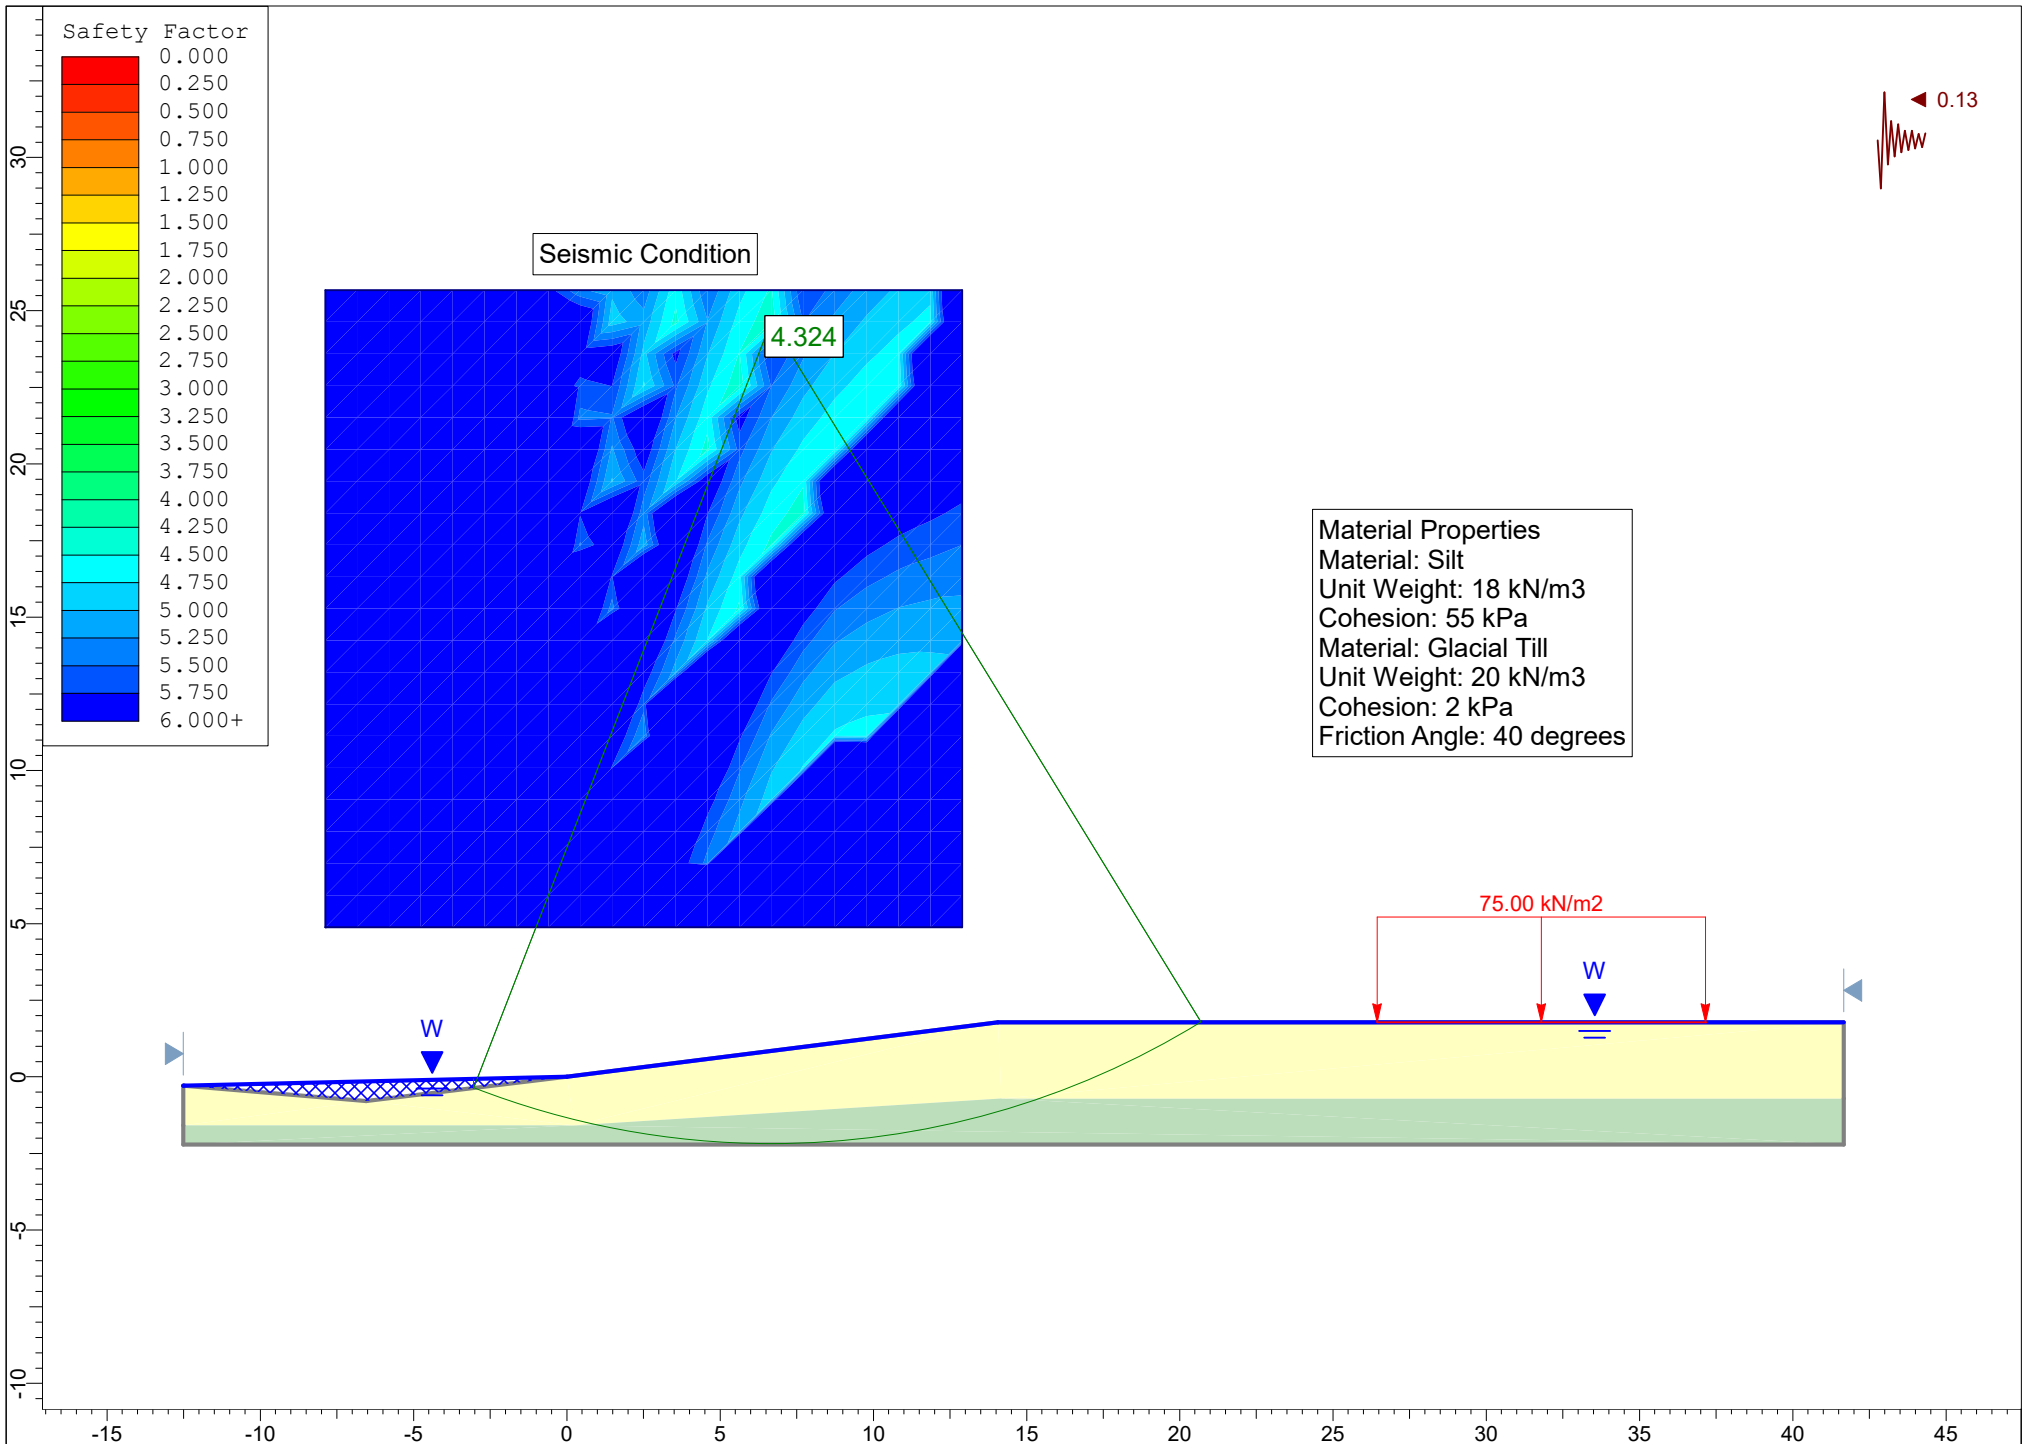
APPENDIX E
Slope Stability Analysis Results

The slope modelling program, Slide 5.0 (Rocscience), was used to implement the Bishop simplified method of slices. **One (1) slope profile was chosen which was considered to be the worst case scenario; and parallel to the approximate highpoint of the slope.** The approximate location of the cross-section selected to be ran in the slope stability study can be found in **Appendix E**. The proposed loading for the building was included in the models. The slope was analyzed under both the undrained (short term failure) and drained (long term failure) conditions.

The FoS against slope failure for the selected slope profile was determined to be 4.44, 9.52, and 4.32 for the drained, undrained, and seismic conditions respectively. A FoS of 1.50 or greater is considered to be safe with regards to slope stability.

The seismic analysis was performed by incorporating the seismic coefficient (k_h) into the modelling. The peak ground acceleration (PGA) for this area is equal to 0.26 for the 2% in 50 year probability of exceedance as per the NBC 2015. The value for k_h was taken as 50% of the PGA, which equates to 0.13. The minimum factor of safety (FoS) with regards to seismic condition is 1.10.

The results of the analyses are potentially dependent on the assumption of groundwater condition. During the development of this report, no information on the groundwater level was available throughout the year. However, as a conservative approach the analysis was completed assuming full saturation throughout the slope profile.
