## **Geotechnical Investigation**

**Final Report**

Geotechnical Investigation Corkery Community Centre Expansion 3447 Old Almonte Road, Carp, Ontario

OTT-21010977-A0

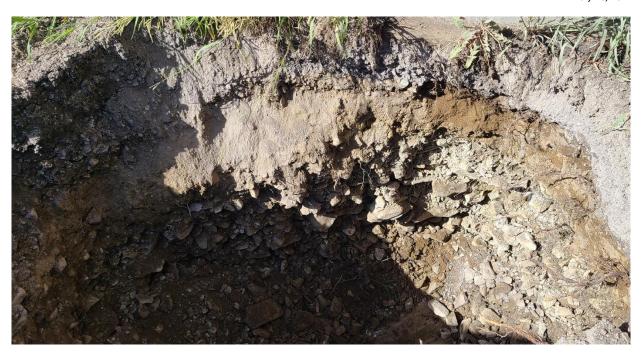
Photograph No. 1: Exposed subsurface soil conditions in Test Pit No. 1

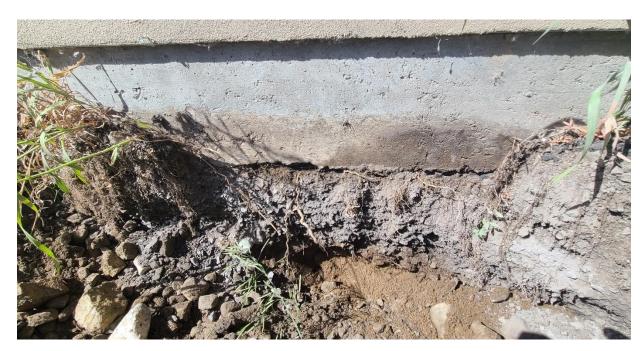
Photograph No. 2: Detailed view of thickened structural slab and subbase materials in Test Pit No. 1

Examination of the existing exposed foundation revealed that the building is likely constructed on a 300 mm thickened or slab on grade foundation founded on compacted granular material placed on top of bedrock contacted at a depth of 1.6 m . Photographs of the exposed 'as-built' details are shown I Appendix A.

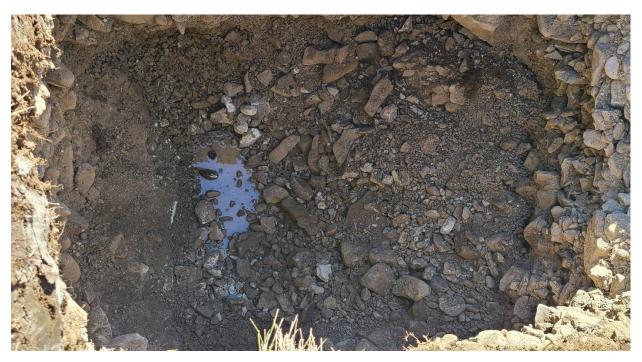
Photograph No. 3: Exposed subsurface soil conditions in Test Pit No. 3

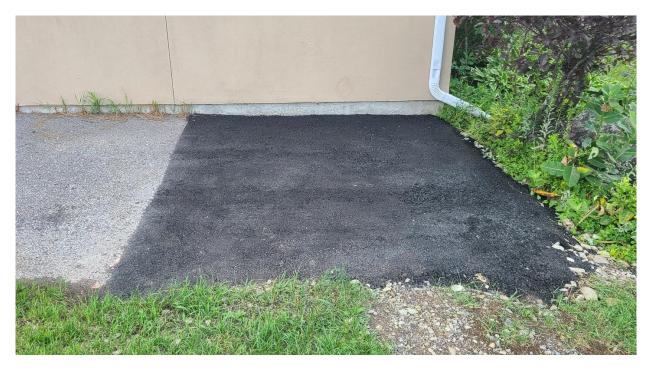
Photograph No. 4: Reinstated pavement conditions at Test Pit No. 1 location
