MEMORANDUM

To: Ottawa Septic System Office
From: Patrick Leblanc, P.Eng., Senior Environmental Engineer
Date: May 3, 2022
Re: City of Ottawa - Corkery Community Centre Expansion - Sewage System Assessment Update
3447 Old Almonte Road, Carp, ON

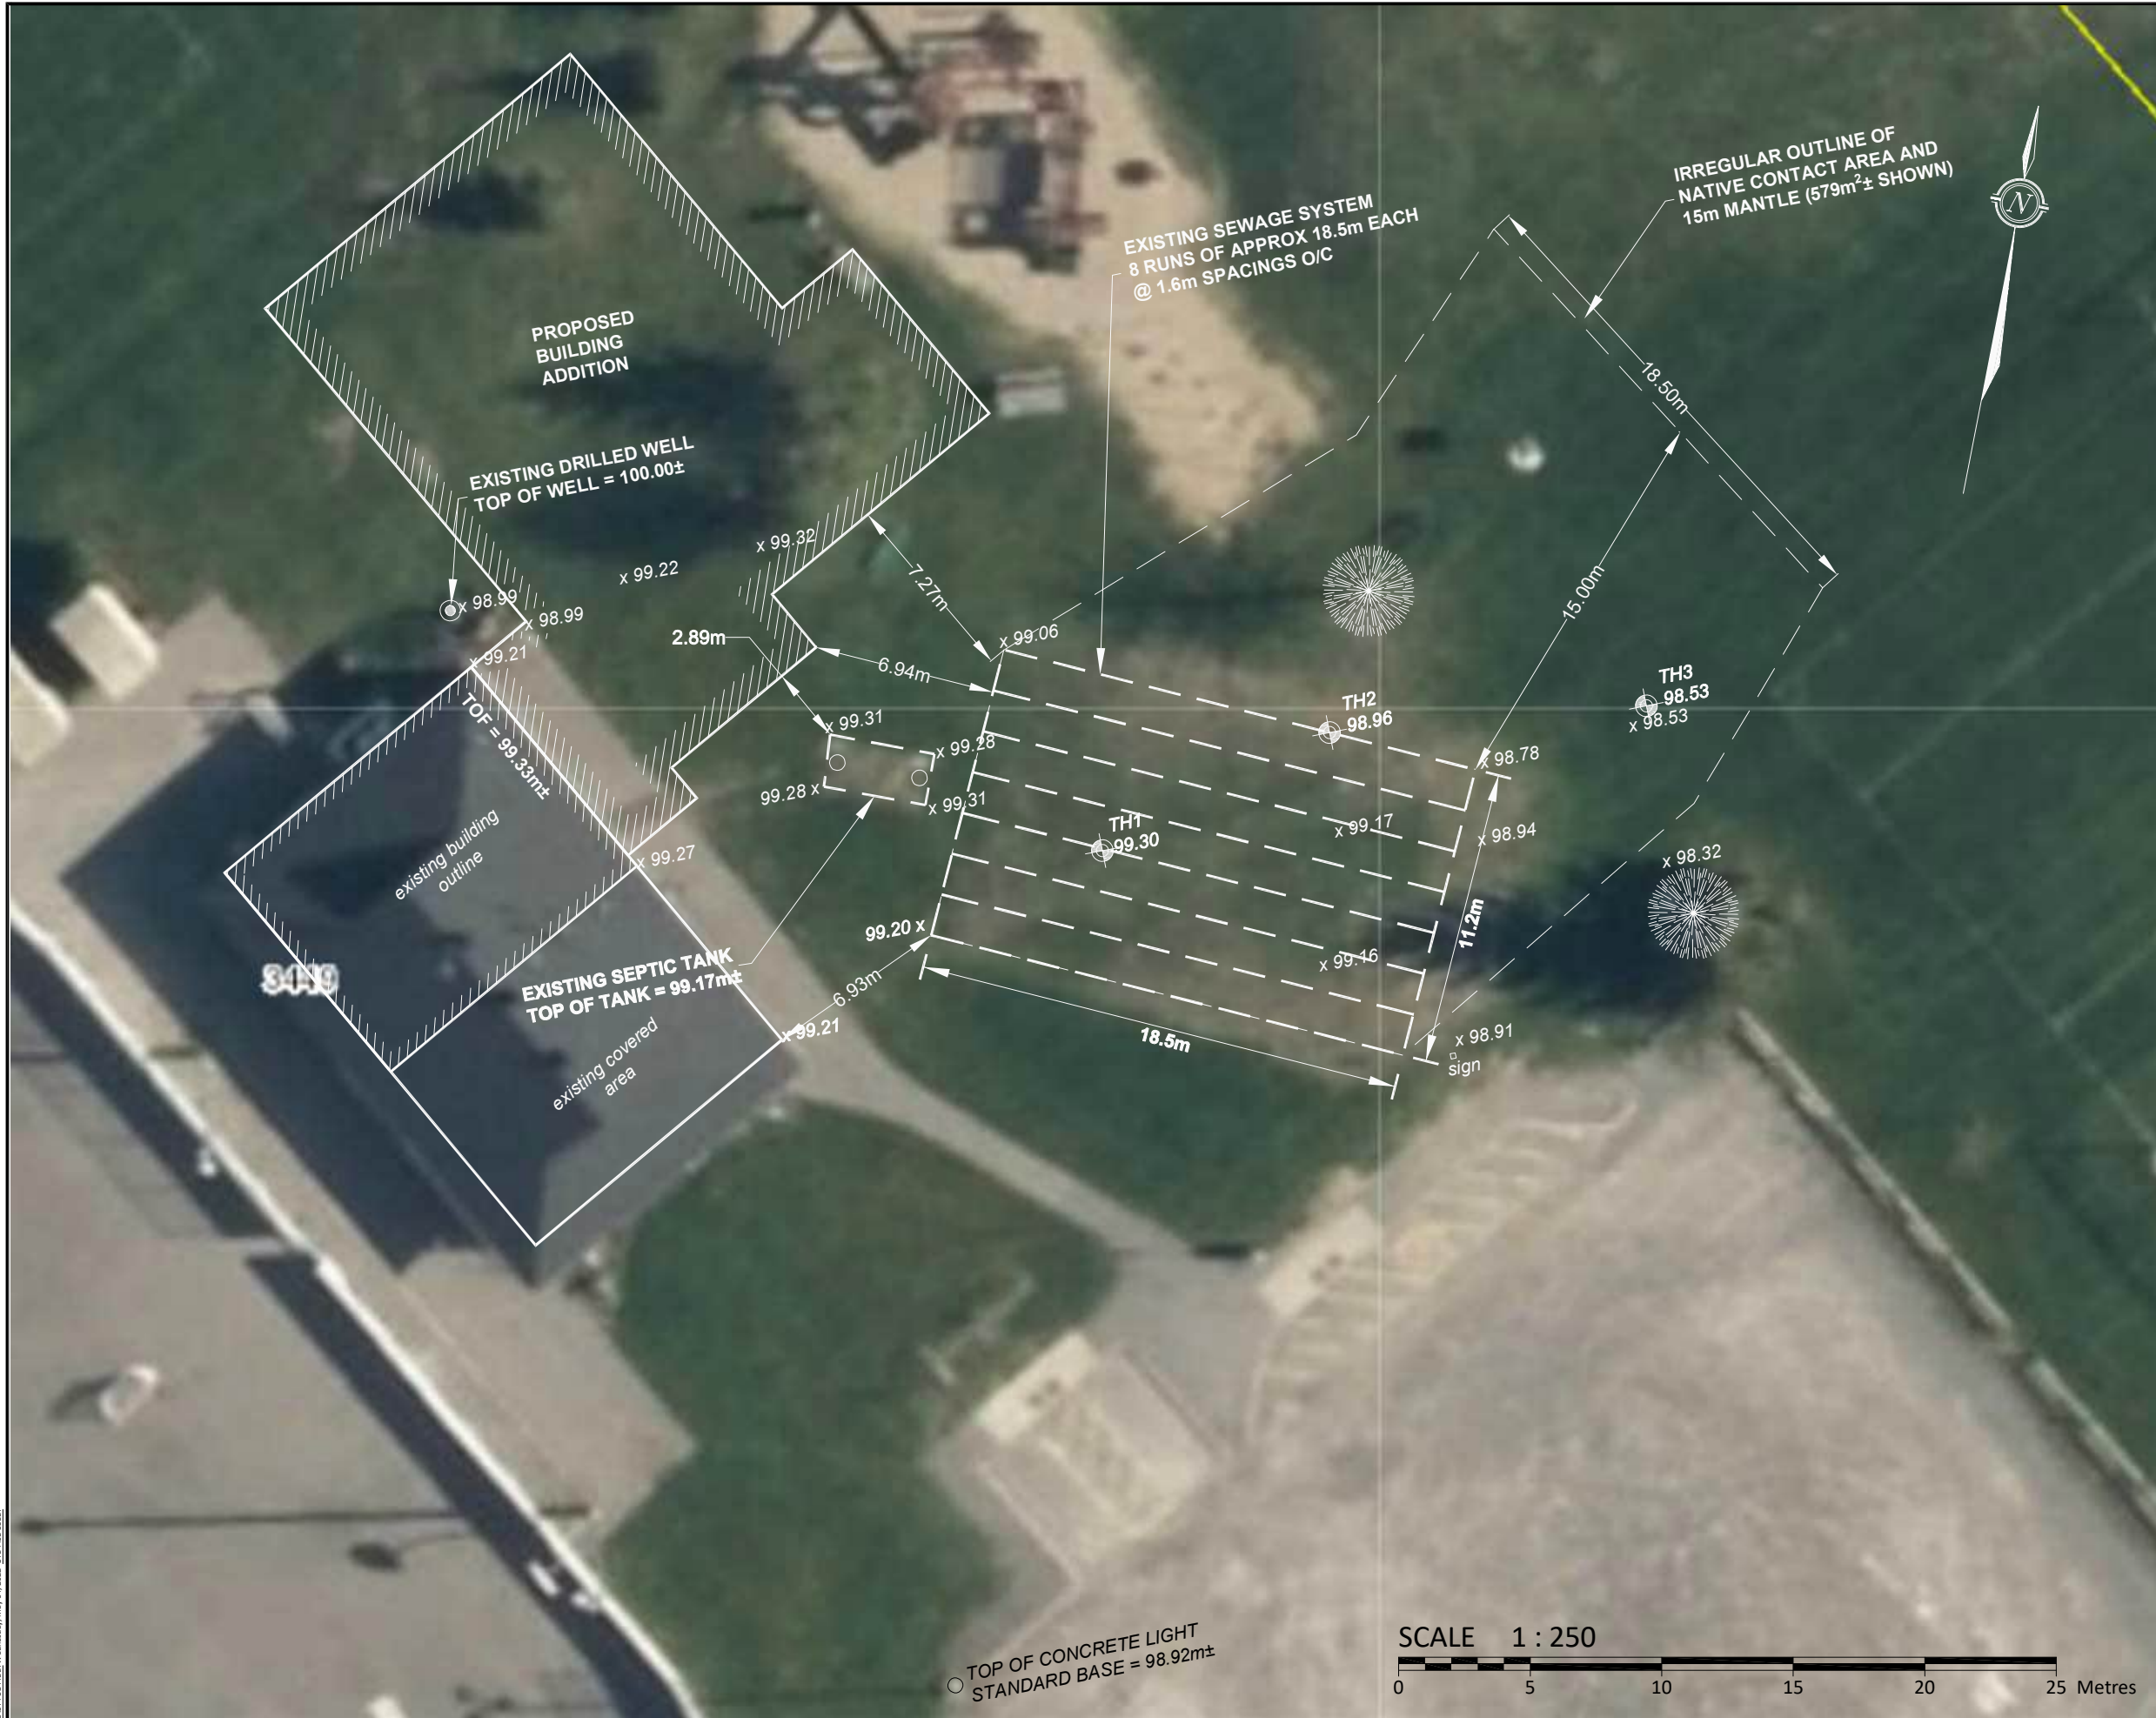
Scale:	1:250	Project Number: CM-19-0590/ CCO-21-3339
Drawn by:	BA	
Checked By:	PL	Drawing Number: FIG.1
Designed By:		
Date:	DEC/20/19

Based on our field investigation, the existing building is serviced by a Class IV sewage system consisting of a two compartment 10,870 L (+/-) concrete septic tank and associated absorption trench leaching bed. Using hand operated equipment, our probe holes and test holes revealed a leaching bed comprised of approximately 8 runs each with a length of 18.5 m, for a total of 148 linear metres of distribution piping.

The leaching bed is comprised of 8 runs of approximately 18.5 m each in length, spaced at 1.6 m, centre to centre. The absorption trenches consisted of a stone layer averaging in 0.35 m in thickness, overlain by approximately 0.3 m to 0.6 m of cover material, based on the observations made at both test hole locations advanced in the leaching bed. The stone layer is underlain by sand material which was observed to a depth of 0.9 m below the stone layer. The absorption trenches appeared to meet the requirements of OBC 8.7.3.2.(1). The clear stone trenches were clearly defined and overlain with a non-woven geotextile. OBC Clause 8.7.3.3(5) states that the stone layer must be comprised of washed septic stone, free of fine material, with gradation conforming to OBC Table 8.7.3.3, be not less than 0.5 m in width, extend not less than 0.15 m below the distribution pipe, and extend not less than 0.05 m above the distribution pipe. Therefore, the stone around the distribution pipes located in test pits met the OBC requirements for the stone layer. OBC Clause 8.7.3.3(2) states that the stone layer must be protected to prevent soil from entering the stone by covering it with untreated building paper or a permeable geo-textile fabric. The stone layer was protected by permeable geotextile as per OBC requirements.

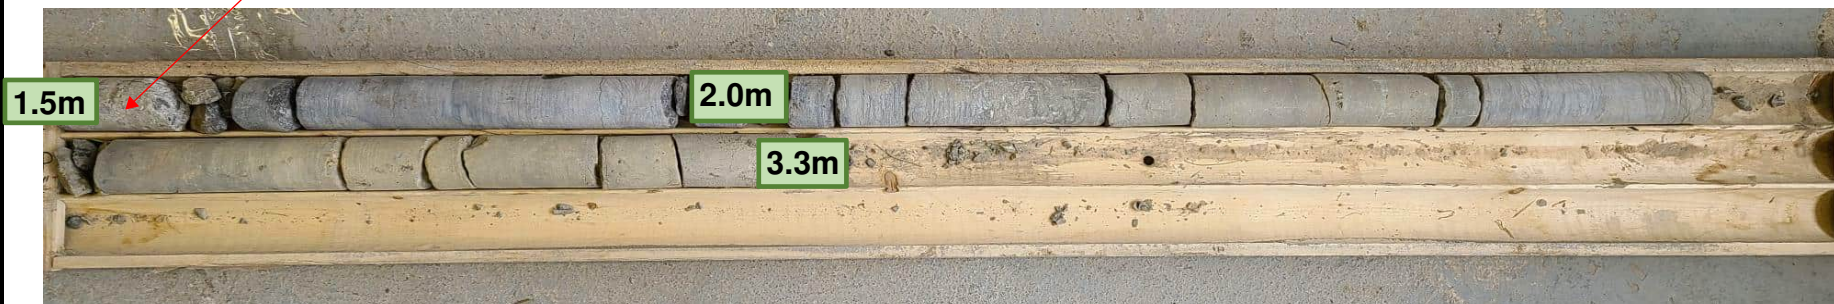
DRY BEDROCK CORES

A review of the test results indicates a bedrock with compressive strength of the bedrock is 122 MPa and 201 MPa. Based on the compressive strength values, the rock can be classified with respect to intact strength as “very strong” (Canadian Foundation Engineering Manual, 4th Edition, 2006). The unit weight of the bedrock is 24.3 kN/m³ to 24.9 kN/m³.

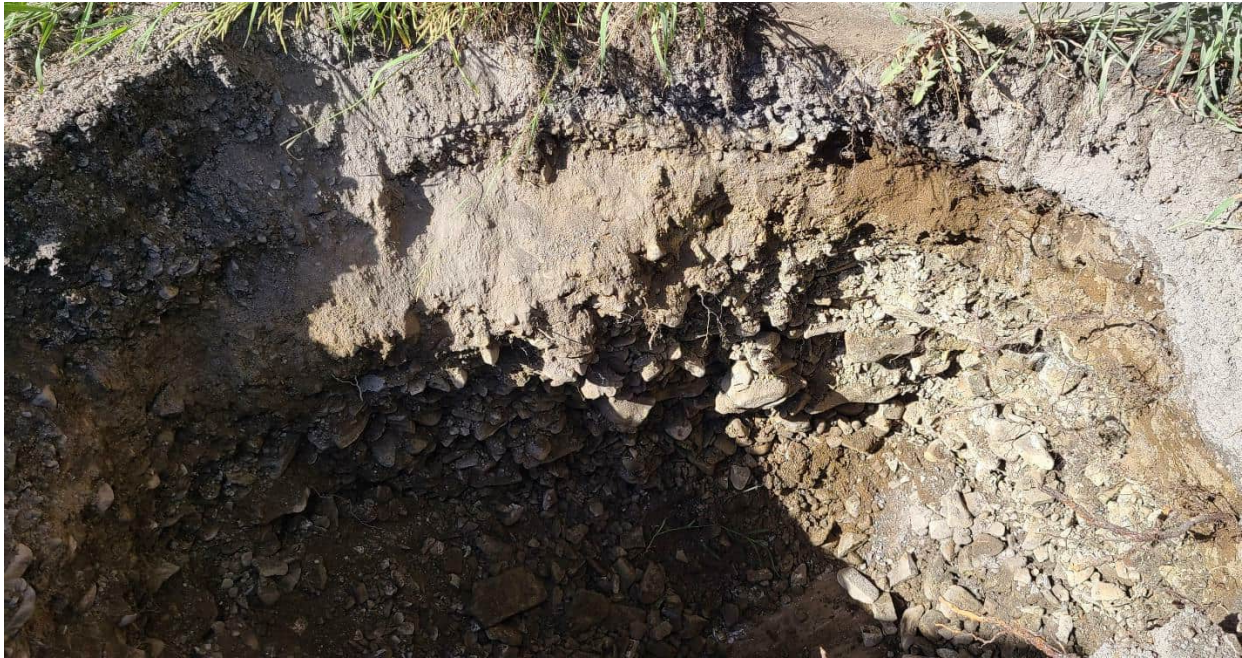
Test Pit No. 1 is located along the exterior wall at the northeast corner of the existing building. The purpose of the test pit is to establish the type and depth of the foundation supporting the existing building. The test pit was advanced to bucket refusal at a 1.6 m depth below grade (Elevation 158.8 m) on bedrock. As previously mentioned, the test pit revealed a pavement structure consisting of a 75 mm thick asphaltic concrete layer overlying a 210 mm thick granular base layer. The upper granular material is underlain by 400 mm thick sand and gravel fill which is further underlain by sandy gravel with cobbles that extend to the surface of the bedrock contacted at a 1.6 m depth (Elevation 158.8 m).

Photograph No. 1: Exposed subsurface soil conditions in Test Pit No. 1

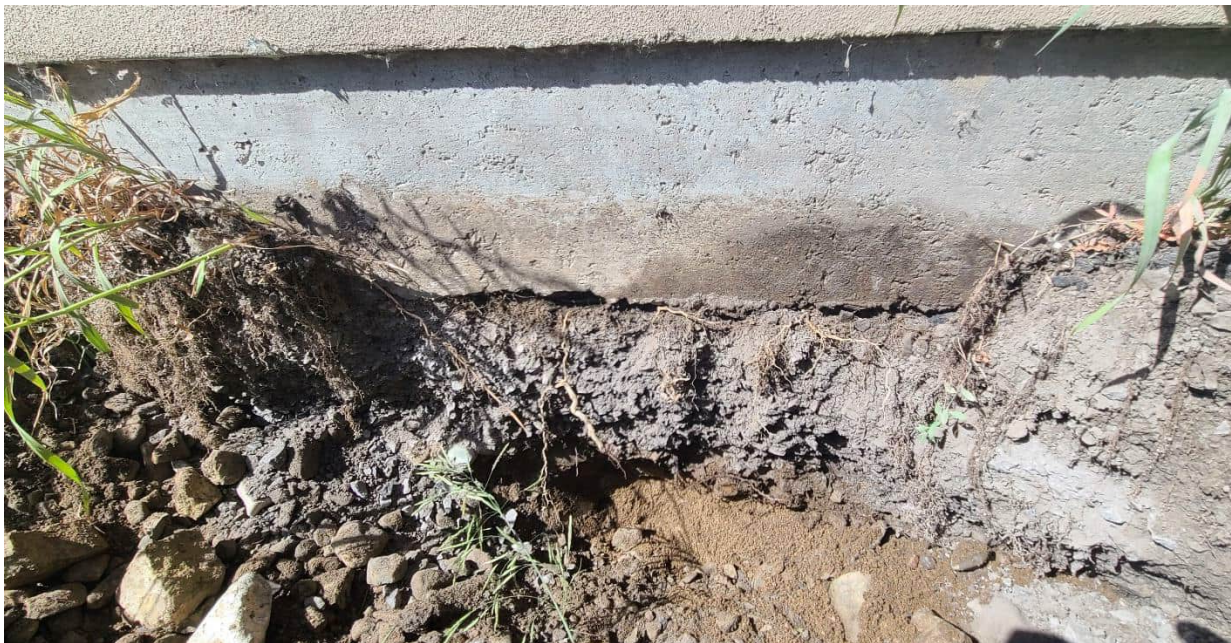
Examination of the existing exposed foundation revealed that the building is likely constructed on a 300 mm thickened or slab on grade foundation founded on compacted granular material placed on top of bedrock contacted at a depth of 1.6 m . Photographs of the exposed 'as-built' details are shown I Appendix A.

Photograph No. 2: Detailed view of thickened structural slab and subbase materials in Test Pit No. 1

Based on a review of our observations of the 'as-built' details exposed in the test pit, it is recommended that the thickened concrete slab that appears to be supporting the existing building be confirmed by conducting additional test pits around the existing building. Based on the findings from the additional test pits, this report may need to be updated.

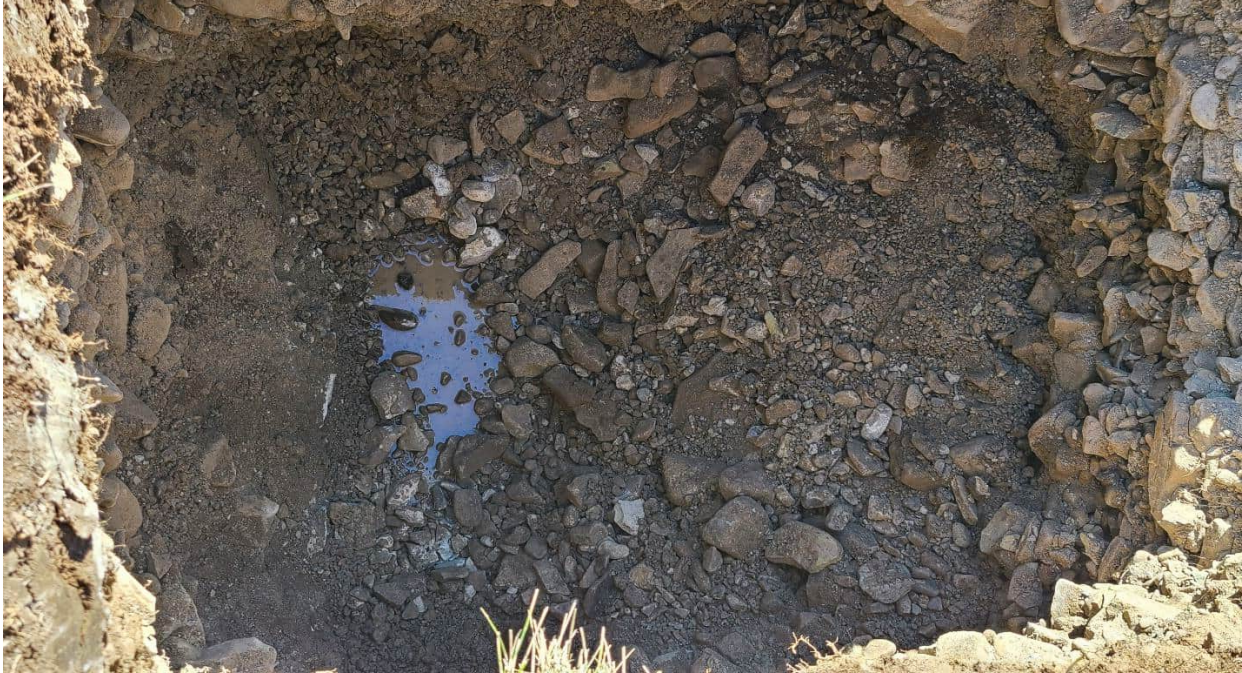
Photograph No. 3: Exposed subsurface soil conditions in Test Pit No. 3

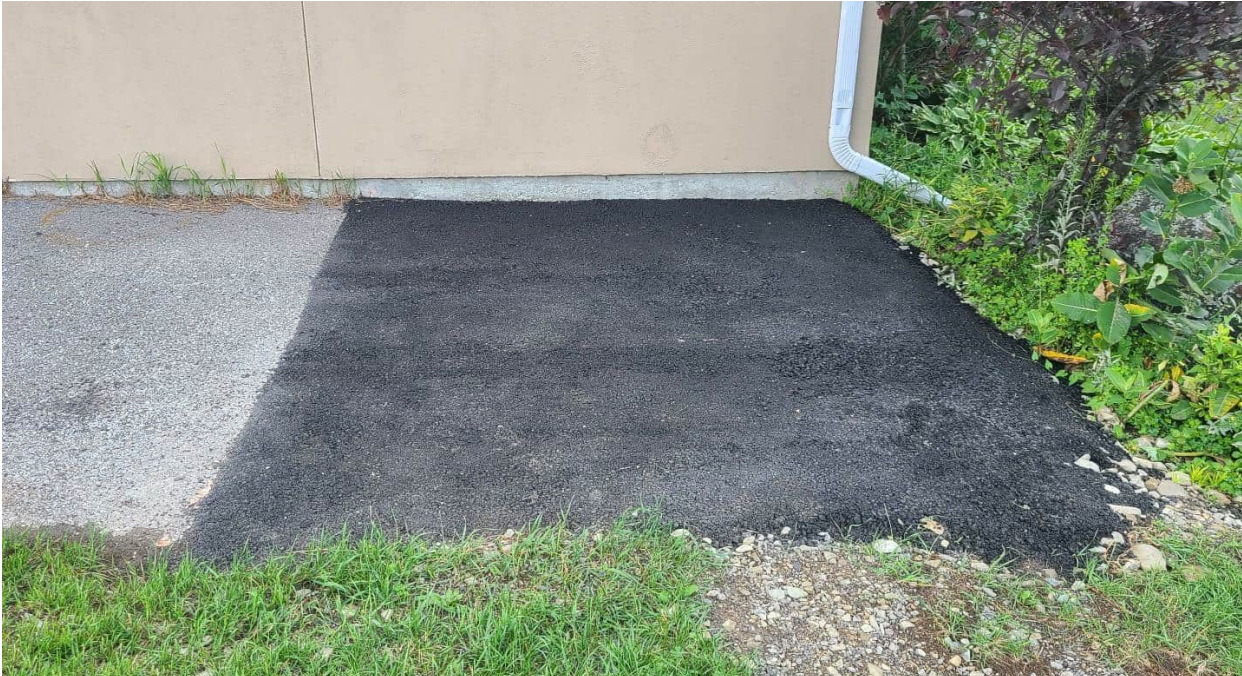
The test pits were excavated using a rubber-tired backhoe. A grab sample of the different soil types exposed in the test pits was taken from the side walls of the test pit during excavation. In Test Pit No. 1 located next to the existing building, the type of foundation and founding material were examined and recorded. Groundwater observations were also made in the open test pits. Upon completion of excavation, the test pits were backfilled and the backfill nominally packed in place with the backhoe bucket. The asphalt surface at the location of Test Pit No.1 was re-instated.

Photograph No. 4: Reinstated pavement conditions at Test Pit No. 1 location
