Geotechnical Investigation

Final Report

Geotechnical Investigation Corkery Community Centre Expansion 3447 Old Almonte Road, Carp, Ontario

Project Number: OTT-21010977-A0

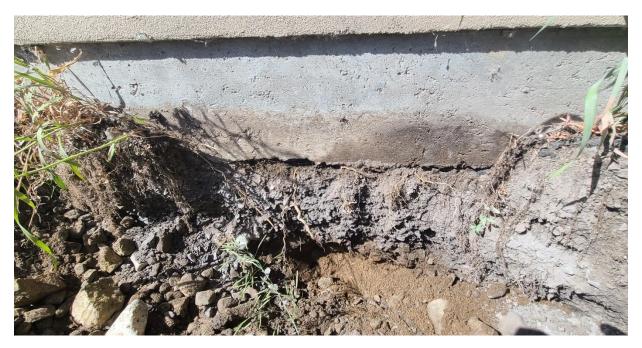
Photograph No. 2: Detailed view of thickened structural slab and subbase materials in Test Pit No. 1

Examination of the existing exposed foundation revealed that the building is likely constructed on a 300 mm thickened or slab on grade foundation founded on compacted granular material placed on top of bedrock contacted at a depth of 1.6 m. Photographs of the exposed 'as-built' details are shown I Appendix A.

Based on a review of our observations of the 'as-built' details exposed in the test pit, it is recommended that the thickened concrete slab that appears to be supporting the existing building be confirmed by conducting additional test pits around the existing building. Based on the findings from the additional test pits, this report may need to be updated.

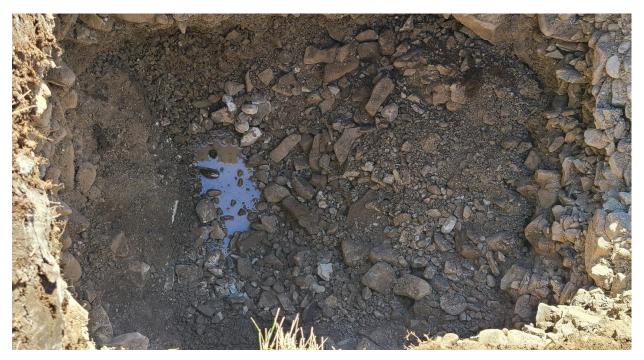
Photograph No. 3: Exposed subsurface soil conditions in Test Pit No. 3

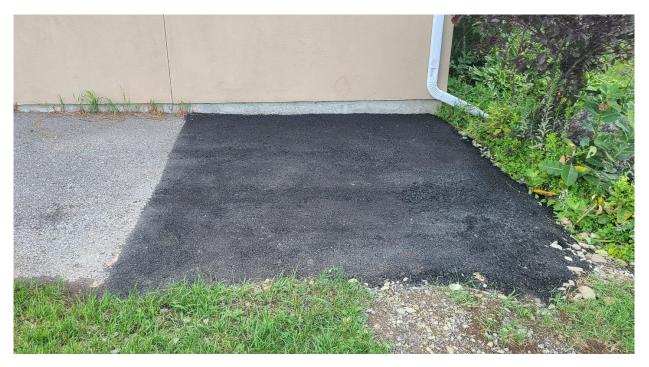
Photograph No. 4: Reinstated pavement conditions at Test Pit No. 1 location

The test pits were excavated using a rubber-tired backhoe. A grab sample of the different soil types exposed in the test pits was taken from the side walls of the test pit during excavation. In Test Pit No. 1 located next to the existing building, the type of foundation and founding material were examined and recorded. Groundwater observations were also made in the open test pits. Upon completion of excavation, the test pits were backfilled and the backfill nominally packed in place with the backhoe bucket. The asphalt surface at the location of Test Pit No.1 was re-instated.
