1305 MARITIME WAY - GEOTECHNICAL REPORT

Project No.: CP-18-0534

April 2021

**GEOTECHNICAL INVESTIGATION and
FOUNDATION DESIGN RECOMMENDATION REPORT
1305 Maritime Way, Kanata, Ontario**

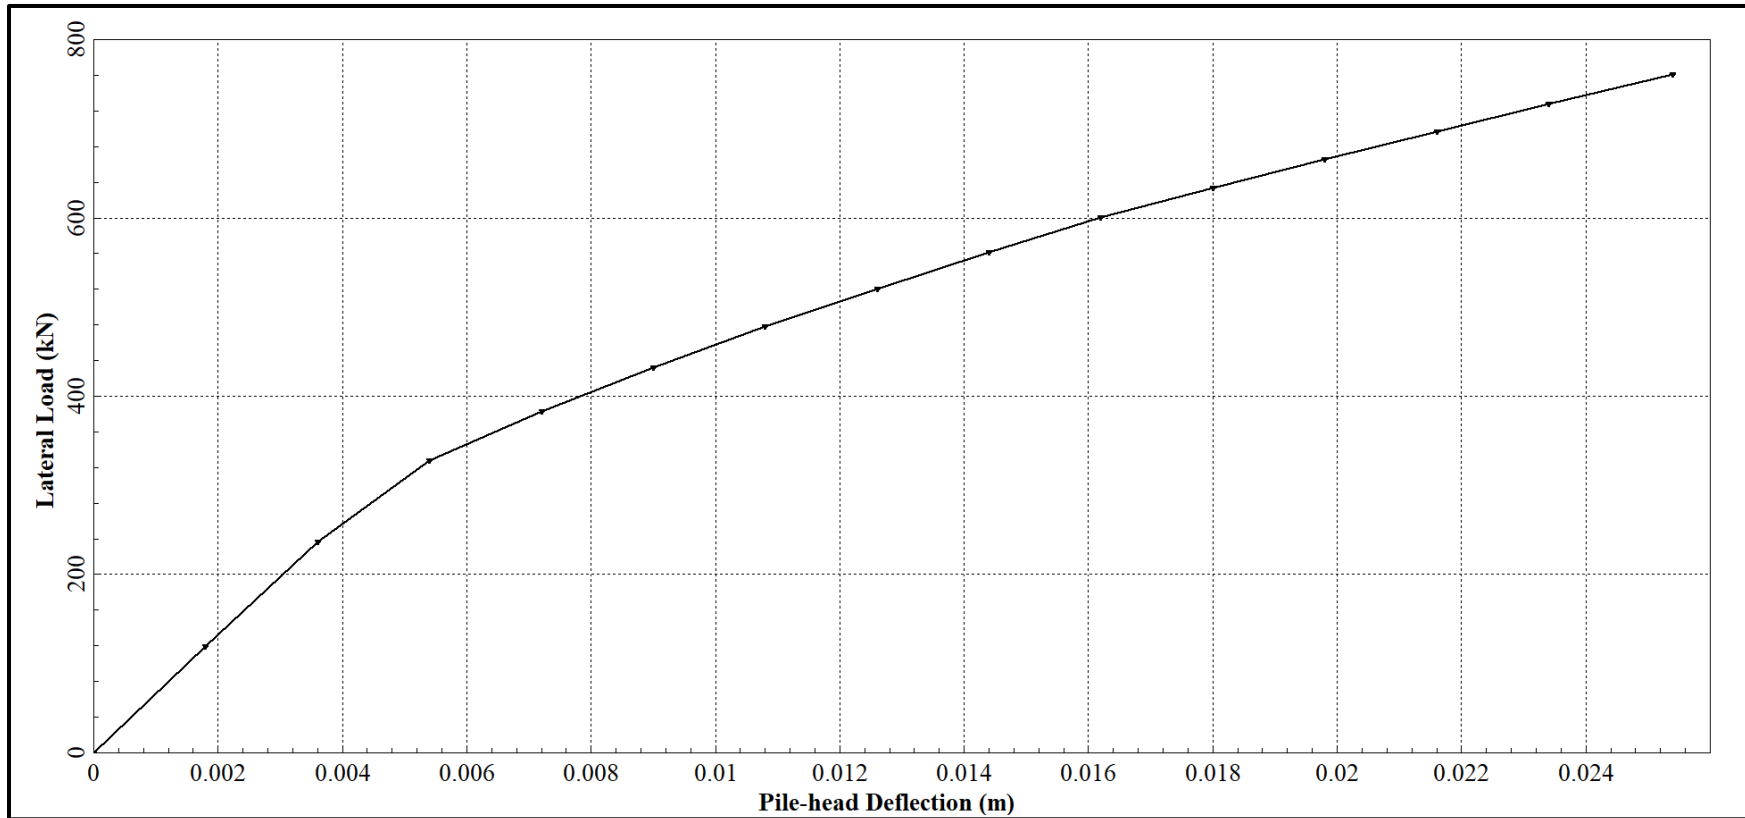
Lateral Load vs. Pile Head Displacement*

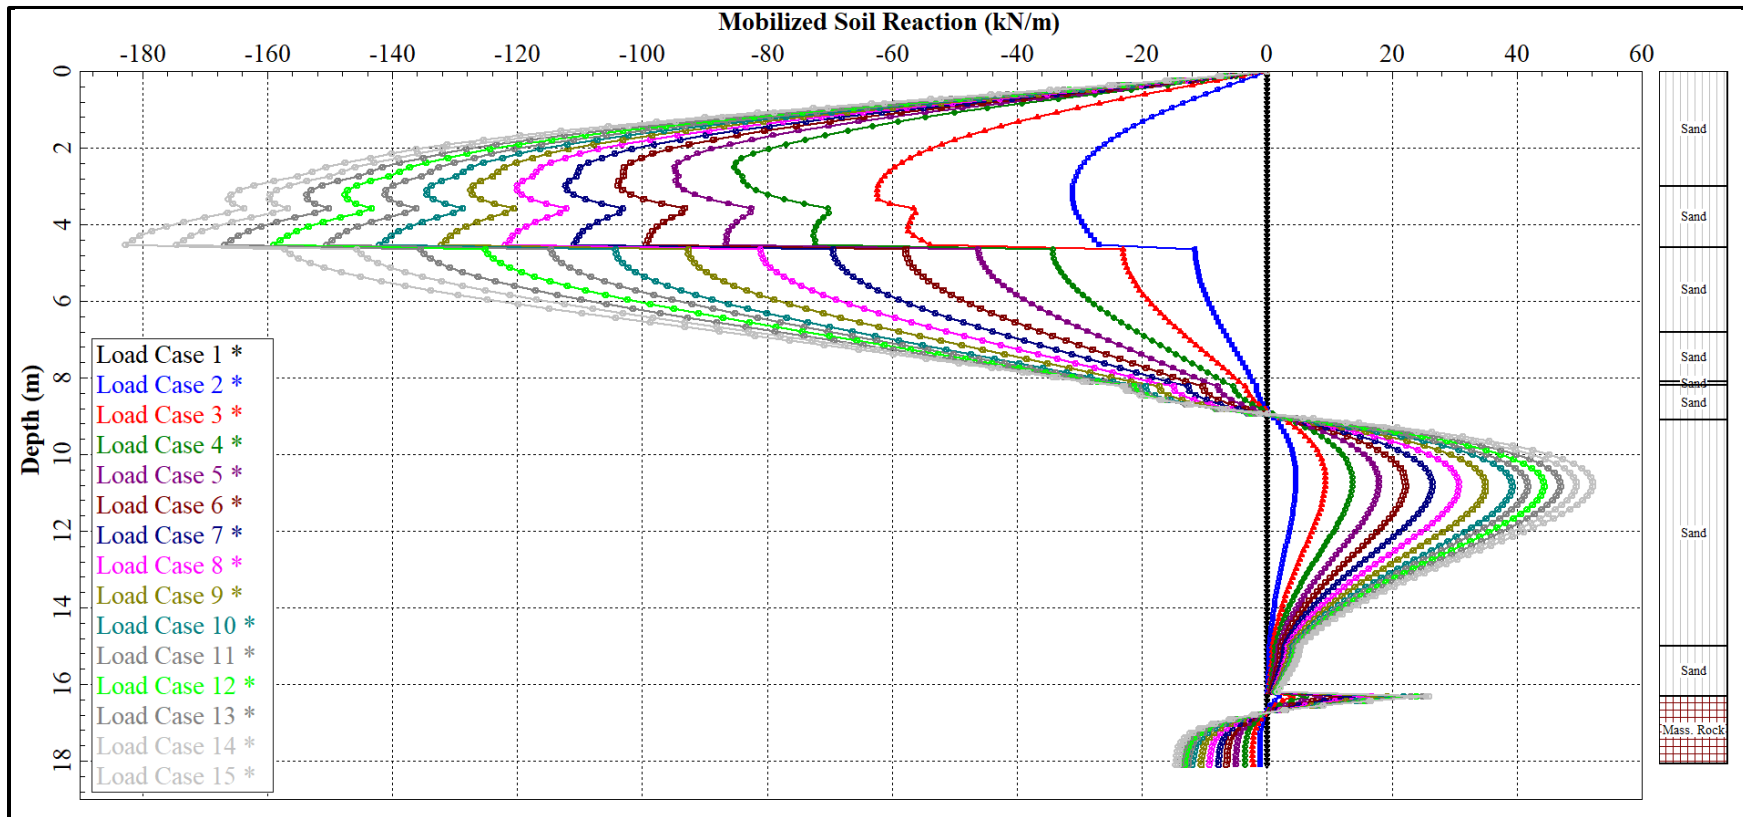
Soil Reaction vs. Depth*
