WELLDALE LIMITED PARTNERSHIP

ENVIRONMENTAL SITE ASSESSMENT

1186-1196 Wellington Street West, Ottawa, Ontario

FINAL REPORT

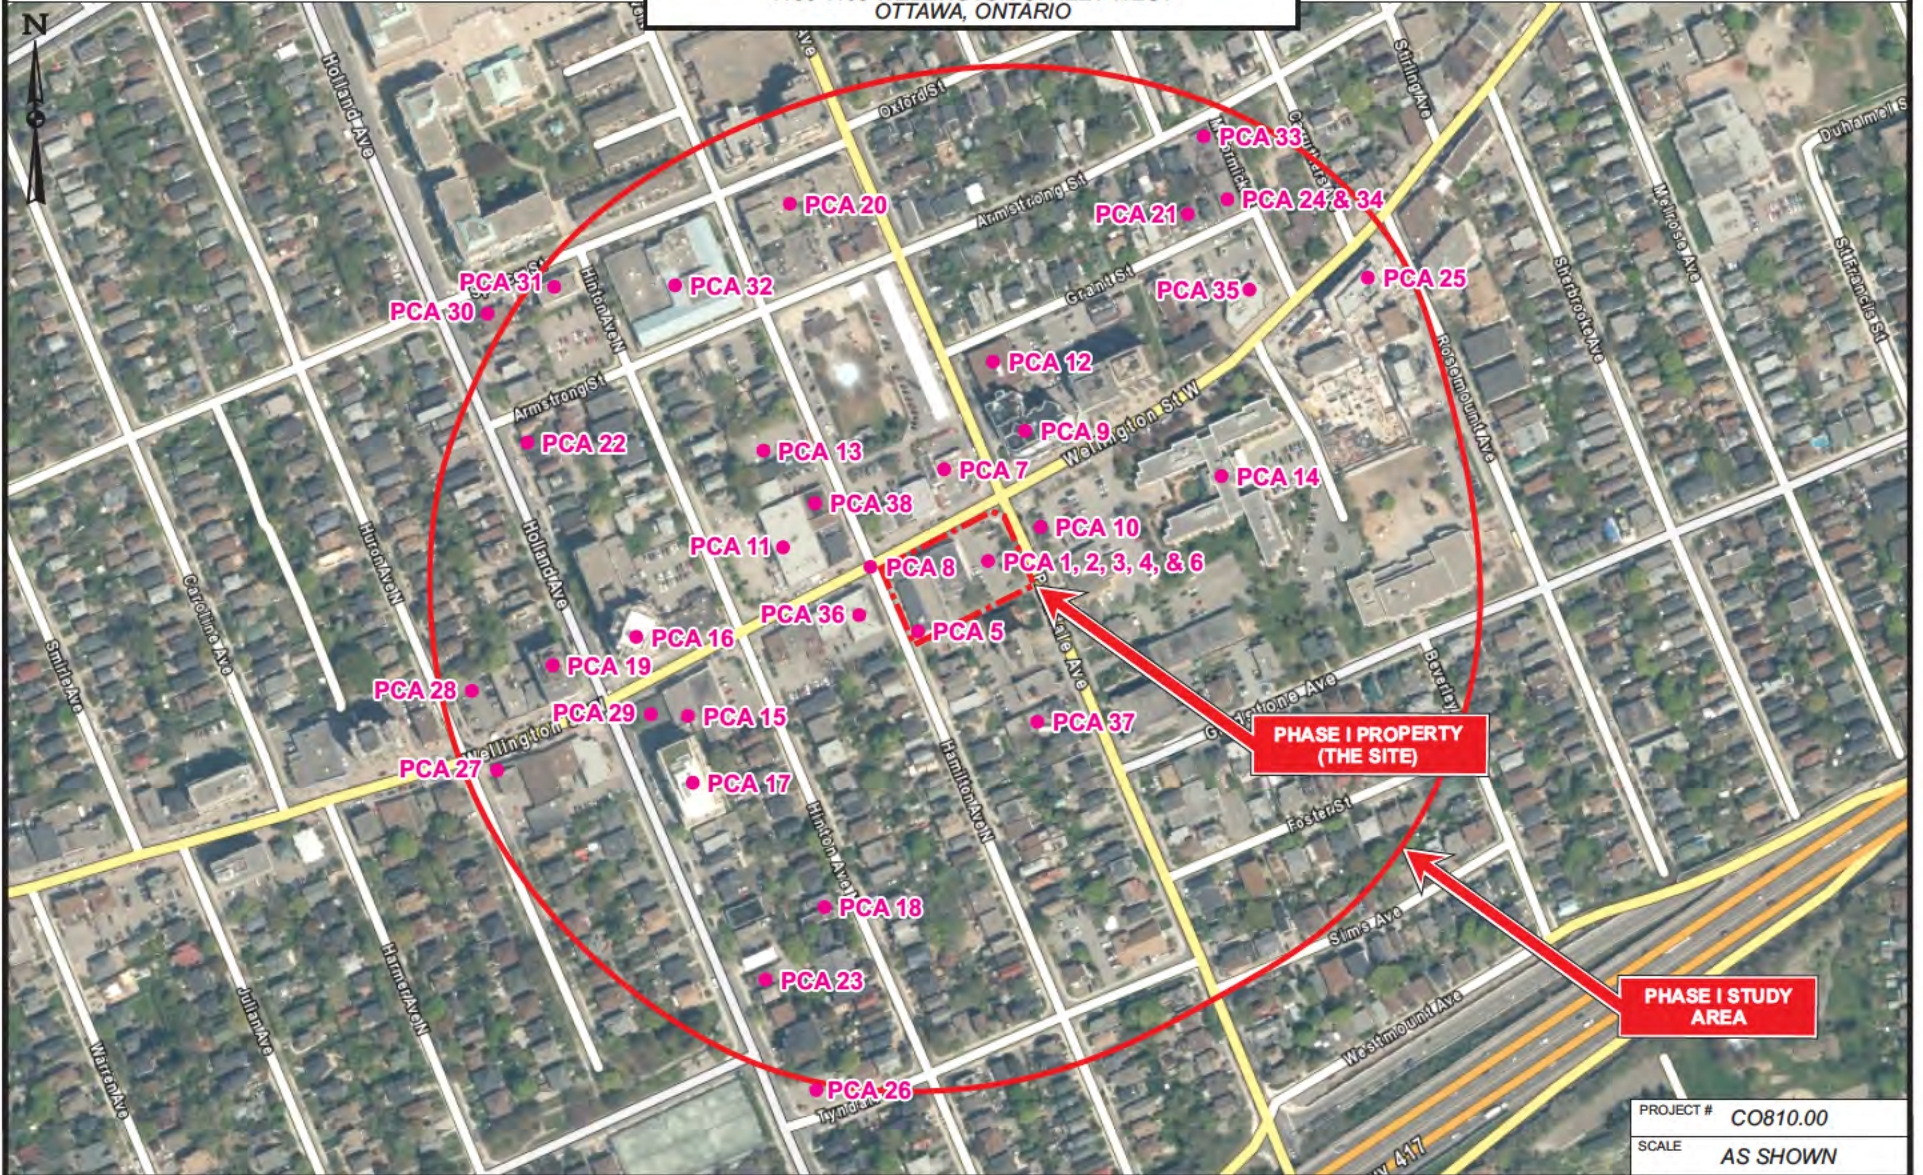
FIGURE 4

APEC	PCA	Location of PCA	COPCs	Media Potentially Impacted
APEC 1	Former Tank Nest / Furnace and Gasoline Leaks	On-Site	BTEX and PHCs	Soil and GW
APEC 2	Former Pump Island	On-Site	BTEX and PHCs	Soil and GW
APEC 3	Former Automotive Repair Garage	On-Site	PHCs VOCs PAHs (soil only) M & I	Soil and GW
APEC 4	Untested Fill Material	On-Site	PAHs M&I	Soil
APEC 5	Former Heating Oil ASTs	On-Site	BTEX and PHCs	Soil and GW
APEC 6	Retail Fuel Outlet	Off-Site	BTEX and PHCs	Soil and GW
APEC 7	Parking Lot Deicing	On-Site	EC / SAR Cl / Na	Soil Groundwater

Where information is available, the approximate location of underground utilities are shown in Figure 4.

APECs are summarized in Table 16 below, and shown on Figure 4.

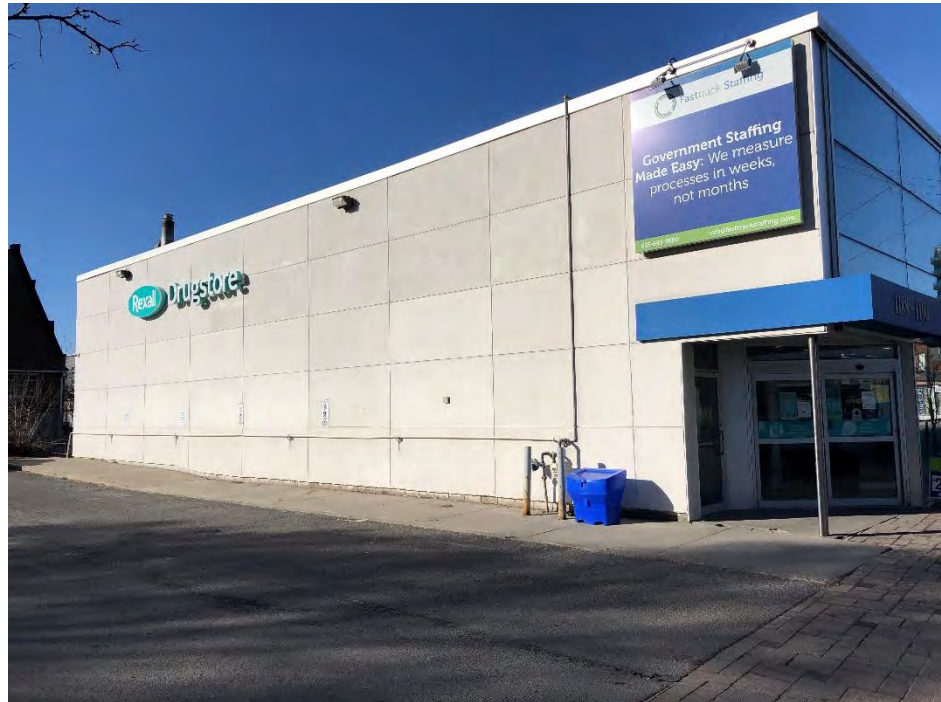
Client: Welldale Limited Partnership**Site Location:** 1186-1196 Wellington Street West, Ottawa, ON**Project No:** CO810.00**Photo No:** 1**Date:** April 8, 2021**Viewing Direction:** Southwest**Description:**

View to the southwest showing the building located at 1188-1190 Wellington Street West.

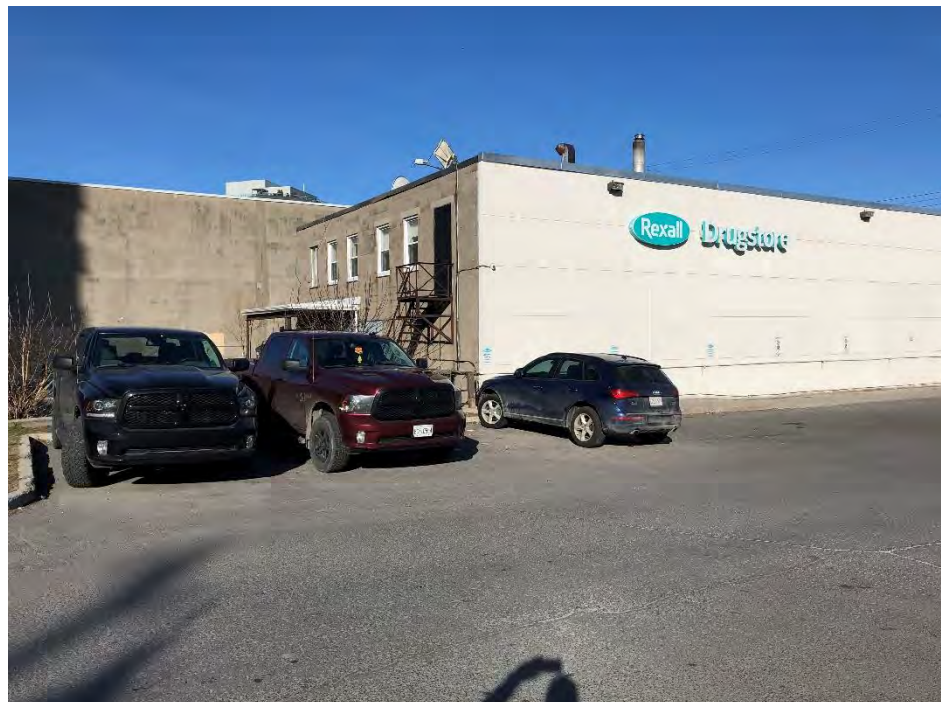
**Photo No:** 2**Date:** April 8, 2021**Viewing Direction:** Northwest**Description:**

View showing the parking lot at 1186 Wellington Street West.

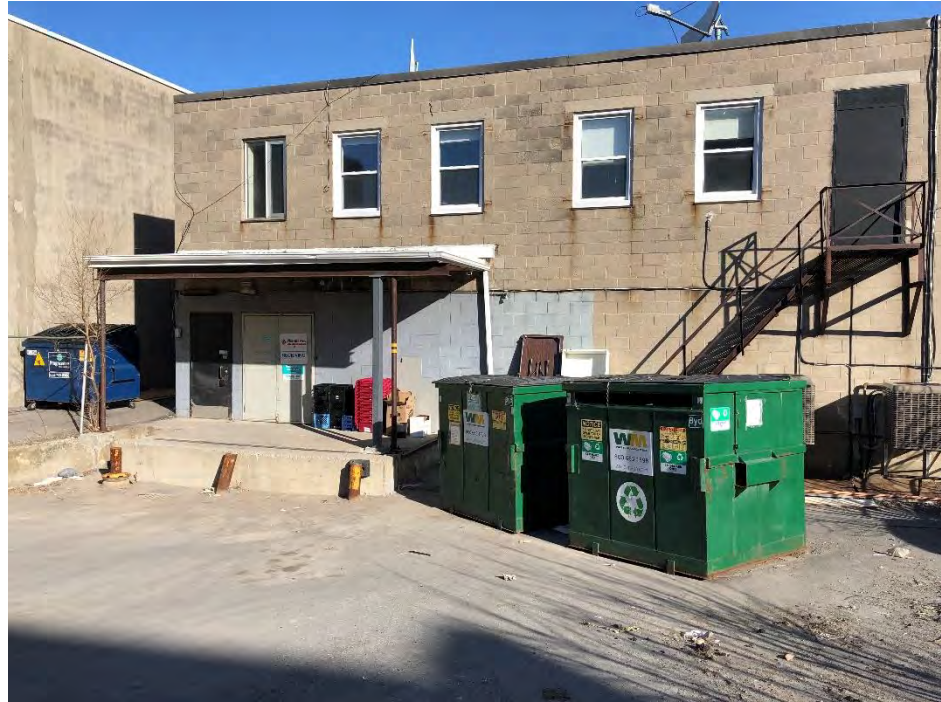
Client: Welldale Limited Partnership**Site Location:** 1186-1196 Wellington Street West, Ottawa, ON**Project No:** CO810.00**Photo No:** 3**Date:** April 8, 2021**Viewing Direction:** Northwest**Description:**

View showing the loading dock at the back of the building at 1188-1190 Wellington Street West.

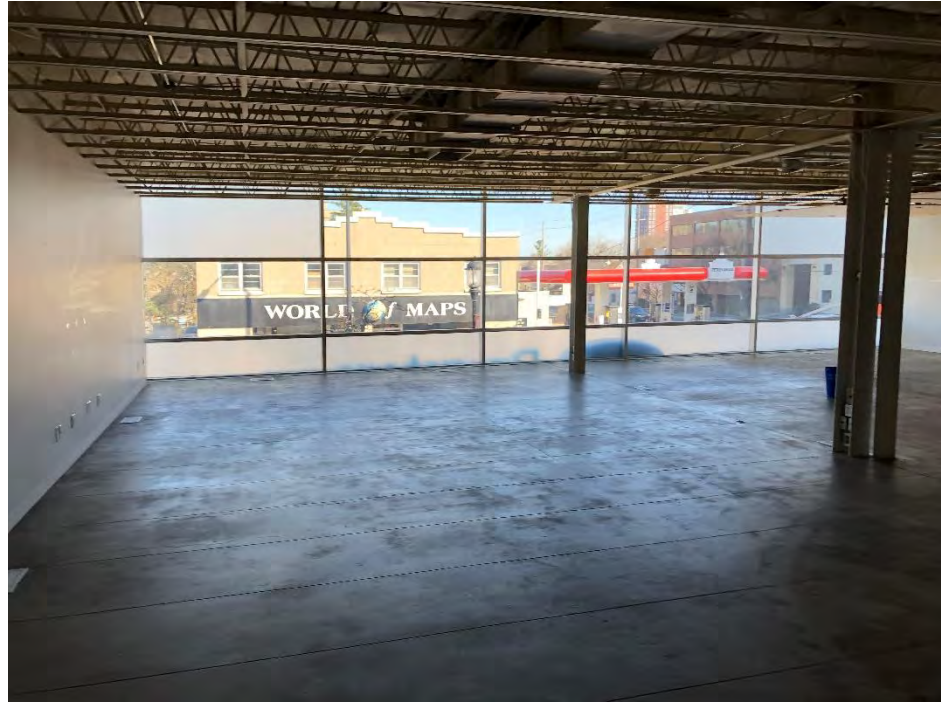
View showing the vacant tenant space at 1188 1188-1190 Wellington Street West (i.e. unit above the Rexall Drugstore).

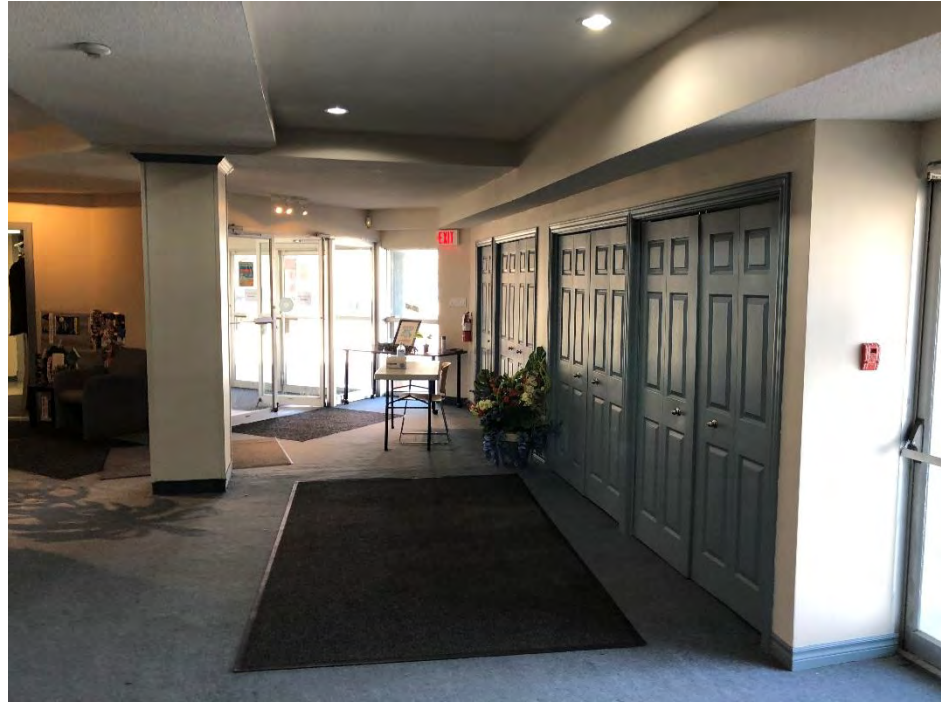
View showing the main entrance of the Cornerstone House of Refuge Apostolic Church at 1194-1196 Wellington Street West.

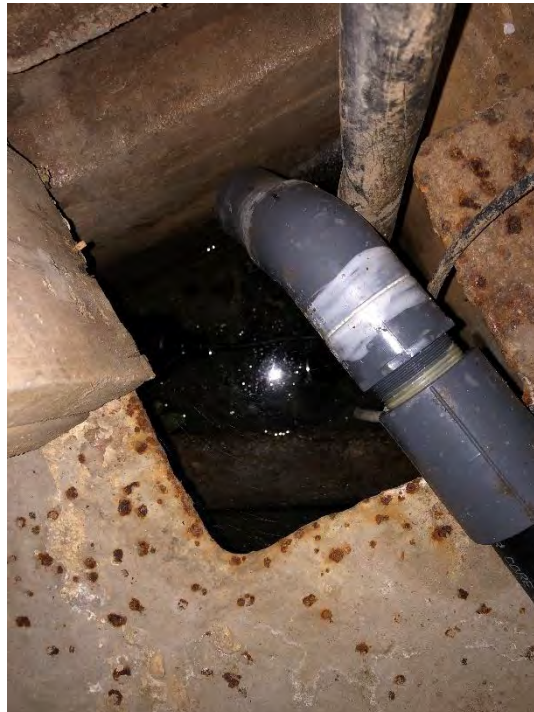
Client: Welldale Limited Partnership**Site Location:** 1186-1196 Wellington Street West, Ottawa, ON**Project No:** CO810.00**Photo No:** 13**Date:** April 8, 2021**Viewing Direction:**
N/A**Description:**

View showing the remaining fill and vent pipes associated with former ASTs in the southwest corner of the partial basement of the

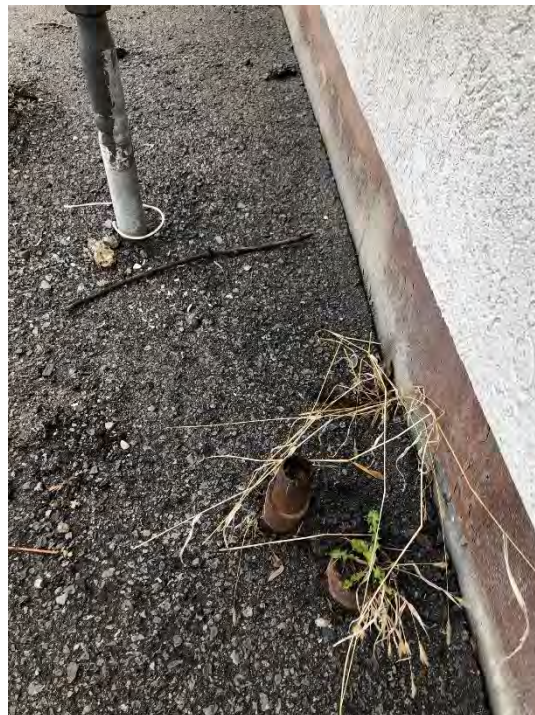
**Photo No:** 14**Date:** April 8, 2021**Viewing Direction:**
North**Description:**

View showing the remaining fill and vent pipes at the exterior near the southwest corner of the building at 1194-1196 Wellington Street West.

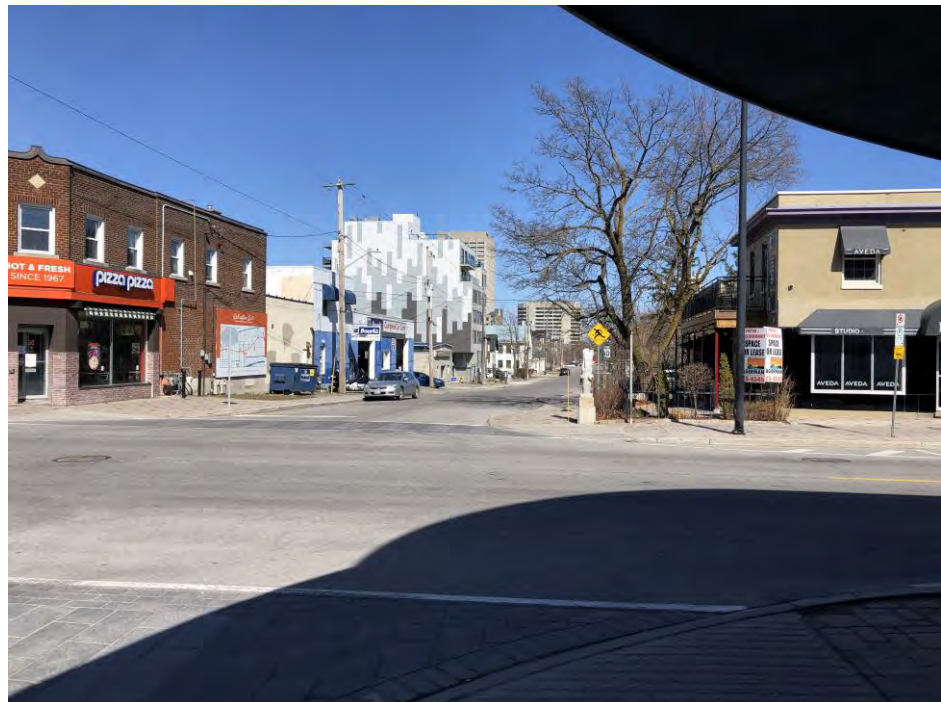
Photo No: 16

View towards Bouk's Complete Car Care located approximately 40 m from the site.

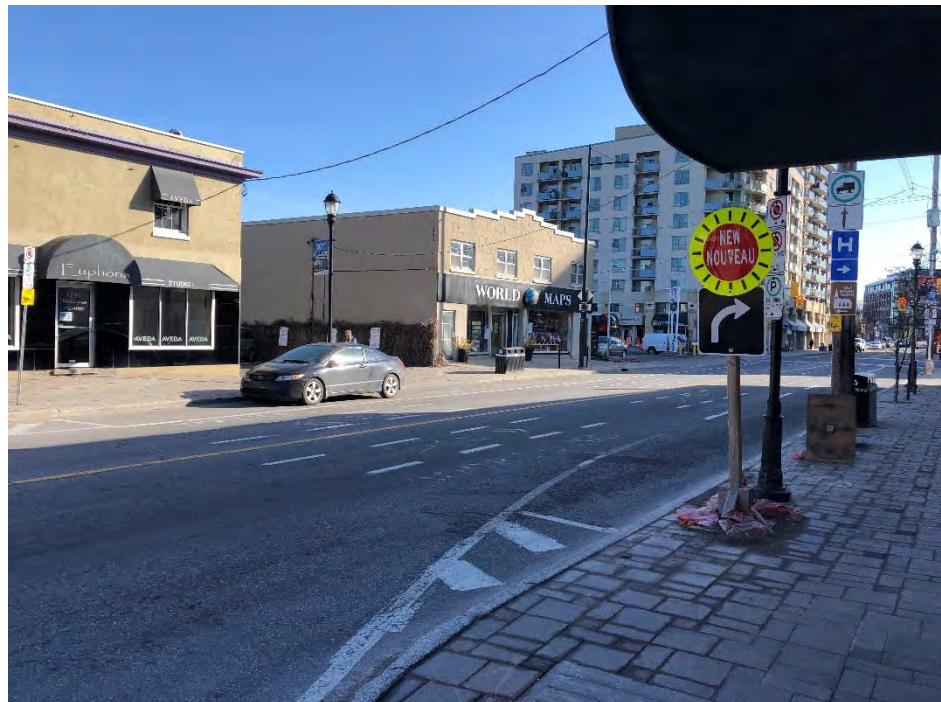
Photo No: 18

View showing commercial properties to the north of the site including gas station approximately 20 m north of the site.
