REPORT

Geotechnical Investigation
Barrett Lands - Phase 3 East
Proposed Residential Development
Findlay Creek

Golder Associates Ltd.

August 22, 2022

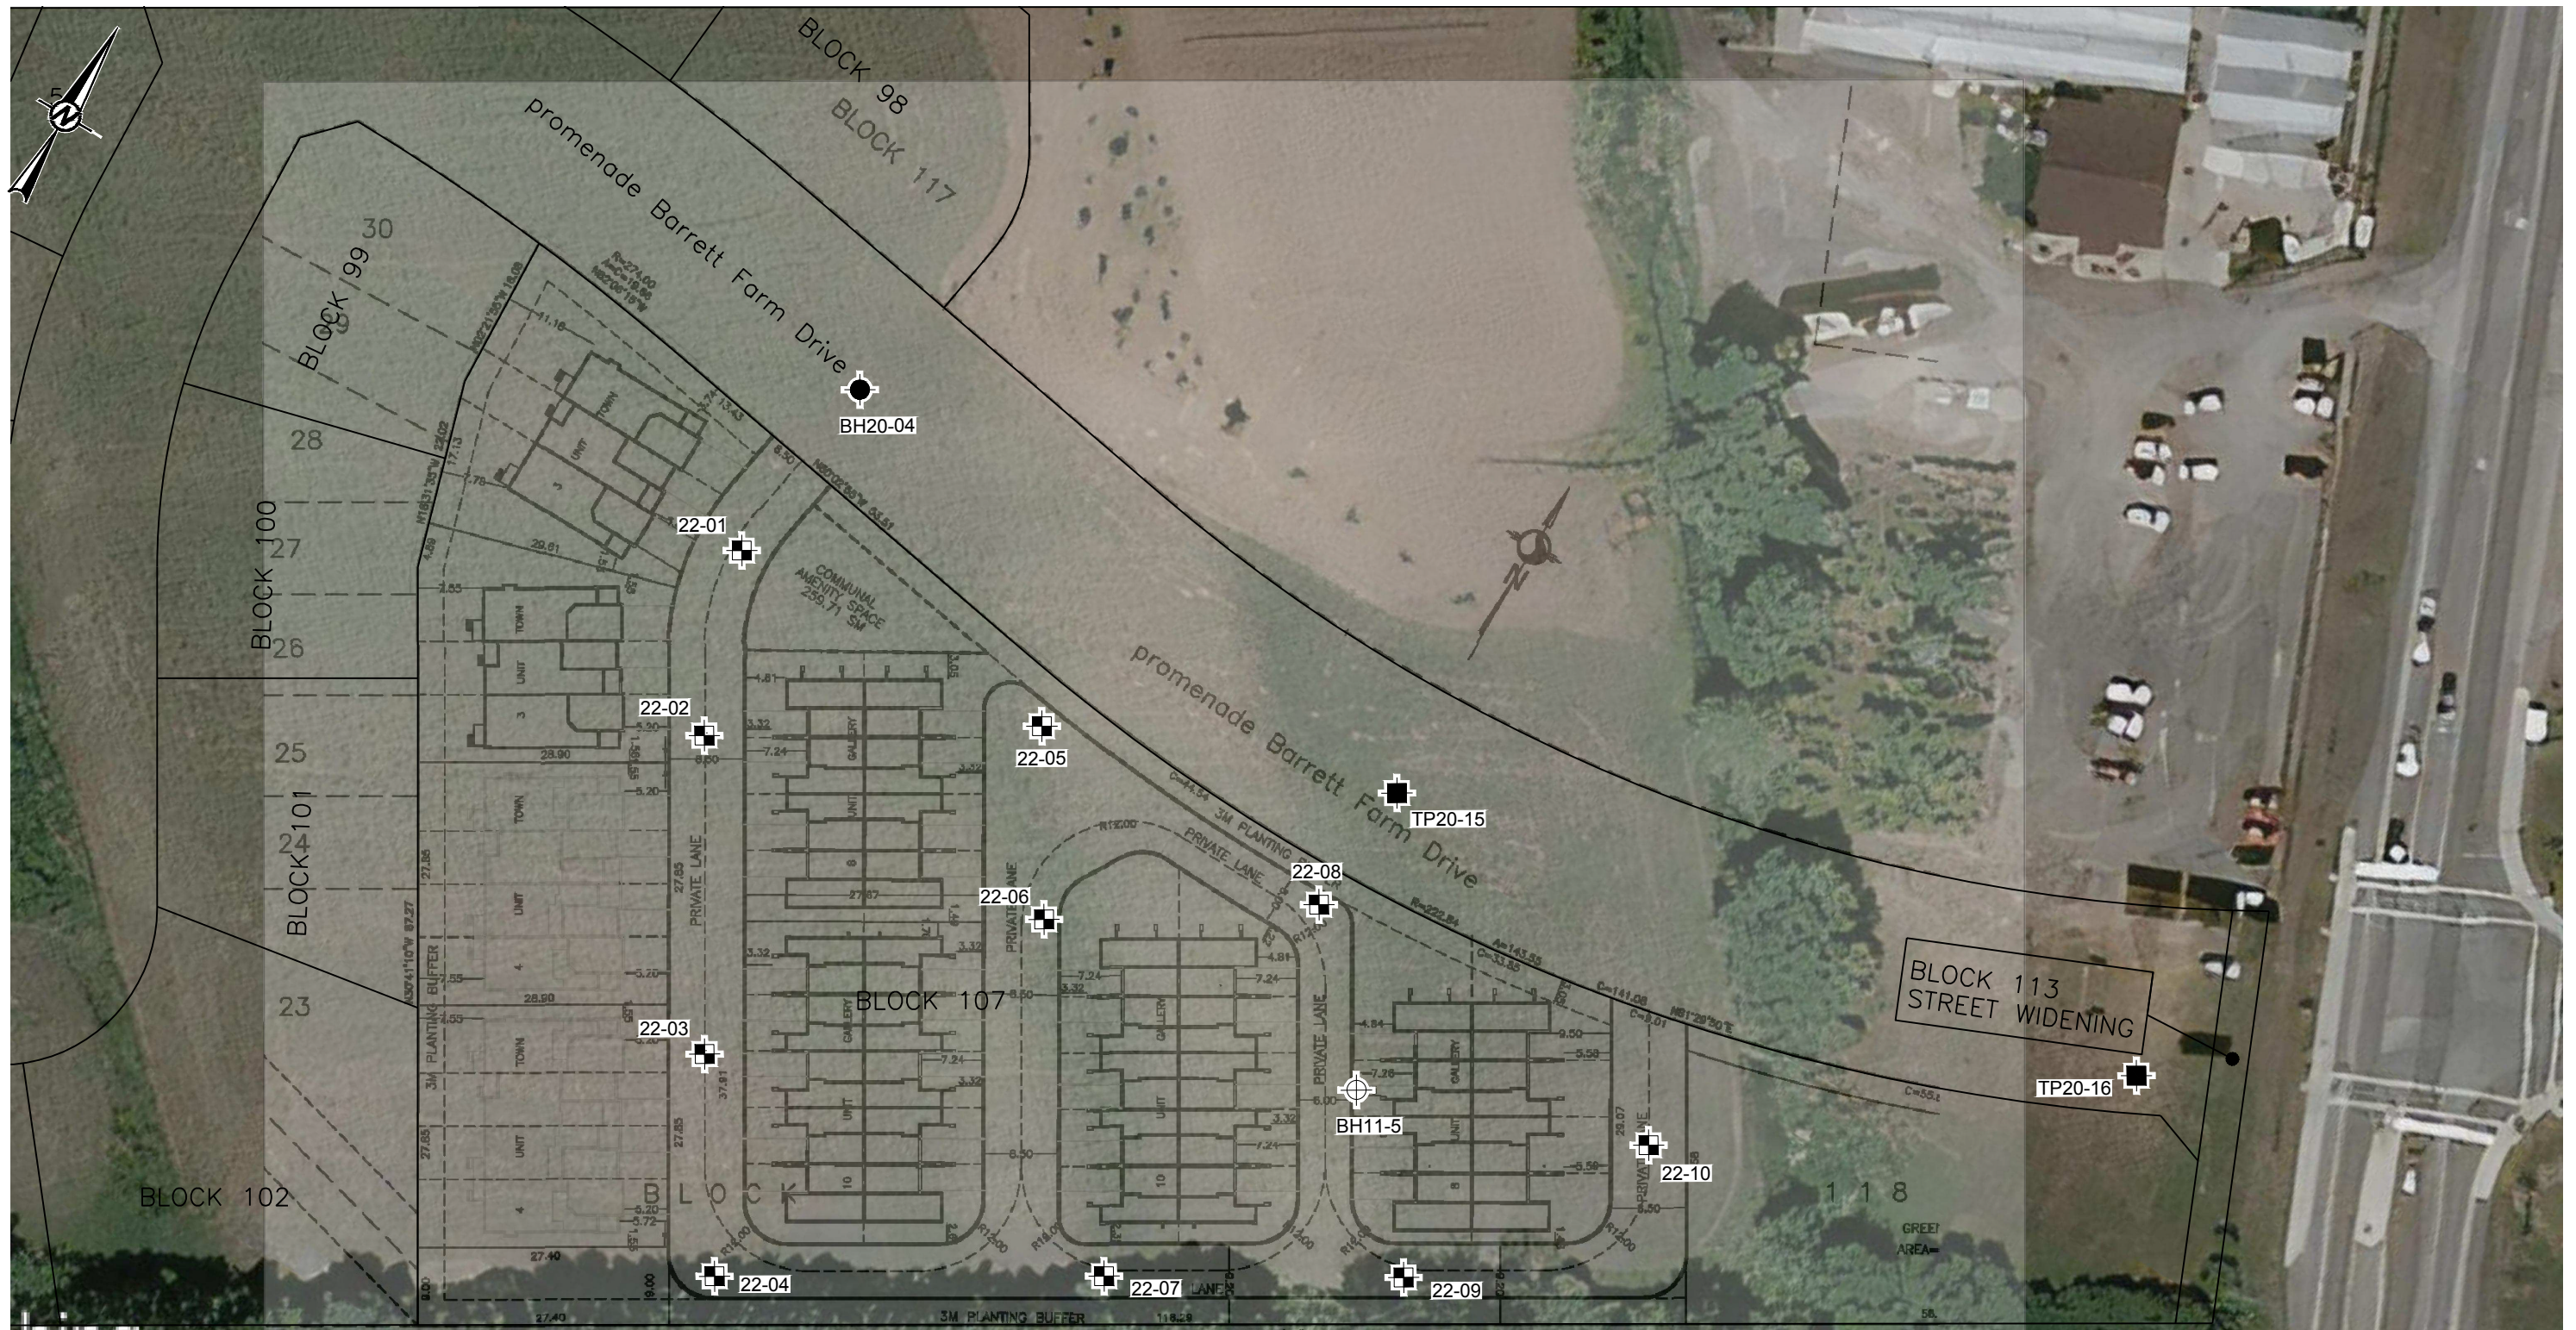
- LEGEND**
- SURVEYED TESTPIT LOCATION, CURRENT INVESTIGATION
 - APPROXIMATE TESTHOLE LOCATION, PREVIOUS INVESTIGATION (GOLDER ASSOCIATES REPORT No. 20442530)
 - APPROXIMATE BOREHOLE LOCATION, PREVIOUS INVESTIGATION (GOLDER ASSOCIATES REPORT No. 20442530)
 - APPROXIMATE TESTHOLE LOCATION, PREVIOUS INVESTIGATION (GOLDER ASSOCIATES REPORT No. 1111210198)
