# Geotechnical Investigation

## National Capital Business Park

Site 2 - 4120 Russell Road  
Ottawa, Ontario

Report PG4854-4 dated October 13, 2022

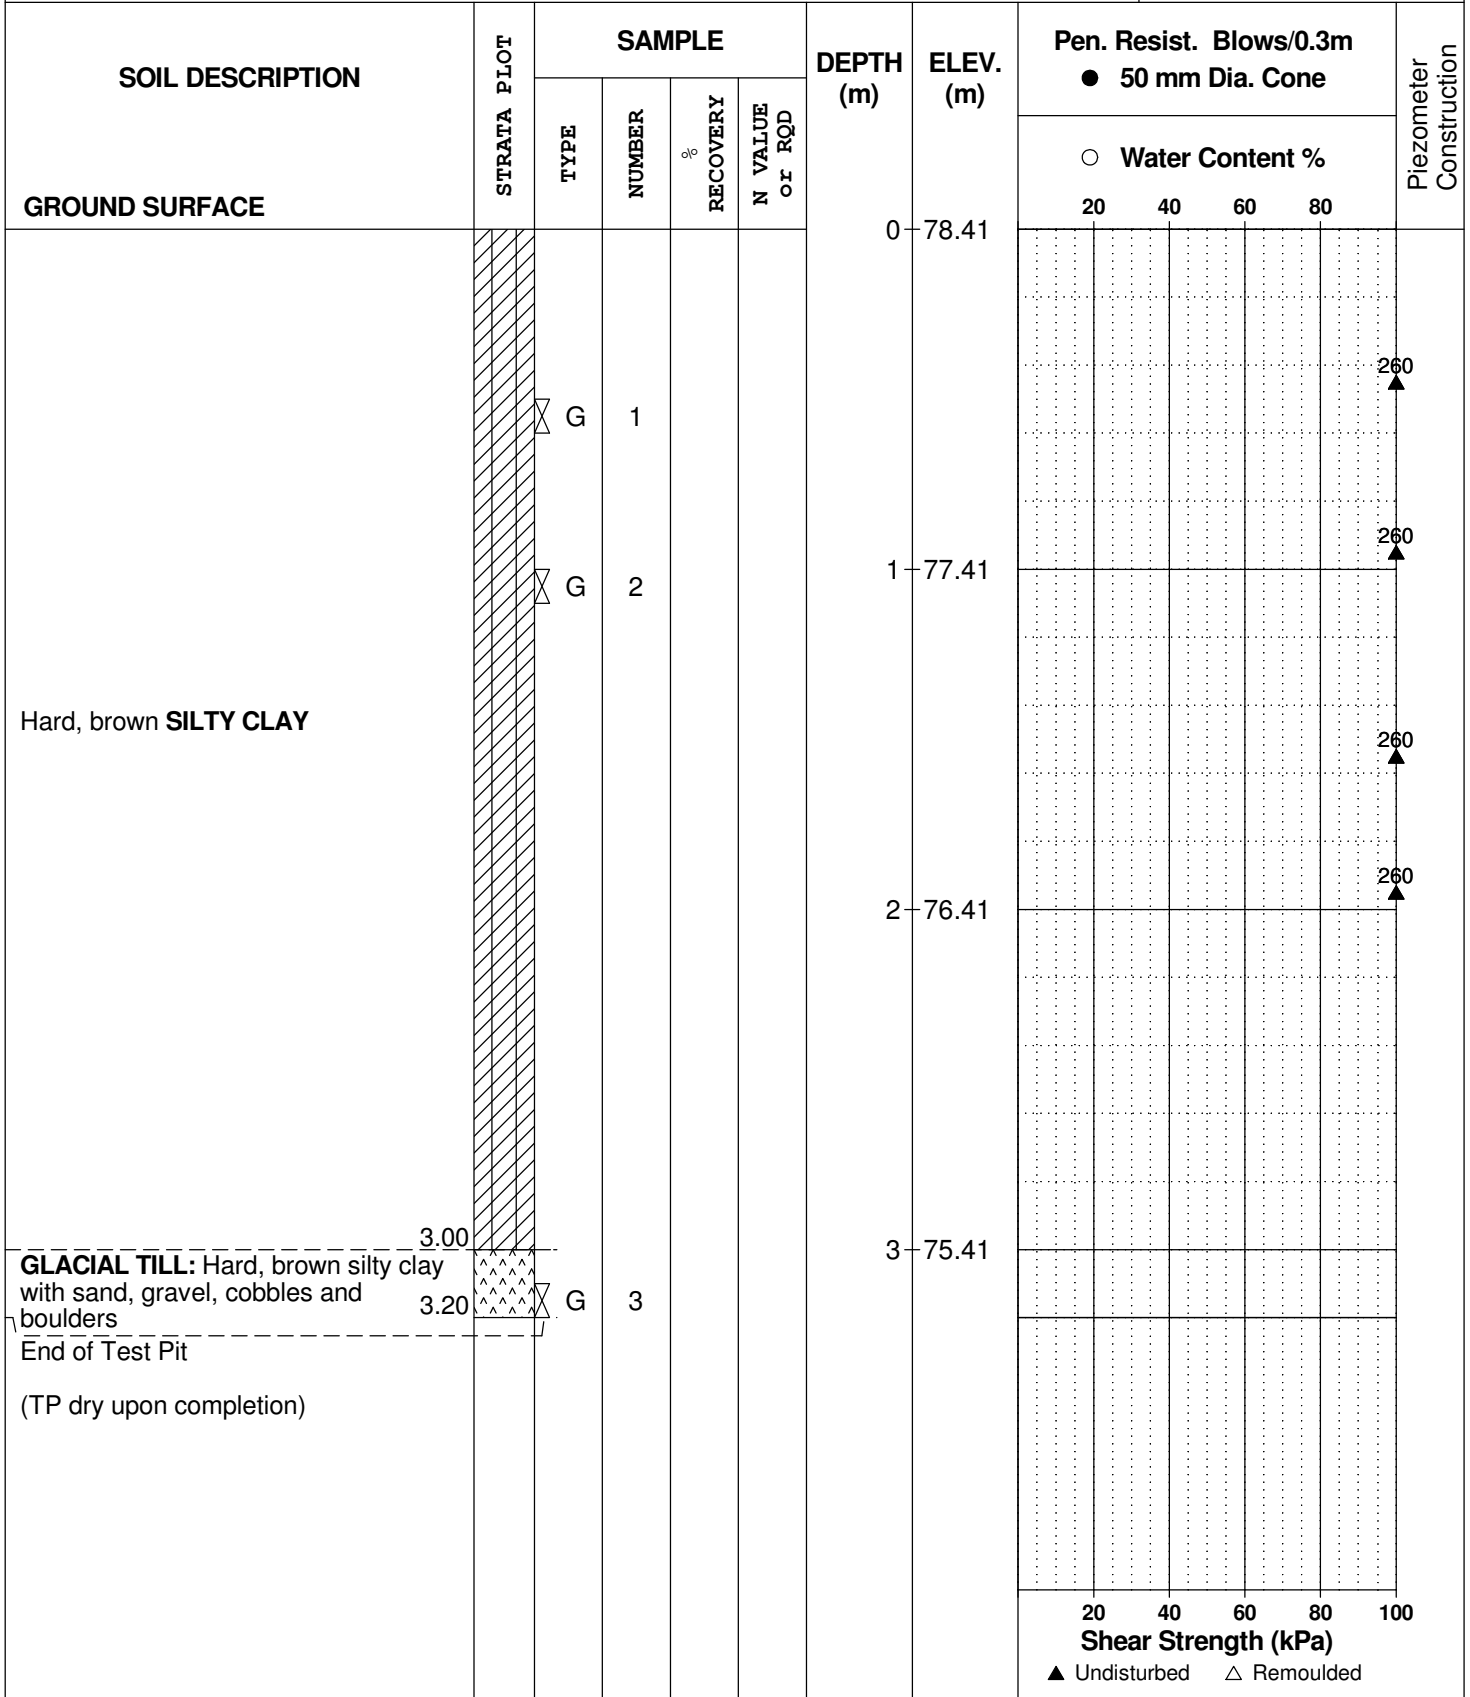
HOLE NO.  
**TP 1-22**

The subsurface conditions observed in the test holes were recorded in detail in the field. The soil profiles are logged on the Soil Profile and Test Data sheets in Appendix 1 of this report.

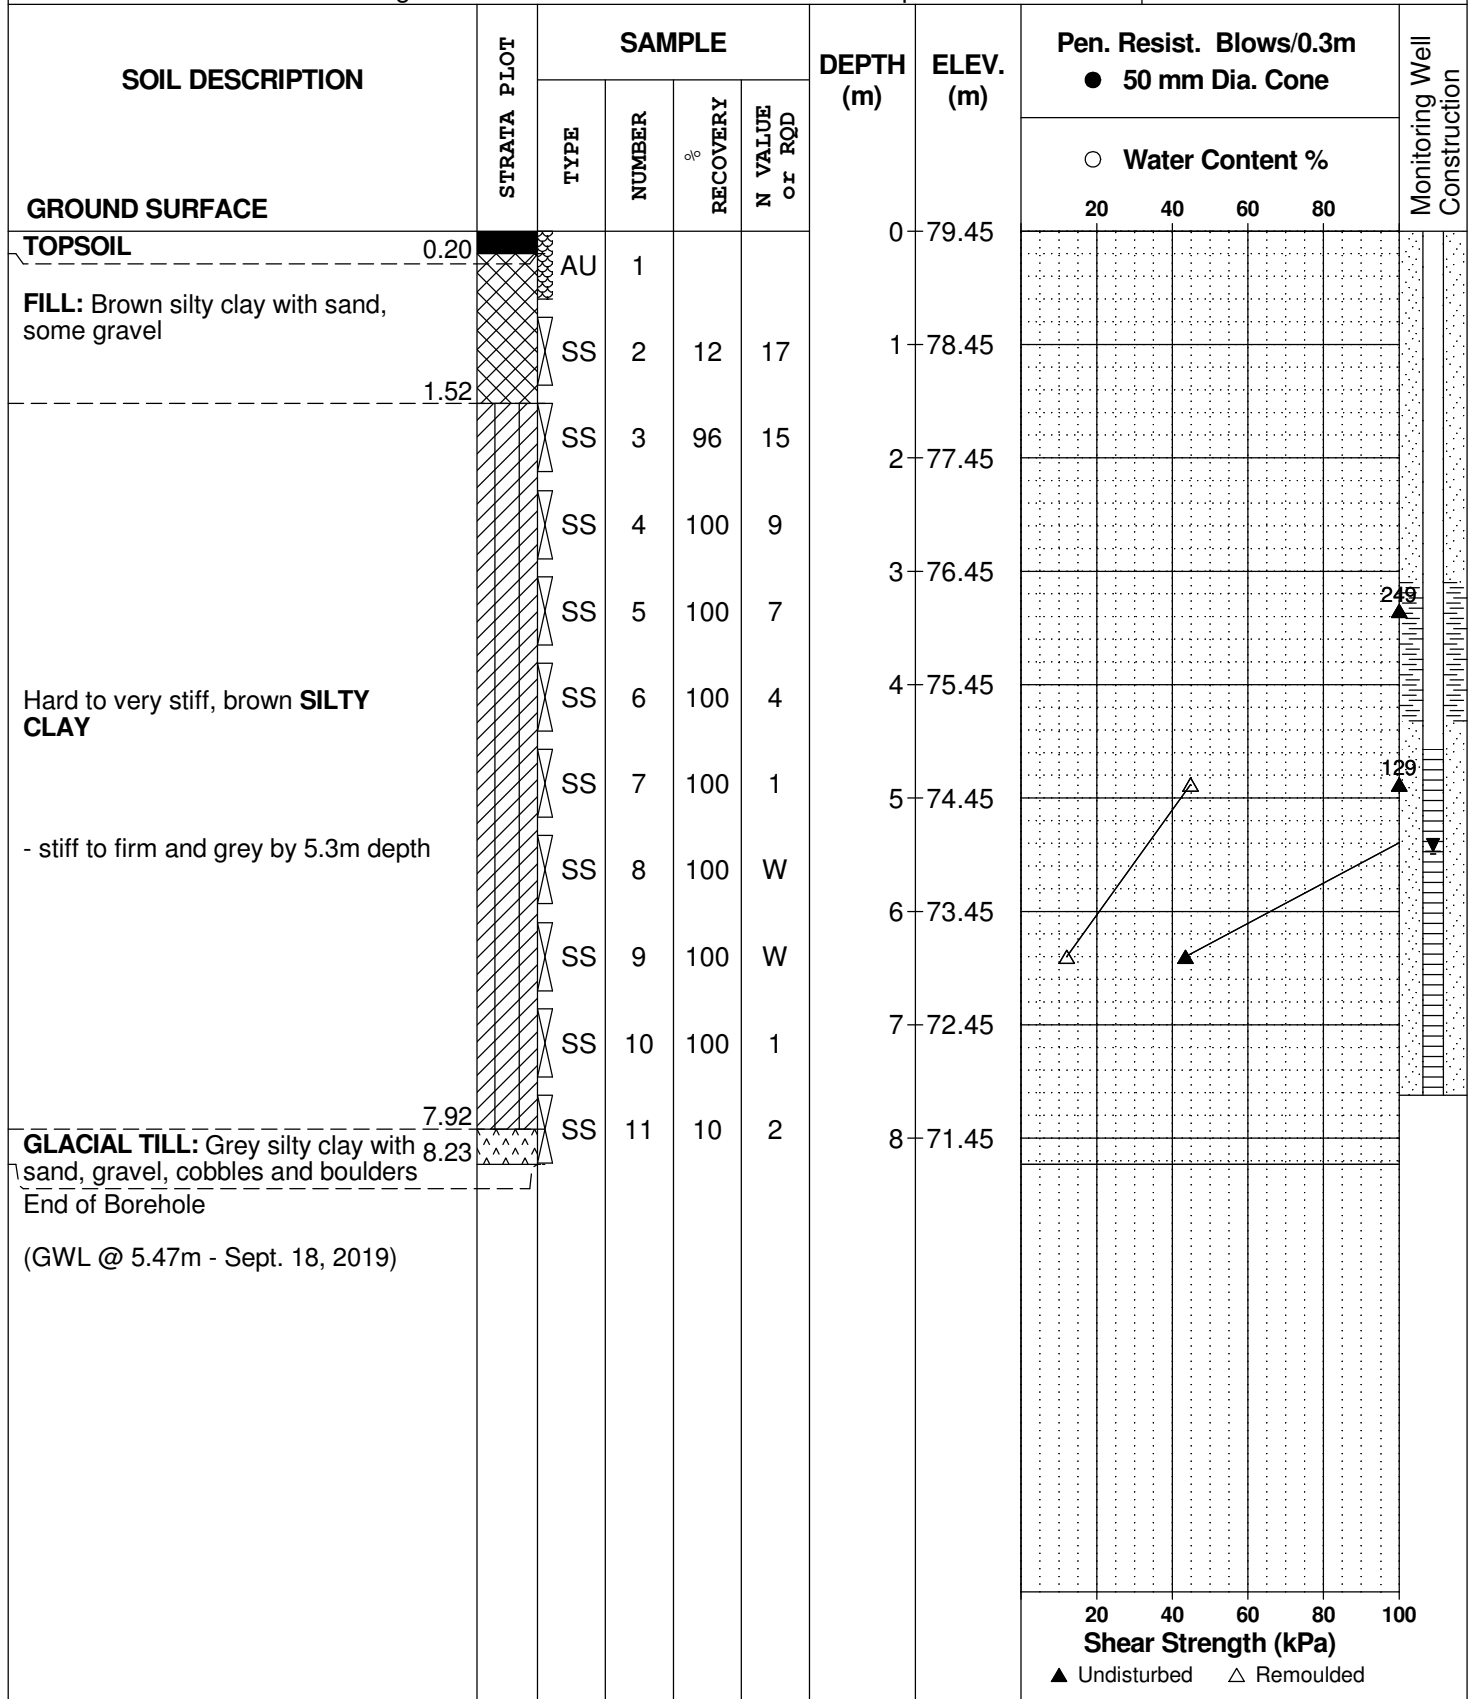
HOLE NO. **BH14**

Underlying the topsoil and/or fill, a hard to very stiff, brown silty clay deposit was encountered. At borehole BH 14, the silty clay was observed to become firm and grey below an approximate depth of 5.3 m.

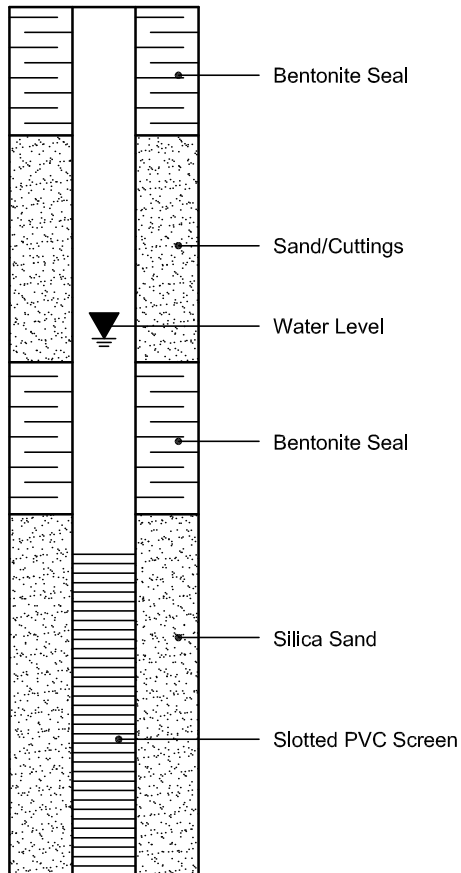
#### MONITORING WELL CONSTRUCTION

Open hole groundwater levels were recorded in the test pits. Additionally, monitoring wells were installed in boreholes BH 14 and BH 15, and standpipe piezometer was installed in borehole BH 16.

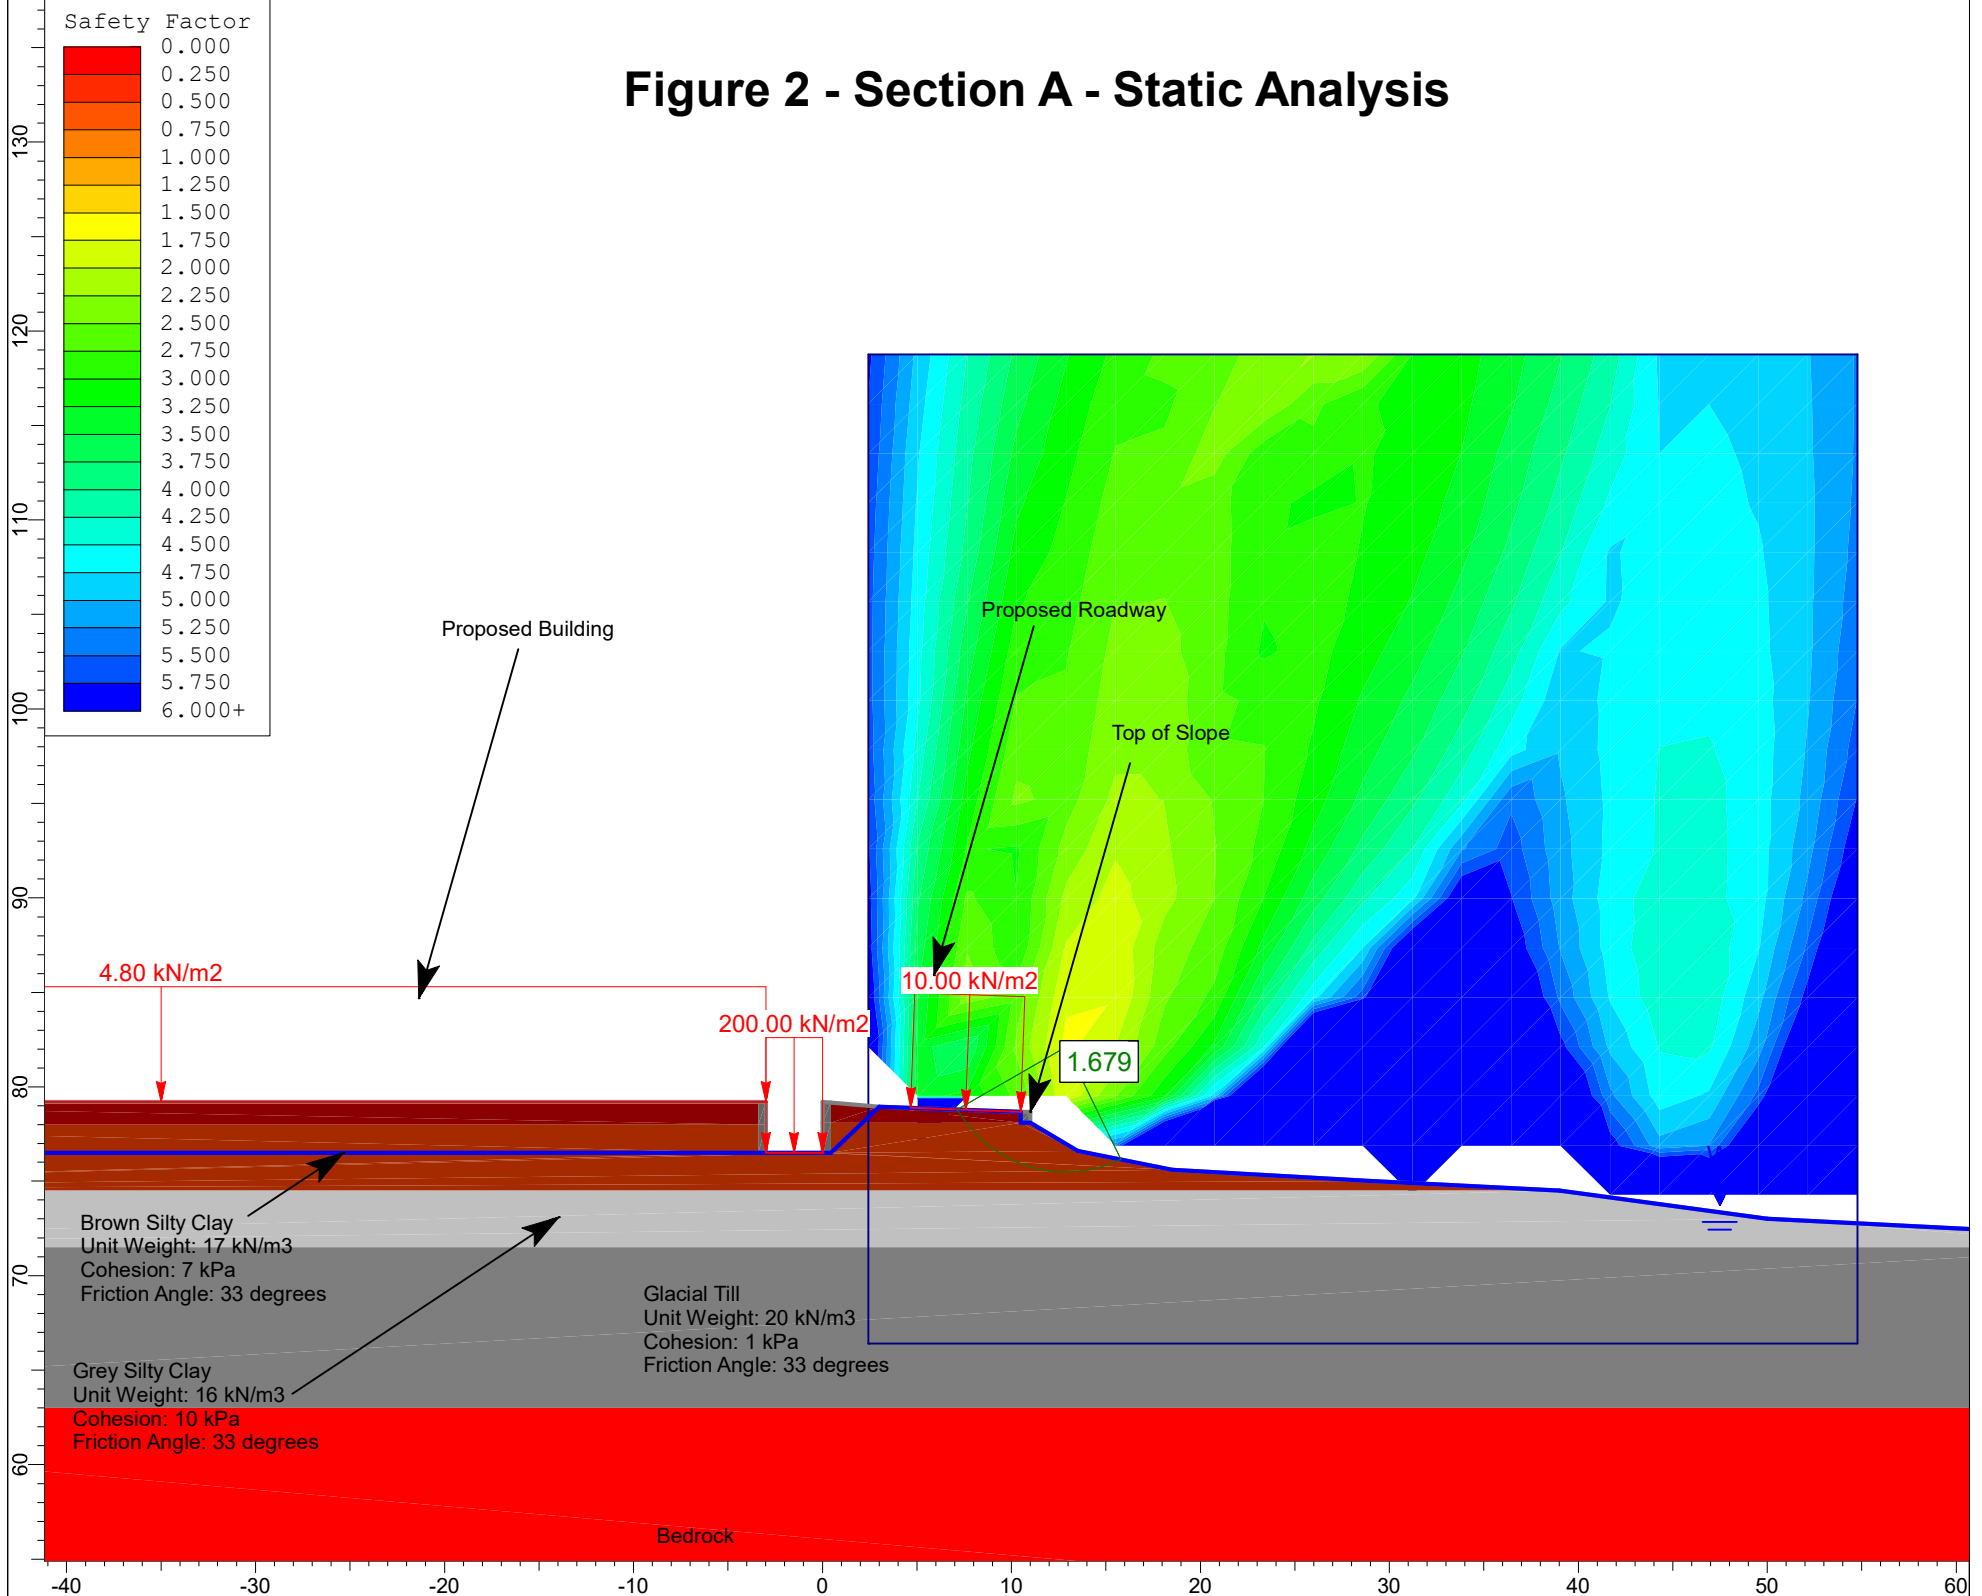
# Figure 2 - Section A - Static Analysis

The static analysis results for slope Sections A-A and B-B are presented on Figures 2 and 4, respectively, in Appendix 2. Based on the results, the factor of safety for the slope is greater than 1.5 for the proposed conditions under static analysis. Further, the results of the analyses with seismic loading for slope Sections A-A and B-B are presented on Figures 3 and 5, respectively, in Appendix 2. The results indicate that the factor of safety for the slope is greater than 1.1 for the proposed conditions under seismic analysis.

The slope stability analysis was modeled in SLIDE, a computer program which permits a two-dimensional slope stability analysis calculating several methods including the Bishop's method, which is a widely accepted slope analysis method. The program calculates a factor of safety, which represents the ratio of the forces resisting failure to forces favoring failure. Theoretically, a factor of safety of 1.0 represents a condition where the slope is stable.

As noted above, 2 slope cross-sections (Sections A-A and B-B) were studied as the worst case scenarios. It should be noted that details of the slope height and slope angle at the cross-section location under proposed conditions are based on the available grading plan for the proposed development.

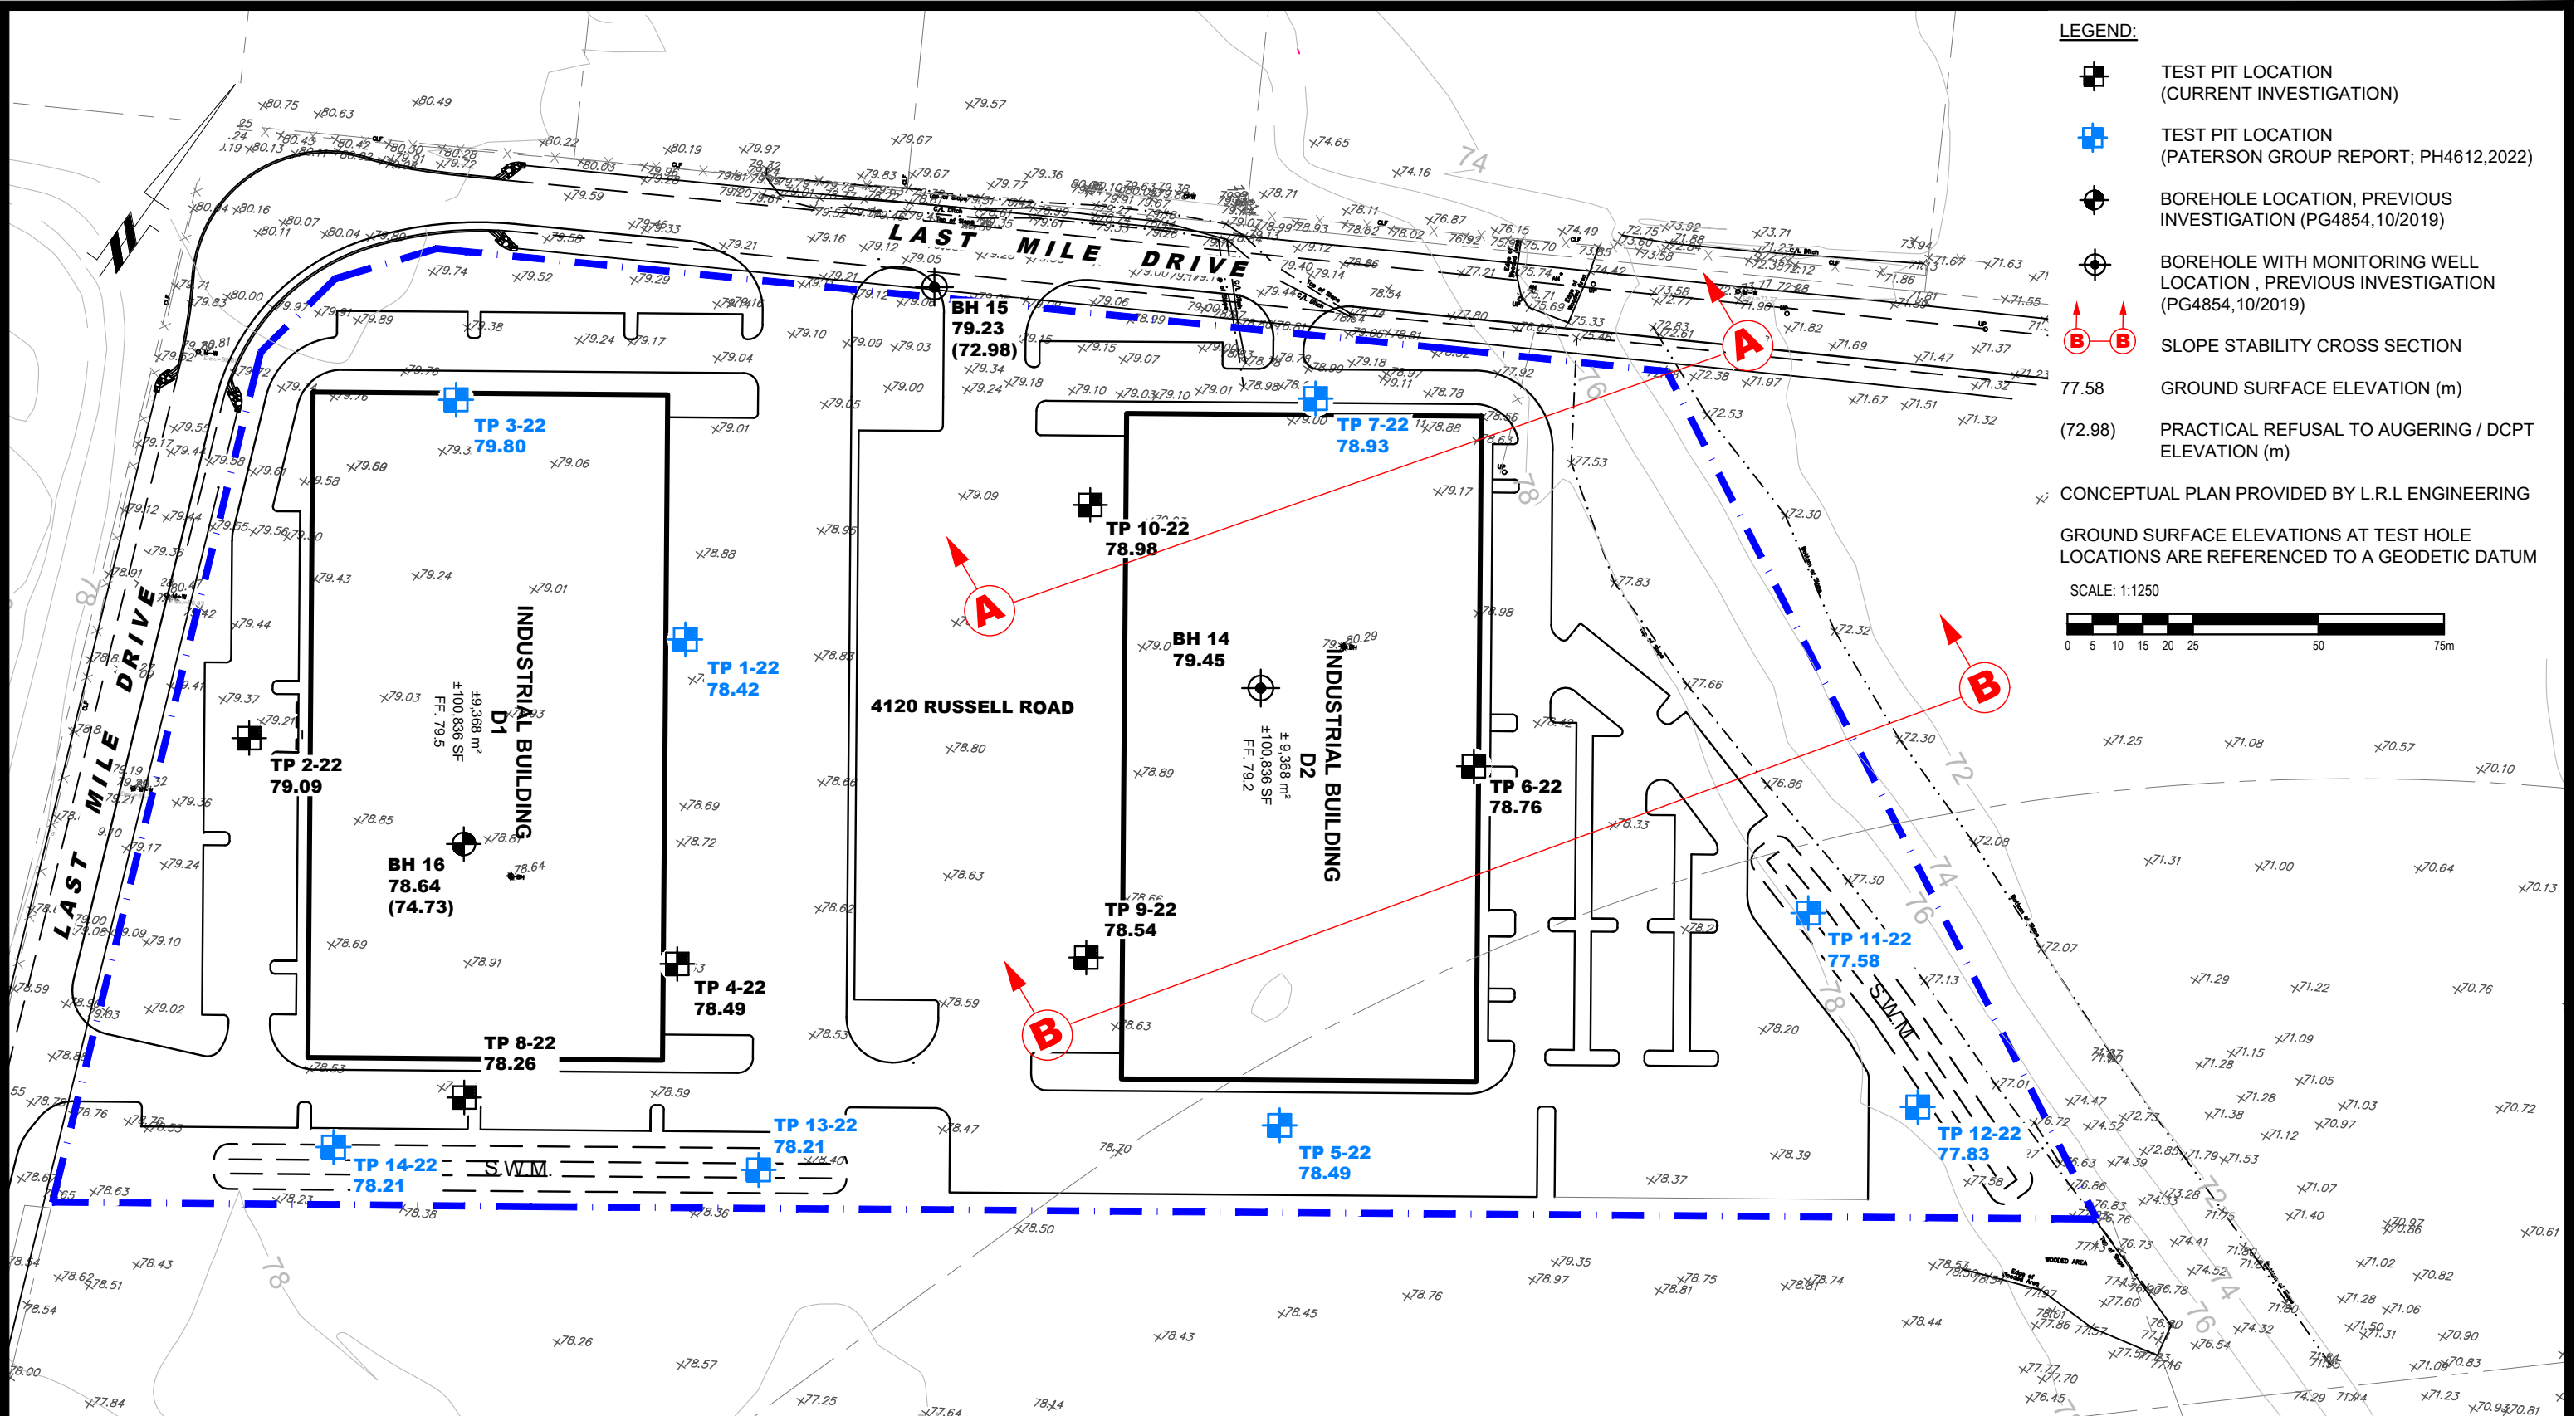
DRAWING PG4854-12 - TEST HOLE LOCATION PLAN

The test hole locations, and the ground surface elevation at each test hole location, were surveyed by Paterson using a GPS unit with respect to a geodetic datum. The locations of the test pits and ground surface elevation at each test pit location are presented on Drawing PG4854-12 - Test Hole Location Plan in Appendix 2.

The slope conditions were reviewed by Paterson field personnel on-site during the recent geotechnical investigation. Two (2) slope cross-sections at the eastern boundary of the site were studied as the worst-case scenarios for the subject site. The cross-section locations are presented on Drawing PG4854-12 - Test Hole Location Plan, attached in Appendix 2.
