Hydrogeological Investigation &
Terrain Analysis
Proposed Commercial Building
4 Campbell Reid Court
Ottawa, Ontario

August 30, 2023 Project: 65103.01

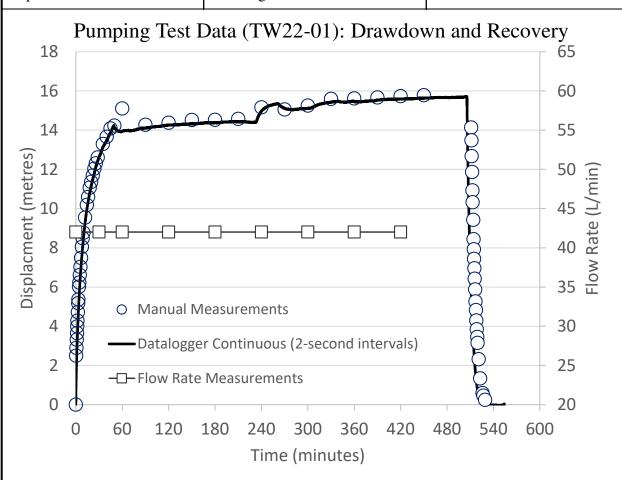
Water Levels TW22-1

Static: 1.26 m below top of casing TOC = 0.59 m above ground surface

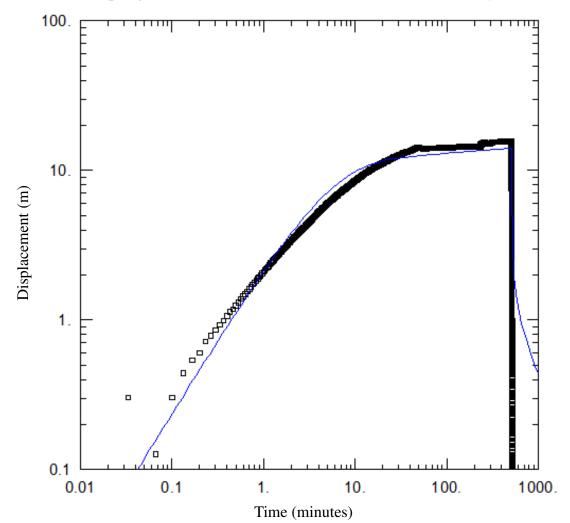
Pumping Test Data (TW22-01): Drawdown Analysis

Transmissivity: 5 m²/day (6 x 10⁻⁵ m/s)

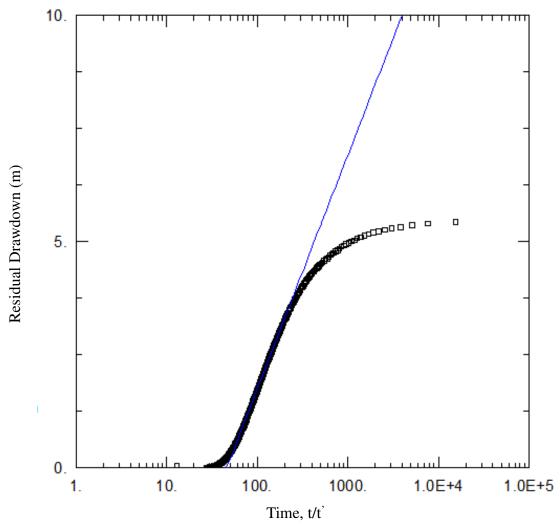
Pumping Test Data (TW22-01): Recovery Analysis

Transmissivity: 2 m²/day (2 x 10⁻⁵ m/s)
