Phase I Environmental Site Assessment

357, 361 and 363 Preston Street
Ottawa, Ontario

Report: PE5699-1
July 4, 2022

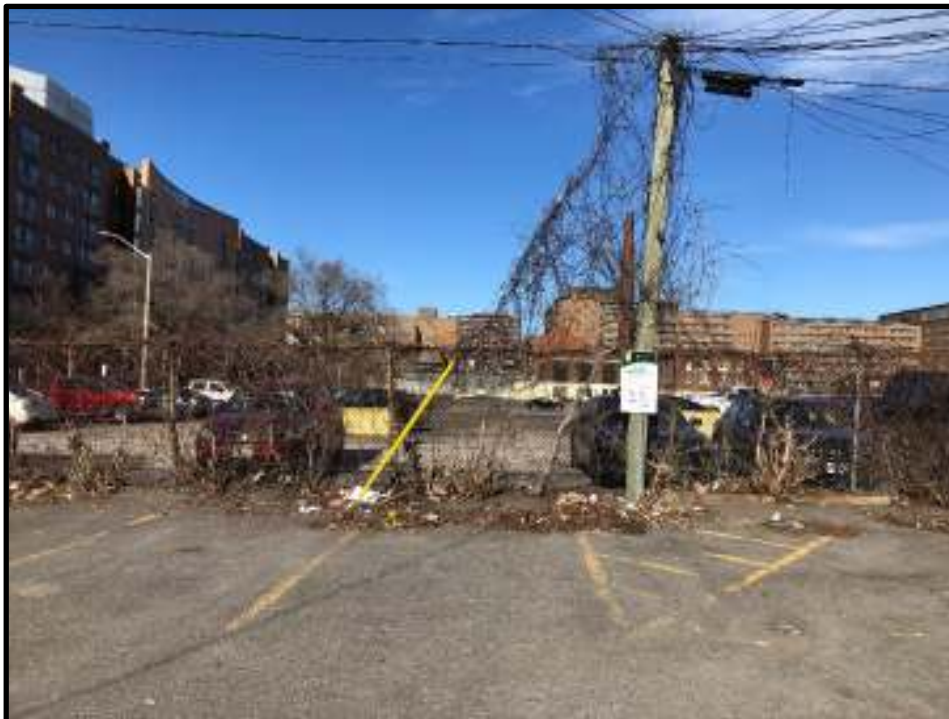
Photograph 4: View of the eastern portion of the Phase I property, looking to east from within the Phase I property.
